Lee County
Southwest Florida

**FINAL
POST STORM FLOOD ASSESSMENT
ANALYSIS**

**Bayshore Creek Watershed
Nalle Grade Road
Popash Creek Watershed
Strouds Creek Watershed
Whiskey Creek Watershed**

FEBRUARY 28, 2018

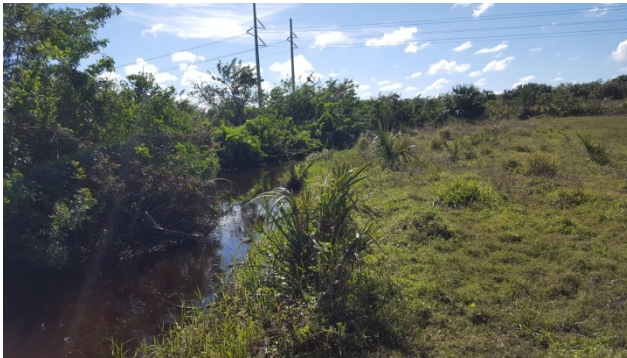
*Data Point 188 Lat: 26.70985 Long: -81.81587

- South of the FPL easement until the Caloosahatchee River requires assessment by other means of foot to verify no damage.

Looking south just before access was lost by foot.

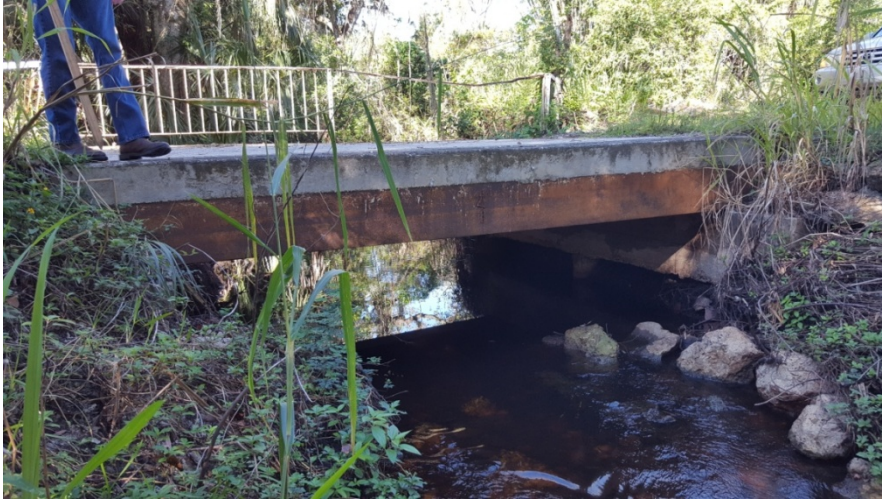
*Data Point 173 Lat: 26.71338 Long: -81.81967

Picture shown is looking west of the driveway being clear of debris.

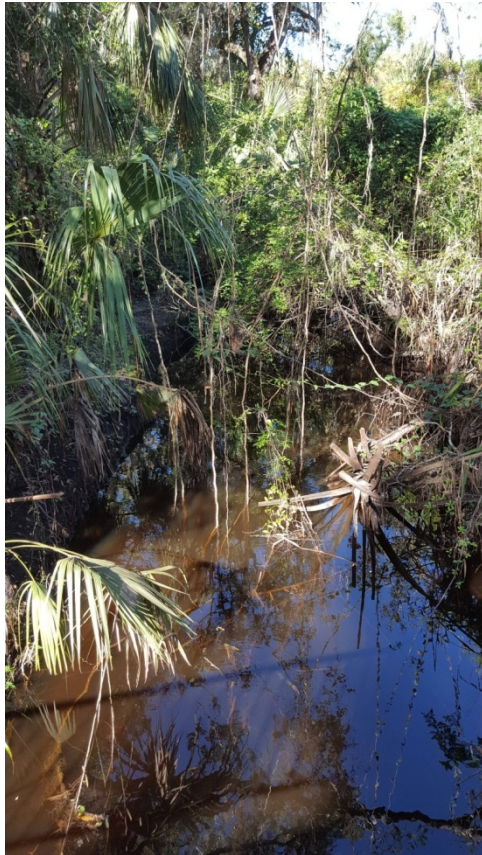
*Data Point 172 Lat: 26.71338 Long: -81.8196

Overgrown vegetation that will conflict with flood water levels looking west.

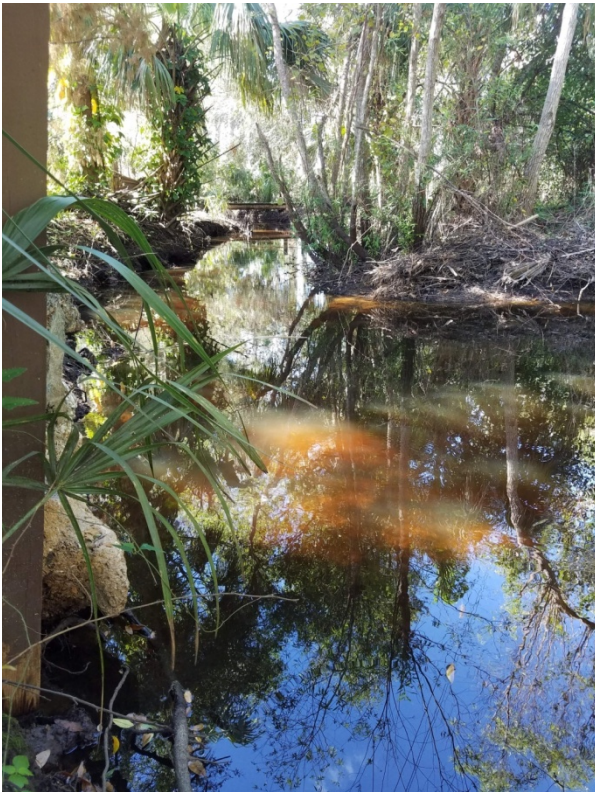
*Data Point 194 Lat: 26.71876 Long: -81.82204

- Upstream from this point was inaccessible via foot and should be observed to ensure optimum flow conditions.

Clear conditions of Bayshore Creek looking south.

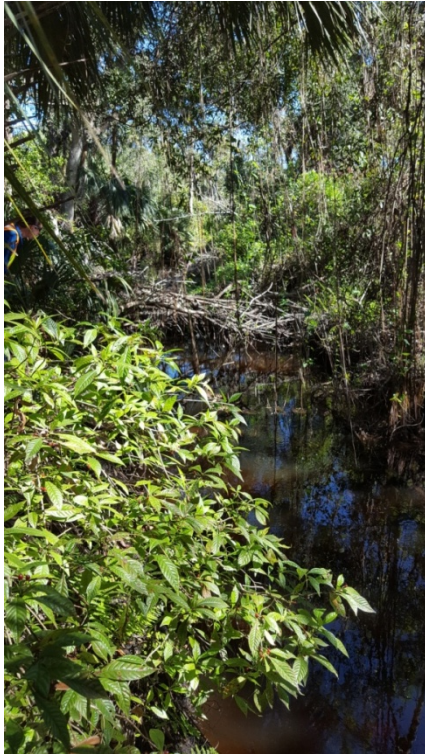
Overgrown vegetation on Bayshore Creek looking upstream. *Data Point 197 Lat: 26.72087 Long: -81.8229

- Once the vegetation is cleared downstream, flows should be evaluated to see if flows have increased.

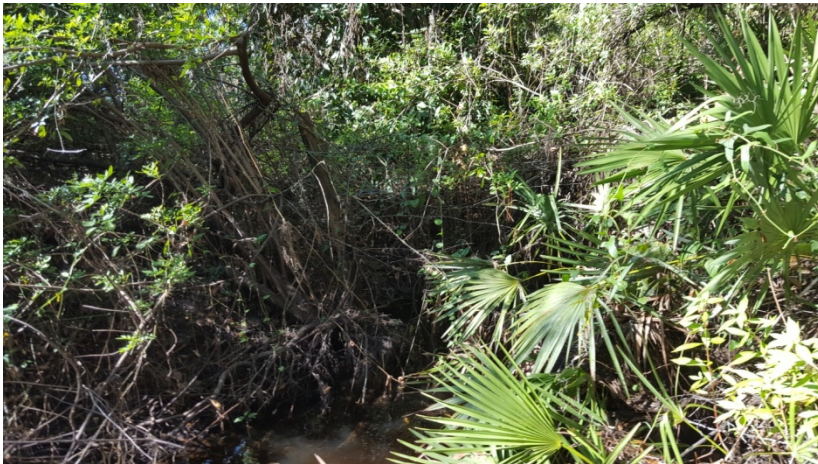
*Data Point 197 Lat: 26.72087 Long: -81.82293

Overgrown vegetation on Bayshore Creek looking downstream.

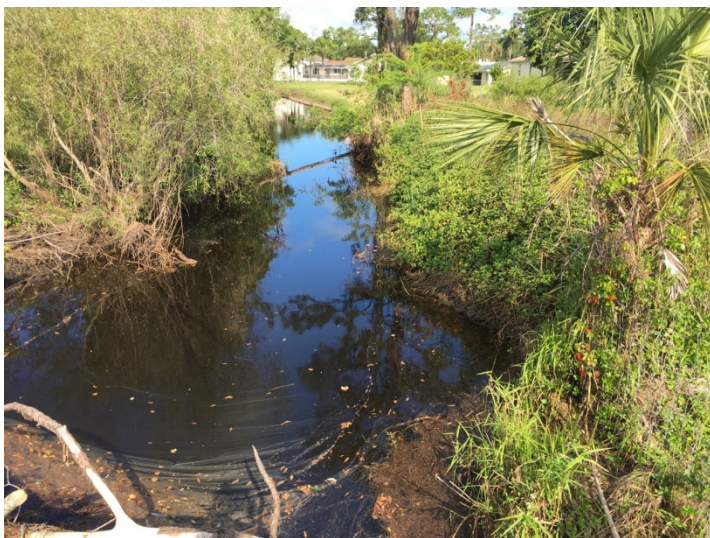
This picture is looking north upstream and showing clear conditions.
*Data Point 1525 Lat: 26.72235 Long: -81.82409

- The creek up and downstream views are clear of debris and vegetation. Although, some debris was collected at the culvert and chocking the optimal flow conditions.

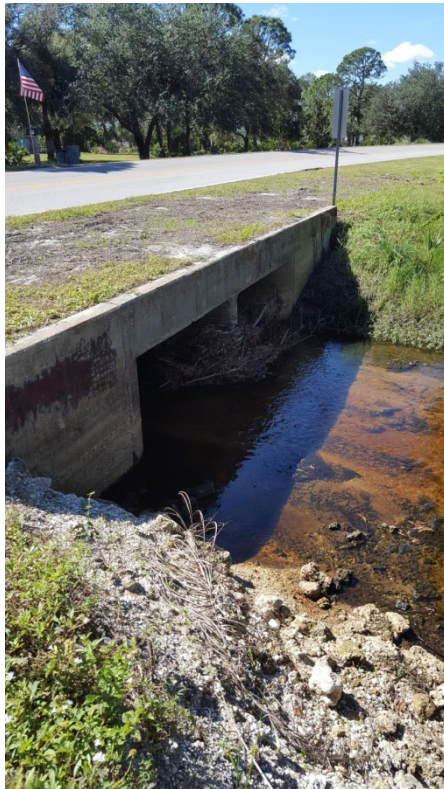
Debris under the road crosses culverts.
*Data Point 1497 Lat: 26.7255 Long: -81.8249

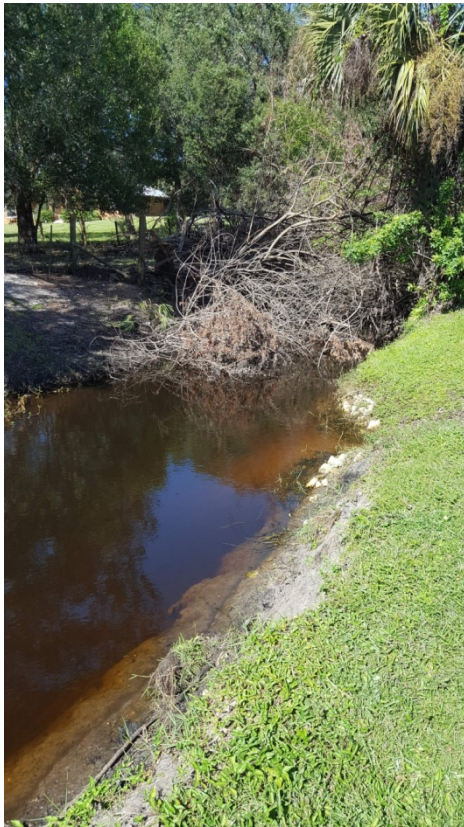
*Data Point 206 Lat: 26.7278 Long: -81.8251

- The creek was assessed as far as possible. It had clear conditions until it passed a retention lake. Evaluation was inaccessible from this point upstream.

Picture shown is looking north behind
Boonesboro Road

- Once the vegetation is cleared, downstream flows should be evaluated to see if they have increased.

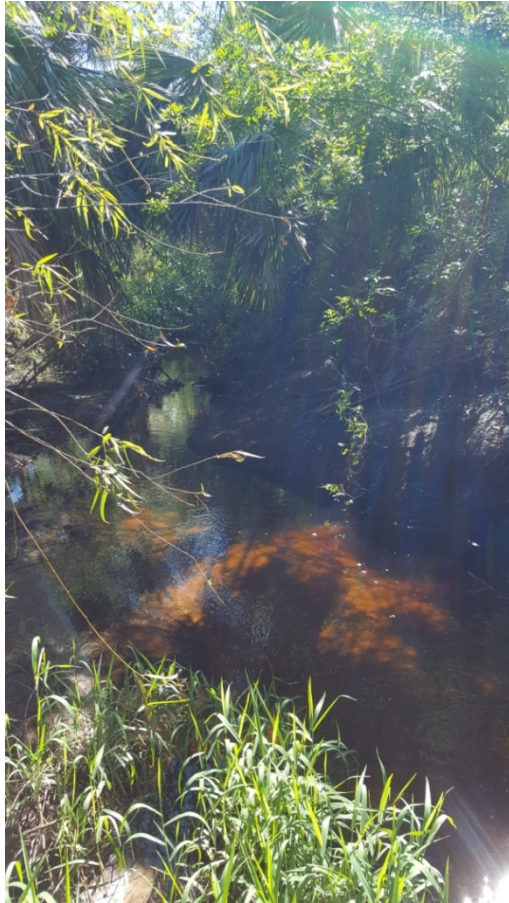
- Conditions along Hunters Glen Road were in moderate shape. Although there was over hanging vegetation, only minor debris would impact flow conditions.

The picture is looking south of Bayshore Creek. *Data Point 211 Lat: 26.731 Long: -81.8256

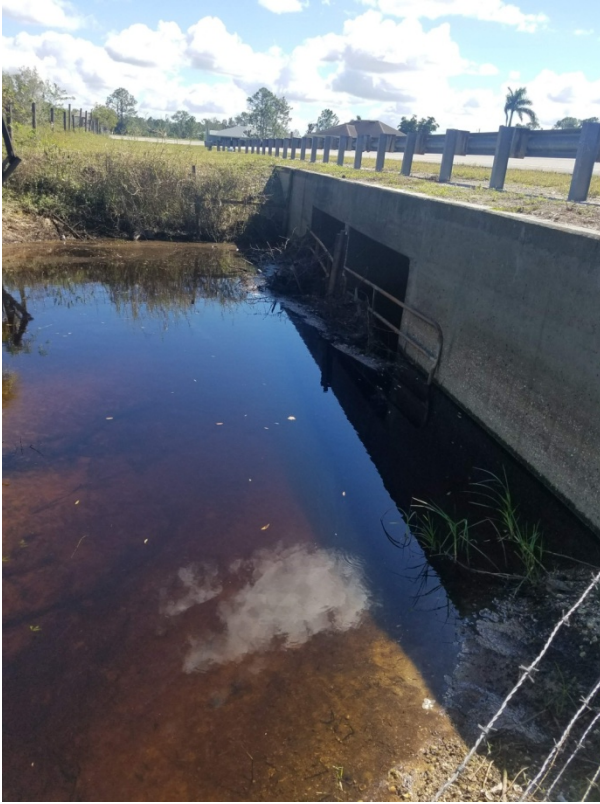
- The creek up and downstream views are clear of debris and vegetation. Although, some debris was collected at a gate at the road culvert's north side and choking the optimal flow conditions.

Gate with debris blocking flows at Pritchett Parkway. *Data Point 1499 Lat: 26.7638 Long: -81.8247

- If the gate is required, find an alternative solution so that it doesn't collect debris and block the flow path.

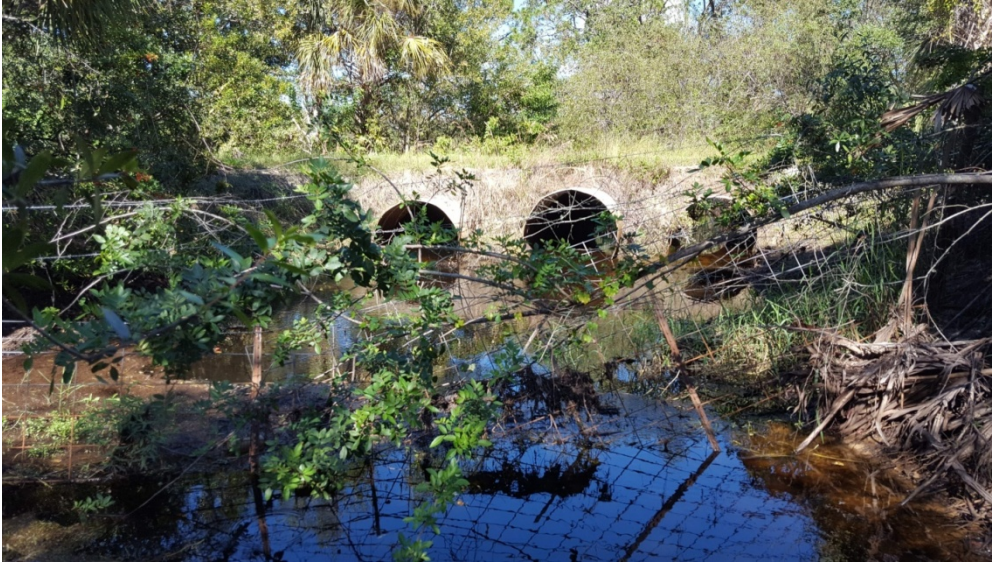
- The crossing at Rich Road contained 3 CMP. Although the CMP's were in good condition, a fence on the south side of the crossing was holding a lot of debris. In addition to this, the north side of the crossing was overgrown with vegetation also restricting flow.

The picture is showing the south side of Rich Road crossing. *Data Point 212 Lat: 26.7389 Long: -81.8228

- Replace fence on the south side of the crossing.
- 500 lineal feet of vegetation removal.

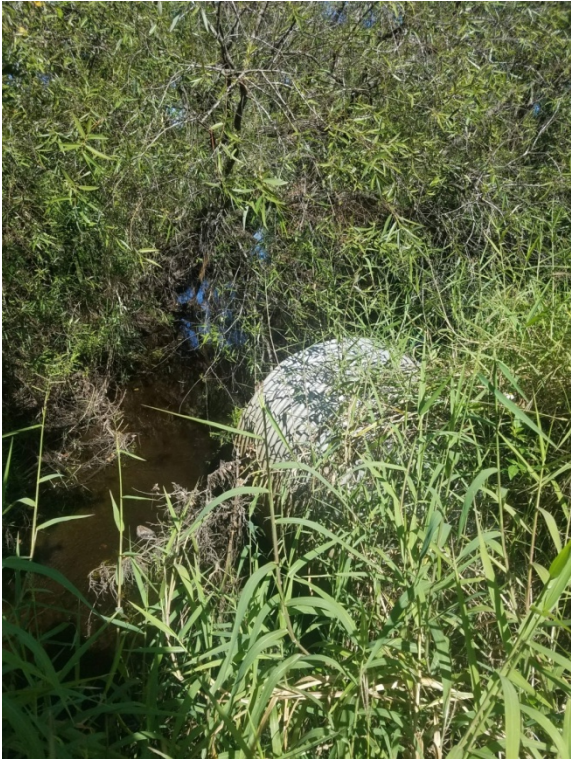
The picture shown is looking north on the north side of Rich Road crossing. *Data Point 215 Lat: 26.7389 Long: -81.8228

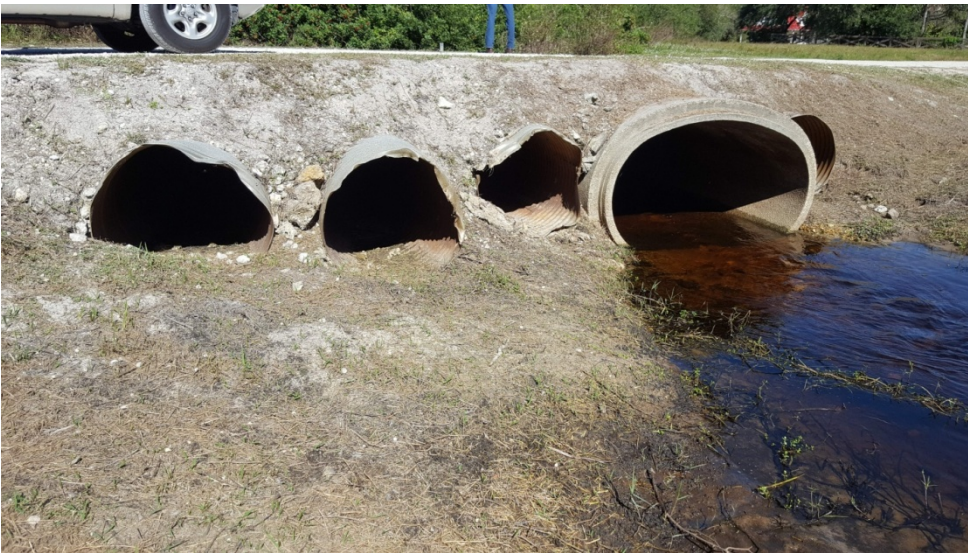
- The cross culverts at this section are in poor conditions. The RCP is in full working condition but the four excess flow CMP's are serving minimal purpose. The north side of this crossing was heavily overgrown with vegetation and effecting flow patterns.

This picture is looking north on the south side of Henderson Grade. *Data Point 219 Lat: 26.7426 Long: -81.8186

- 500 lineal feet of vegetation removal.
- Replace the 4 CMP's with a more effective pipe.

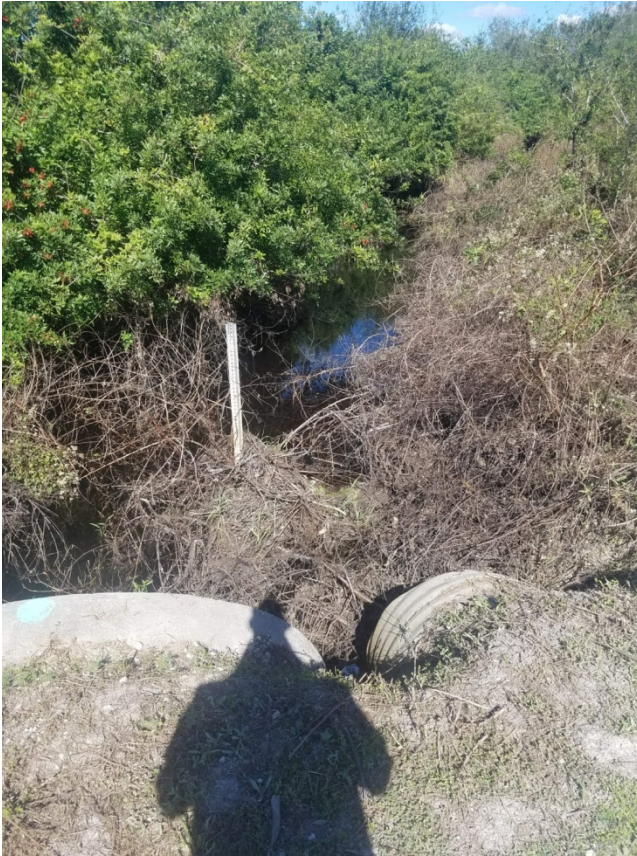
This picture is looking north on the north side of Henderson grade showing the overgrown vegetation.
*Data Point 216 Lat: 26.7426 Long: -81.8186

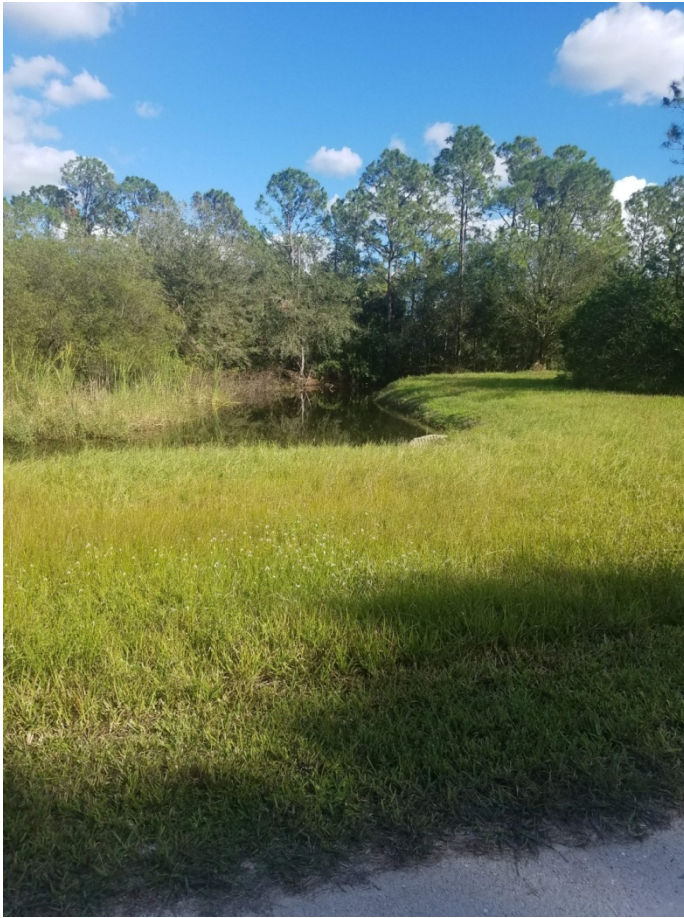
- The creek was inspected going through Nalle Grade Park. The conditions of the creek were clear and ideal. Hole Montes, Inc. spoke with a park representative and he said that the only issue that occurred during the past events happened at the entrance where Bayshore Creek reaches Nalle Grade Road. No flooding occurred throughout the park. Please refer to Nalle Grade Road report for this section's assessment.

Shown are the typical clear conditions of Nalle Grade Park. *Data Point 226 Lat: 26.7524 Long: -81.8186

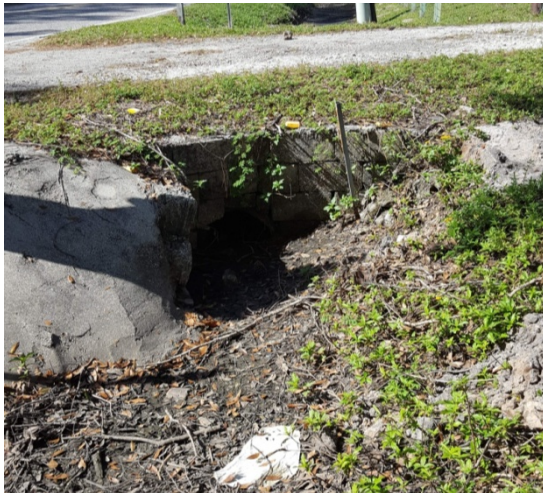
*Data Point 299 Lat: 26.7553 Long:-81.8560

Typical driveway culvert partially filled with sediment in poor conditions.

- Maintenance is required to clear over growth at the West ditch access to Daughtrey's Creek.
- 150 lineal feet of driveway culverts to be cleared of sediment build up.
- 3 driveway culverts require replacement.

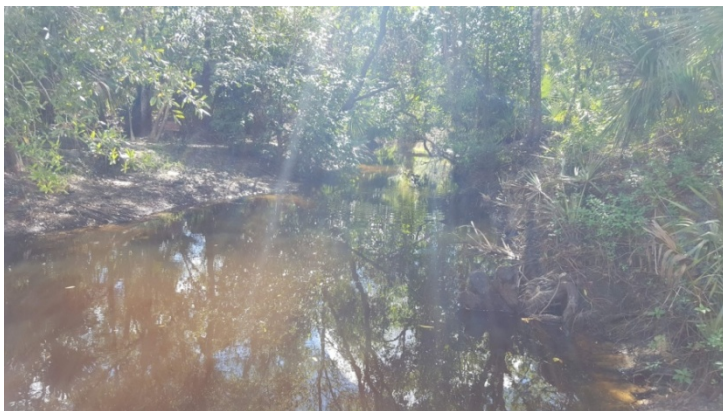
From Daughtrey's Creek Bridge looking South downstream.
*Data Point 1533 Lat: 26.7553 Long:-81.8514

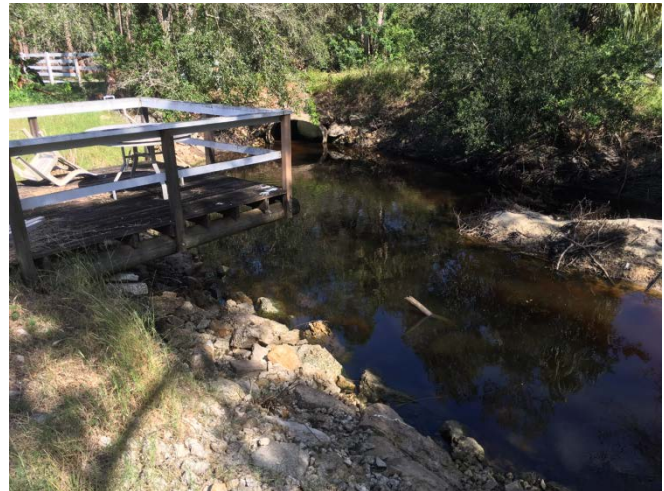
Looking North at resident’s driveway access.
*Data Point 2084 Lat: 26.7568 Long:-81.8503

- The area upstream needs to be evaluated to calculate what size pipes will be sufficient.

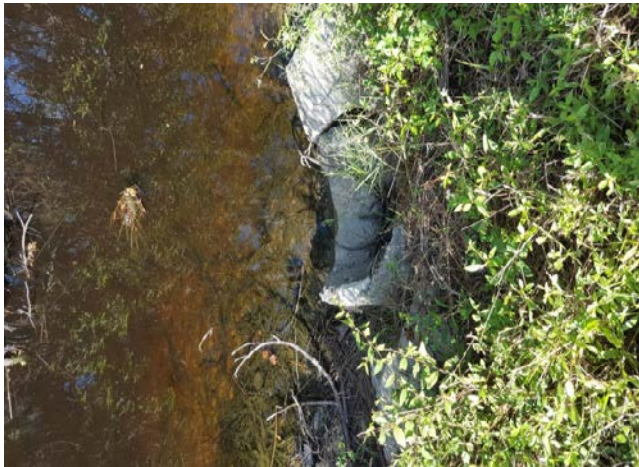
- Flow is restricted to move only eastward. Some survey elevations could verify if it is elevation issues forcing irregular flow patterns.

North/south culvert not accepting water due to high invert.
*Data Point 1588 Lat:26.7554 Long: -81.8341

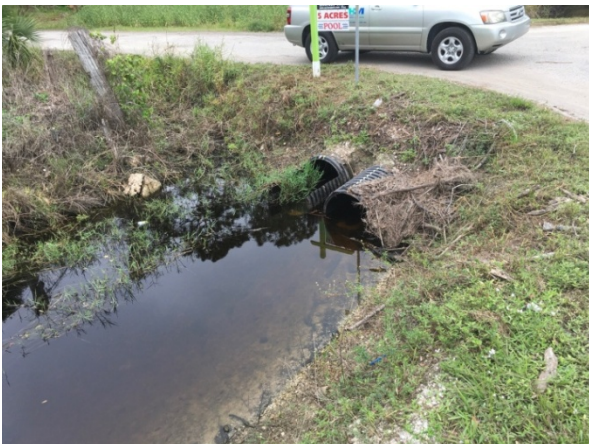
West side of Nalle Grade Road and Bowen Road.

- This intersection contains 2-24" cross culverts. The culverts conditions were clear of debris and sediment, but the flow was eastward while the pipe slope was westward. There was 9-10" of water flowing East on the west invert while only 3" of water flowing East on the east invert. Also, due to scouring a sediment weir has formed choking the flow of water downstream. Due to erosion and sediment build up, there is no access to drain South at this point.

- Check elevations and see if this is the highest point that may cause problems to drying out.

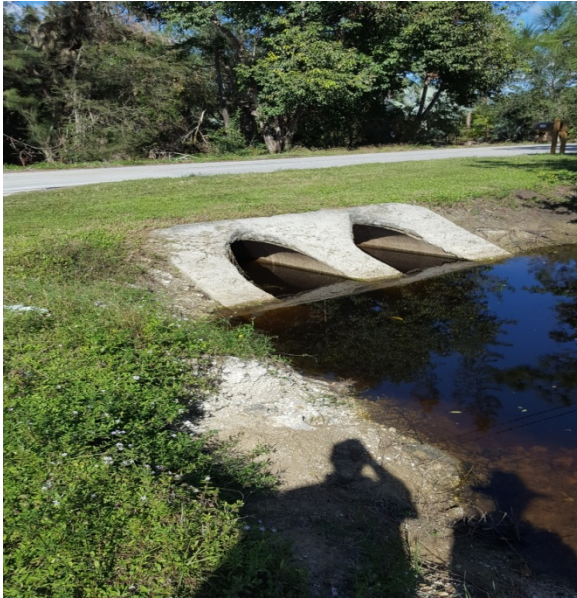
South of Nalle Grade Road culvert to Bayshore Creek looking north. Severe erosion caused at Bayshore Creek
*Data Point 223 Lat: 26.7554 Long: -81.8181

- Check North of Nalle Grade Road at Bayshore Creek to assess canals conditions.

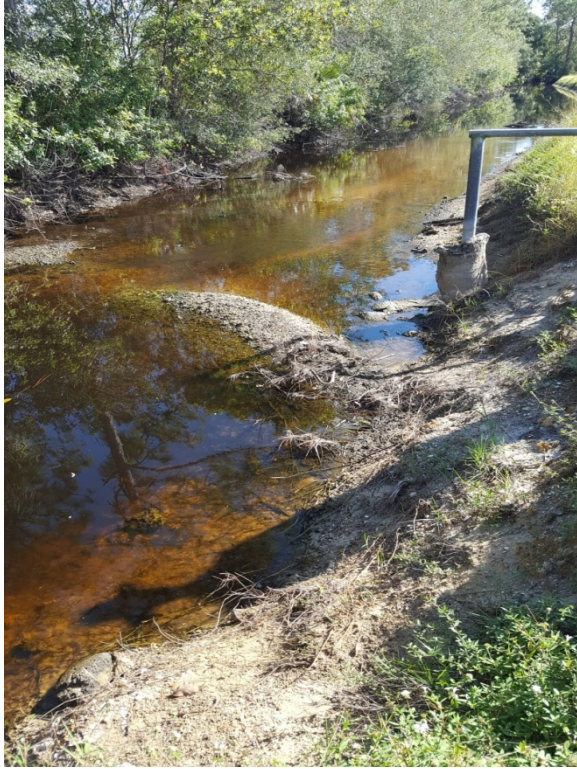
Sediment weir created by the erosion.
*Data Point 223 Lat: 26.7554 Long: -81.8181

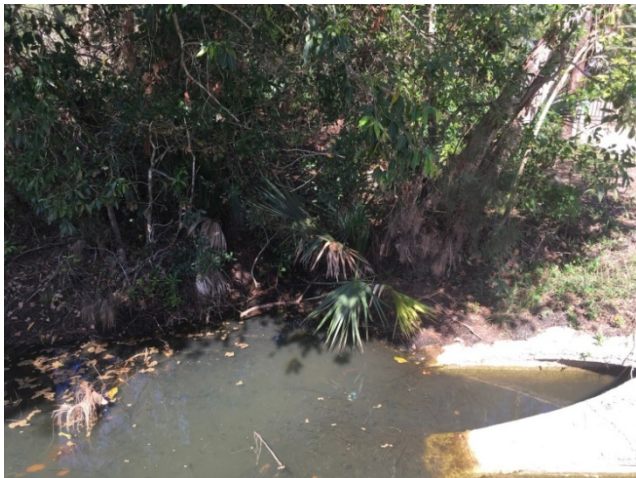
Receiving drainage ditch just east of Bayshore Creek access culverts
*Data Point 1785 Lat: 26.7554 Long: -81.8181

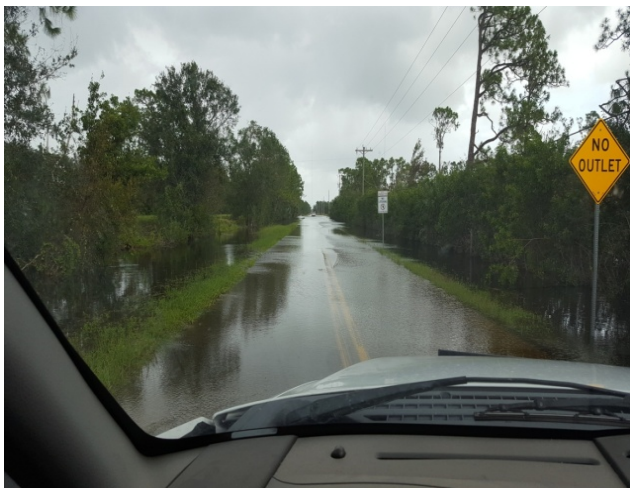
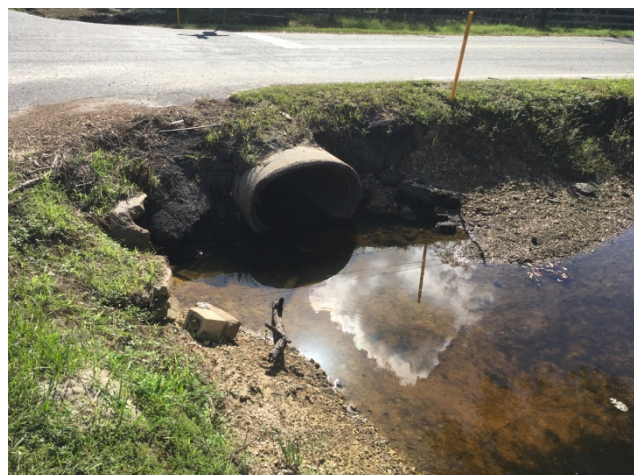
*Data Point 893 Lat: 26.7554 Long: -81.8017

- Signs of high flow rate at this intersection caused scouring, erosion and sediment build up.

Picture from County looking North at Nalle Grade Road intersection. The NW culvert at Nalle & Nalle Grade Roads.

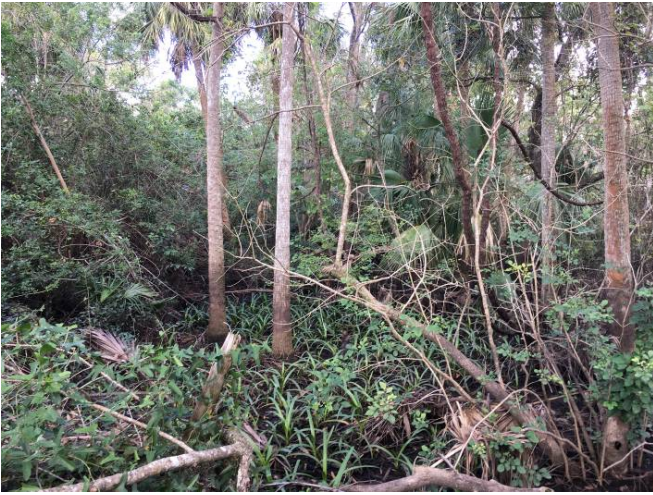
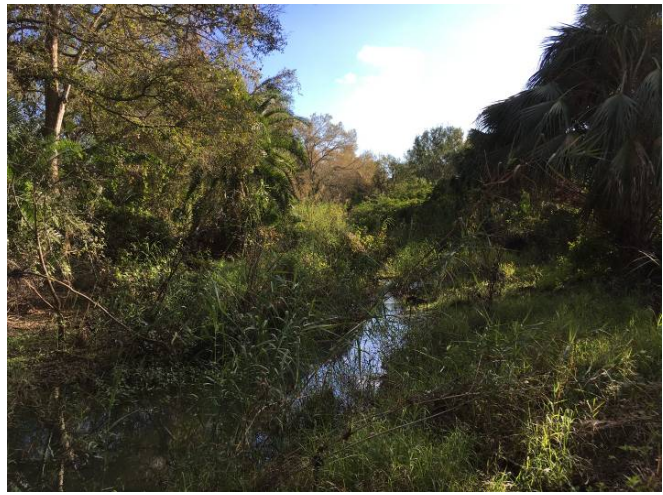
Typical examples of vegetation blocking the creek include an area north of the Pritchett Parkway Bridge and an area just south of Henderson Grade;

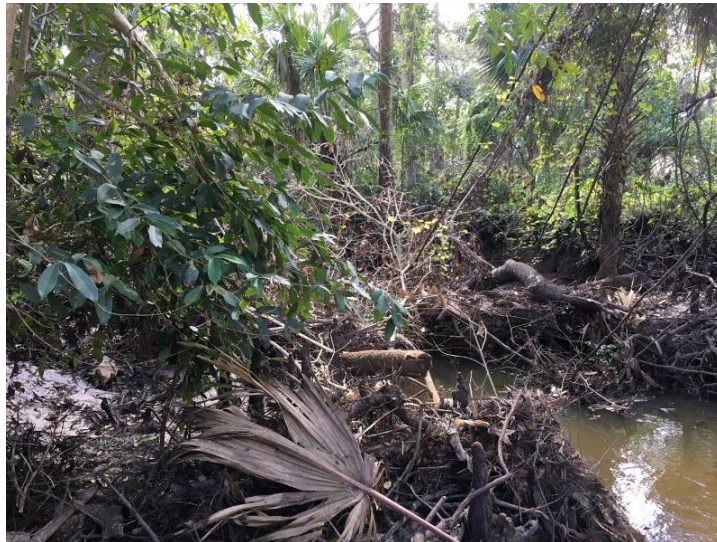
*Data point 1397 Lat: 26.718609 Long: 81.811624

Typical examples of debris blocking the creek include an area on the south edge of the Seminole Campground:

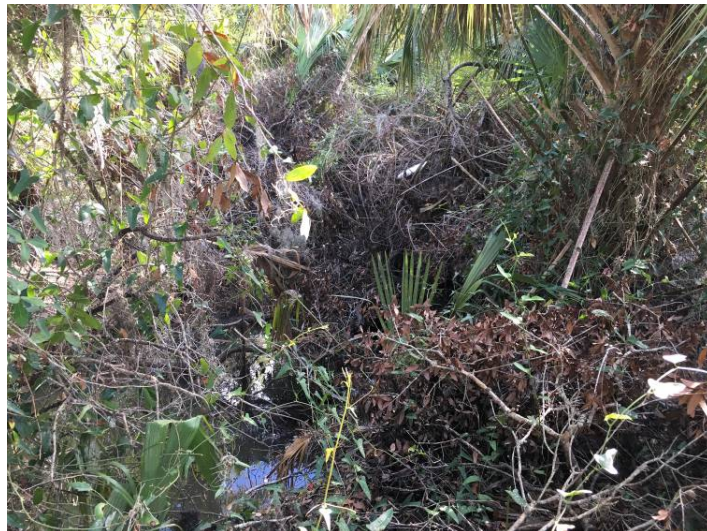
*Data point 2182 Lat: 26.732657 Long: 81.807027

And debris blocking the creek is 1,500 ft. south of Sedgefield Road:

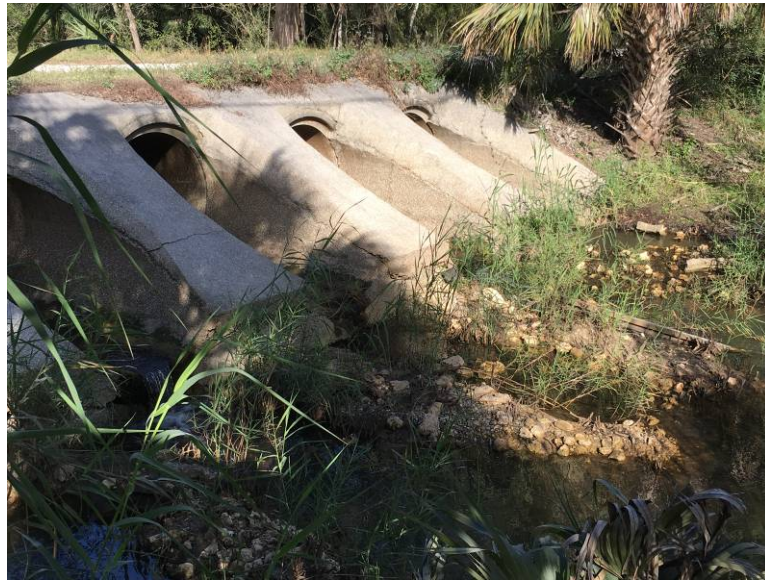
*Data point 2186 Lat: 26.742352 Long: 81.804354

Example of erosion is the south inverts for the crossing of Henderson Grade:

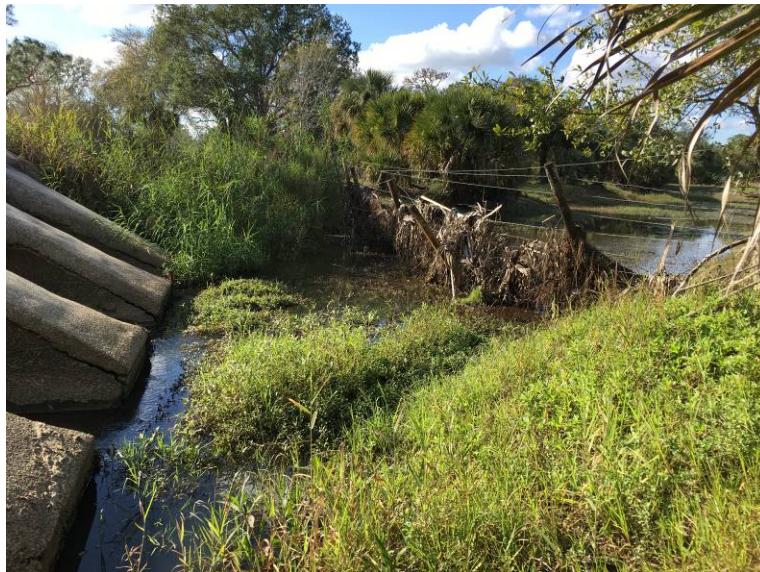
*Data point 2236 Lat: 26.742621 Long: 81.804292

Example of a fence water gap crossing north side of Henderson Grade:

- North side of the culvert crossing at Henderson Grade Road remove ± 15 c.y. of sediment and replace water gap.
- At Meredith Road remove ± 5 c.y. sediment at the south pipe crossing on the east end. Replace water gap on east side of Meredith Road. On west side of the culvert crossing excavate bank away from the west pipe inverts to increase the flow access.

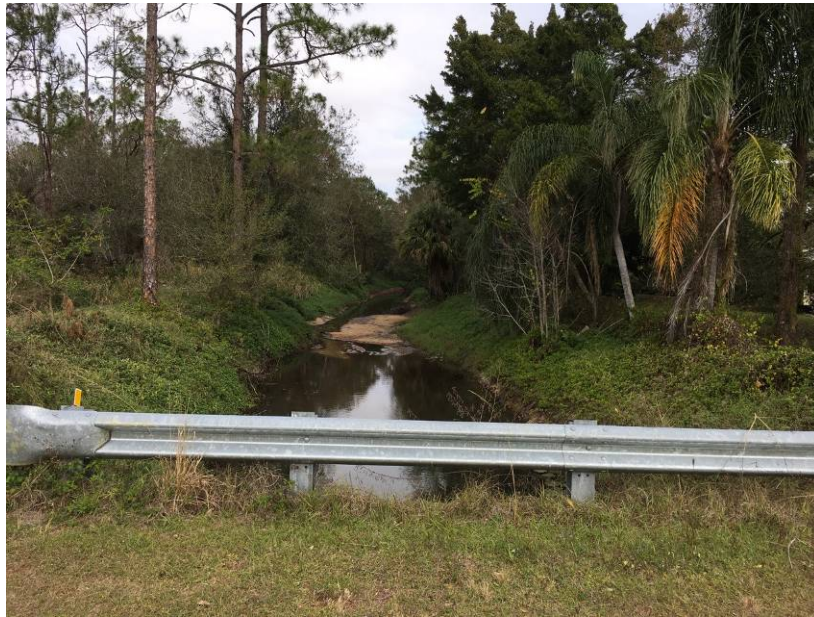
*Data point 2240 Lat: 26.747107 Long: 81.807080

An example of sediment that needs to be removed from the creek is at the north end of Meredith Road:

- ± 160' northwest of Meredith Road replace the creek water gap
- ± 800' northwest of Meredith Road remove ± 110 c.y. of sediment
- ± 1,000' northwest of Meredith Road remove or replace private bridge crossing

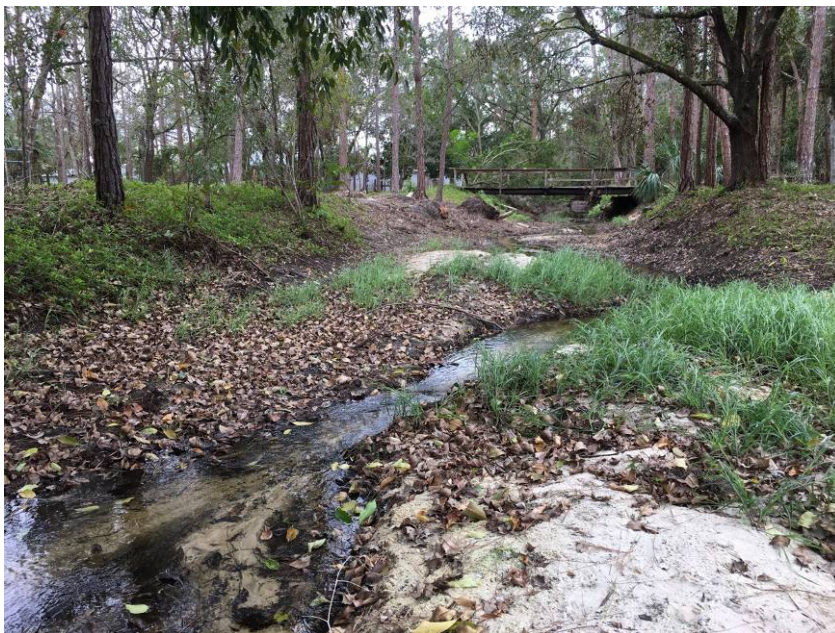
* Data point 2250 Lat: 26.754089 Long: 81.809551

And an area south of Nalle Grade Road:

- $\pm 450'$ south of Nalle Grade Road, remove ± 250 c.y. of sediment from creek flow line.

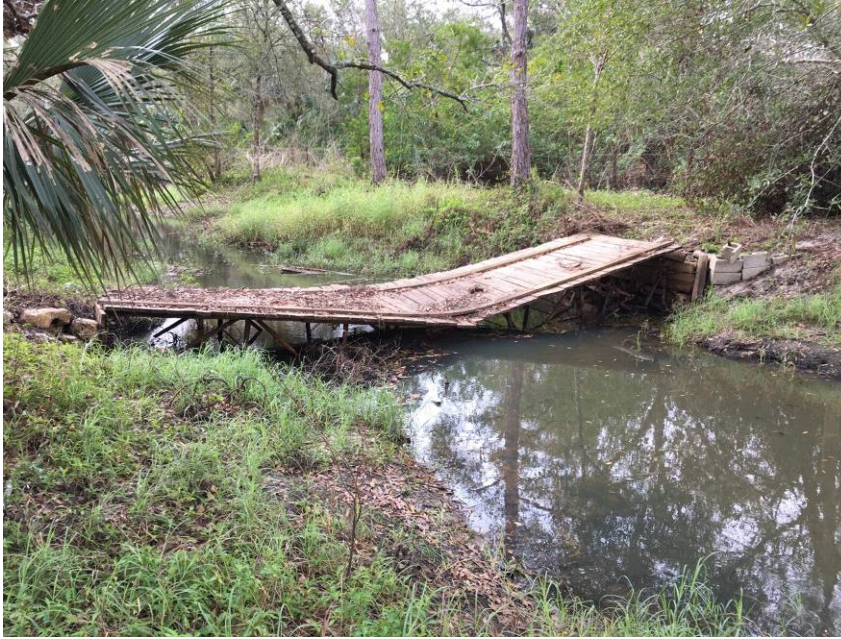
*Data point 2237 Lat: 26.745611 Long: 81.806952

Examples of old bridge structures that need to be removed or replaced, one located north on Meredith Road:

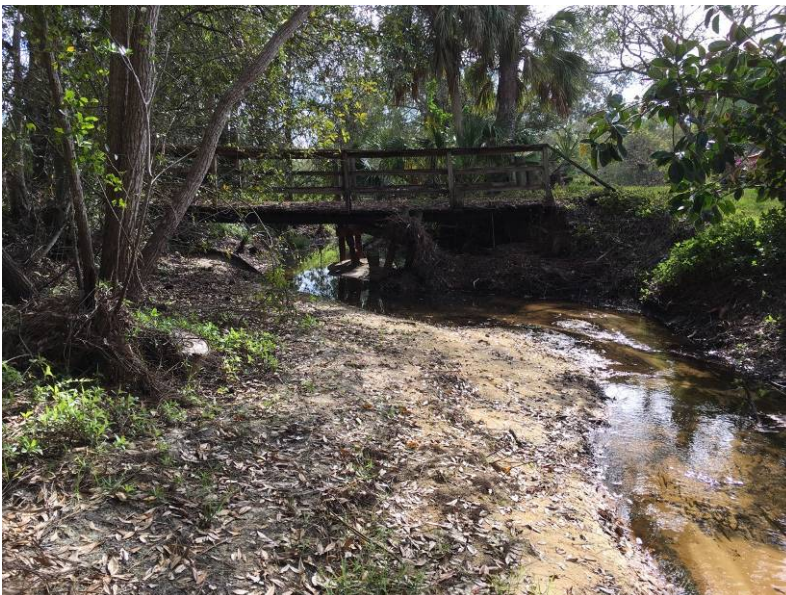
*Data point 2202 Lat: 26.749791 Long: 81.808206

And an abandoned bridge located just west of Pine Echo Road:

- $\pm 200'$ northwest of Pine Echo Road, remove old wood bridge crossing which appears to be abandoned.
- $\pm 550'$ northwest of Pine Echo Road, replace the private wood bridge crossing which narrows the flow section of the creek.

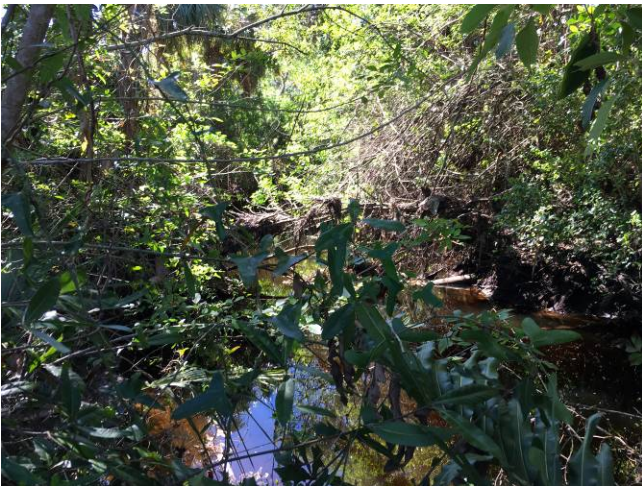
*Data Point 231 Lat: 26.714822 Long: 81.799753

A couple of examples of vegetation blockage is the area just south of the Bayshore Bridge and an area at the end of Veronica Blvd. which is vegetated, also has a fence water gap.

Just south of ROW, looking south.

- It is recommended that approximately 175' wide x 450' long area (~79,000 sq.ft. or 1.82 ac.) of debris and vegetation removal from the flowway just south of the bridge.

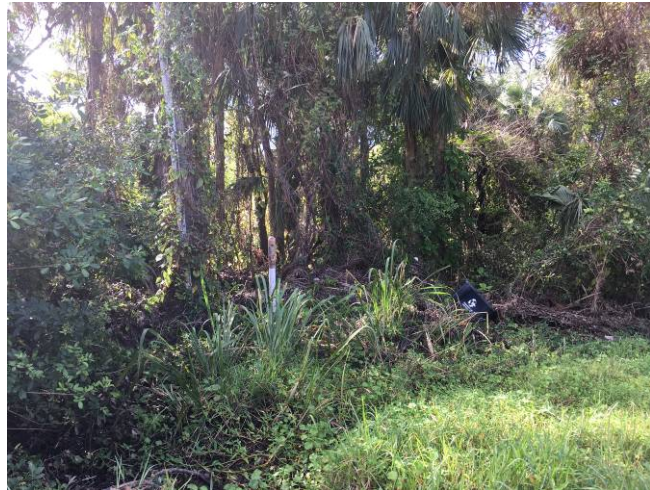
*Data Point 1493 Lat: 26.714938 Long: 81.799895

Looking south from bridge HMW debris

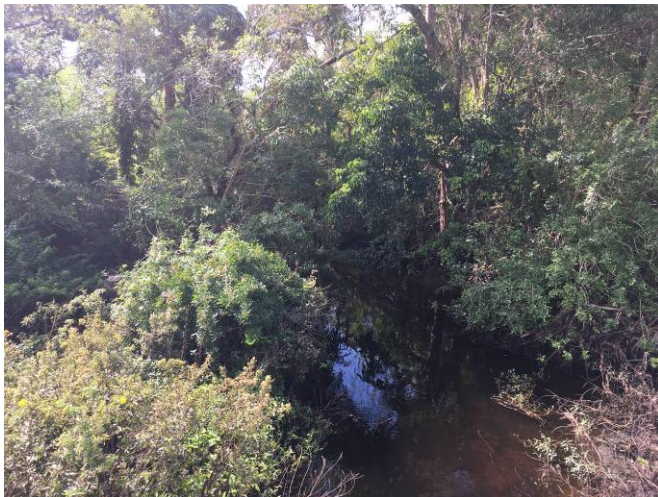
*Data Point 1493 Lat: 26.714938 Long: 81.799895

Looking south on bridge

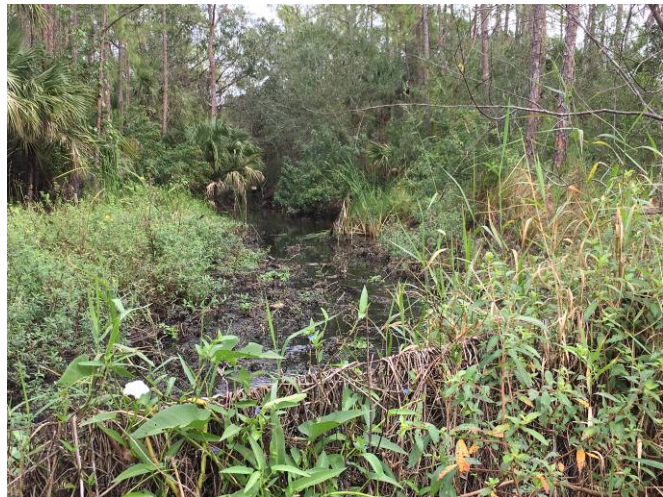
Water gap fence in foreground, looking north

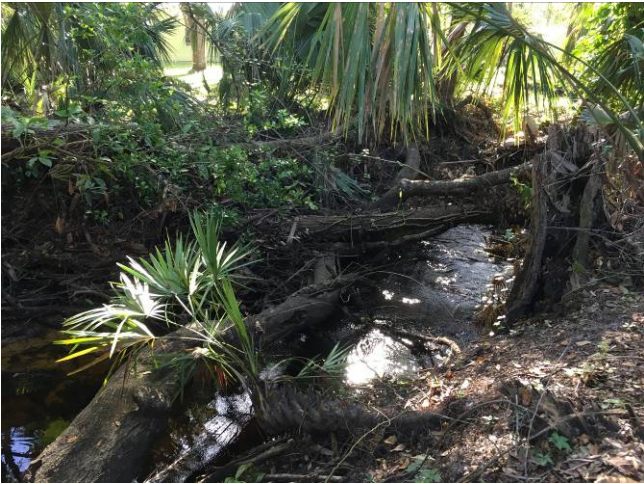
Flowway blocked with debris, looking south
*Data Point 245 Lat: 26.720708 Long: 81.798975

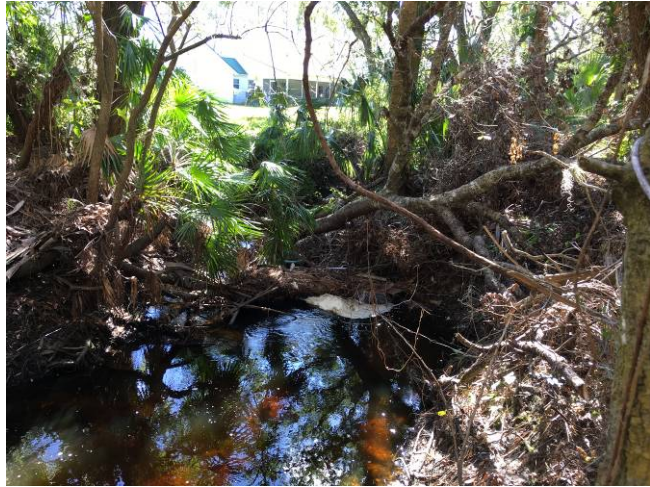
Debris, looking south
*Data Point 331 Lat: 26.724457N Long: 81.797855

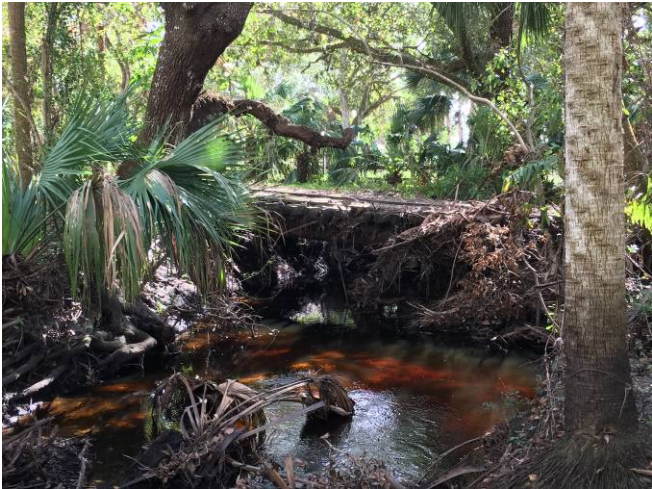
North side, north bridge, flood debris blocking about half section
*Data Point 171 Lat: 26.718705 Long: 81.799410

- One area has 2 private wood bridge structures that serve residences that are adjacent to each other. It is recommended that these structures be replaced with one crossing for use to both residences. It is suggested that a Conspan structure be considered for this location.

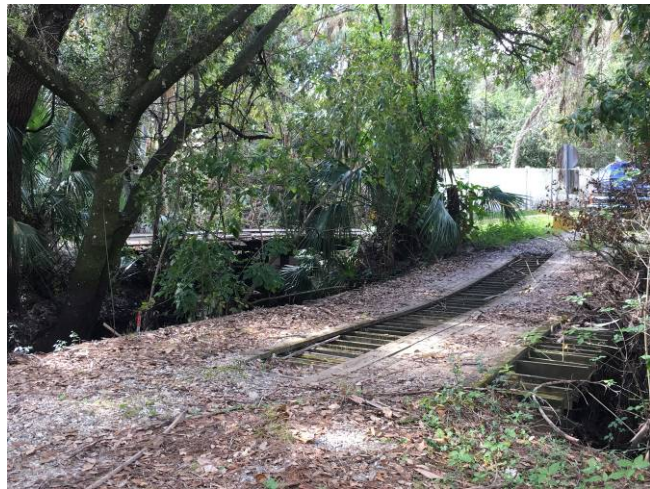
2 private bridges looking south
*Data Point 171 Lat: 26.718705 Long: 81.799410

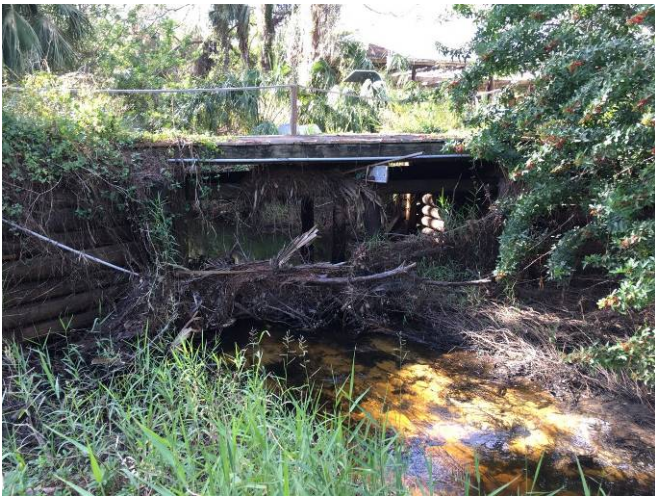
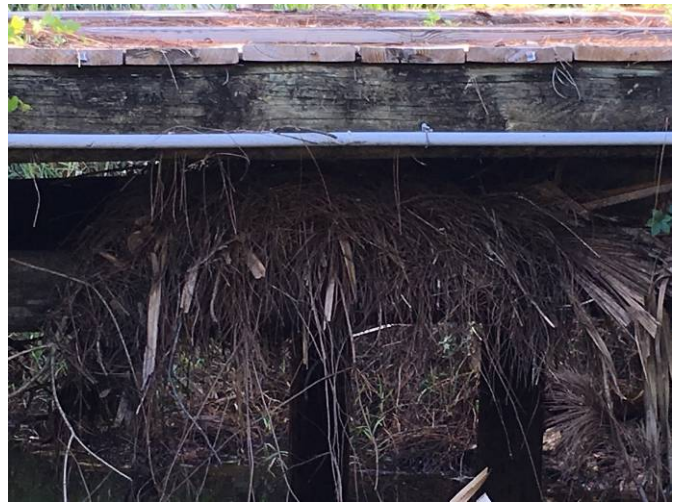
Most southerly of 2 bridges located at 18331 Durrance Road
*Data Point 801 Lat: 26.731179 Long: 81.796640

- One in particular where there are 2 bridge crossings at the residents address: 18331 Durrance Road. Suggestion is replace the more northerly bridge, which appears more actively used and the southern bridge is deteriorated and currently blocked off.
- A total of 4 bridge replacements south of Deal Road.
- The creek crossings for driveways have transitioned to multiple pipes.
- The 2 most northerly creek crossings are larger in diameter or double ±60" pipe of various conditions. It is recommended that the culvert pipe be cleaned and debris be removed or consider a smaller Conspan structure.

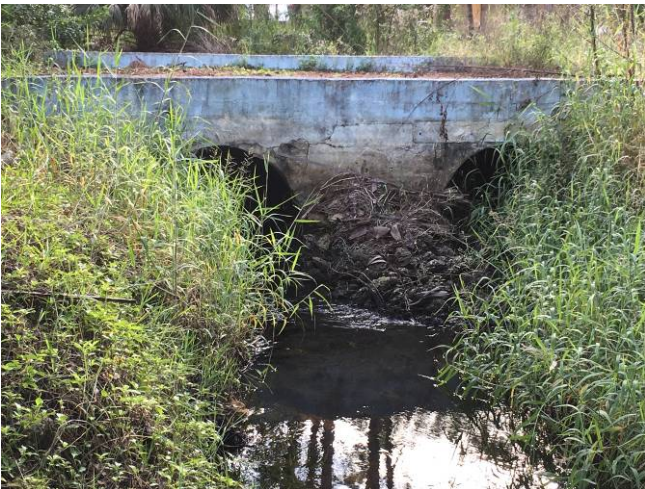
Debris & sediment blocking large diameter pipe
@ 18681 Durrance Rd.

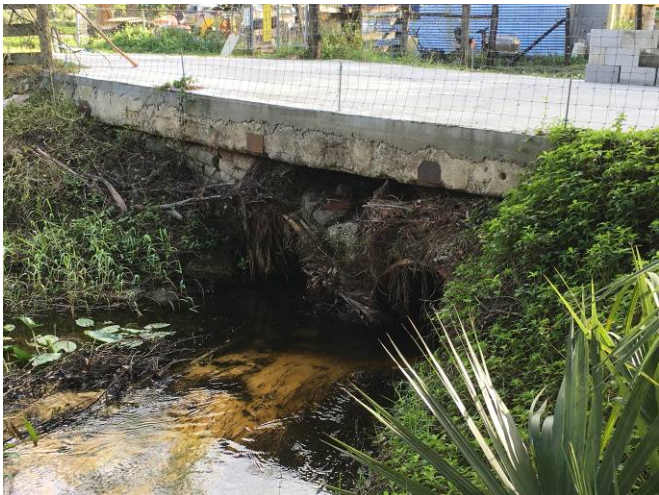
*Data Point 924 Lat: 26.733847 Long: 81.793949

North side of crossing @ 18571 Durrance Rd.

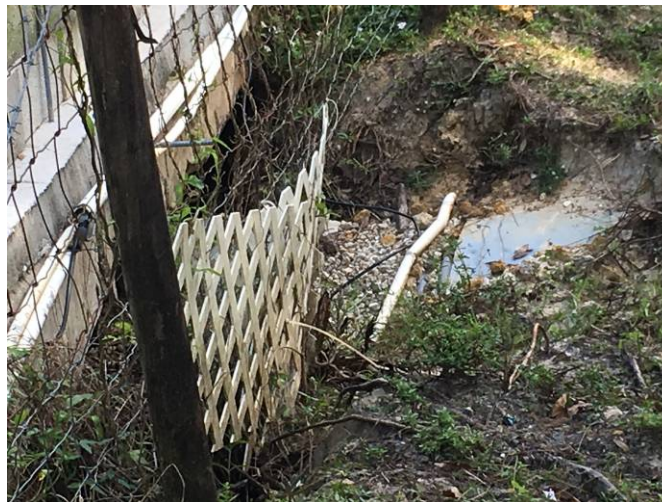
Water pushed thru under slab

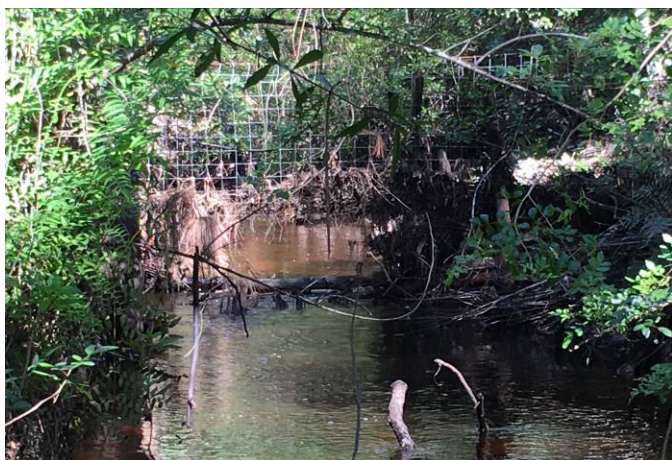
There are a number of locations where there are fences crossing the creek (water gaps). The first one that was encountered was just north of the east/west LCEC easement. The worst case scenario is when the property owner uses hog-wire fence or chain-link fence which catches most of the debris and creates considerable backup. Other crossings utilize barbwire fencing which lets most of the debris pass through.

Fence water gap looking north

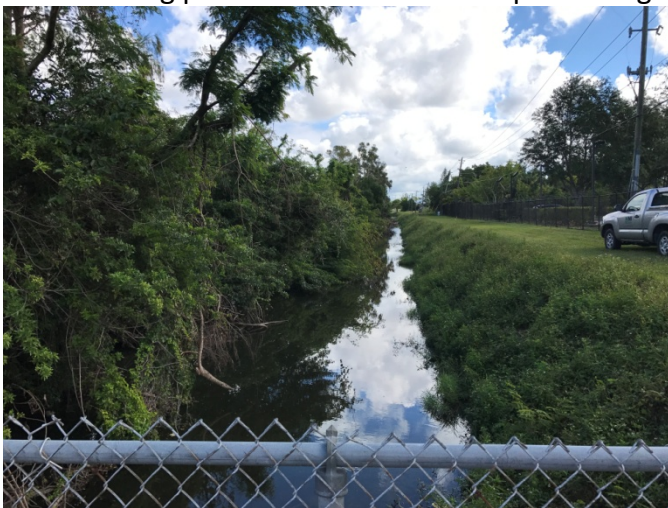
*Data Point L18 Lat:26.57539 Long:-81.86741

The following photos are a few of examples of vegetation blockage.

Along L canal at Danley Dr., looking east.

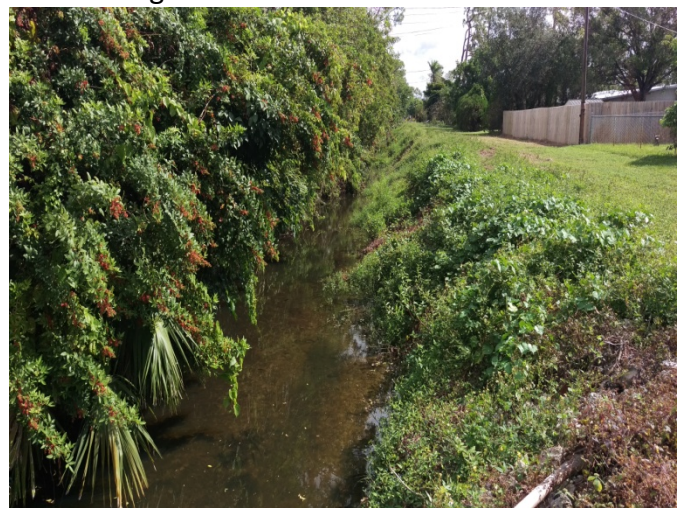
*Data Point A24 Lat:26.56087641 Long:-81.87043445

Looking east along Dover Canal at Austin St.
