Lee County
Southwest Florida

**FINAL
POST STORM FLOOD ASSESSMENT
ANALYSIS**

**Bayshore Creek Watershed
Nalle Grade Road
Popash Creek Watershed
Strouds Creek Watershed
Whiskey Creek Watershed**

FEBRUARY 28, 2018

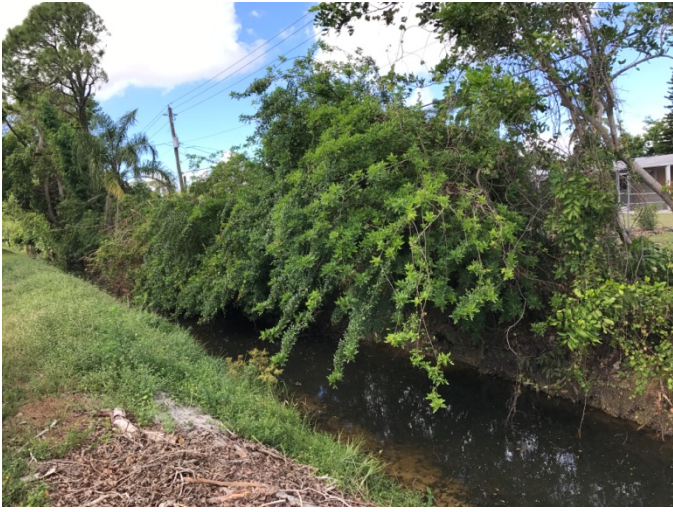
Looking west along Dover Canal east of Beacon St.
* Data Point L33 Lat: 26.56088 Long:-81.8652

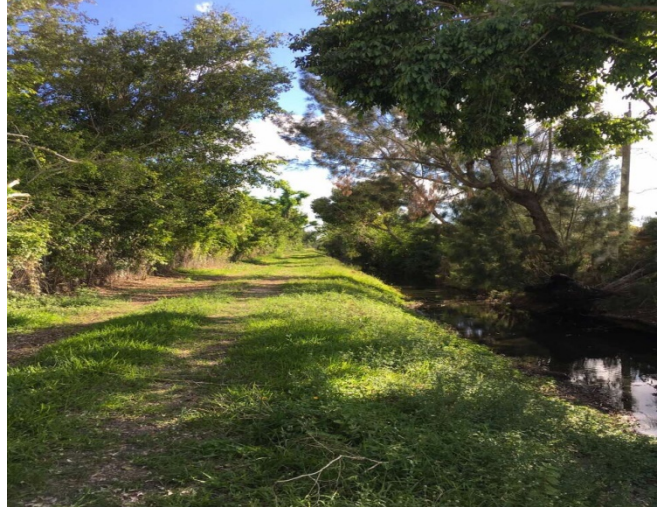
N/S Canal North of Trailwinds Dr., looking north
*Data Point L35 Lat:26.57060536 Long:-81.86328131

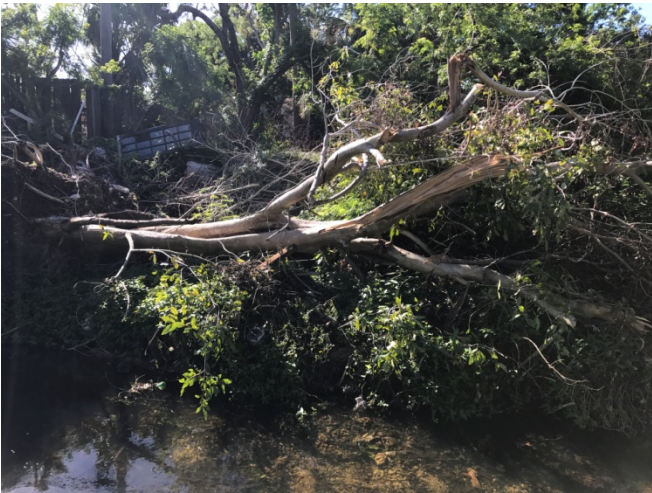
L canal Flowway blocked with debris, looking south
*Data Point L10 Lat:26.57539 Long:-81.87557

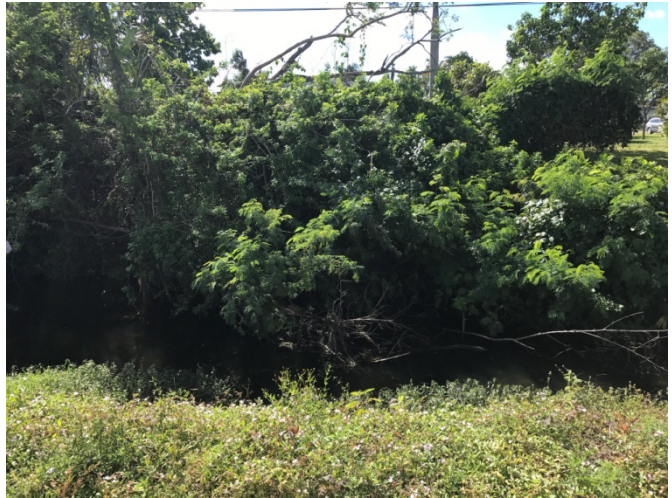
L canal debris, looking south
*Data Point L17 Lat:26.5755 Long:-81.86874

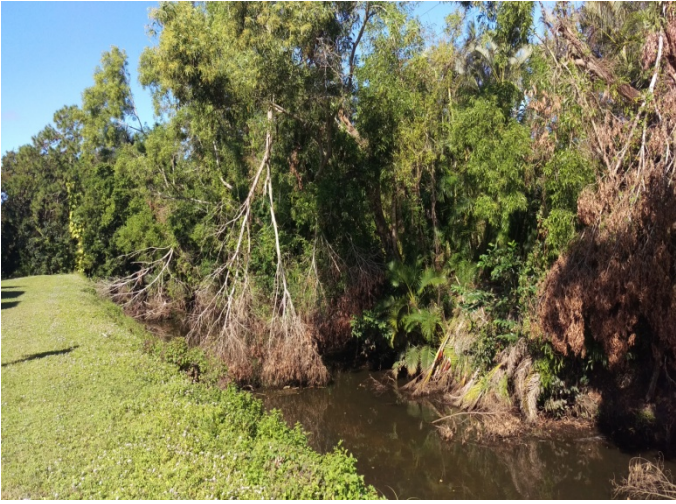
Brantley canal debris west of Summerlin Rd.,
*Data Point A18 Lat:26.56056529 Long:-81.88583851

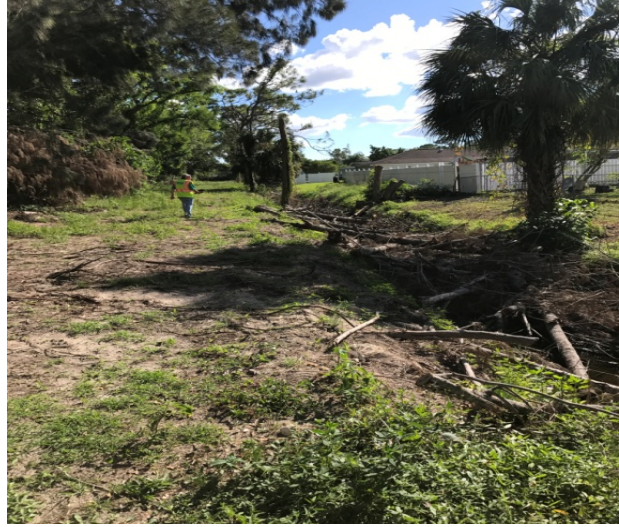
Debris in N/S canal south of Trailwinds Dr.
*Data Point L34 Lat:26.5678 Long:-81.86329

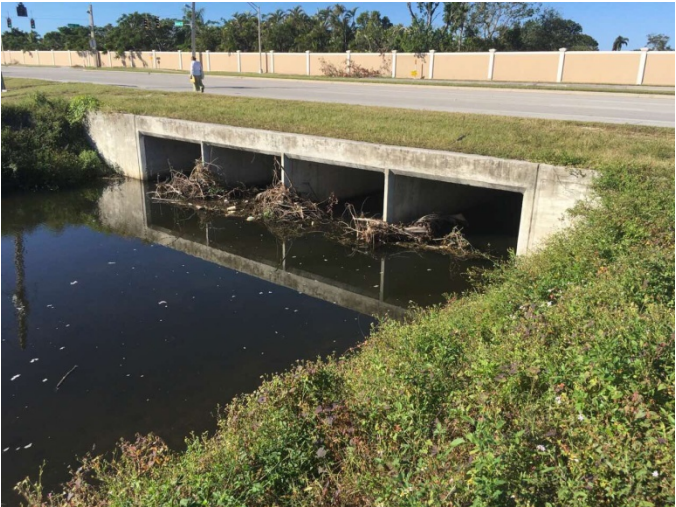
Examples of partially blocked culverts with debris:

L canal east of Summerlin Rd.
*Data Point L8 Lat:26.57521283 Long:-81.88401293

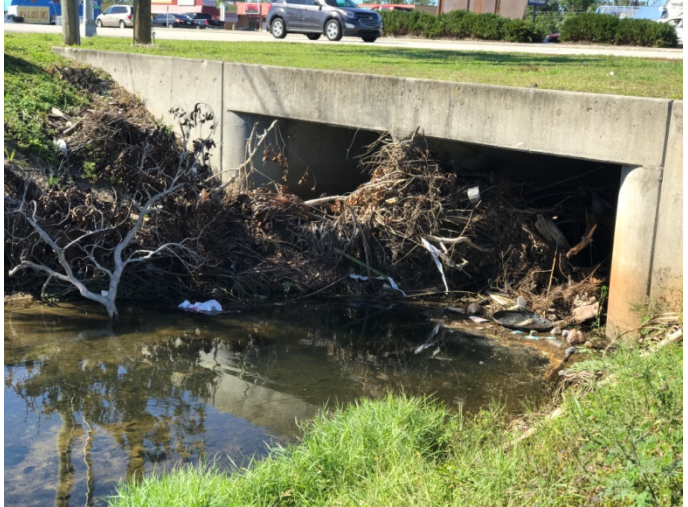
L canal east of US 41.
*Data Point L14 Lat:26.57537081 Long:-81.87160361

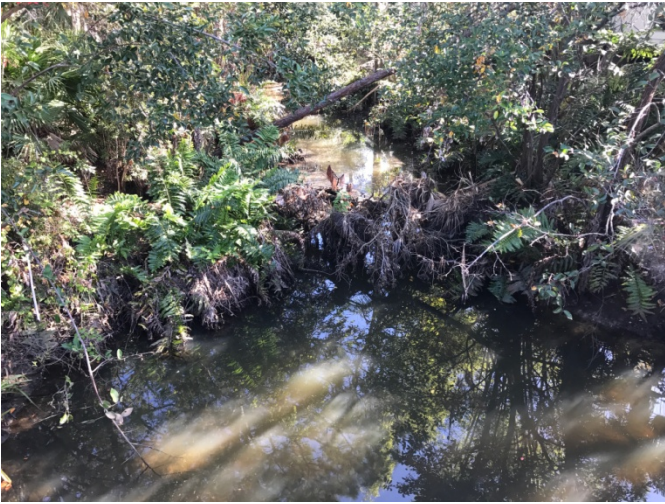
*Data Point A16 Lat:26.55973616 Long:-81.88862712

Brantley canal just east of Whiskey Creek Dr.

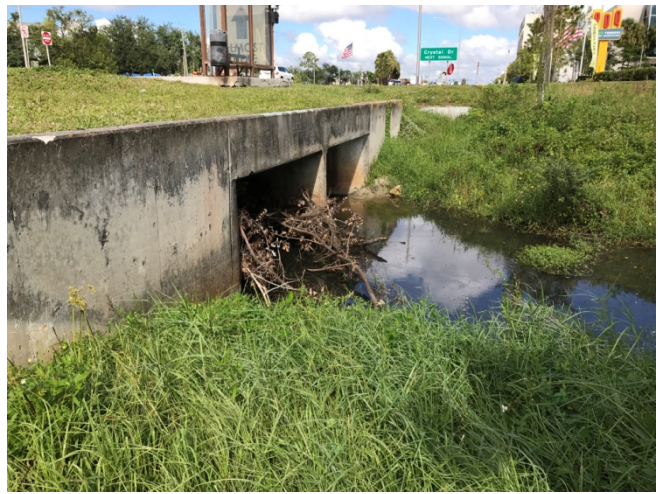
Dover canal east of US 41.
