# **EAST MULLOCH DRAINAGE DISTRICT FACILITY ANALYSIS REPORT**

**Volume 1**

**Boyle Engineering Corporation  
4415 Metro Parkway, Suite 404  
Fort Myers, FL 33916**

**July 2008**

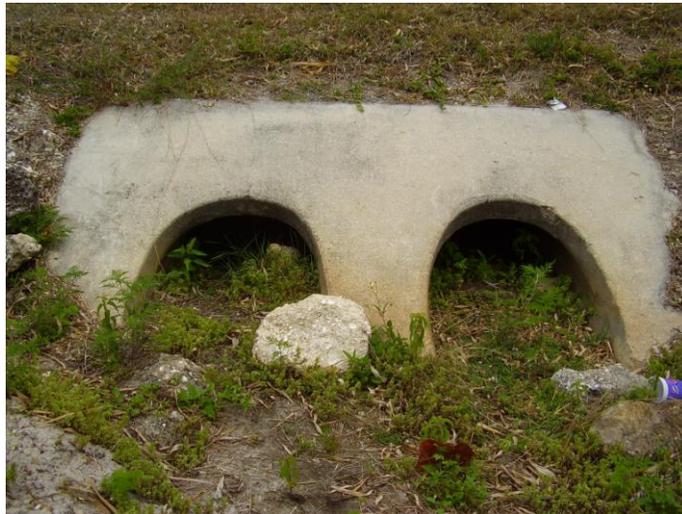
### Culvert EM-065P – Pipe Across Oriole Road

The structure is located at the headwaters of Mulloch Creek and consists of 2-18” reinforced concrete pipes that are being maintained by Lee County DOT. The pipes are in good structural condition with some moderate silting. This structure is draining an estimated area of 102.58 acres.

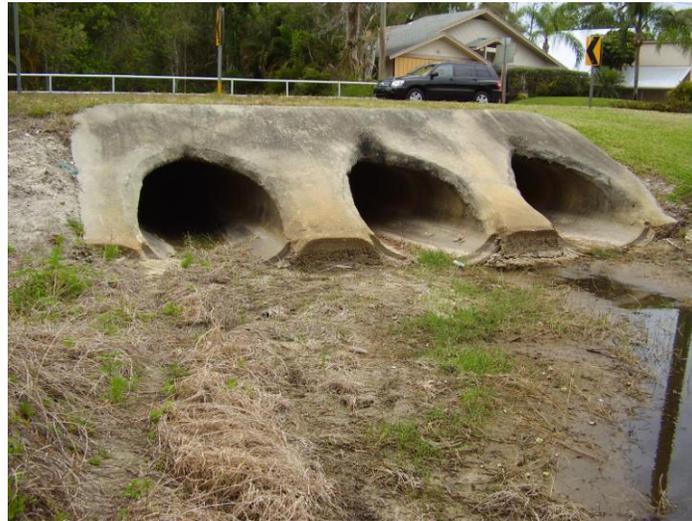
Culvert EM-055P – Pipe Across Lee Road

The structure is located downstream of EM-065P and consists of 3-60”x36” elliptical reinforced concrete pipes that are being maintained by Lee County DOT. The pipes are in good structural condition with no silting observed. This structure is draining an estimated area of 410.34 acres.

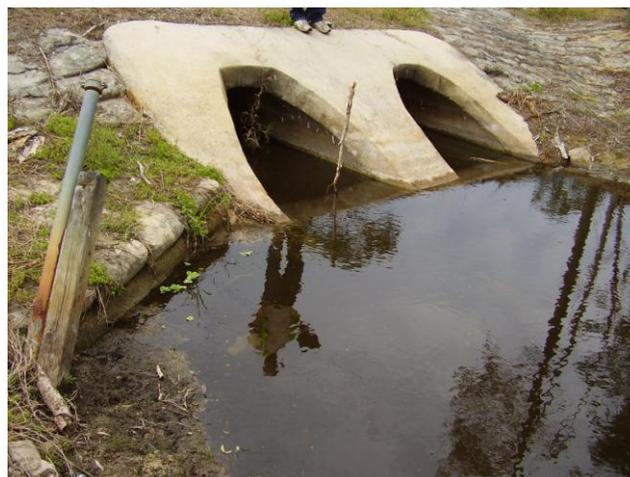
Culvert EM-045P – Pipe Across Phlox Drive

The structure is located downstream of EM-055P and consists of 2-48” reinforced concrete pipes, that are being maintained by Lee County DOT. The pipes are in good structural condition with no silting observed. This structure is draining an estimated area of 533.61 acres.

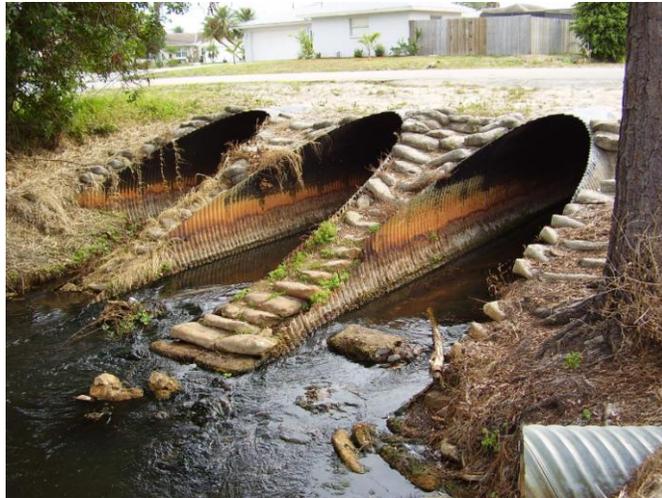
Culvert EM-035P – Pipe across Wood Drive

The structure is located downstream of EM-045P and consists of 3-72” corrugated metal pipes, that are being maintained by Lee County DOT. The pipes have corrosion appearing on 45% of the surface in which corrective actions, such as coating with asphalt, needs to be taken to slow the degradation. No silting was observed, but the sacked concrete end treatment is not holding up and is being deposited into the channel. This structure is draining an estimated area of 2,346 acres.

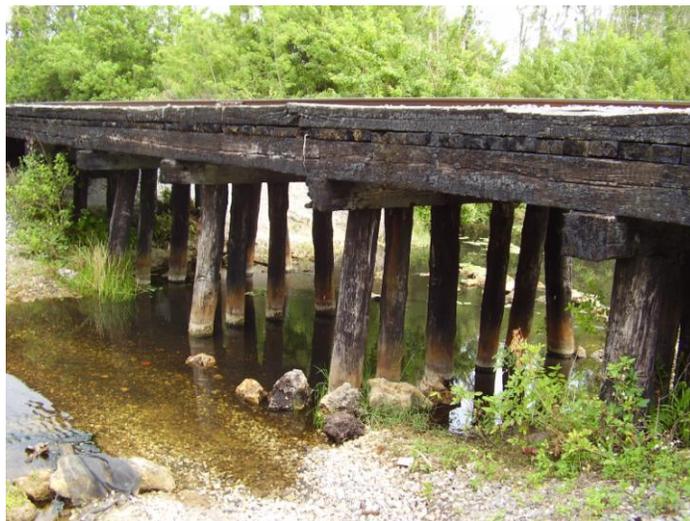
ACL Railroad Bridge

The structure is located downstream of EM-035P and consists of a timber trestle bridge that is located under the railroad. This structure is being maintained by ACL Railroad. The structure is in fair condition with no major deficiencies observed that would result in a failure. This structure is draining an estimated area of 2,652 acres.

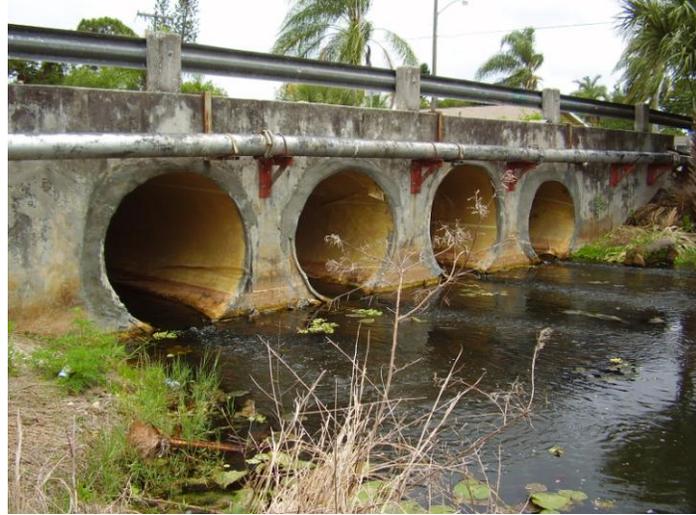
Culvert EM-015P – Across Constitution Circle

The structure is located downstream of EM-025B and consists of 3-66” and 1-54” high-density polyethylene pipes that are being maintained by Lee County DOT. The pipes are in good condition and have recently been lined with a dense plastic material to maintain the integrity of the structure and increase capacity. This structure is draining an estimated area of 2,802 acres.

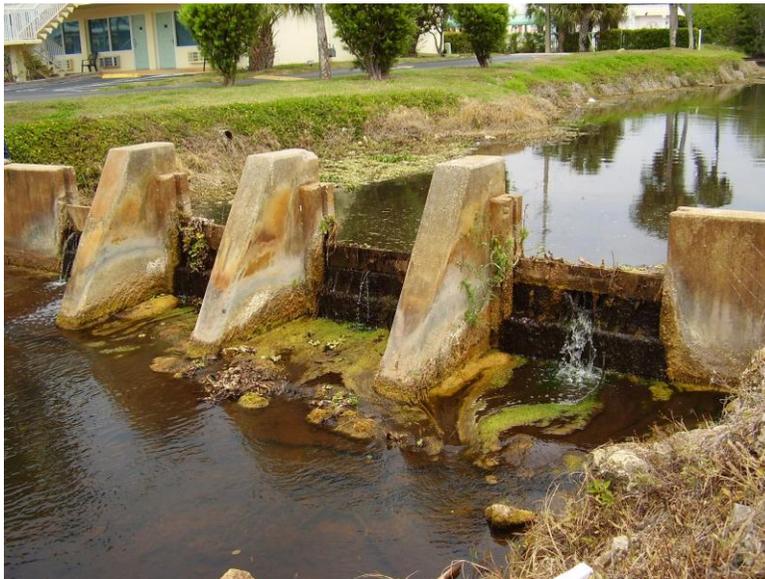
Weir EM-004W – East of US 41, Outfall for EMDD Retention Pond

The structure is located downstream of EM-015P and consists of a concrete weir that controls the water elevation in the retention pond. The structure is being maintained by EMDD. The structure is in poor condition due to water overtopping the entire structure and eroding the banks of the channel. Wood planks, which are in need of replacement, have been inserted into the structure to increase the elevation of the water in retention pond. This structure is draining an estimated area of 3,195 acres. The hydraulic model assumes that the wooden flash boards, which are shown in the photograph below, remain in place for the entire event as this is the worst case scenario.

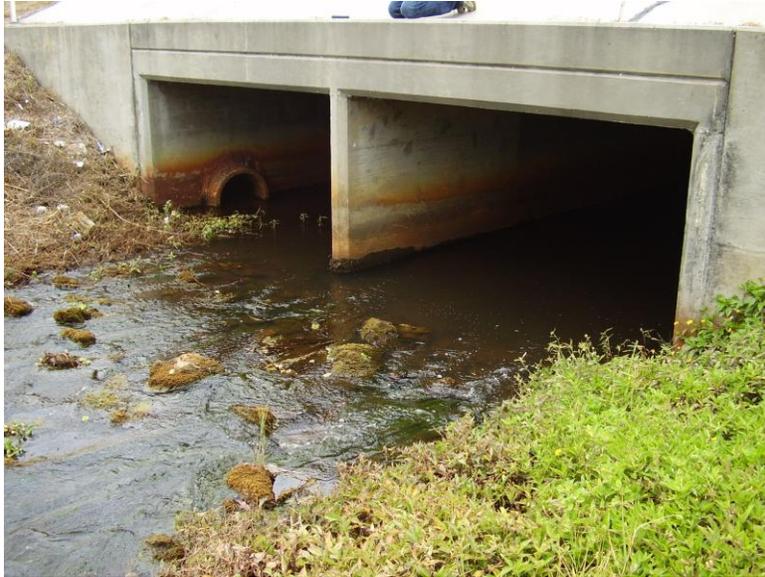
Culvert EM-001P – Across US 41

The structure is located downstream of EM-004W and consists of a 2-10'x6' concrete box culvert, which is being maintained by FDOT. The structure is in good condition and does not appear to have been overtopped based on the observed high water marks. This structure is draining an estimated area of 3,195 acres.

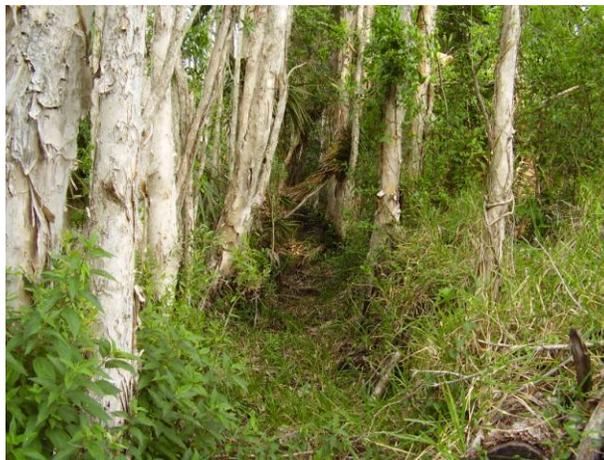
A. *Excessive amount of trees, brush and obstructions. (\$22,000/acre)*

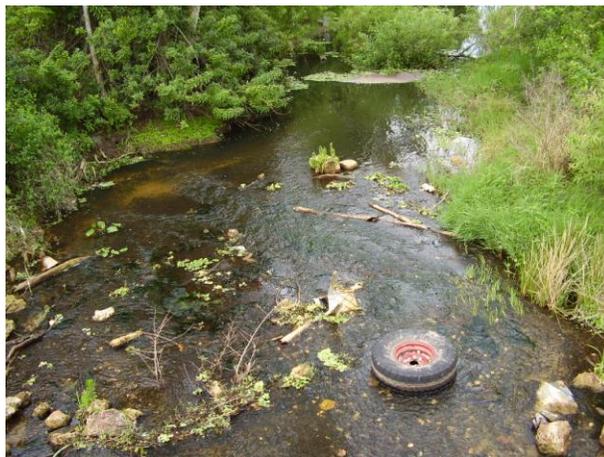
B. *Moderate amount of trees, brush and obstructions. (\$17,000/acre)*

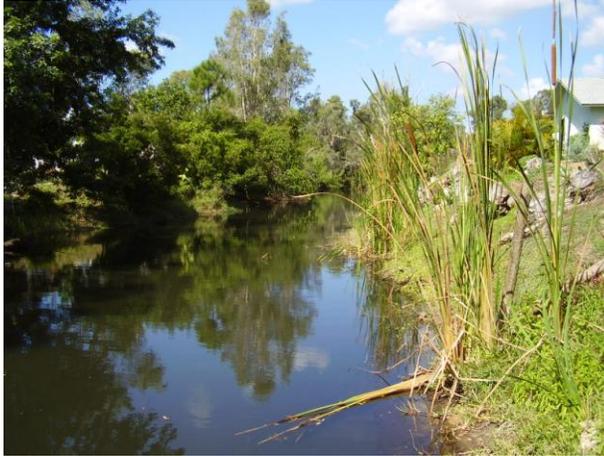
*C. Light amount of trees, brush and obstructions. (\$12,000/acre)*
