Estero River, Imperial River, & Springs Creek Storm Assessment

Summary Report

Lee County
1500 Monroe St
Fort Myers, FL 33901

February 28, 2018

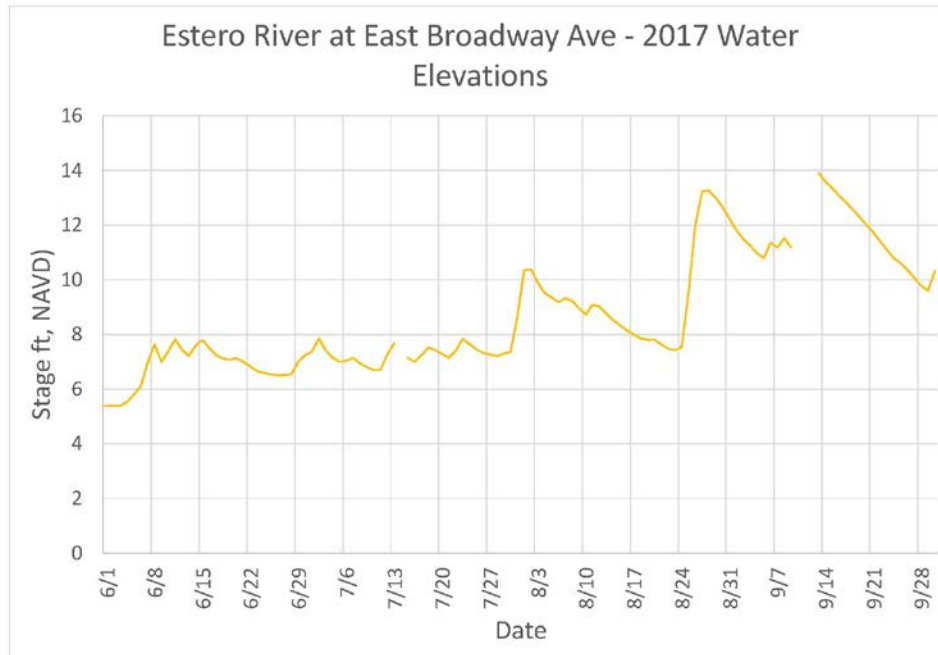
Figure 1 - Water Elv. Estero River at Broadway

The relatively small storm event on July 31st increased water levels in the North Branch approximately 2.0 ft. The River almost recovered back to its previous elevation before the Invest 92L rainfall. The Invest rain increased water levels approximately 5.5 ft. Water levels were only able to recover approximately 2 ft before Hurricane Irma. Water levels were 3.5 ft higher than the June water levels. The peak water elevation for Irma was not recorded due to a recorder malfunction. Extending the recover slope back to the start of the data gap would provide an upper limit (15.0 ft, NAVD) for the potential peak stage. The actual peak stage would be expected to be between 15.0 ft and 14.0 ft, NAVD. This is between 2.5 ft and 3.5 ft higher than the water level before the storm. The peak water levels for Irma were between 6.5 ft and 7.5 ft higher than the water levels before the July 31st event or Invest 92L.

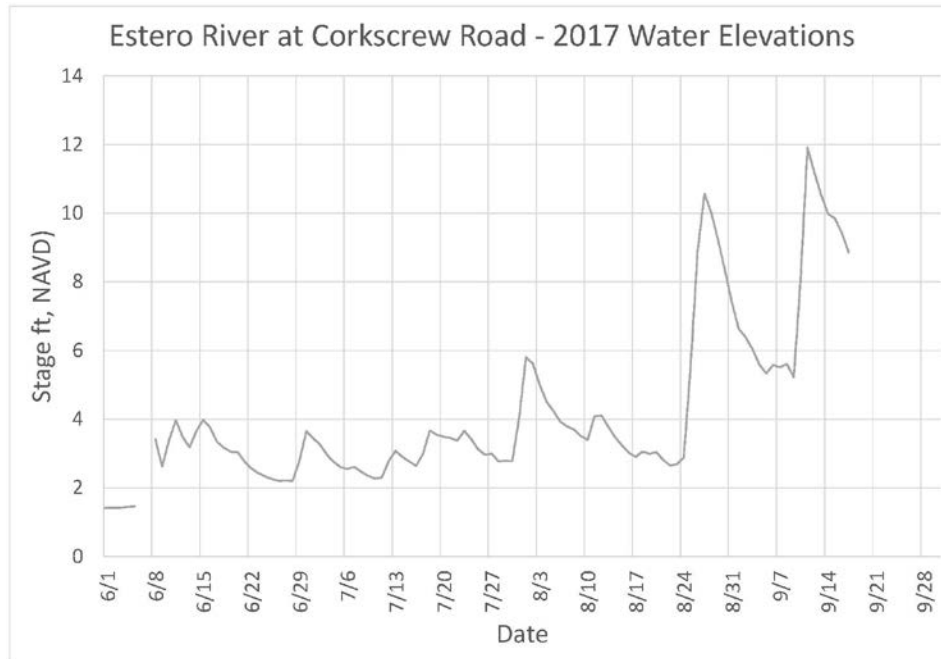
Figure 2 - Water Elv. Estero River at Corkscrew

The July 31st storm event increased water levels at Corkscrew Road approximately 2.5 ft. Water levels recovered prior to the Invest 92L rainfall. With the Invest event, water levels jumped approximately 7.5 ft and recovered approximately 5.0 ft before Hurricane Irma. Water levels just prior to Irma were approximately 2.5 ft higher than they were, prior to Invest 92L. The Hurricane Irma rainfall increased water levels approximately 6.5 ft, peaking at approximately 12.0 ft, NAVD. The peak water levels for Irma were 9.0 ft higher than the water levels before the July 31st event or Invest 92L.

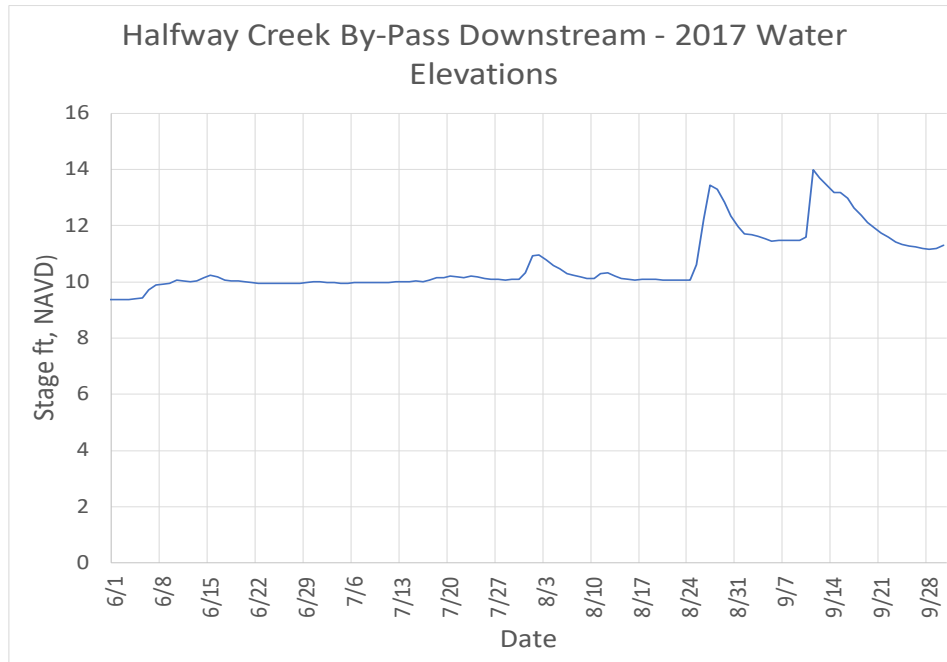
Figure 3 - Water Elv. Halfway Creek Bypass Downstream

Water levels downstream of the bypass structure, generally remained near elevation 10.1 ft – 10.3 ft, NAVD, except after larger rainfall events. This is very close to the downstream weir elevation of 9.84 ft, NAVD. This indicates there is very little water flowing over this weir, except after larger rainfall events.

The July 31st storm event increased water levels by approximately 1.0 ft. Water levels recovered back to the pre-storm elevation in less than two weeks. With the Invest event, water levels jumped approximately 3.3 ft. Water levels only recovered 2.0 ft before Hurricane Irma. Water levels prior to Irma were approximately 1.3 ft higher than they were prior to Invest 92L. The Hurricane Irma rainfall increased water levels approximately 2.3 ft, peaking at approximately 14.0 ft, NAVD. The peak water levels for Irma were 4.0 ft higher than the water levels before the July 31st event.

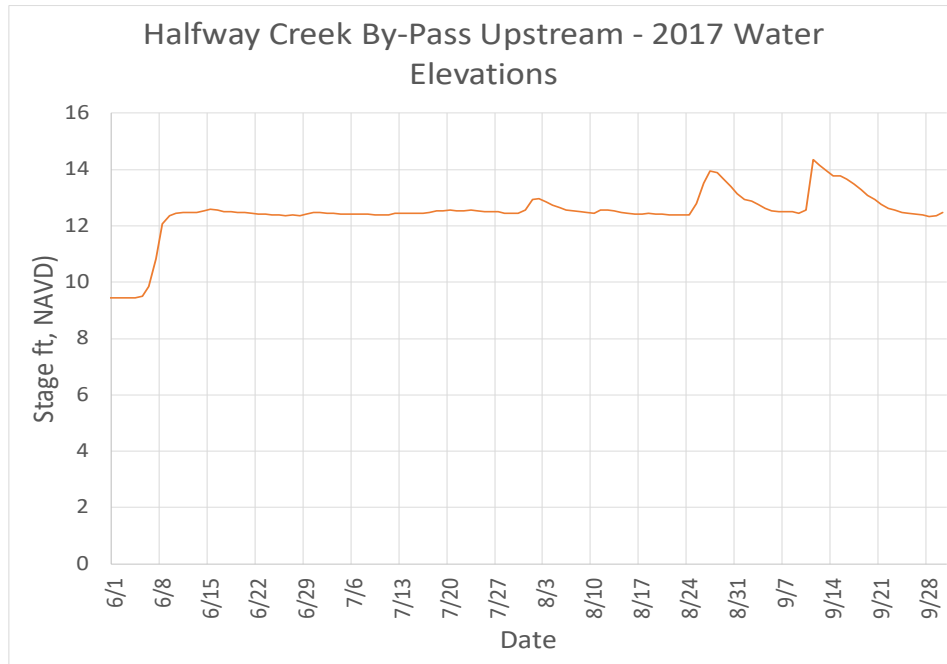
Figure 4 - Water Elv. Halfway Creek Bypass Upstream

Water levels upstream of the bypass structure generally remained near elevation 12.4 – 12.6 ft, NAVD, except after larger rainfall events. This number is very close to the structure’s overflow elevation of 12.44 ft, NAVD, indicating there is very little water flowing over this weir, except after larger rainfall events.

The July 31st storm event increased water levels upstream of the bypass, by approximately 0.5 ft. Water levels recovered back to the pre-storm elevation in less than a week. The Invest event caused water levels to jump approximately 1.3 ft. Water levels recovered to approximately 12.4 ft, NAVD before Hurricane Irma. The Hurricane Irma rainfall increased water levels approximately 1.8 ft, peaking at approximately 14.2 ft, NAVD.

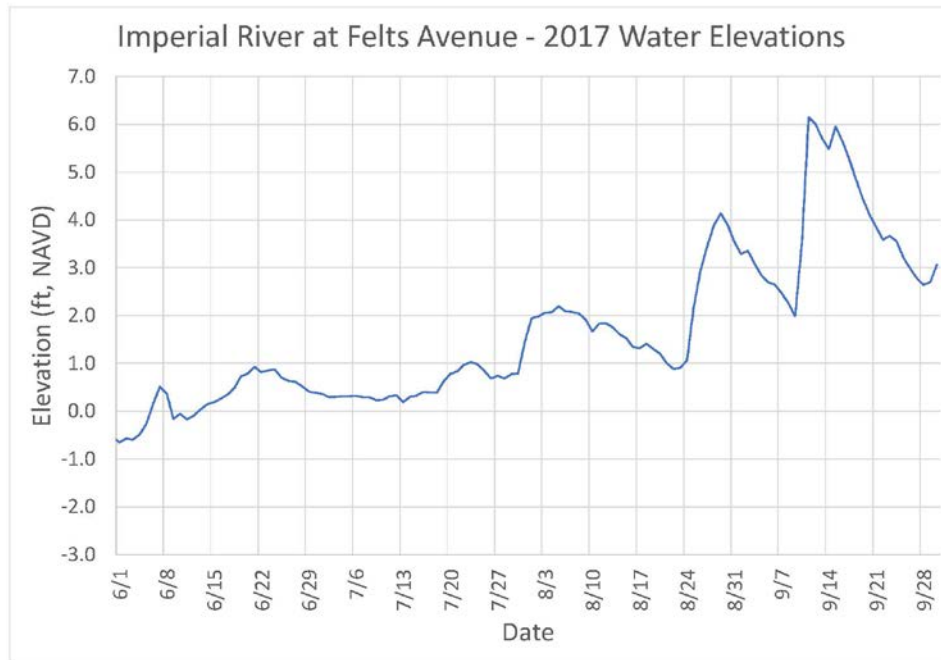
Figure 5 - Water Elv. Imperial River at Felts Ave.

Water levels at Felts Ave. increased by approximately 1.35 ft after the July 31st rainfall. Water levels almost recovered back to the pre-storm levels, prior to the Invest rainfall. With Invest 92L, water levels increased by approximately 3.1 ft and then recovered approximately 2.1 ft prior to Hurricane Irma. The Hurricane Irma rainfall then increased water elevations by 4.1 ft, the storm elevation peaked at approximately elevation 6.1 ft, NAVD. Water levels associated with Hurricane Irma were approximately 5.3 ft higher than the water level, prior to the July 31st rainfall.

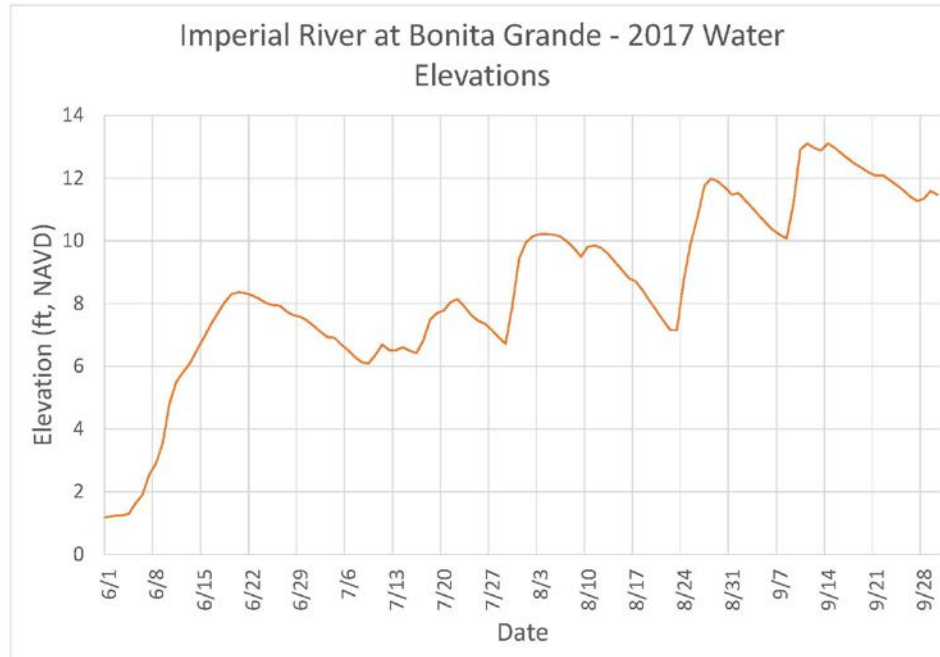
Figure 6 - Water Elv. Imperial River at Bonita Grande

Water levels at Bonita Grande increased by approximately 3.3 ft., after the July 31st rains. This is more than at any of the other recorder locations. Water levels almost recovered back to pre-rainfall levels, prior to Invest 92L. Water levels increased by approximately 5.0 ft with Invest 92L. Water levels only recovered about 2.0 ft before Hurricane Irma. Hurricane Irma increased water levels by approximately 3.0 ft. The peak stage was just over 13.0 ft, NAVD. The peak water levels for Irma were 6.5 ft higher than the water levels before the July 31st event.

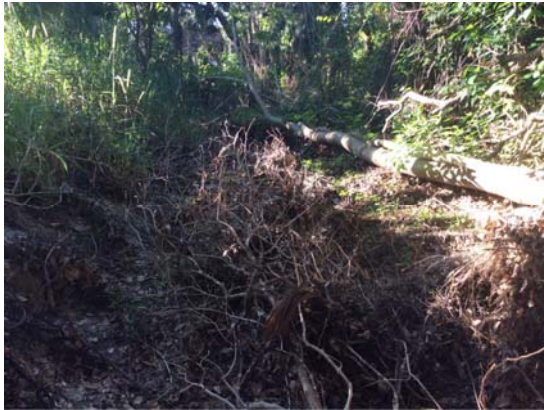
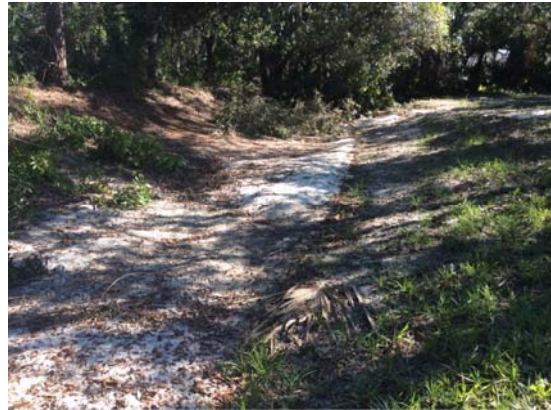
8.1.1 Country Creek Bypass (Table 1, Observation ID: 64, 65, 82)

- Flow into and out of the Country Creek bypass ditch was reduced by sediment, debris and vegetation.
- Stain lines at the Villagio Gardens Court box culvert are 1.2 ft higher on the upstream side than the downstream site. This could be an indication of an undersized culvert or additional flows being directed to this location.

- Install a concrete or sheet pile structure at the bypass inflow to better divert low flows down the creek and high flow through the bypass.
- Remove sediment and vegetation at the bypass outfall to the river.
- Perform calculations to determine if additional capacity is needed through the bypass. If additional capacity is needed, investigate ways to expand capacity including widen ditch and replace culvert crossings.

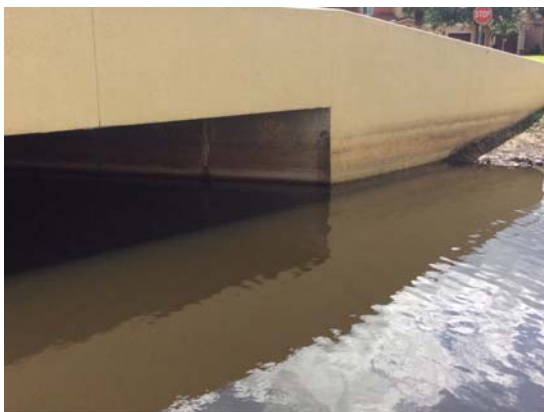
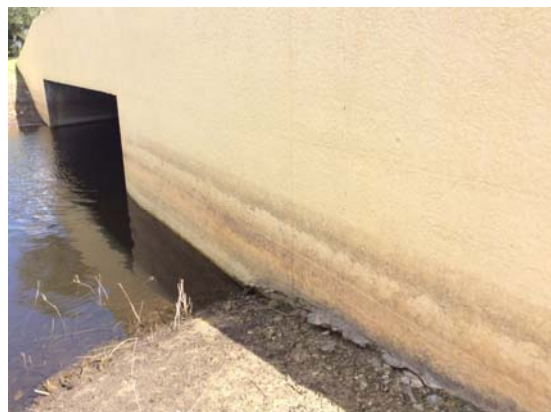
8.1.15 Villagio Gardens Court Culvert (Table 1, Observation ID: 907)

Stain marks on the Villagio Gardens Ct culvert crossing indicate an extended period of high head loss. This could be a result of excess water being diverted to this location from flow restrictions, in other areas or an undersized crossing. Additional stormwater modeling is recommended to identify flow issues in this area.

Stain lines on the Villagio Garden Court box culvert indicate there was significant head loss through the culverts during the 2017 storm events. The upstream stain line on the culvert crossing was 1.2 ft higher than the downstream stain line.

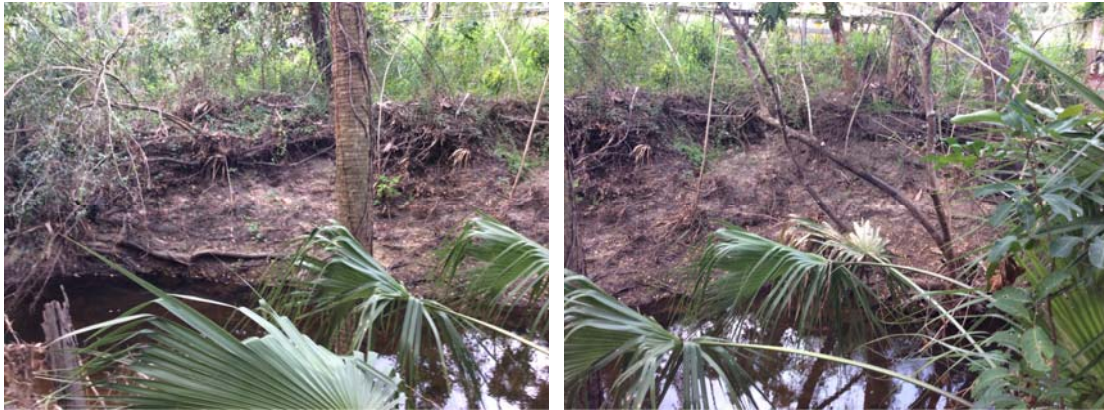
8.1.19 Bank Stabilization (Table 1, Observation ID: 127)

Very steep bank slopes along Old Oak Place and Winterberry Way appear to be impacting adjacent properties. Property owners have installed timber retaining walls that appear to be failing. A more permanent stabilization method is recommended to prevent further erosion, which could impact creek flow.

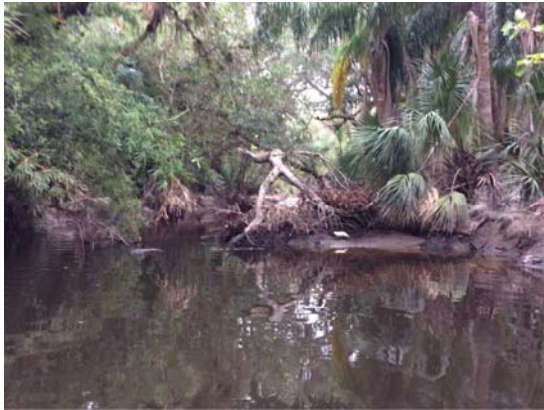
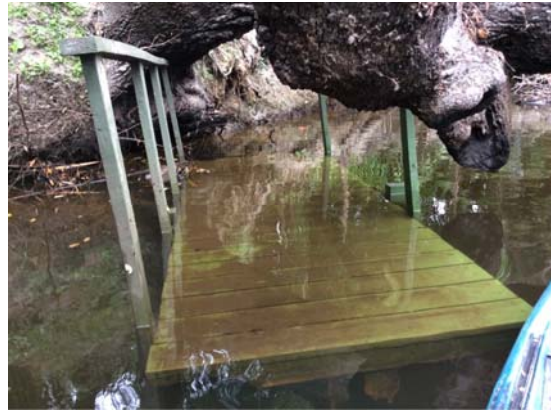
8.1.21 Bamboo Island Sediment Removal (Table 1, Ranking: 1)

Relatively large areas of sediment, that span the entire creek, were found to the south of Bamboo Island. While other areas of sediment are likely to have limited impact on creek flow, these areas could reduce flows if storms occur prior to the sediment being flushed downstream. It is recommended that this sediment be monitored. If the sediment does not move downstream, removing the sediment is recommended.

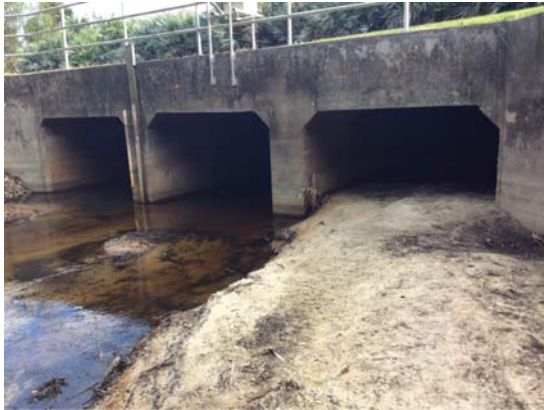
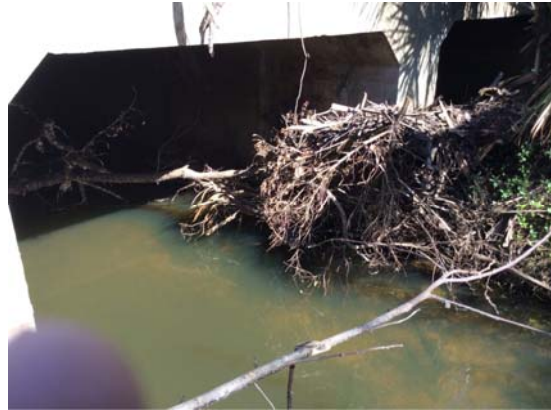
8.1.23 Corkscrew Road Box Culvert Sediment (Table 1, Observation ID: 1300, 1673, 1696)

Accumulated sediment was observed in the Estero River South Branch, Corkscrew Road box culvert. This sediment should be removed, to ensure the culvert is functioning at full capacity for the next storm events.

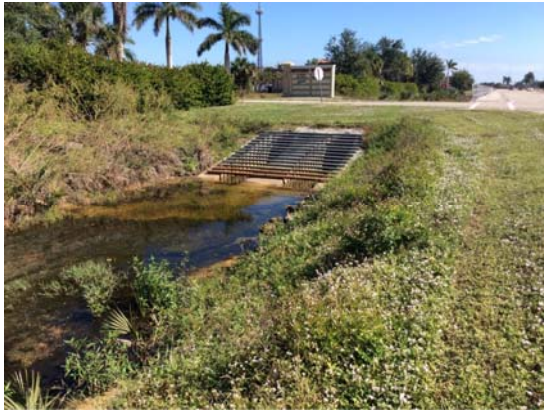
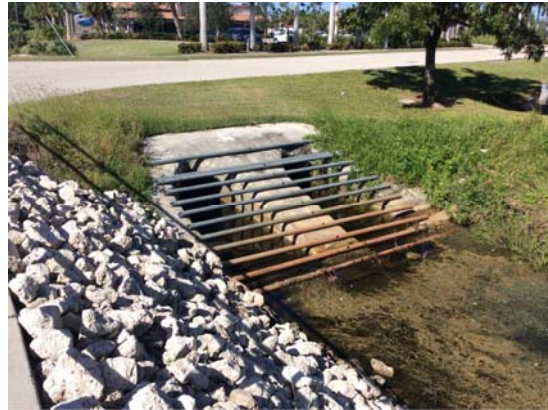
8.1.25 Corkscrew Road Driveway MES Grates (Table 1, Observation ID: 745, 1703-1705)

The driveway culverts, along the north side of Corkscrew Road, vary in size. The appropriate sized culverts should be calculated. If larger culverts are required, existing culverts should be replaced.

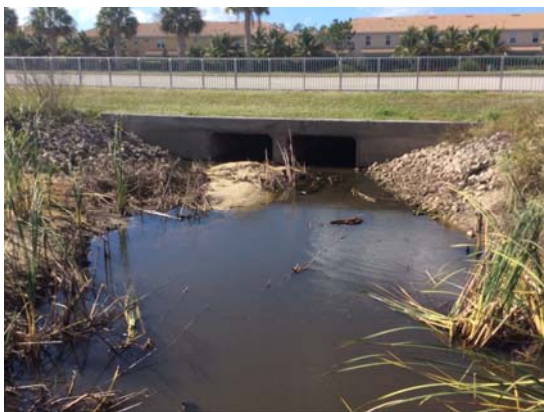
8.2.14 I-75/Imperial Parkway Sediment (Table 1,
Observation ID: 1883)

Some sediment was found in the Rosemary Canal at I-75 and Imperial Parkway. This sediment should be removed.

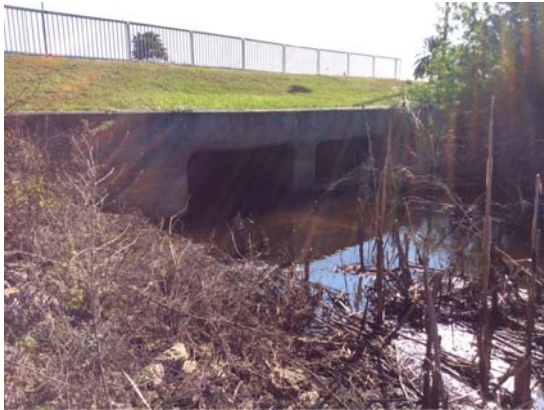
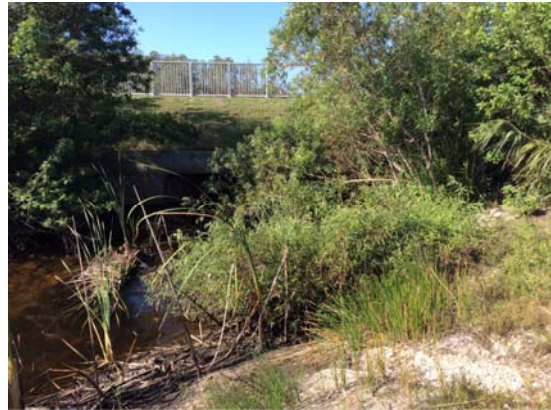
8.2.15 Imperial Parkway Sediment (Table 1, Observation ID: 1017, 1020, 1022)

Some sediment was found in the Rosemary Canal at the middle Imperial Parkway crossing. This sediment should be removed.
