**LEE COUNTY, FLORIDA
SHORE PROTECTION PROJECT**

**GASPARILLA ISLAND SEGMENT
2019 BEACH RENOURISHMENT**

YEAR 1 POST-CONSTRUCTION MONITORING REPORT

**U.S. ARMY CORPS OF ENGINEERS
JACKSONVILLE DISTRICT**

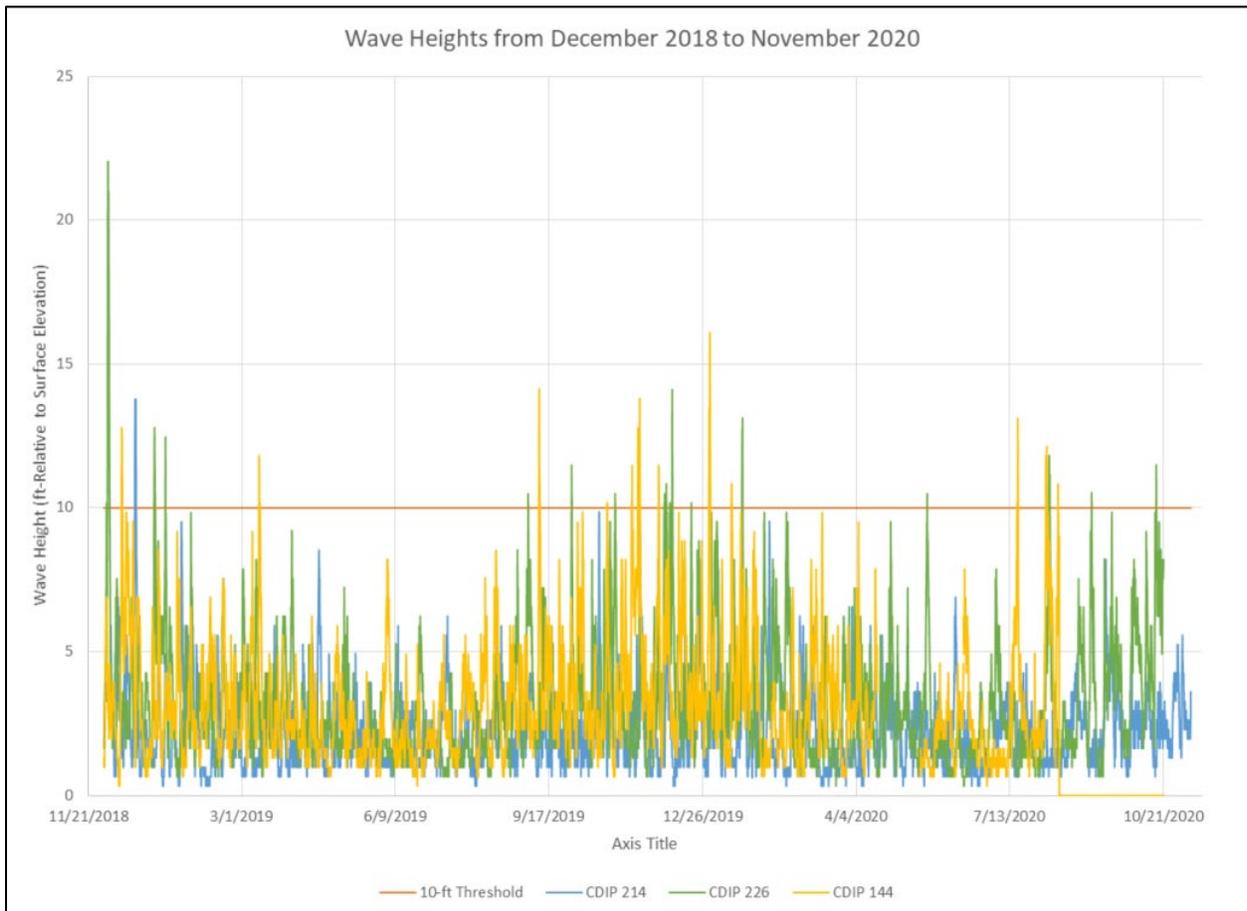
Figure 6: Wave Heights in Gulf of Mexico from November 2018 to November 2020

The wave conditions between November 2018 and November 2020 are displayed in **Figure 6**. Wave heights from the three closest wave buoys were obtained to develop and understand of the overall wave climate off the west coast of Florida because there are no wave gauges in the immediate vicinity of the project area. The wave heights reflect the general conditions of the waves off the west coast of Florida which give an idea of the wave climate during this time period but may not reflect the exact wave conditions at Gasparilla Island. The wave heights in this figure were taken from Coastal Data Information Program (CDIP) buoy Station 144, Station 226, and Station 214. CDIP Station 144 is located 130 miles northwest of the project area. CDIP Station 214 is located 70 miles north of the project area and CDIP Station 226 is located 120 miles southwest of the project. The location of all three stations in relation to the project area can be seen in **Figure 7**.

In general, the wave conditions during this time period were typical of the region with lower wave heights in the summer and larger wave heights in the fall and winter months. The threshold for elevated wave conditions was set at 10 feet relative to water surface elevation and there are very few instances of wave heights crossing this threshold in this time period. Hurricane Michael (October 2018) became a Category 5 Hurricane but stayed more than 250 miles offshore of the project area, keeping the wave heights below the 10-ft threshold. Hurricane Michael caused significant damage to the panhandle region of Florida but did not cause significantly higher wave heights in the project area. The subsequent weather events in the project area were not significant and likely caused no more than normal background erosion. Only one event was noted between the survey interval of February 2019 and October 2019; a winter storm that exceeded the threshold at CDIP buoy 144. The storm did not cause significant wave heights at any of the other buoys in the region and likely did not have a significant impact on the project area. The 2020 hurricane season was particularly active, but the majority of storms did not provide elevated wave heights to the project area.

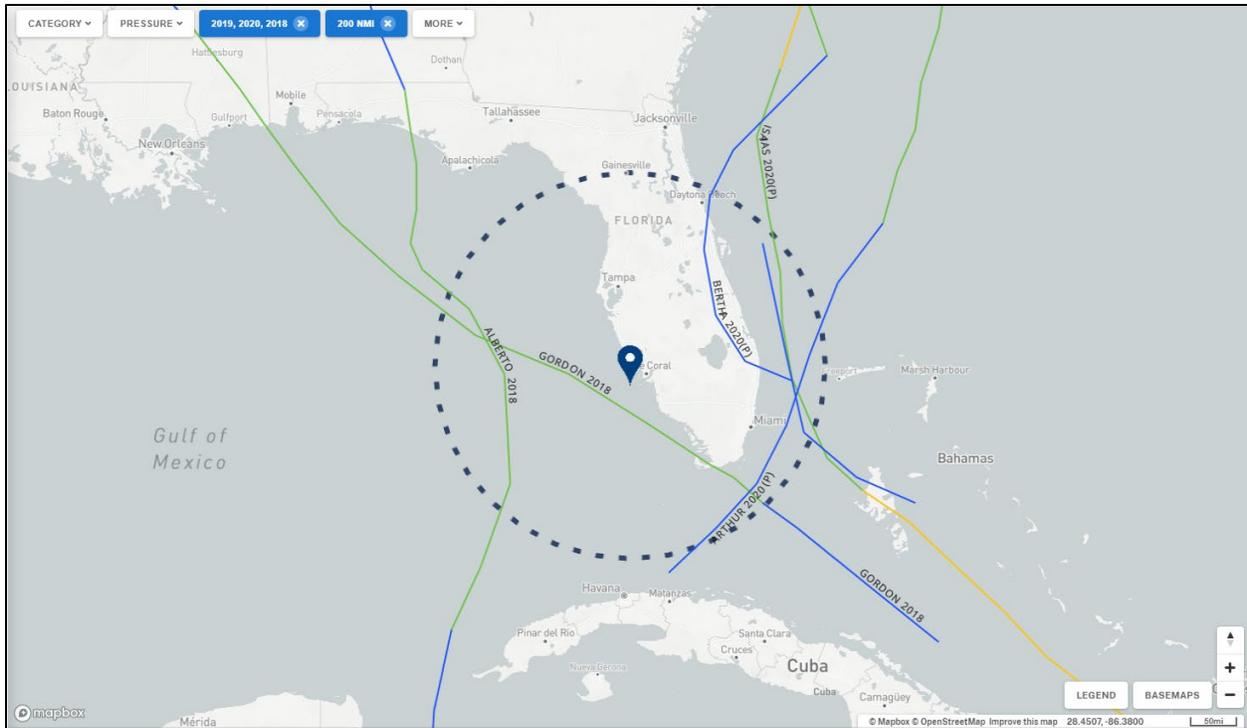
Figure 8: Hurricane Tracks from 2018 to 2020 within 200 nm of Gasparilla Island

Figure 8 shows the tracks of tropical storms and hurricanes from 2018 to 2020 within 200 nautical miles (nm) of Gasparilla Island. Following Hurricane Irma in September 2017, Tropical Storm Alberto (May 2018) and Tropical Storm Gordon (September 2018) were the only tropical events in the Gulf of Mexico that passed within 200 nm. Additionally, Tropical Storms Arthur and Bertha (May 2020) and Hurricane Isaias passed within 200 nm but were in the Atlantic Ocean and did not generate significant wave heights in the project area.

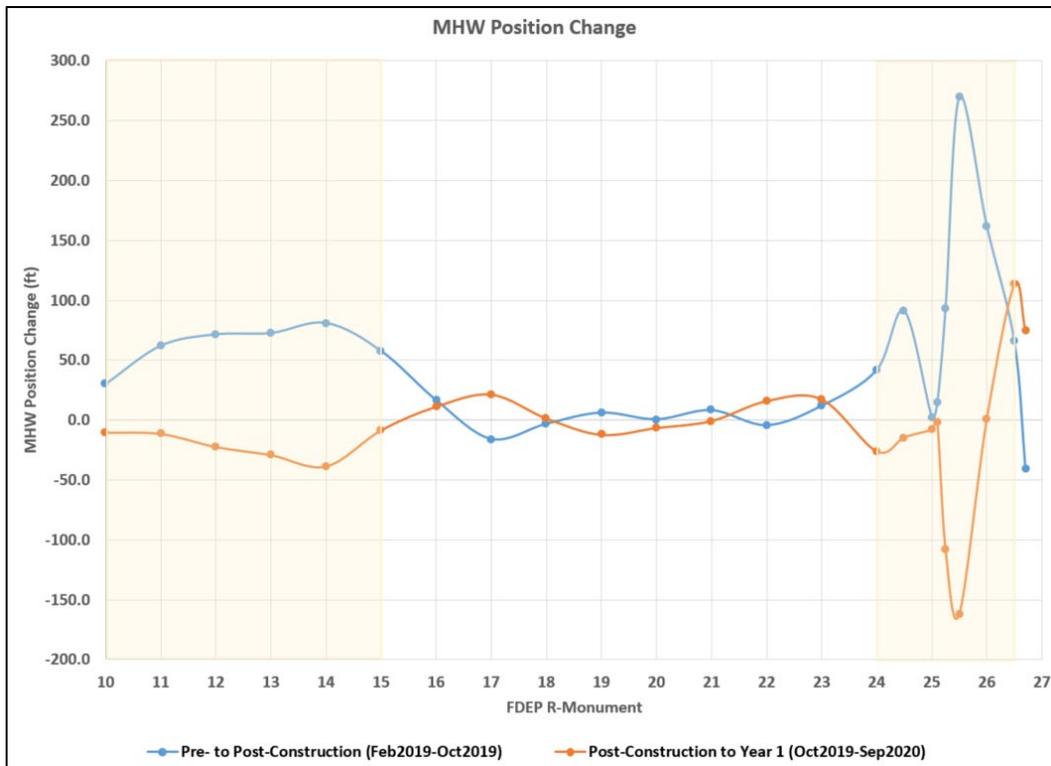
Figure 9: MHW Position Change
(Highlighted areas denote fill placement areas R-10 to R-15 & R-24 to R-26.5)

The area between the federal and non-federal fill areas (R-16 to R-23) had shoreline advance at 5 out of 8 profiles and only experienced shoreline retreat between R-19 and R-21. This shoreline retreat was only 1 to 12 ft. The shoreline advance in this area is a result of the fill dispersing from both the federal and non-federal fill areas.

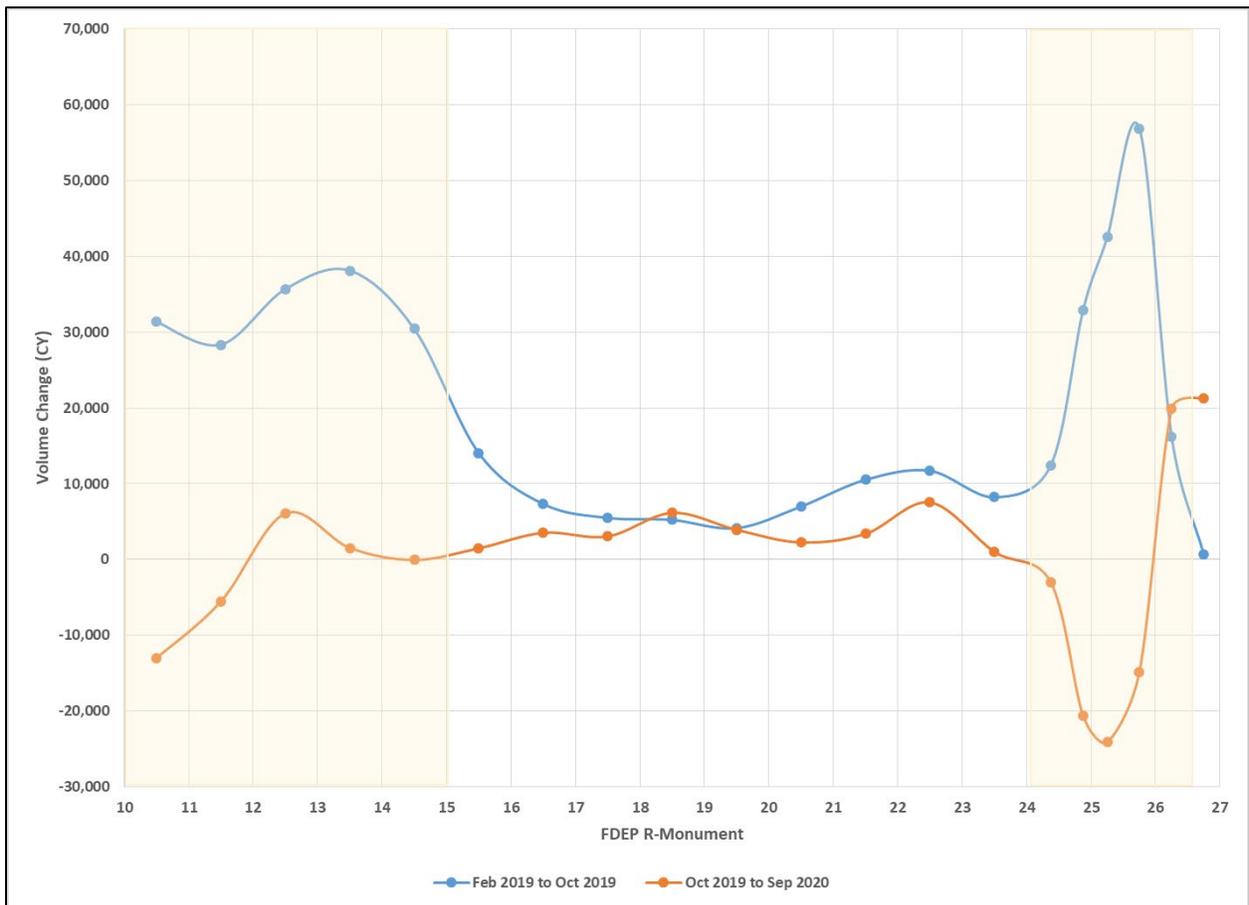
Figure 14: Volumetric Change from Dune To -13 Ft NAVD88 in the Beach Fill Area

In total the project area (R-10 to R-26A) saw a gain of 399,240 cy of volume while only receiving 281,638 cy from the nourishment projects. This is a difference of 117,562 cy (6.8 cy/ft). From analysis of the beach profiles this additional volume gained within the project area is likely due to material migrating onshore and filling troughs within the profiles - likely caused by Hurricane Irma in September 2017. This natural recovery of the beach following a large storm can occur over a couple of years following the storm, depending on the severity of the storm and how far offshore the storm moved the material. Even the pre-construction survey (February 2019) shows some of the troughs starting to be filled during the period between the August 2018 monitoring survey and the pre-construction survey, despite the large amount of erosion seen during this time period.

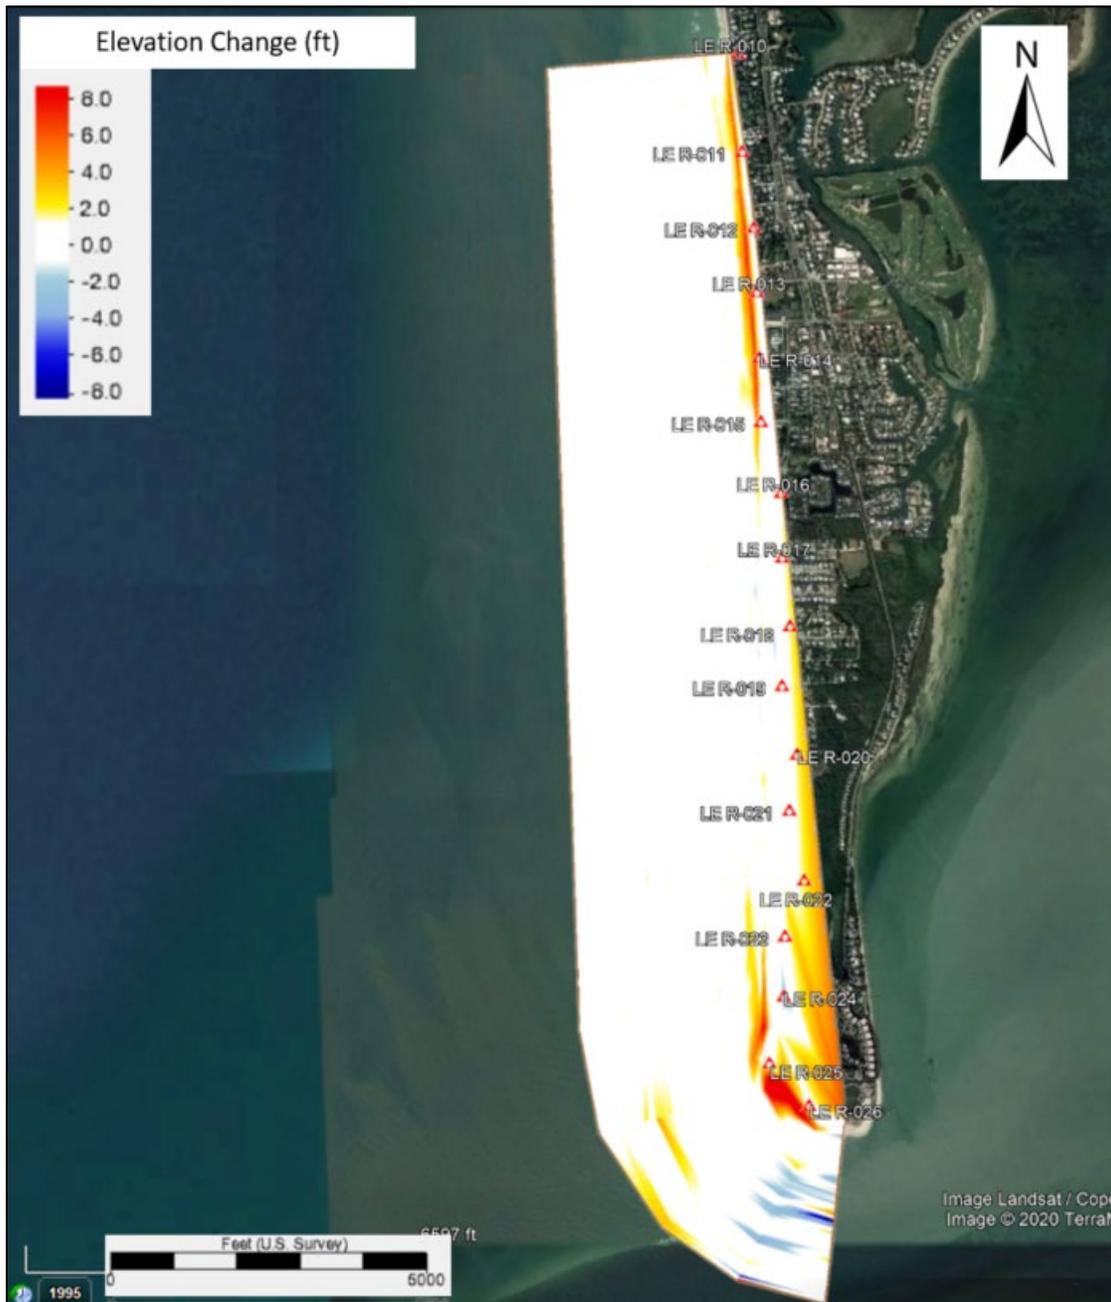
Figure 15: Elevation Change from Pre to Post-Construction Surveys

In addition, the pre- to post-construction monitoring surveys occur between the spring and fall months of the year. Typically, on Florida beaches, erosion is seen in the winter months as winter storms deliver large amounts of energy to the shoreline. During summer months, recovery from these winter storms is typically seen. The overall pattern of accretion is likely due to the timing of the surveys. As discussed above, in Section 2.1) Summary of Previous Monitoring Cycle, the amount of erosion seen between August

2018 and February 2019 was approximately 158,900 cy. When adding the erosion from this time period to the net accretion from February 2019 to October 2019 (117,602 cy after removing the volume added due to the nourishments), the net change in volume neglecting the nourishment was approximately 41,300 cy of erosion from August 2018 to October 2019. Although a significant amount of erosion occurred from during winter from August 2018 to February 2019, the project area saw natural recovery (in addition to the volume from the nourishments) from February to October 2019. This volume of erosion is relatively close to the average annual erosion rate from the previous monitoring cycle of 52,600 cy of erosion per year.

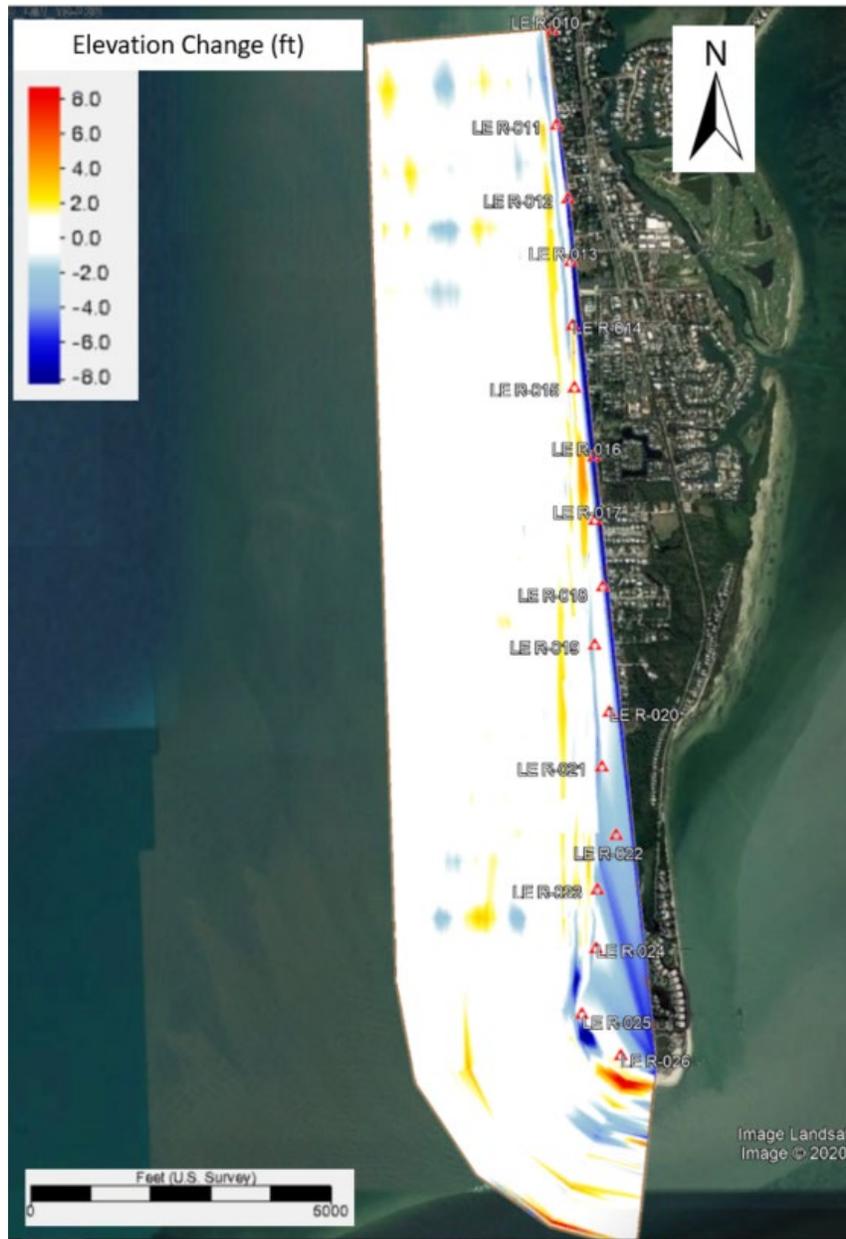
Figure 16: Elevation Changes between Post-Construction and Year 1 Monitoring Surveys

Within the non-federal project fill area the maximum loss of material was 39.5 cy/ft between R-24.75 and R-25.5 and the maximum gain was 50.9 cy/ft between R-26 and R-26.5. The fill that was placed in front of the revetment (R-25 to R-25.5) eroded immediately after placement and began to drift to the south, where it accumulated at the terminal groin at R-26.5. The fill that was placed in front of the revetment was protruding from the shoreline, which caused it to erode more quickly than the adjacent shorelines. The material predominantly followed the direction of the alongshore transport and moved south. Some of the material was trapped by the terminal groin but some of the material moved around the groin and has accumulated at R-26A. It is likely that this material will continue to erode from this area over time and be lost from the project area. The material lost from the project area will likely return to the inlet shoal complex.

Despite the general health of the project, the non-federal fill area is an area of concern moving forward. As seen in **Table 10**, the area between R-24 and R-25.5 has lost at least 57% of the volume placed during the 2020 nourishment. This is the area in front of the revetment at Boca Bay Pass Club. As material erodes from this area, it feeds the adjacent shorelines to the north and south but at the current rate of erosion, the area will run out of capacity in the near future. The beach north of the revetment will likely continue to receive volume from the federal fill area since the typical littoral drift is from north to south but the area to the south of the revetment will likely see a net deficit as more material erodes than the northern beaches supply - especially once the revetment structure acts like a terminal groin and traps material. It is likely that the beach in the vicinity of R-26 (south of the revetment) will begin to erode at a more rapid pace once this happens.

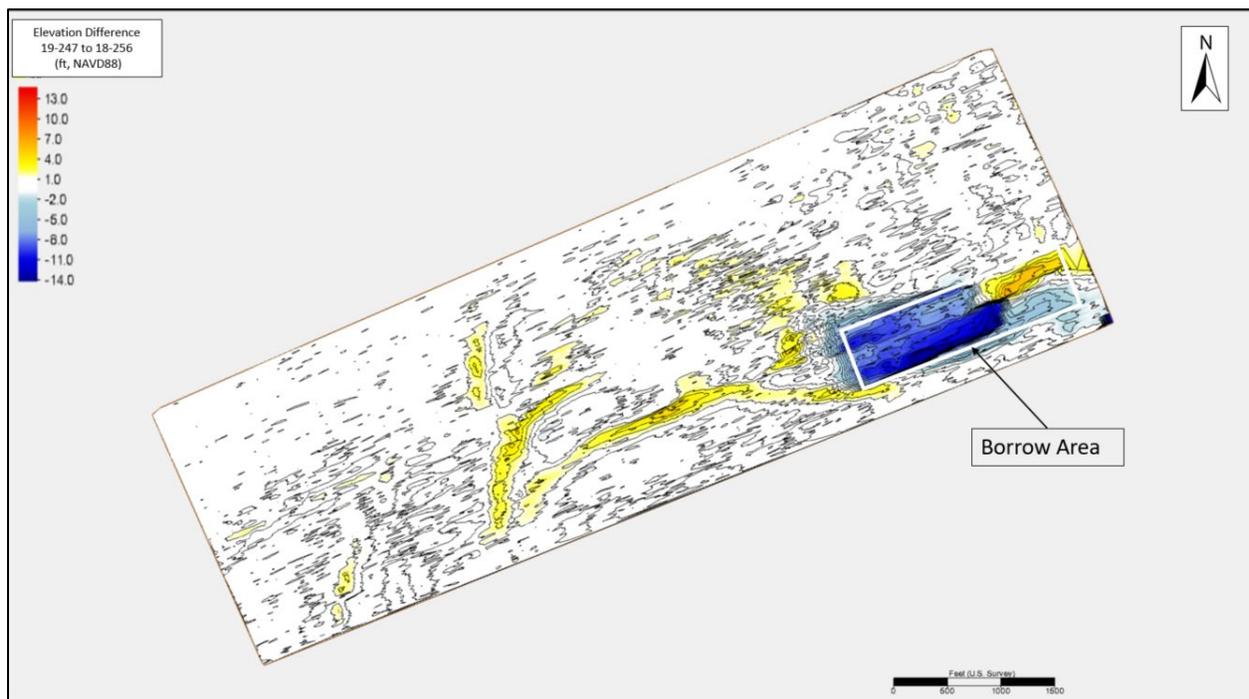
Figure 20: Borrow Area Pre To Post-Construction Bathymetry Change

This section assesses the condition of the borrow area based on survey 19-247 performed on 6-8 August 2019. **Figure 20** displays the bathymetric changes from the pre-construction (December 2018) to post-construction (August 2019) monitoring surveys.

The Corps conducted the pre-construction survey on 28 December 2018 (Survey 18-256) and the post-construction borrow area survey on 6-8 August 2019 (Survey 19-247). The total net volume change measured within the limits of the permitted borrow area is -285,000 cy. This is approximately equal to the contract pay volume within the fill template on the beach (281,638 cy). The difference in volume between the borrow area and beach placement area is likely due to some of the sediment being lost during transport to the beach by the contractor combined with some material entering the borrow area after material was excavated.

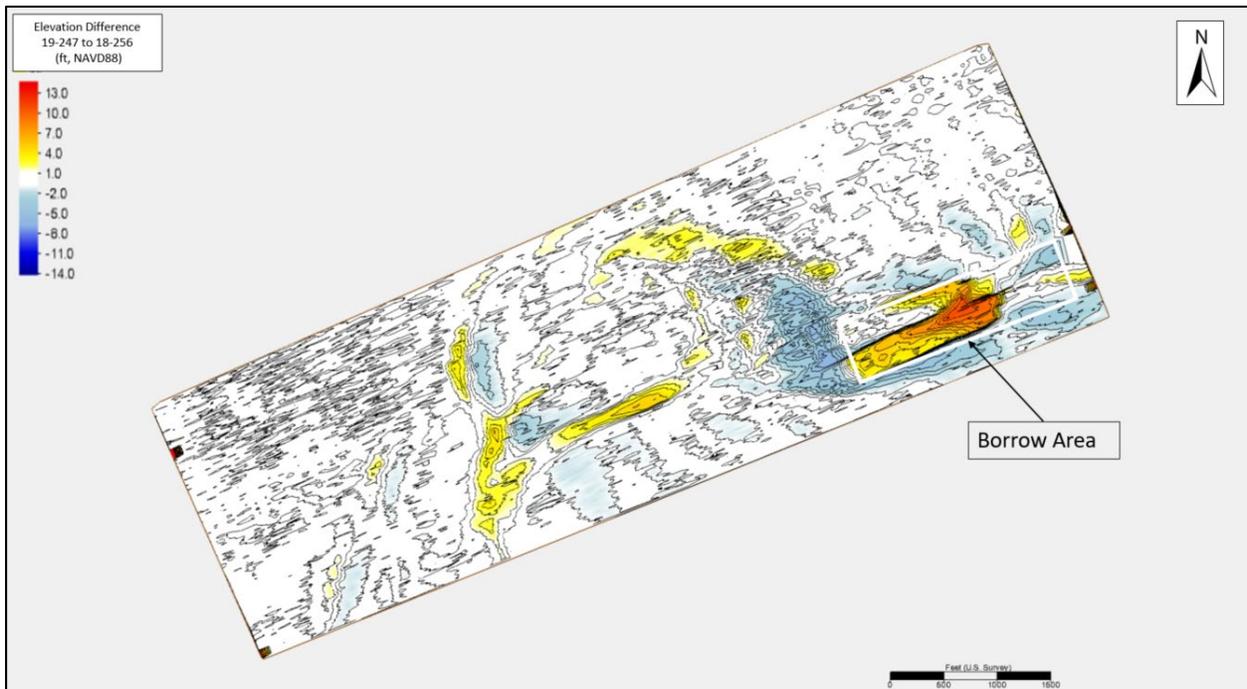
Figure 21: Borrow Area Post-Construction to Year 1 Monitoring Bathymetry Change

This section assesses the condition of the borrow area based on survey 20-244 performed by the Corps on 14 October 2020. **Figure 21** displays the bathymetric changes from the post-construction (August 2019) to the year 1 (October 2020) monitoring surveys.

The total net volume change measured within the limits of the permitted borrow area is accretion of 94,500 cy (110,250 cy/yr). Based on **Figure 21**, the material appears to be filling the borrow area from the side slopes adjacent where the dredging occurred. Over time this area is expected to equilibrate and be recharged from material in the Boca Grande Ebb shoal complex. This includes material that erodes from the southern tip of Gasparilla Island and rejoins the shoal complex.
