RE: NESHAP Asbestos Survey Report and Screening for Metals-Based Coatings
Big Carlos Pass Bridge (FDOT Structure No. 120028)
Lee County, Florida
Lee County CN-16002
Tierra Project No.: 6511-16-051E

**NESHAP ASBESTOS SURVEY
AND SCREENING FOR METALS-BASED COATINGS**

Big Carlos Pass Bridge (FDOT Structure No. 120028)

Tierra Project No.: 6511-16-051E

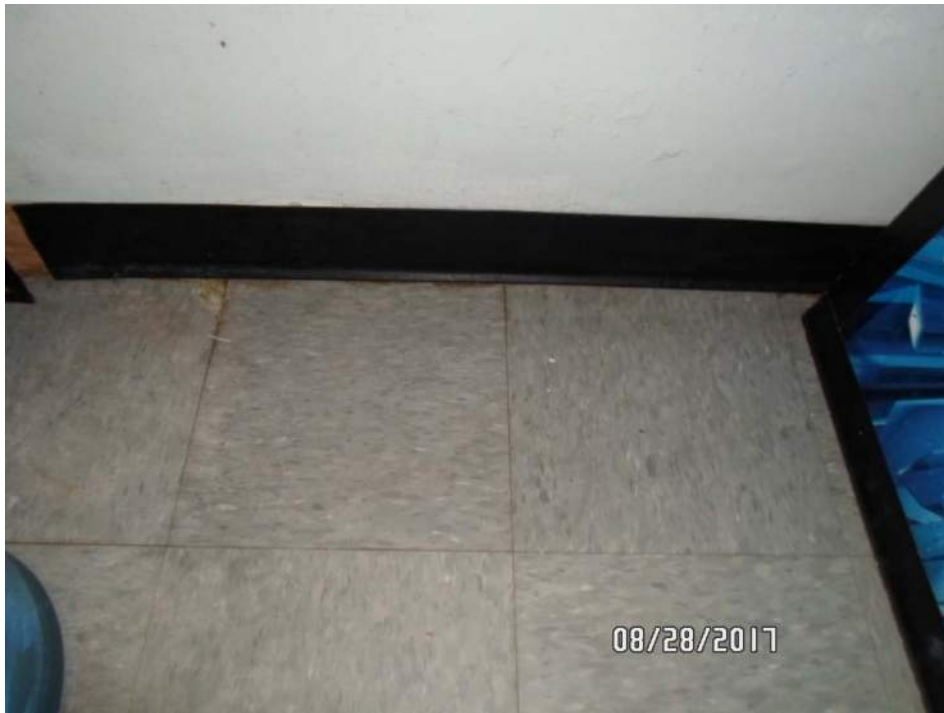
Homogeneous Area #1 (sample 001-003): 12"x12" Gray VCT w/brown mastic; tender house

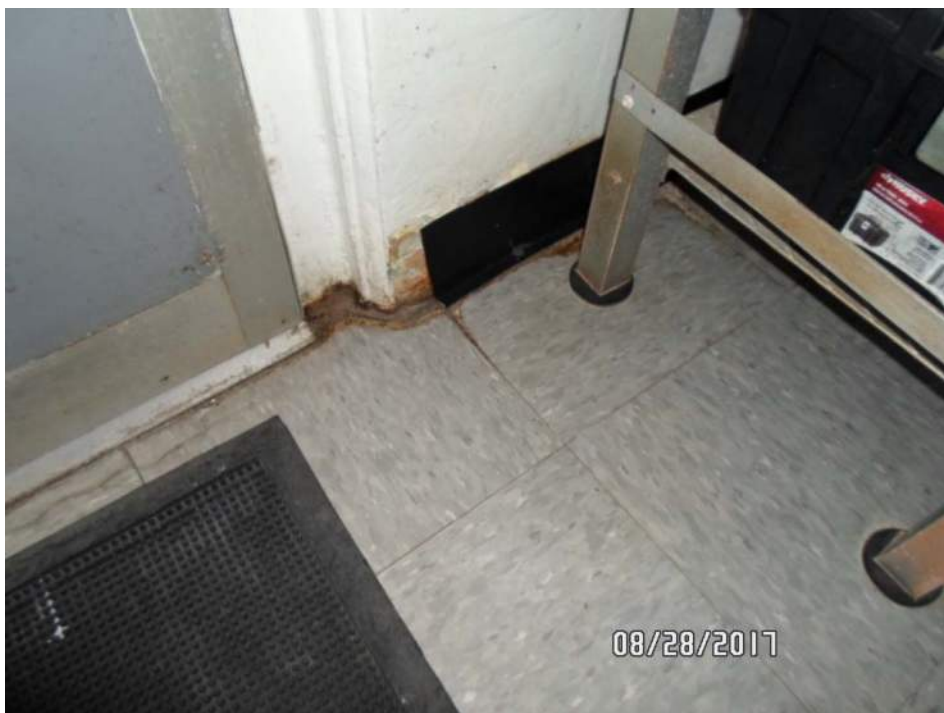
Homogeneous Area #2 (samples 004-006): Black baseboard with light brown mastic;
north wall inside tender house

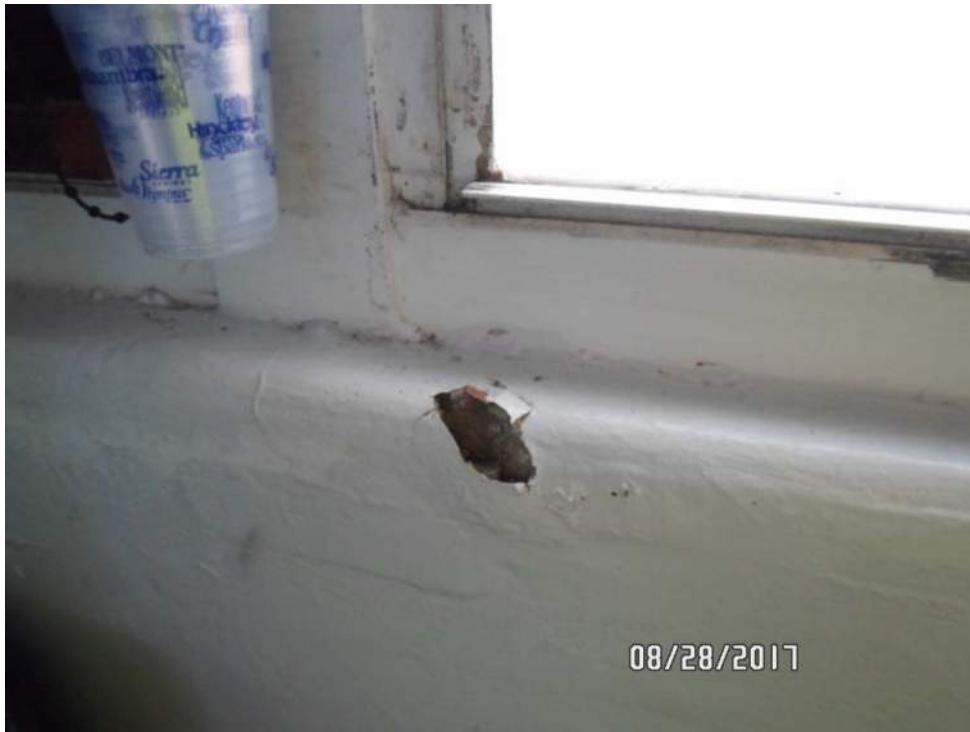
Homogeneous Area #3 (samples 007-009): Gray concrete w/white paint; west wall inside tender house

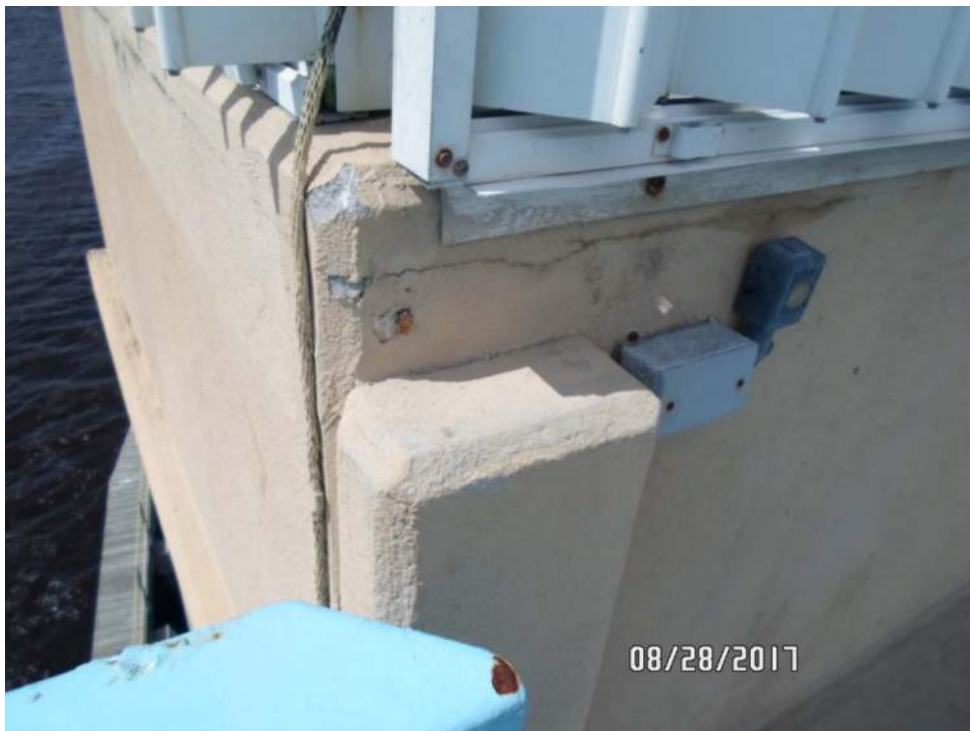
Homogeneous Area #4 (samples 010-011): Gray concrete w/ tan paint, northeast corner of tender house

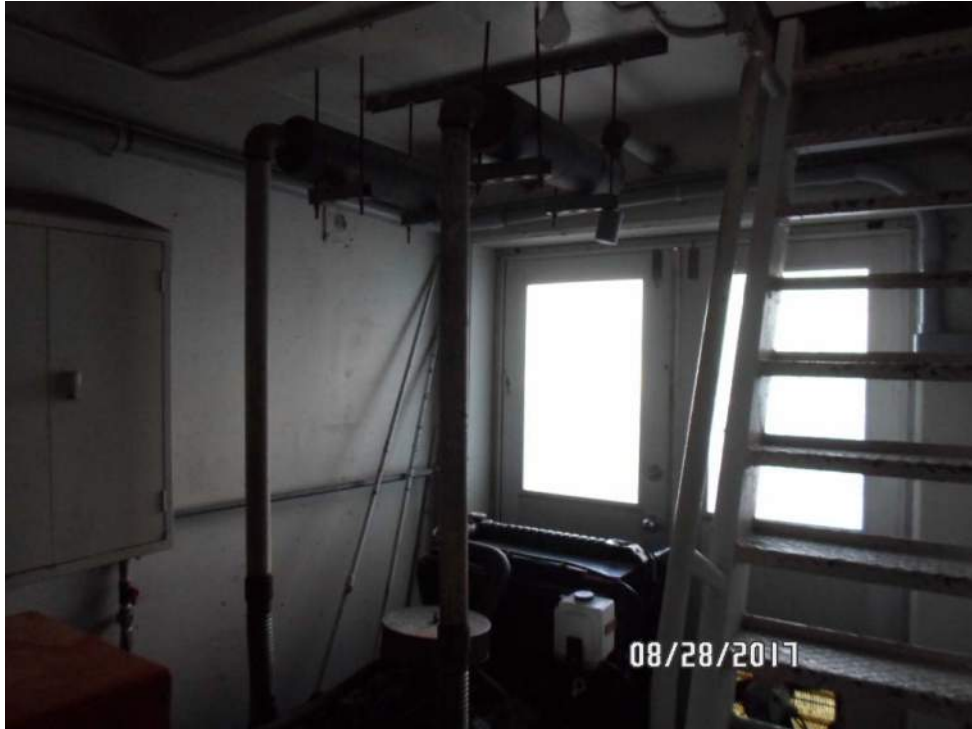
Homogeneous Area #5 (samples 013-015): Gray concrete with gray paint; tender house electrical room

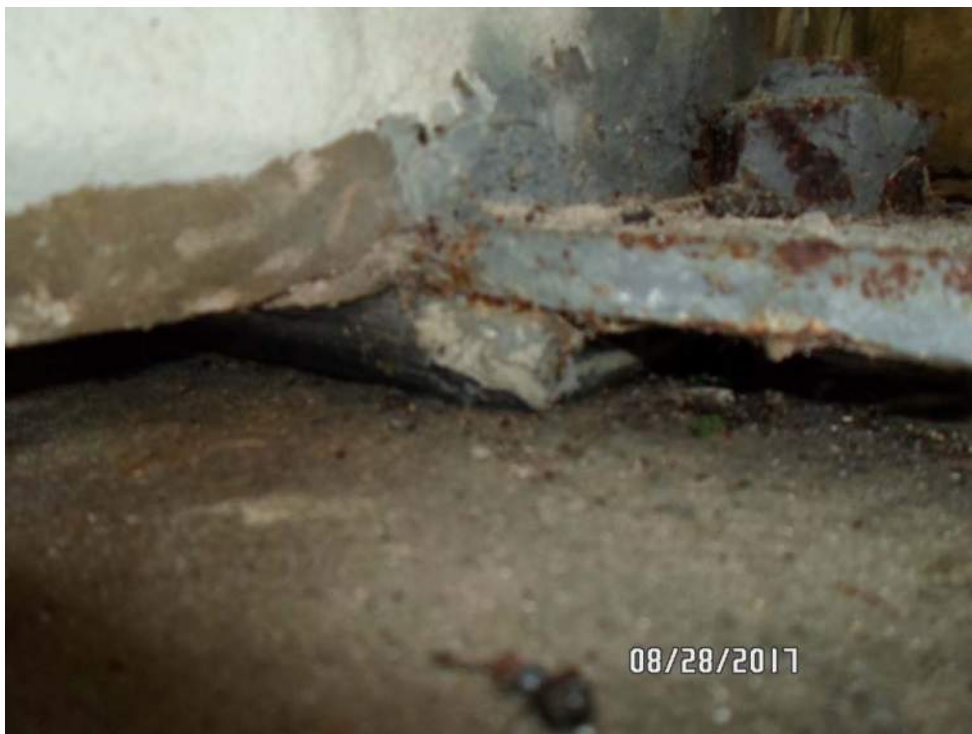
Homogeneous Area #6 (samples 016-018): Black bearing pad-end bent; bridge structure

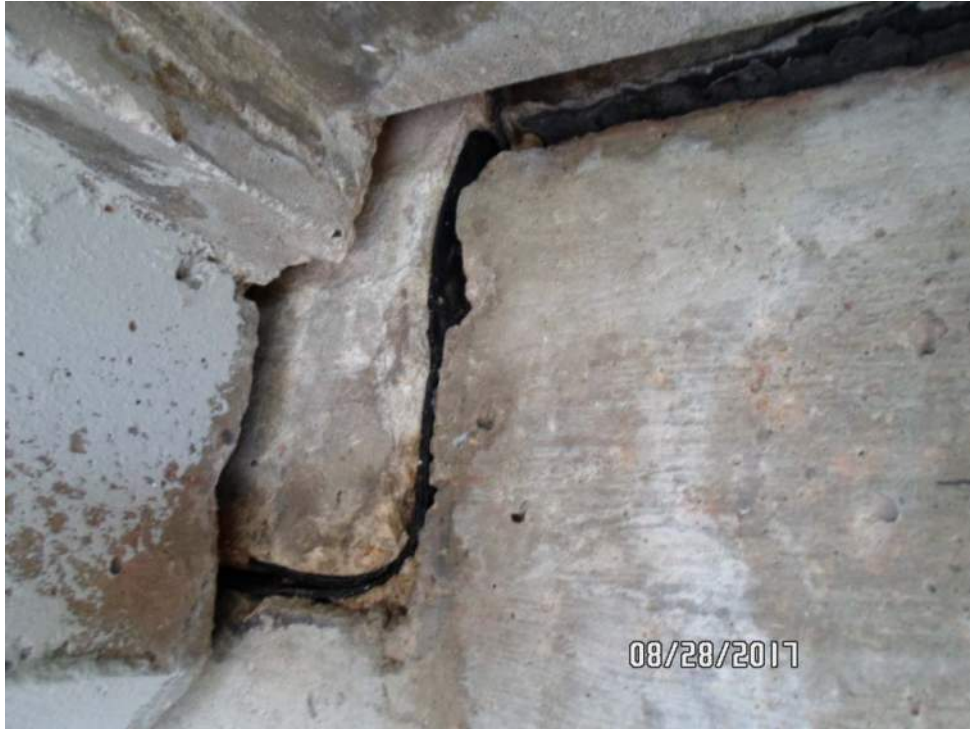
Homogeneous Area #7 (sample 019-021): Black felt pad- end bent between girder and end bent

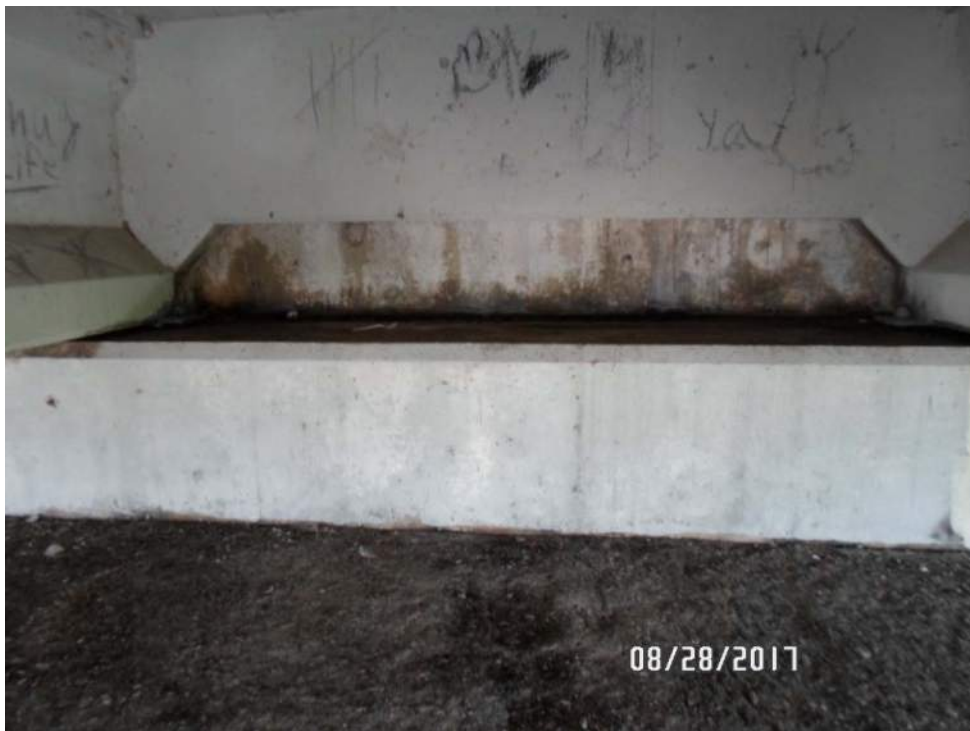
Homogeneous Area #8 (sample 022-024): Gray end bent concrete

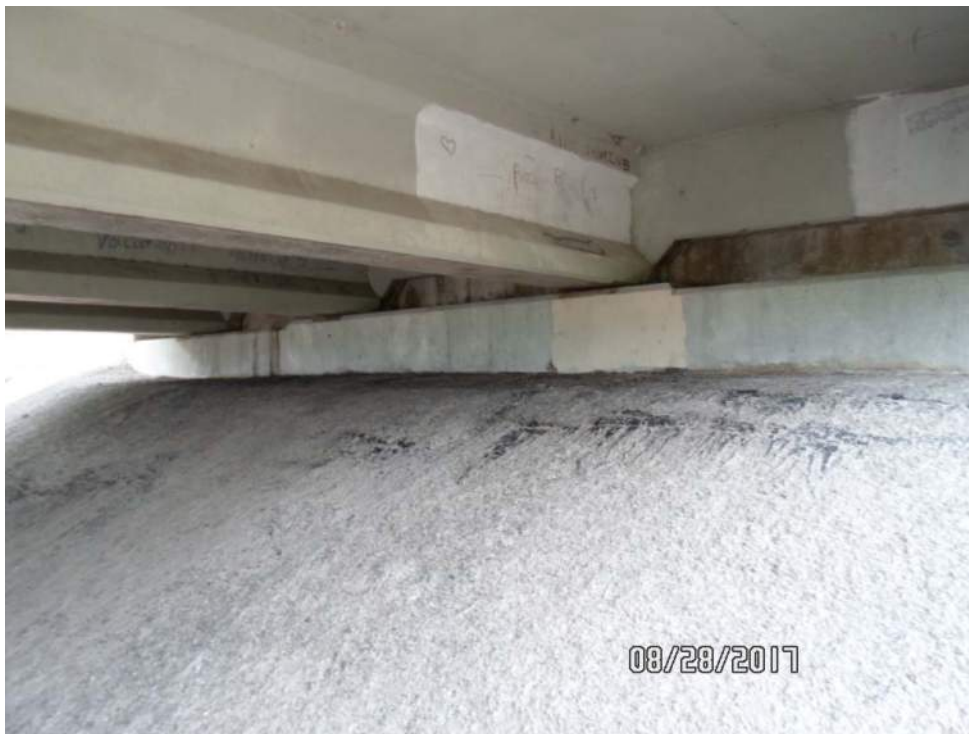
Homogeneous Area #9 (sample 025-027): Gray deck concrete, west end of bridge

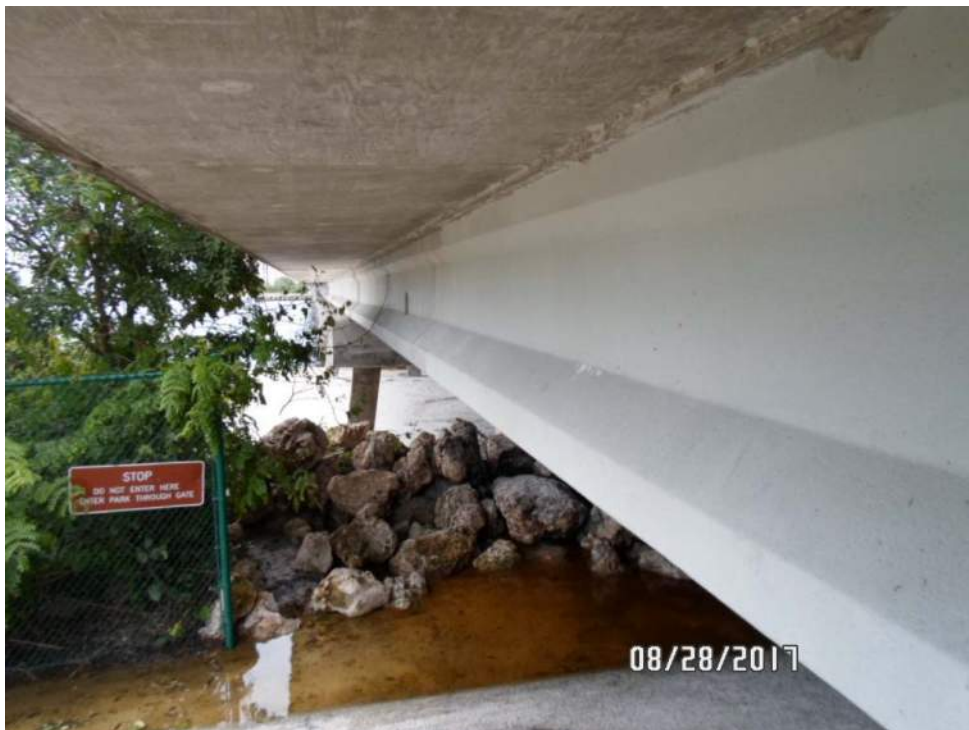
Homogeneous Area #10 (sample 028-030): Gray girder concrete

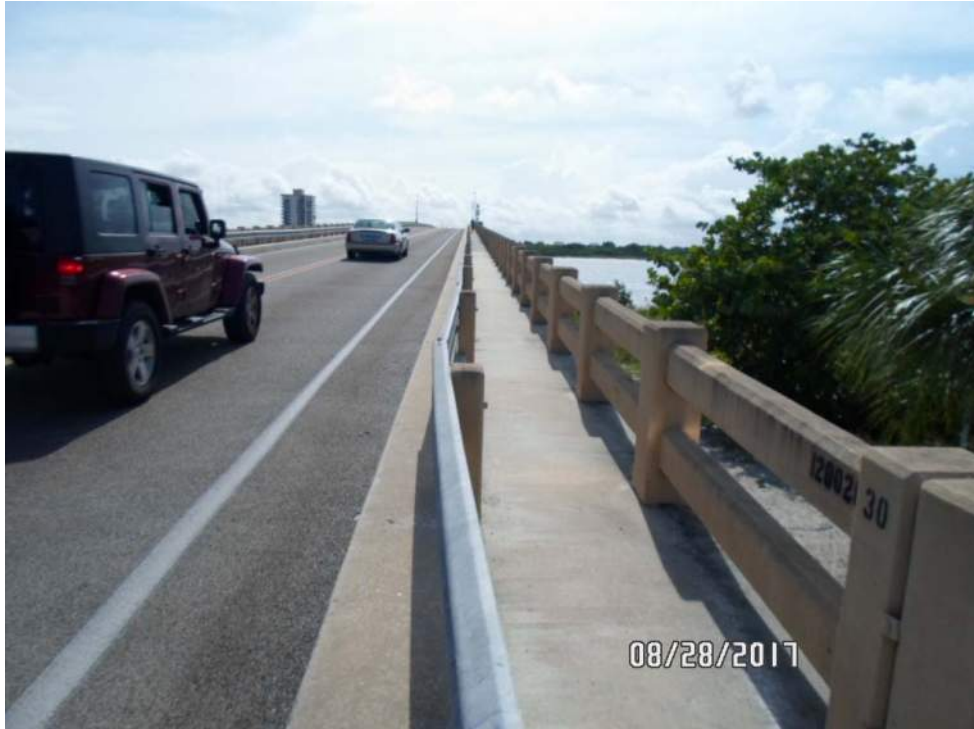
Homogeneous Area #11 (sample 031-033): Gray sidewalk concrete, west end of bridge looking east

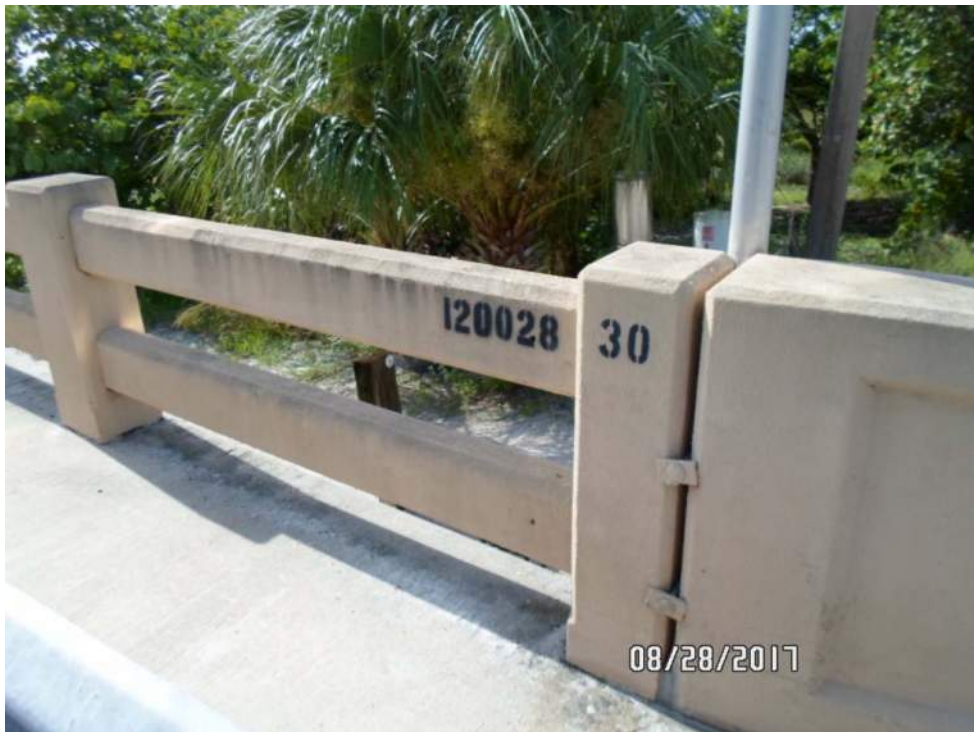
Homogeneous Area #12 (sample 034-036): Gray concrete w/tan paint-guardrail; west end of bridge

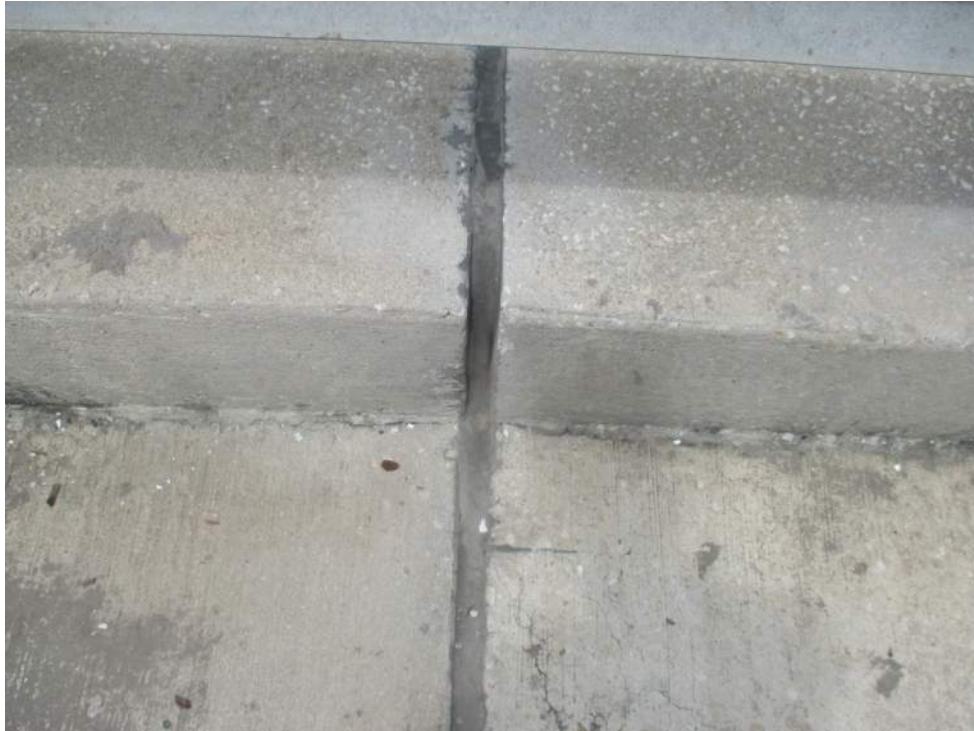
Homogeneous Area #13 (sample 037-039): Gray expansion fill-sidewalk

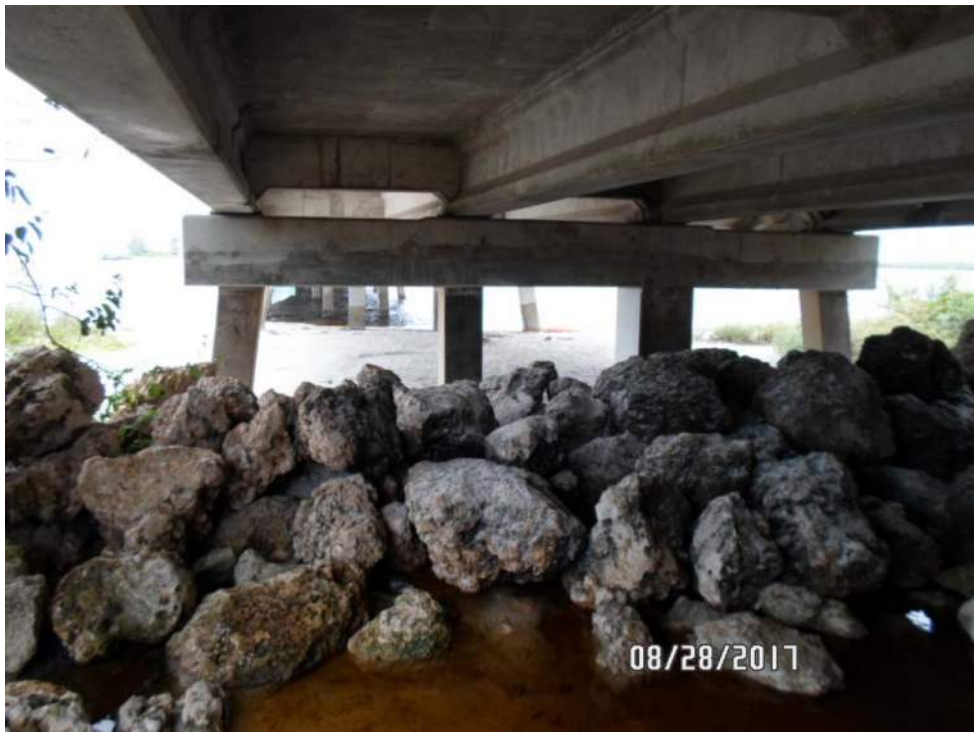
Homogeneous Area #14 (sample 040-042): Gray pile concrete

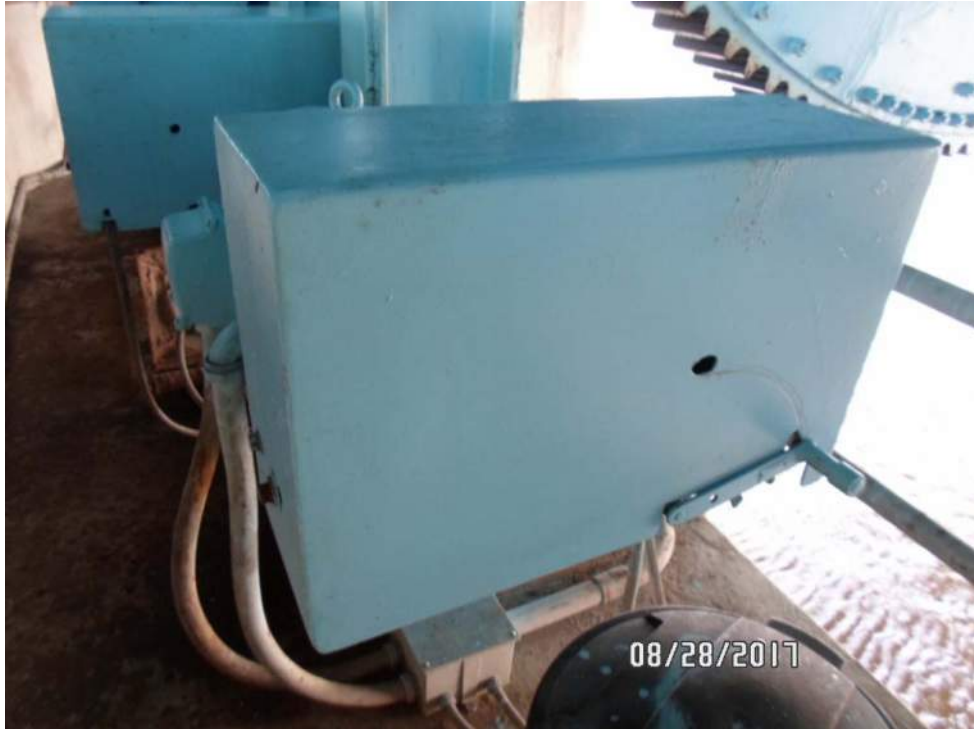
- Emergency brake on Sheet B-48 (brake composition and brake dimensions were not found in plans) – Brake box was not accessible during site visit (bolted shut); presumed ACM
- Service brake on Sheet B-48 (brake composition and brake dimensions were not found in plans) – Brake box was not accessible during site visit (bolted shut); presumed ACM
- "Johns Manville," a common trade name for asbestos containing materials was noted for the gray, 9-inch by 9-inch floor tile inside "Control House" on Sheet B-53 (EB-39) – suspect ACM samples were collected and analyzed
- Details of fender and platform show treated timber piles (creosote oil and pitch) on Sheet B-56 (EB-42) – Based on field observations, the timber pile clusters were replaced with concrete piles

Homogeneous Areas #15 and #16: service brake and emergency brake boxes – east pit

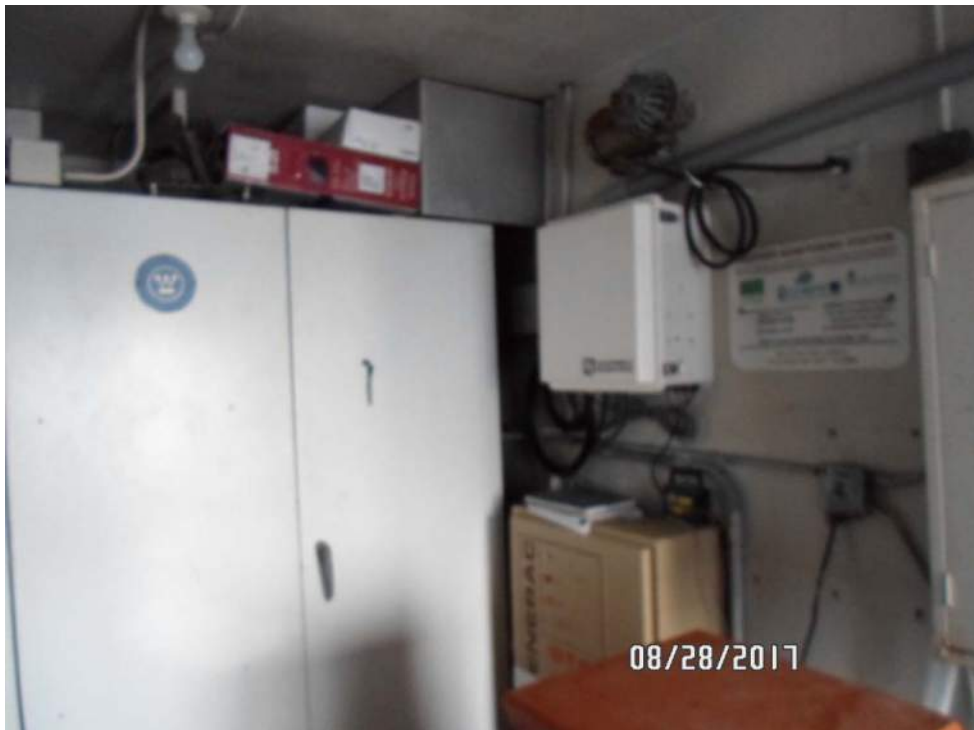
Electrical gear switch/control panels were observed inside of the electrical room (bottom floor) and visually identified as *suspect* ACM. See photograph in **Appendix B** and locations on Sheet B-48 in **Appendix F**. Samples of the switching panels were not collected and panels were not opened to preclude possible safety and bridge operational integrity concerns. The electrical gear switch/control panels appeared to be in good condition. Tierra estimated the electrical components to be approximately 150 cubic feet. The electrical gear switch/control panels are assumed to be ACM and Category II non-friable. It is important to note, according to the USEPA (<https://www.epa.gov/asbestos/us-federal-bans-asbestos>), the manufacture, importation, processing and distribution of many ACM products are not banned. Therefore, non-metallic electrical components such as bus-blocks, terminal strips, mounting boards, panels, breaker boxes, wire coatings, switch gear/boxes may be considered suspect ACMs.

Homogeneous Area #17: Electrical Components – mechanical room

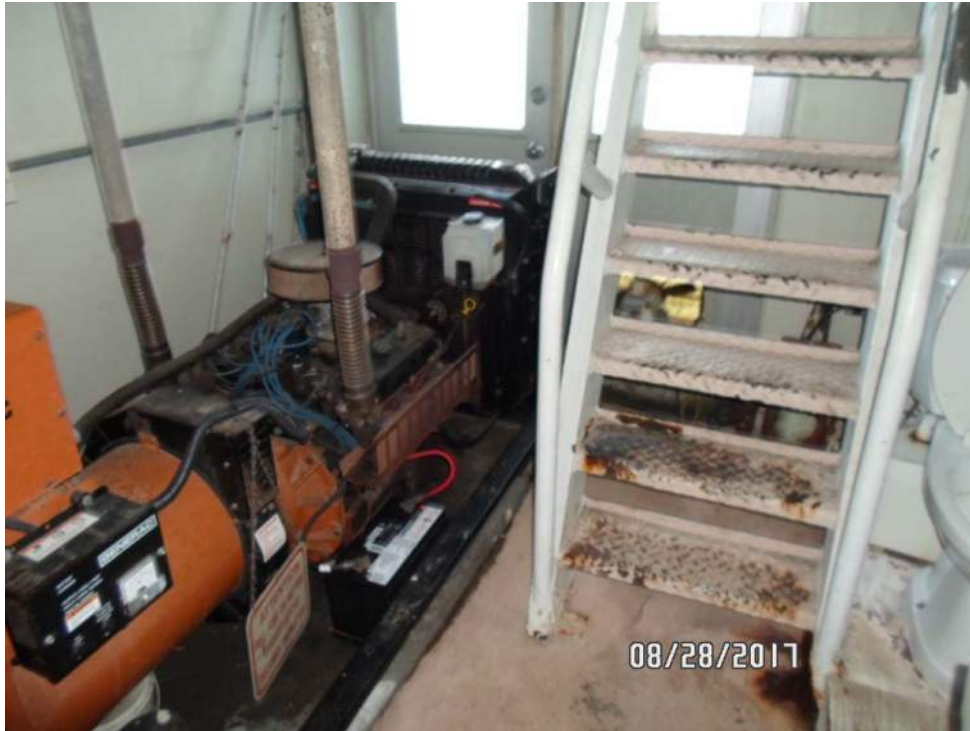
TCLP analysis was conducted for a total of three (3) paint chip samples: PC-1 (chromium and lead only), PC-2 (chromium and lead only) and PC-3 (lead only). TCLP lab analytical results indicate *lead exceeds the Maximum Concentration of Contaminants for the Toxicity Characteristic for PC-2, and PC-3*. TCLP analysis was not conducted for zinc since it is not listed in Table 1 Maximum Concentration of Contaminants for the Toxicity Characteristic (mg/L) found in 40 CFR 261.24

PC-1: White paint with gray undercoating on metal staircase inside electrical room

Based on the presence of metals in the paints, any renovation activities which could result in exposure to workers, such as sand blasting, should be performed in accordance with OSHA regulations to protect workers. *Based on the TCLP results for the tested metals it does appear that the paint waste would be deemed a hazardous waste for PC-2, and PC-3.* However, if paint removal is conducted, then the method used to remove the paint has an impact on the outcome of the waste determination (i.e. sandblasting verses solvent based paint removers). A sample of the *actual* waste generated during the demolition process should be tested prior to disposal.

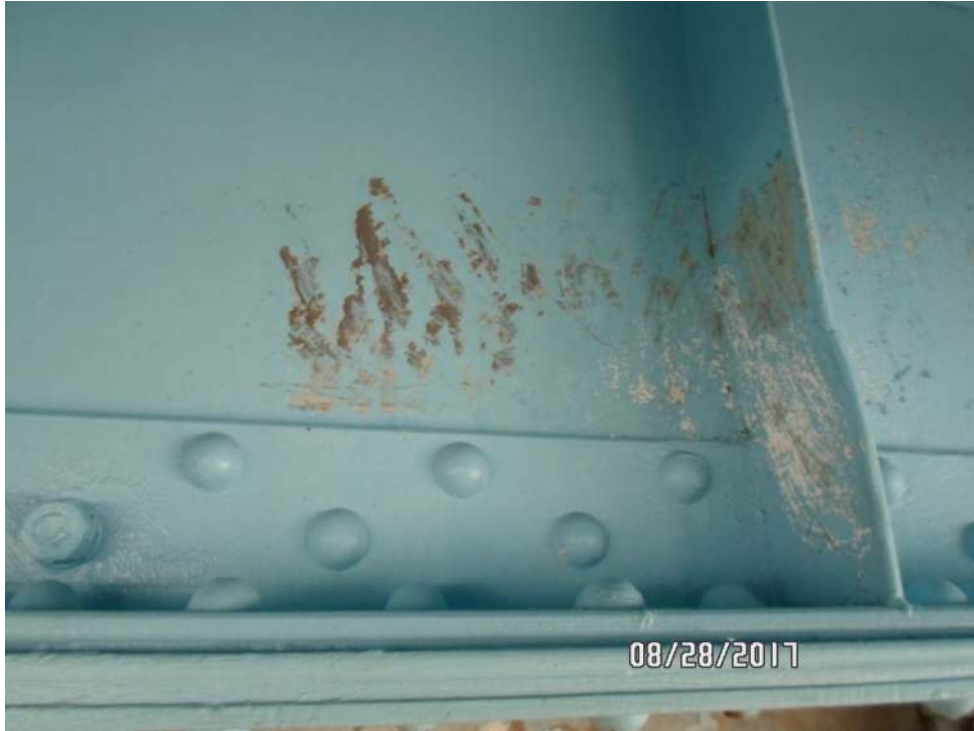
PC-3: Blue paint with white undercoating located on steel bascule girder in trunnion area
