LeeTran Transfer Stations

Fort Myers Beach Park and Ride
Cape Coral Transfer Station
Rosa Parks Transportation Center
Edison Mall Transfer Station

February 2022

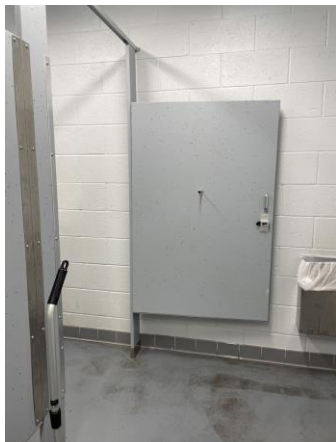
The door to the accessible water closet is not self closing. Either self-closing hinges are not installed on the door or if installed, they are defective.

Install or reinstall self-closing hinges on the door to ensure that the door is self-closing per the ADA requirements.

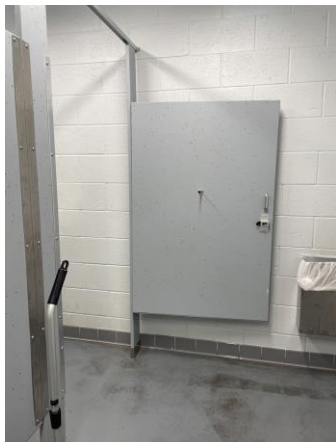
The door to the accessible water closet is not self closing. Either self-closing hinges are not installed on the door or if installed, they are defective.

Install or reinstall self-closing hinges on the door to ensure that the door is self-closing per the ADA requirements.

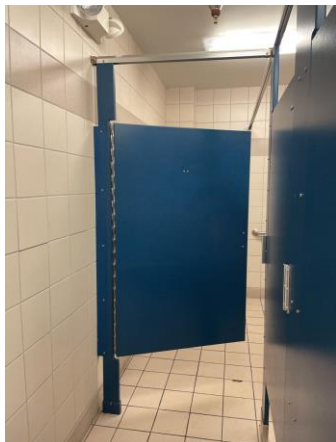
The door to the accessible water closet is not self closing. Either self-closing hinges are not installed on the door or if installed, they are defective.

Install or reinstall self-closing hinges on the door to ensure that the door is self-closing per the ADA requirements.

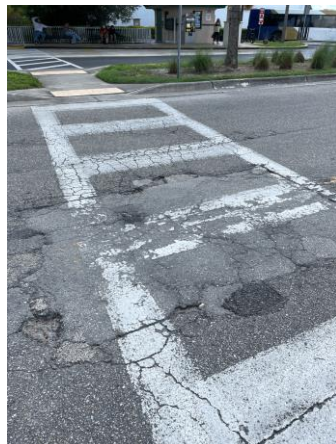
The changes in vertical elevation in the accessible route are tripping hazards for users.

Repave the area of the sidewalk to remove the bump. Ensure that the change in level does not exceed 1/4".
