Roof Failure Investigation Lee County Sheriff Core II Building 2505 Ortiz Avenue, Ft. Myers, Florida

Date: September 7, 2012

Roof Failure Investigation Lee County Sheriff's Core II Building

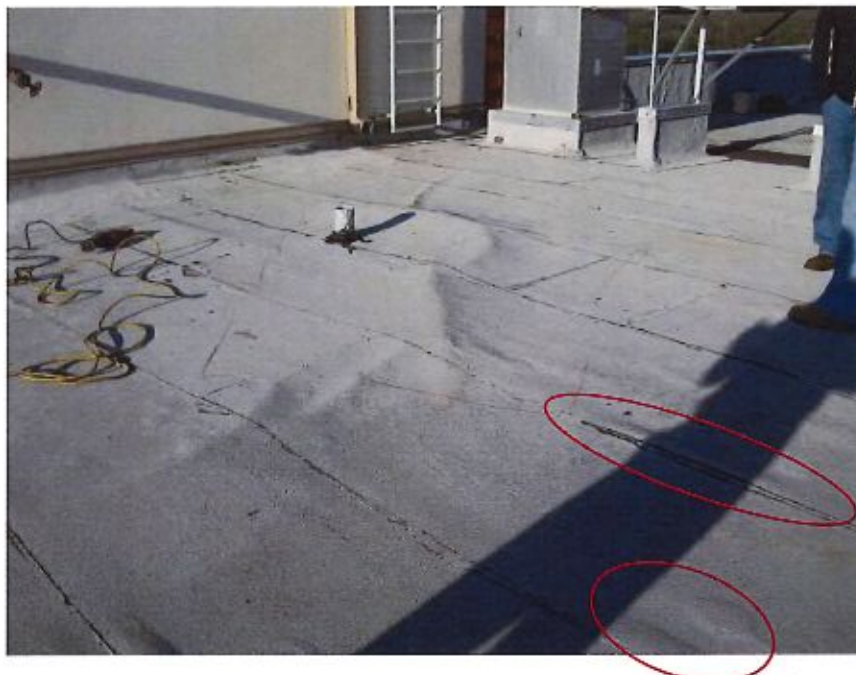
Photo 2 – Overview of area of displaced insulation resulting in roof membrane damage. Additionally, note the formation of blisters illustrated in red. These blisters are widespread throughout the entire roofing system.

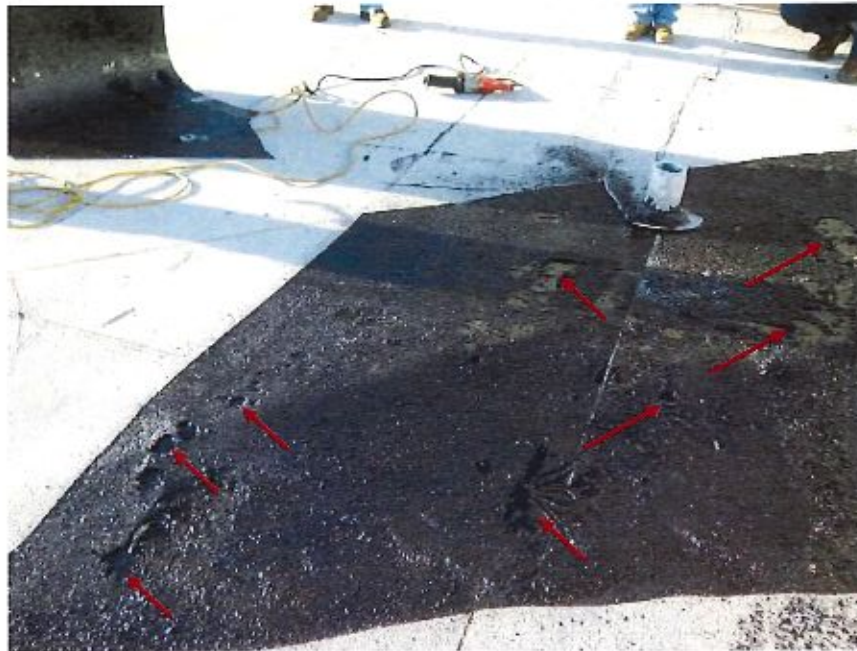
Photo 3 – View of cap sheet peeled away at location of damage observed in Photo 2. Note the voids present (highlighted by arrows) between the fiberglass felts and the cap sheet. These voids contain air which expands and contracts with temperature changes resulting in the formation and growth of blisters.

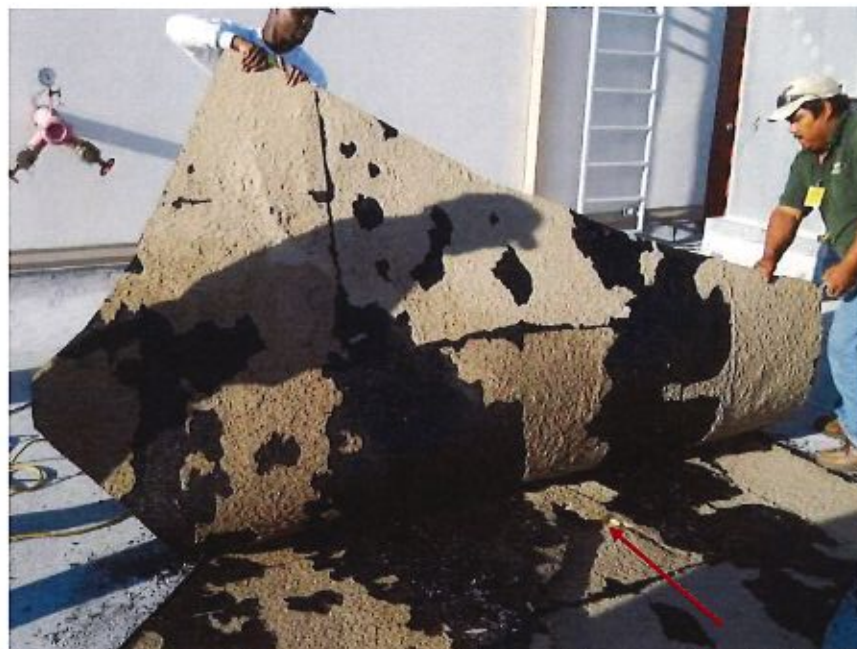
Photo 4 – View of fiberglass felts being peeled off the perlite coverboard. Note the split in the underlying isocyanurate insulation (indicated by arrow).

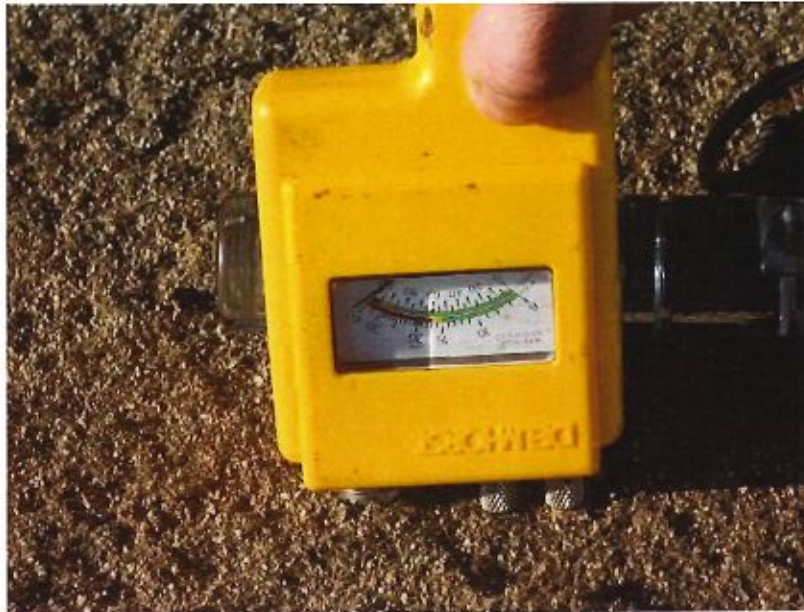
Photo 5 – Moisture meter probes confirmed the presence of high moisture content within the perlite coverboard. We believe this moisture contamination occurred as a result of the membrane split illustrated in the previous photographs.

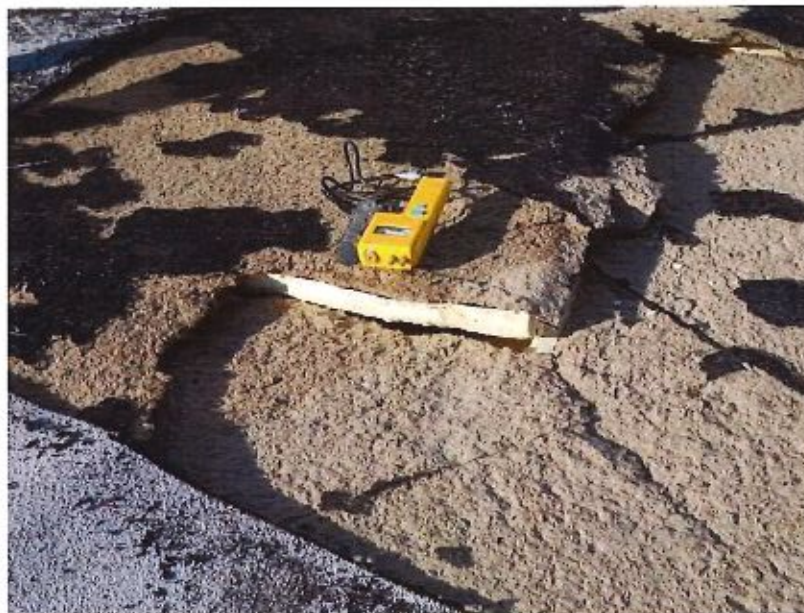
Photo 6 – Close-up view of the split isocyanurate insulation and perlite coverboard.

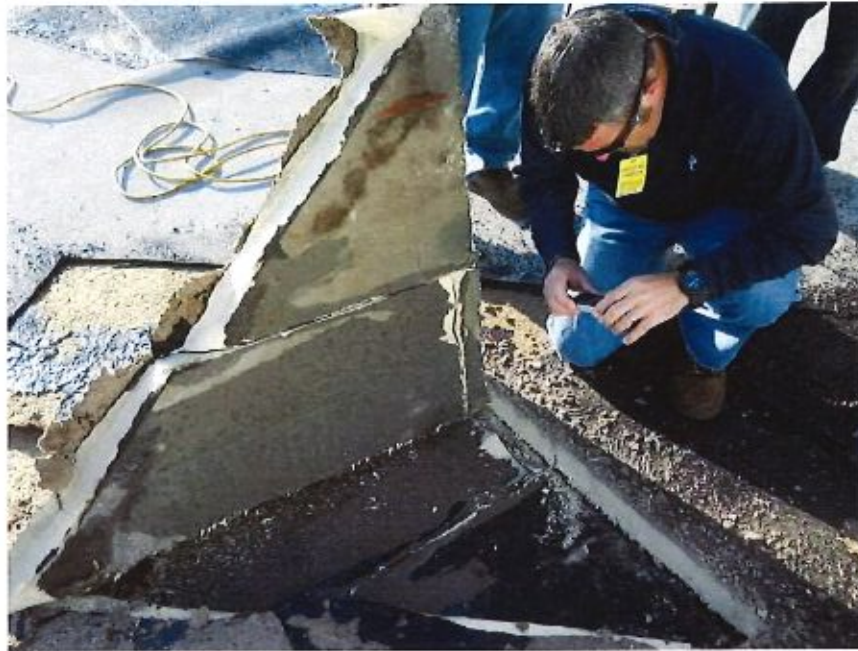
Photo 7 – Upon lifting of the isocyanurate insulation, we observed the bottom facer to be in tact with no evidence of adhered asphalt. This observation is significant because the absence of asphalt on this facer indicates a lack of adhesion to the substrate. Also note the moisture present on the facer. As previously indicated, we believe this moisture contamination is a result of the membrane split.

Upon review of the of the roof deck at the locations of the test cores, we determined that a full bed of asphalt was applied at the time of installation. Based on the appearance of this asphalt (glassy surface) and the lack of asphalt stains on the underside facer of the isocyanurate board, it is our opinion that the insulation boards at many locations did not come in contact with the asphalt prior to it cooling. After the asphalt cools, a bond cannot be formed, resulting in the conditions observed.

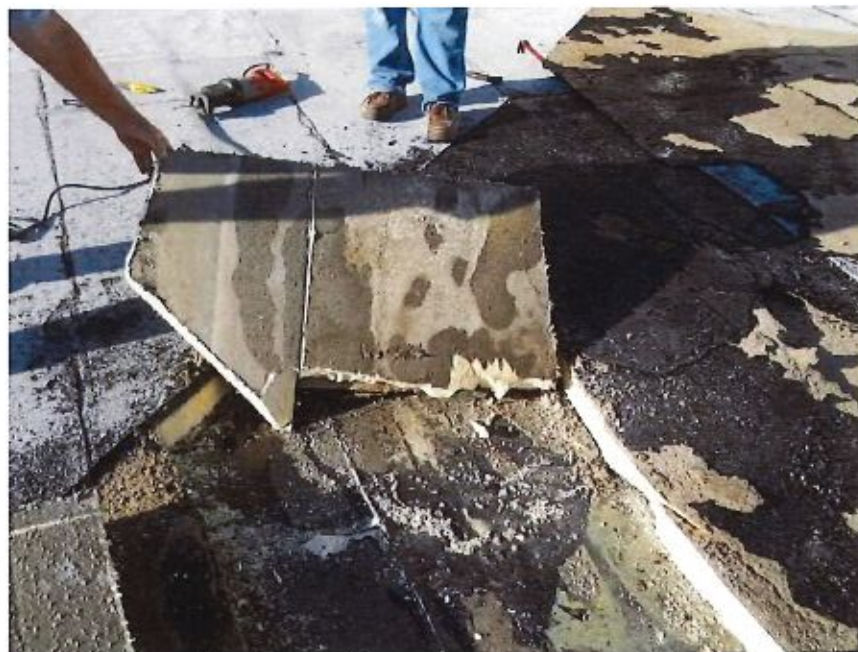
Photo 8 – Additional view of undamaged isocyanurate facer due to inadequate asphalt adhesion.

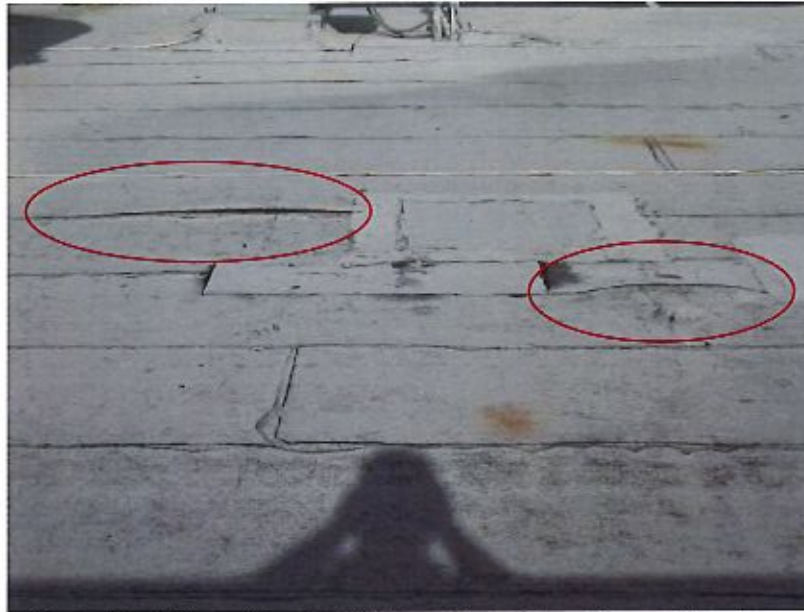
Photo 9 – View of typical blisters throughout the roof system.

Additionally, it is our opinion that the widespread occurrence of blisters throughout this roofing system is attributable to cold asphalt. According to installation instructions obtained on Johns Manville's website, all layers of roofing membrane are to be adhered with full moppings of hot asphalt applied 25 degrees F above its equiviscous temperature (EVT) at a rate of 23 lbs/sq (1 sq = 100 sq. ft). The EVT is the temperature at which asphalt reaches the proper viscosity for the specified application rate.

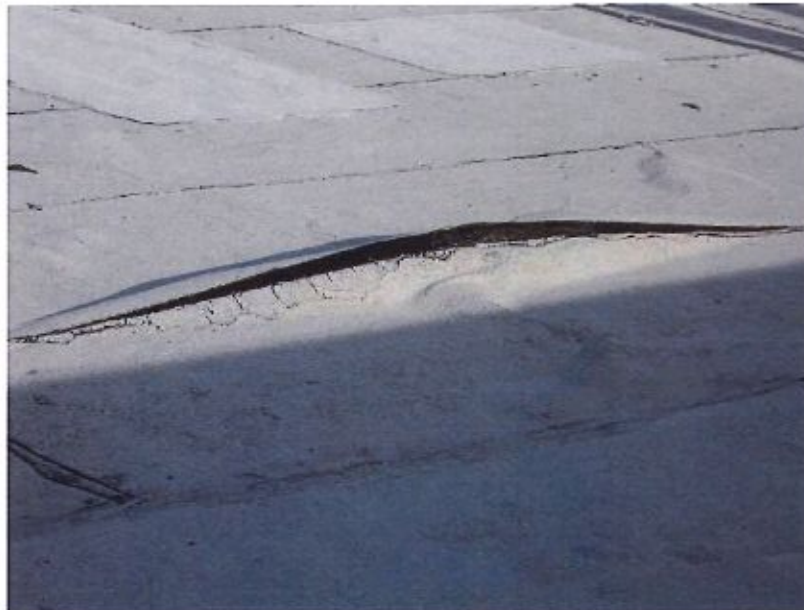
Photo 10 – Close up view of membrane blister

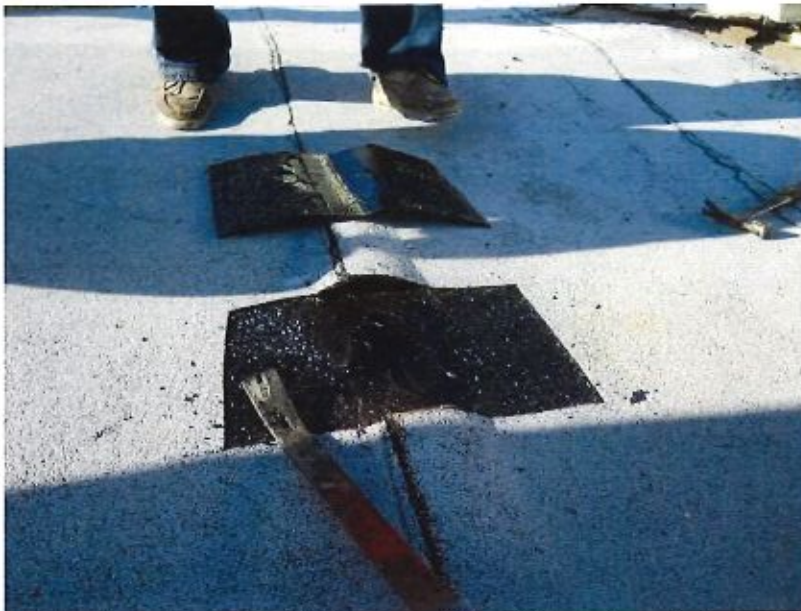
Photo 11 – Test cuts taken across the blister reveal the failure plane between the cap sheet and the upper fiberglass ply. This condition is consistent at all locations cut. Membrane samples were collected, labeled and submitted for laboratory analysis (results of analysis included at the end of this report).

A total of 6 test cuts were taken at blister locations throughout the roof and submitted for laboratory analysis. The analysis revealed cap sheet asphalt application rates of: 88 lb/sq, 120 lb/sq, 88 lb/sq, 96 lb/sq, 72 lb/sq and 72 lb/sq. These application rates exceed the rates recommended by Johns Manville and are an indication of asphalt temperatures less than those recommended at the time of installation.

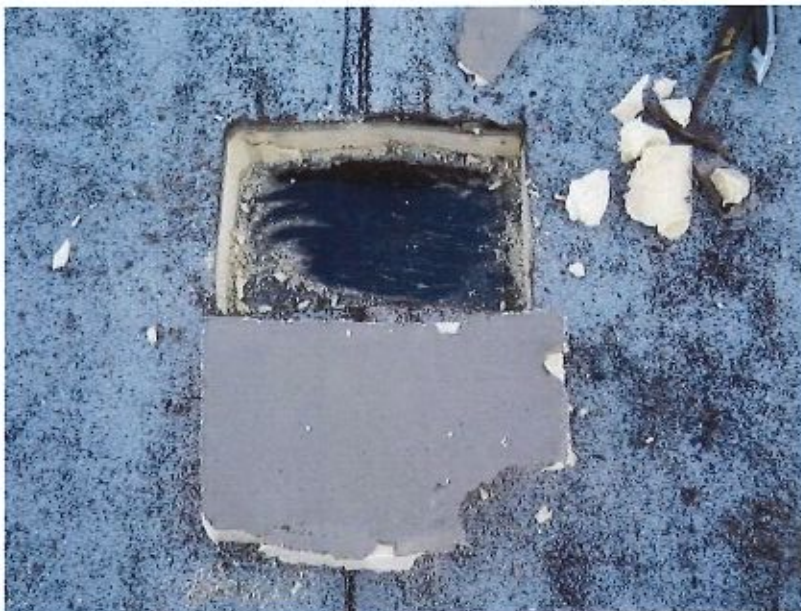
Photo 12 – Due to the inadequate adhesion observed on the southeast corner of the building (Photos 2 through 7), test cuts at blister locations were extended to the deck in an effort to determine the degree of adhesion at these locations. As is evident in this photograph, areas completely void of asphalt were encountered.

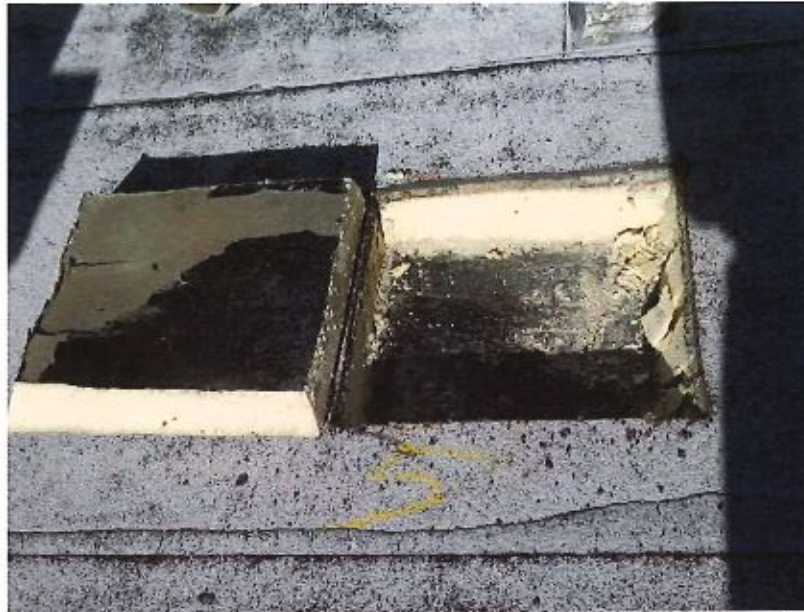
Photo 13 – Other test cuts revealed approximately 35% asphalt adhesion on the isocyanurate facer. We did not encounter full adhesion at any test cuts taken during this site visit.

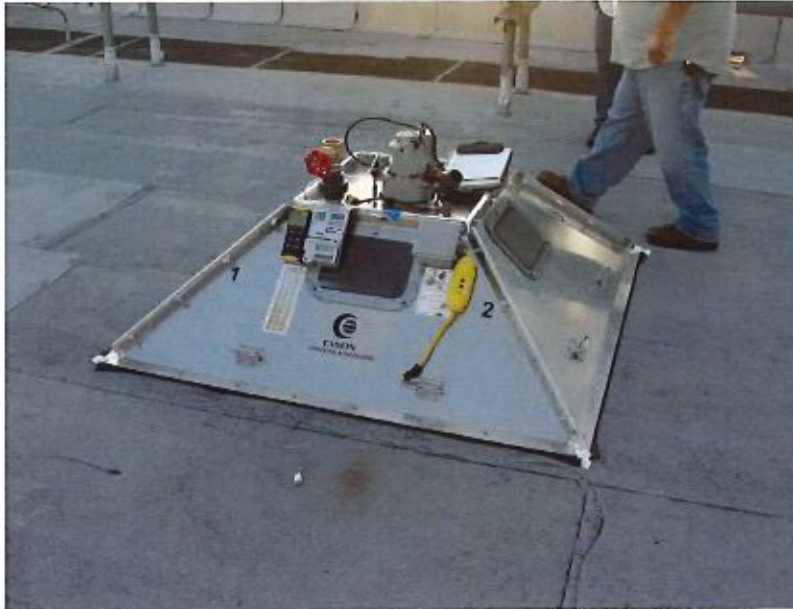
Photo 14 – View of negative pressure chamber testing apparatus. The system creates a vacuum inside the chamber which imparts an upward force on the roofing system. In accordance with test standards, deflection of the roofing system is measured and compared to allowable tolerances. Excessive upward deflection observed prior to achieving the required design pressures, indicates inadequate system securement.

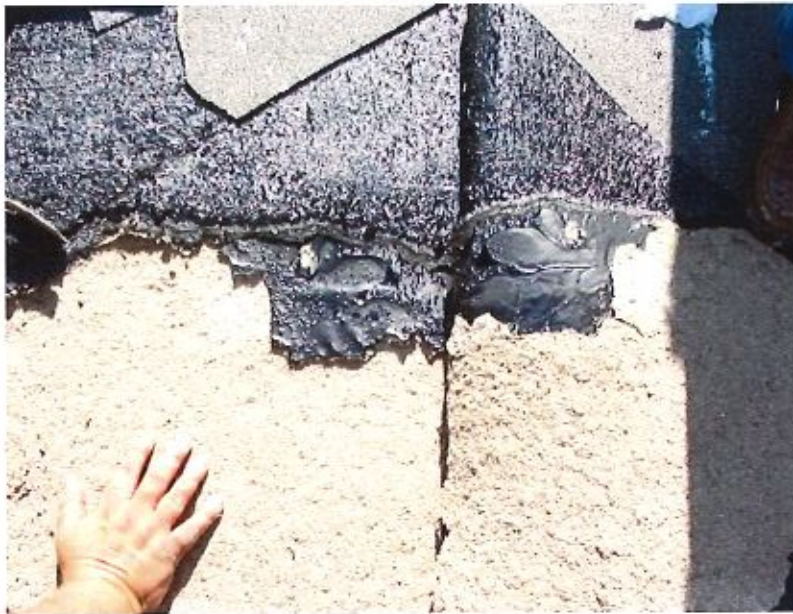
Photo 16 – Of the 5 negative pressure tests performed, only one test did not achieve an “apparent passing” result. The failure occurred near the location of the damaged roof system in the southeast corner of the facility. A test cut at this location revealed the presence of saturated insulation most likely resulting from the damaged roofing membrane. See the following section for a discussion regarding the “apparent passing” of the remaining tests.

As indicated in Section VI of this report, the base layer of roof insulation is composed of a single thickness of 3” isocyanurate. It is our opinion that this thickness of insulation provides enough rigidity to skew the results on the high side. Since the testing was initially recommended due to concerns with the adhesion of the isocyanurate to the concrete deck and since we believe the thickness of the isocyanurate insulation skewed the results, we ruled the tests inconclusive.

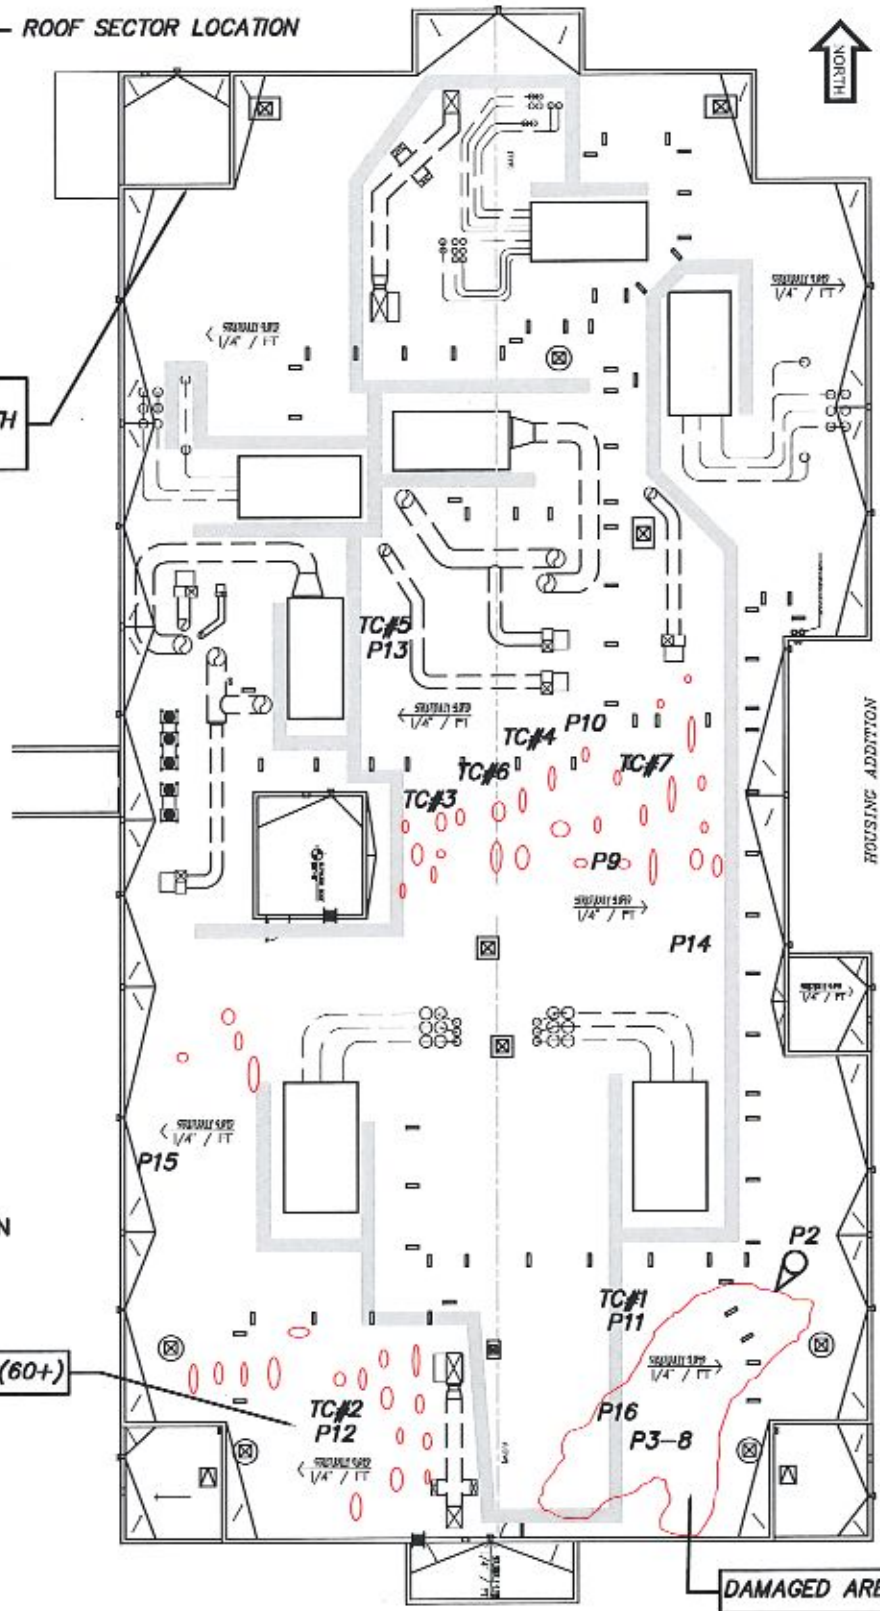
BLISTERS TYPICAL ON WALL FLASHINGS AT ALL WALLS WITH A SOUTHERN EXPOSURE.

TYPICAL BLISTERS (60+)
