H.B. Fuller

Pull Test Results Form

Project Name: LEE COUNTY PUBLIC SAFETY BUILDING		
Address: 14750 6 MILE CYPRESS PARKWAY, FORT MYERS, FL 33912		
Roof Area Location: MAIN BUILDING REAR	Ambient Temp: 82.00°F	Test Date: 04/12/22
Building Height: ONE STOREY	Building Width:	Building Length:
Adhesive Tested: FTR-601		
Batch Number: 0921-0335		
Adhesive Bead Spacing: 6"O.C, 12"O.C.		
Board Stock Tested: 3/4 PLYWOOD AND DENSDECK		
Test Equipment: PFT2000A		
Calibration Date: 12/22/20		
Max Capacity of Tester: 2000		
Test Performed By: ANDREW BATEMAN		
Witnessed By: LEE COUNTY		
Test Areas Repaired By: LEE COUNTY MAINTENANCE		
Project Type (Check One): <input type="checkbox"/> New Construction <input checked="" type="checkbox"/> Tear-Off <input type="checkbox"/> Recover		
Substrate Tested:		
<input type="checkbox"/> Steel	<input type="checkbox"/> Structural Concrete	
<input type="checkbox"/> Fiberglass	Check One: <input type="checkbox"/> Poured In Place <input type="checkbox"/> Precast

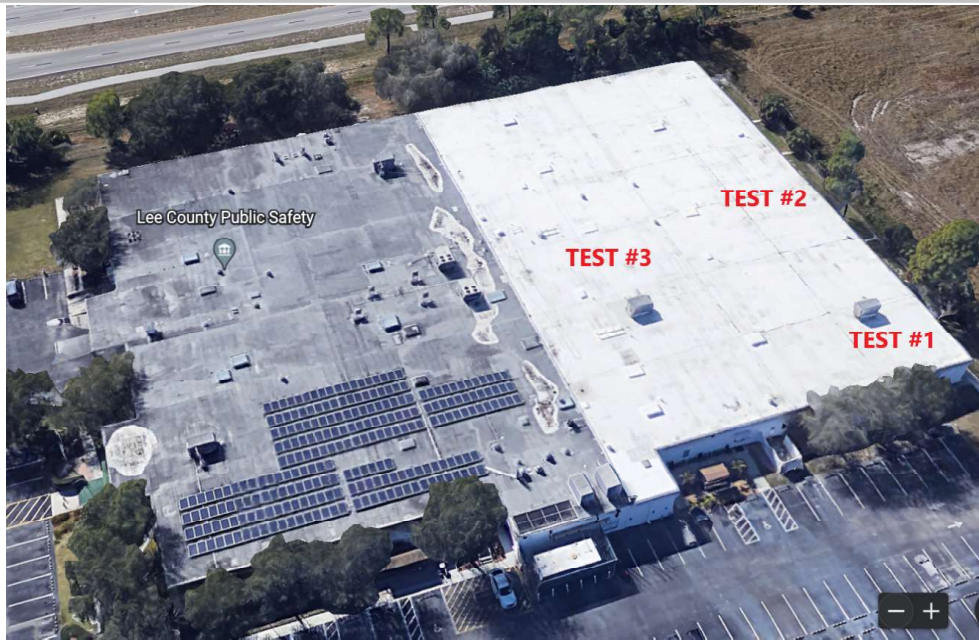
Insert Aerial Photo or draw roof sketch (mark test area locations)

Comments: TESTED THREE LOCATIONS. TEST LOCATION ONE WAS CONDUCTED IN THE REAR RIGHT CORNER OF THE BUILDING. TEST ONE WAS CONDUCTED AT 12" O.C. AND PULLED TO FAILURE. TEST LOCATION TWO WAS CONDUCTED IN THE CENTER OF THE PERIMETER IN REAR OF THE BUILDING. TEST NUMBER TWO WAS CONDUCTED AT 12" O.C. AND PULLED UNTIL UPLIFT REQUIREMENTS WHERE MET. TEST LOCATION THREE WAS CONDUCTED IN THE MIDDLE OF THE FIELD OF REAR OF BUILDING. TEST NUMBER THREE WAS CONDUCTED AT 6" O.C. AND WAS PULLED UNTIL UPLIFT REQUIREMENTS WHERE MET. ALL THREE TEST WERE CONDUCTED OVER LIGHT WEIGHT INSULATING CONCRETE WITH A DENSDECK COVER BOARD.

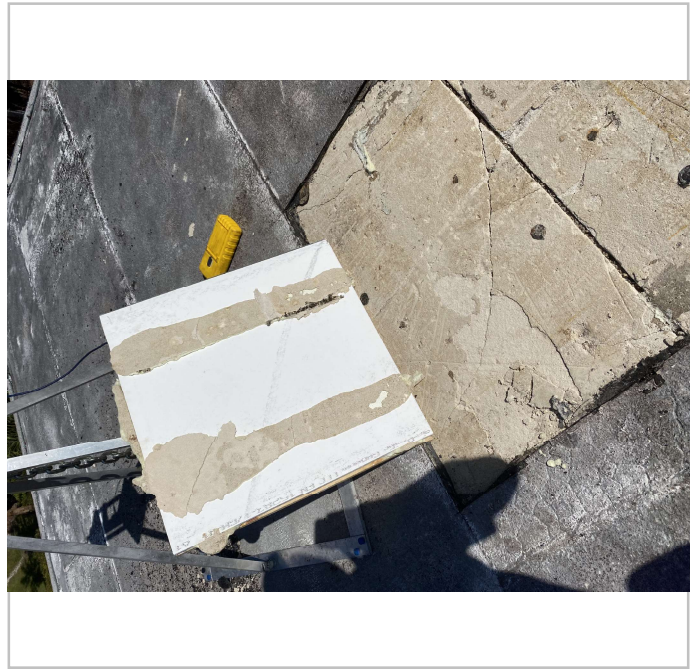
SUBSTRATE FAILURE

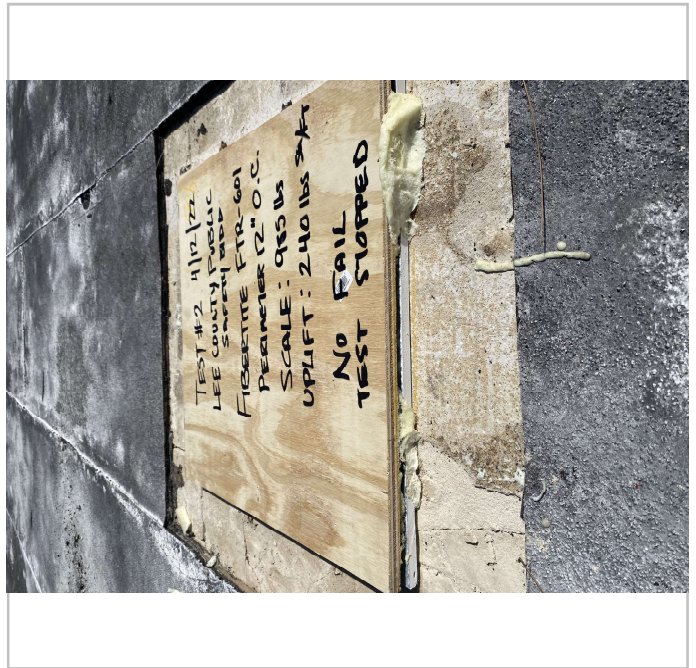
UPLIFT REQUIREMENTS MET TEST STOPPED

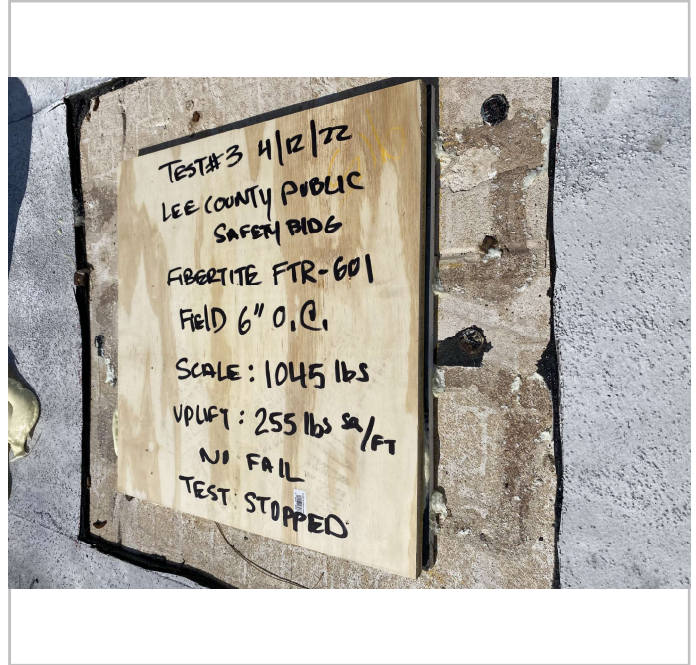
UPLIFT REQUIREMENTS MET TEST STOPPED
