H.B. Fuller

Pull Test Results Form

Project Name: LEE COUNTY PUBLIC SAFTEY BUILDING PHASE 2		
Address: 14750 6 MILE CYPRESS PARKWAY, FORT MYERS, FL 33912		
Roof Area Location: MAIN BUILDING FRONT	Ambient Temp: 91.00°F	Test Date: 08/09/22
Building Height: ONE STORY	Building Width:	Building Length:
Adhesive Tested: FTR-601		
Batch Number: 0722-0252		
Adhesive Bead Spacing: 6" O.C, 12" O.C.		
Board Stock Tested: 3/4 PLYWOOD AND 1/2 DENSDECK		
Test Equipment: PFT2000A		
Calibration Date: 07/21/22		
Max Capacity of Tester: 2000		
Test Performed By: ANDREW BATEMAN		
Witnessed By: LEE COUNTY		
Test Areas Repaired By: LEE COUNTY MAINTENANCE		
Project Type (Check One): <input type="checkbox"/> New Construction <input checked="" type="checkbox"/> Tear-Off <input type="checkbox"/> Recover		
Substrate Tested:		
<input type="checkbox"/> Steel	<input type="checkbox"/> Structural Concrete	
<input type="checkbox"/> Fiberglass	Check One: <input type="checkbox"/> Poured In Place <input type="checkbox"/> Precast

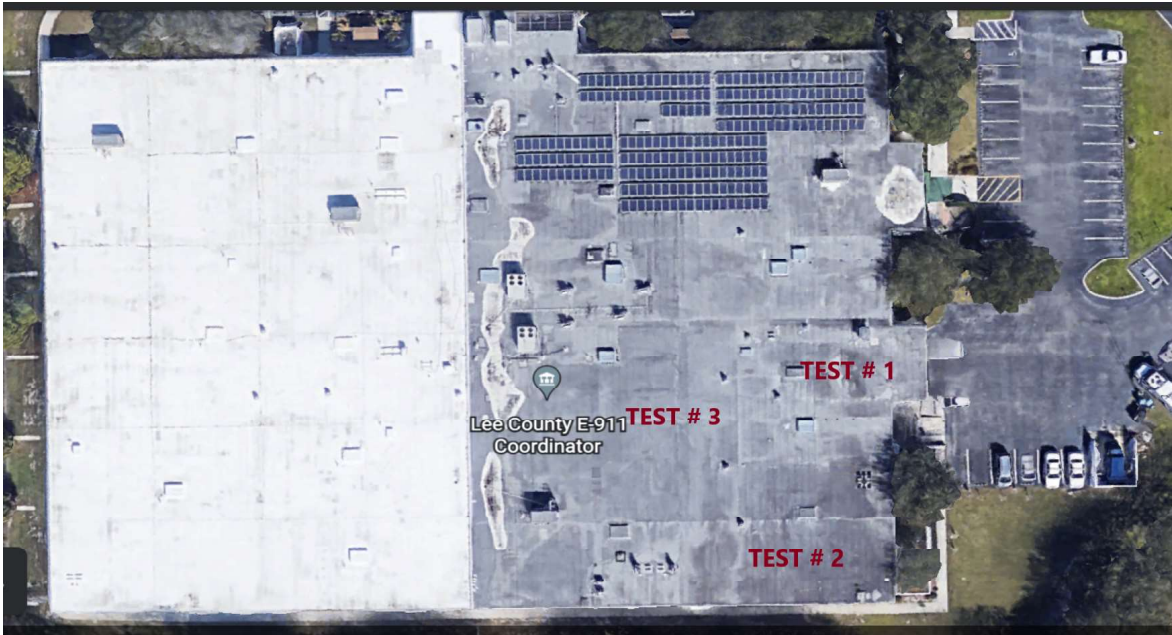
Comments: TESTED THREE LOCATIONS. TEST LOCATION ONE WAS CONDUCTED IN THE FRONT MIDDLE PERIMETER OF THE BUILDING. TEST ONE WAS CONDUCTED AT 6" O.C. AND PULLED TO FAILURE. TEST LOCATION TWO WAS CONDUCTED IN THE FRONT LEFT OF BUILDING AND PERFORMED IN THE CORNER. TEST LOCATION TWO WAS CONDUCTED AT 6" O.C. AND PULLED TO FAILURE. TEST LOCATION THREE WAS CONDUCTED IN THE MIDDLE OF THE FRONT LEFT PORTION OF THE ROOF IN THE FIELD. TEST LOCATION THREE WAS CONDUCTED AT 12" O.C. AND PULLED TO FAILURE.

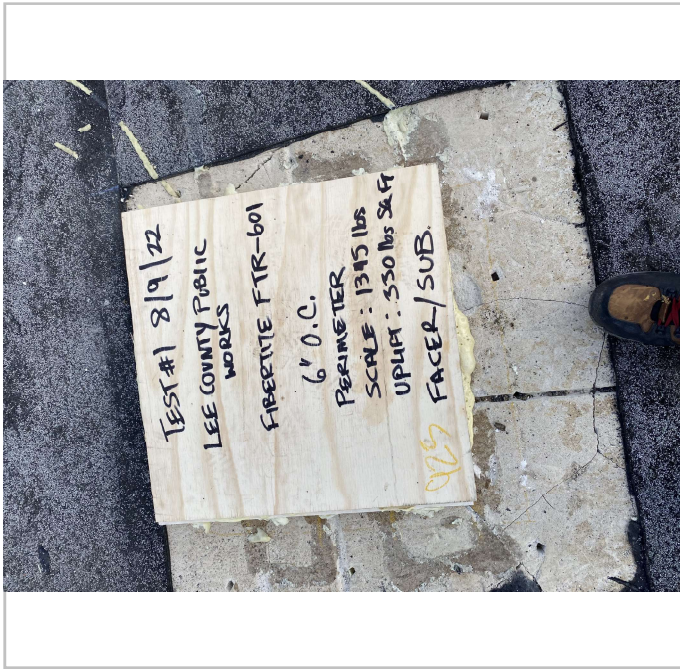
TEST #1 6" O.C. PERIMETER

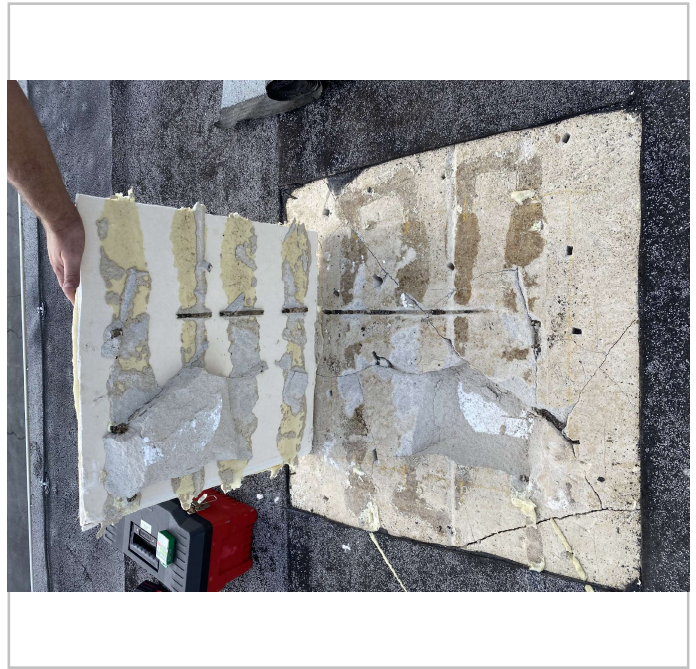
SUBSTRATE FAILURE

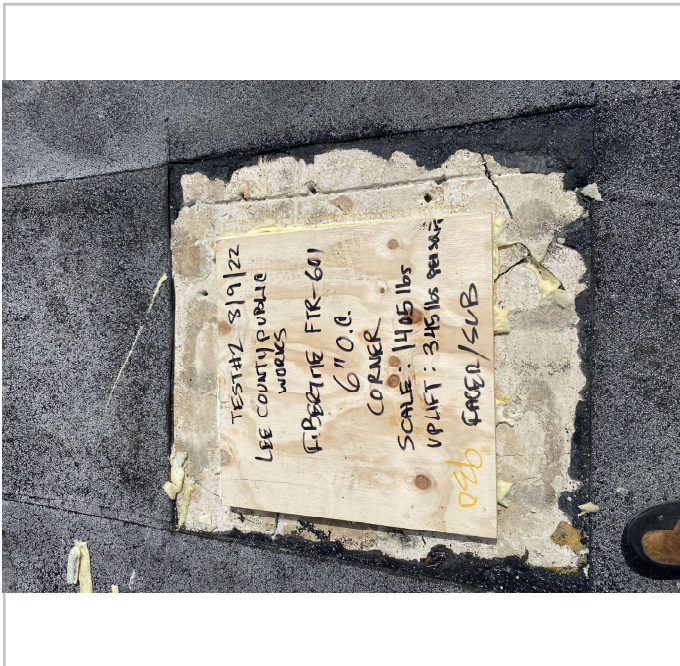
TEST #2 6" O.C. CORNER

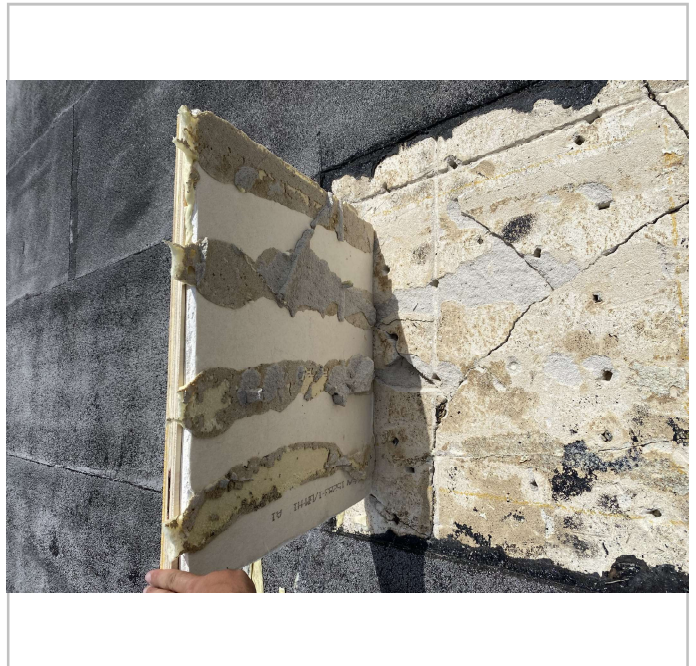
SUBSTRATE FAILURE

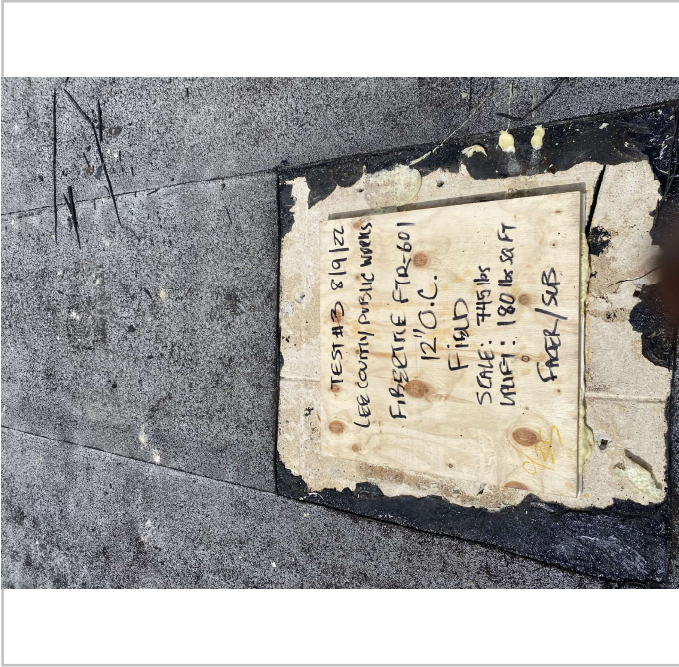
TEST #3 12" O.C. FIELD

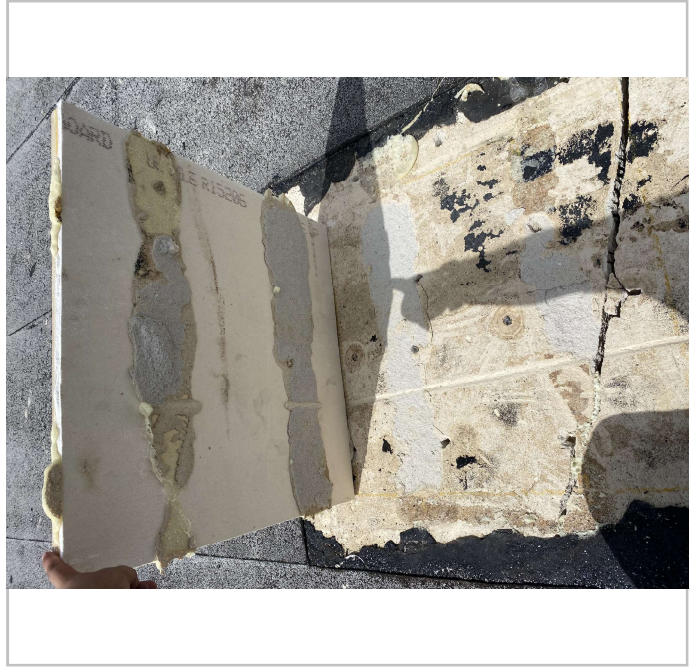
SUBSTRATE FAILURE
