June 2025

Lee County Bridge Inspection Report

Subject: Lee County General Inspection of Transportation Facilities – 2025 Report

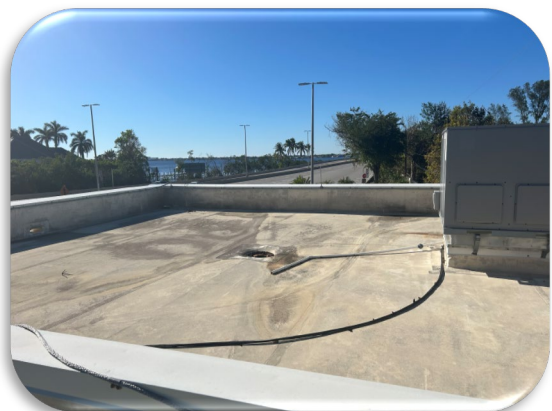
The latex membrane roof of the administrative building appears to be in good condition overall. There are signs of low areas that pond water near the central portion of the roof below the communications wire conduits. However, there were no signs of leakage on the interior of the building associated with these areas. The stagnant water traps debris and promotes algae growth, which can create a slippery walking surface. The portion of the roof above the conference room was resealed in 2015 and is still in good condition.

Figure 12: Administration Building Roof - Signs of Ponding

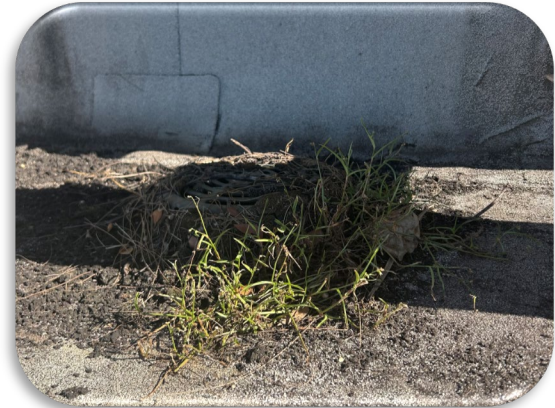
The toll canopy has a rolled asphalt roof covering that appears to be in good condition, though there are several locations where the material has lifted at the seams and is beginning to split. This can create an opening for water intrusion. Additionally, there are areas of the rooftop which exhibit blistering. The roof surface slopes towards the east side of the canopy, where it drains through an interior downspout. The rooftop drains are collecting dirt, debris, and vegetation, and are scheduled to be cleared and unclogged.

Figure 18: Toll Canopy Roof Covering Lifted at Seams

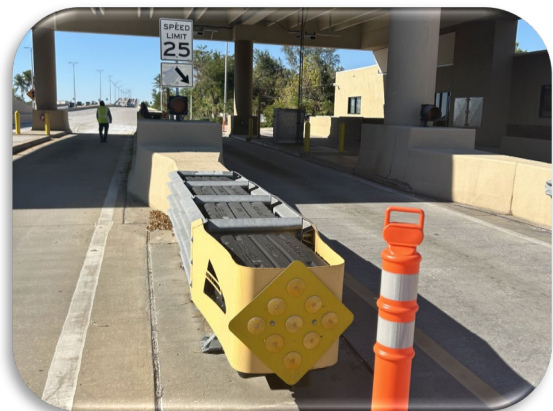
There are moderate cracks at the ends of the concrete traffic barrier islands separating the westbound lanes. The toll canopy precast prestressed canopy double tee beams exhibit longitudinal top flange cracks toward beam ends, observable from underneath the structure, with no sign of efflorescence or rust staining.

Figure 22: Toll Canopy Beam Top Flange Longitudinal Cracks

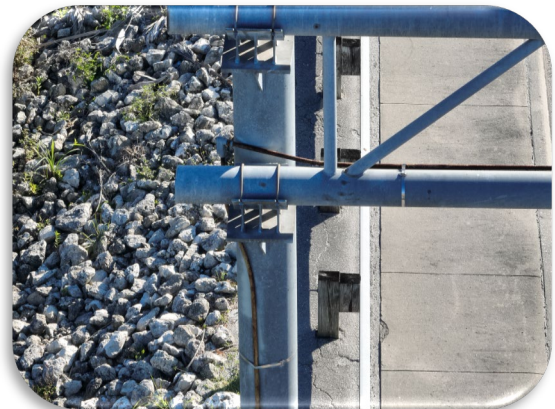
Figure 41: Cape Coral - WB OSS 1-1/4 Miles from Plaza
– Baseplate Corrosion

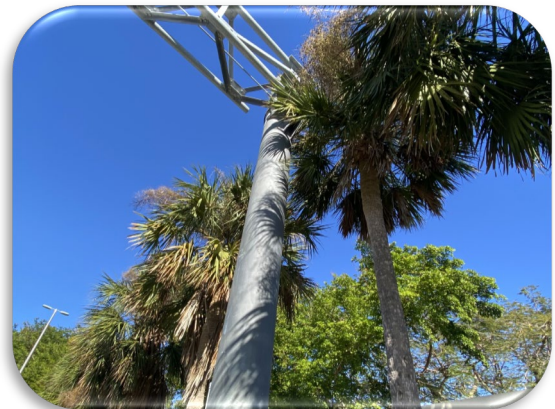
Figure 53: Cape Coral - WB OSS 100 Yards from Plaza – Chord Splice Connection Corrosion

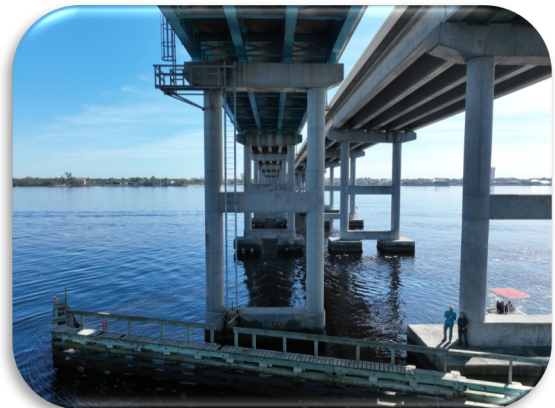
Figure 59: Cape Coral Bridge Westbound – Fender System Access Ladder Corrosion

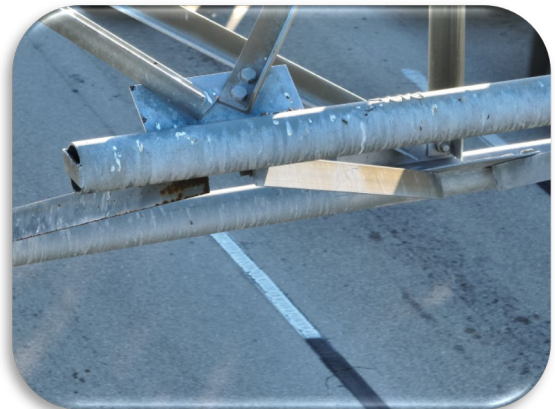
Figure 114: Midpoint - WB OSS 3 ¼ Miles from Plaza – Typical Galvanizing Spray Rehab

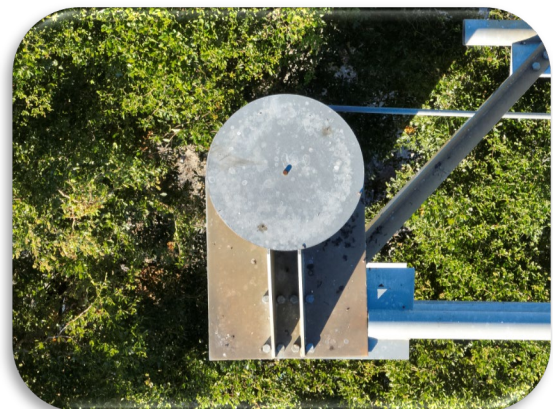
Figure 122: Midpoint - WB OSS 3 Miles from Plaza – Typical Galvanizing Spray Rehab

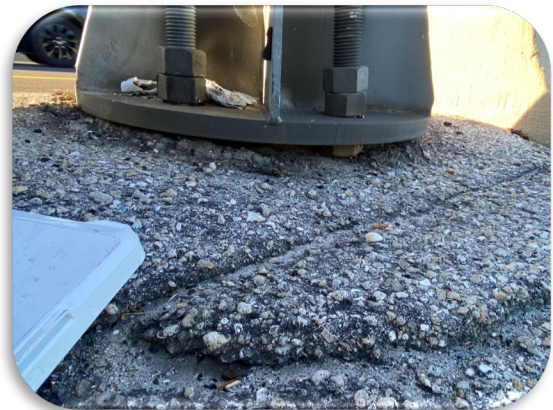
Figure 126: Midpoint - WB OSS 1 Mile from Plaza – Typical Lighting Conduit Corrosion

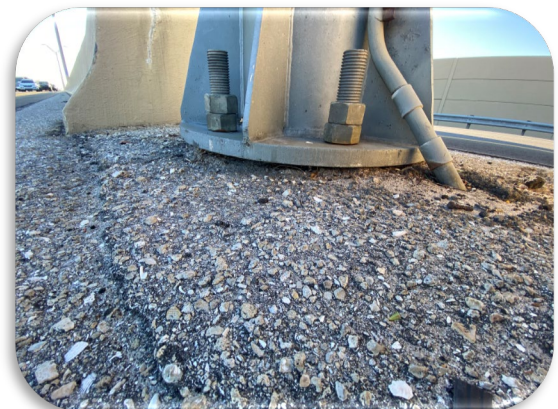
Figure 130: Midpoint - WB OSS ½ Mile from Plaza – Upright Surface Corrosion and Lighting Conduit Corrosion

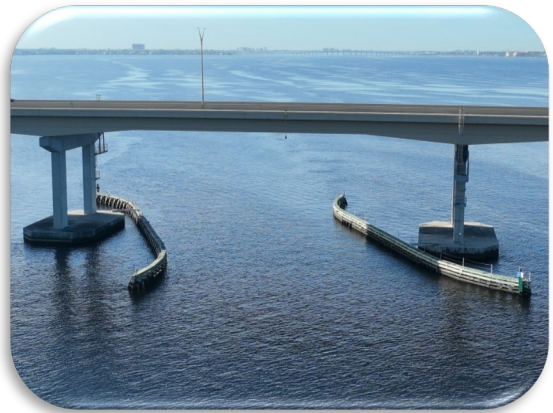
Figure 138: Midpoint Bridge – Pier Cap Cracking and Painted Graffiti

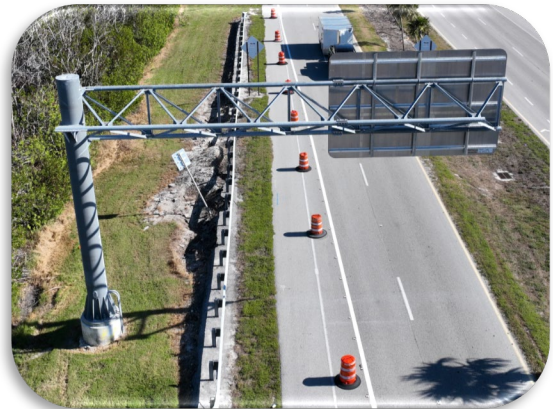
Figure 173: Sanibel - WB OSS 1 ½ Miles from Plaza - Typical Galvanizing Spray Rehab & Spot Corrosion

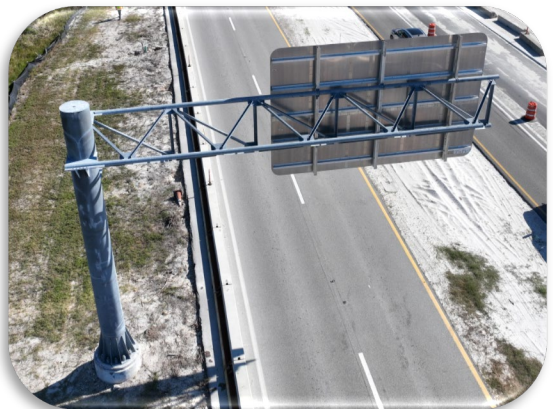
Figure 181: Sanibel - WB OSS ½ Mile from Plaza - Typical Galvanizing Spray Rehab

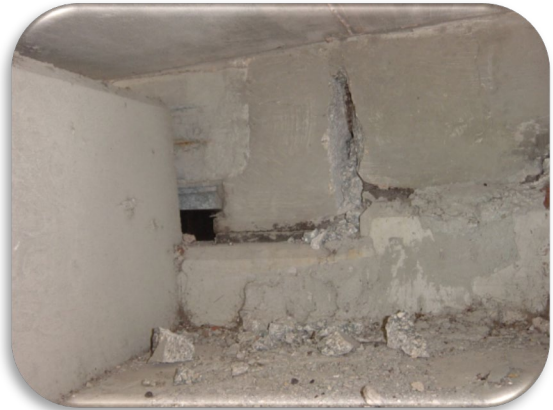
Figure 193: Sanibel Bridge – Typical End Diaphragm Spalling at Exterior Beam

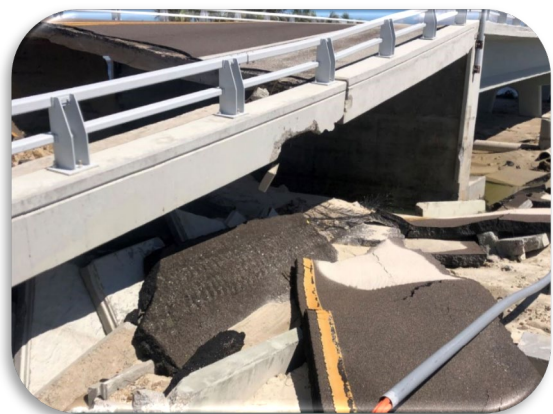
Figure 195: Sanibel Bridge – Hurricane Ian Damage

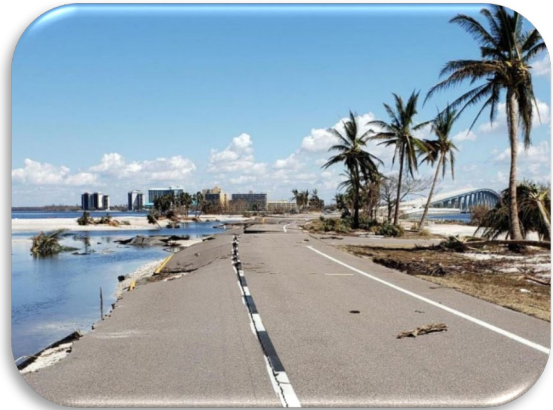
Figure 197: Sanibel Bridge – Hurricane Ian Damage

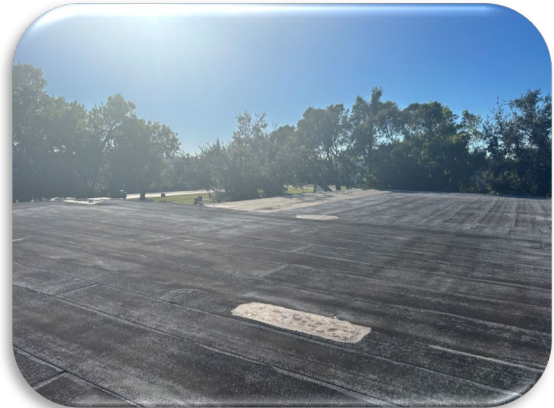
Figure 236: Deteriorating Roof Patching in Need of Repair
