Ten Mile Canal Filter Marsh Final Report

Prepared by Lee County Division of Natural Resources

September 24, 2007

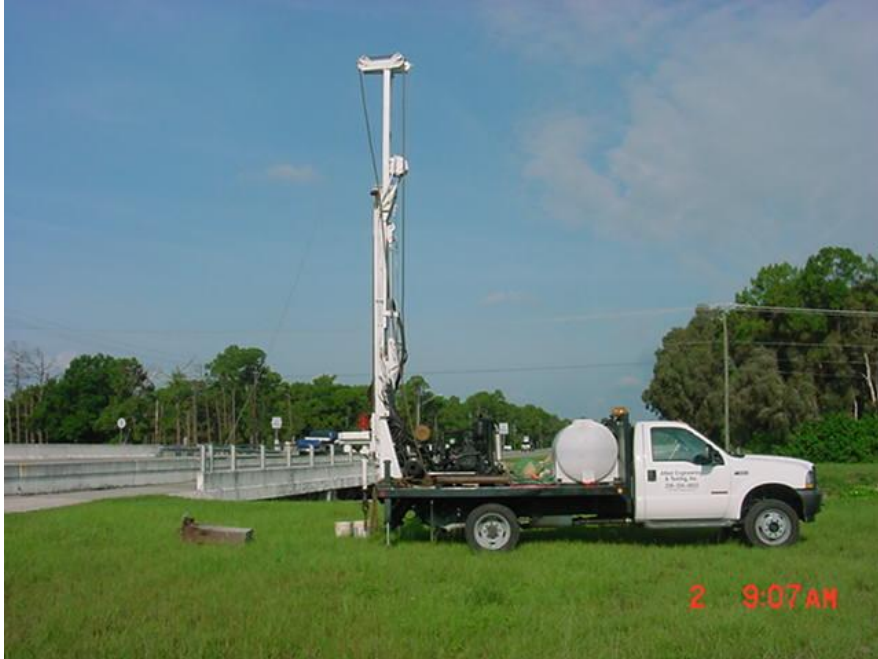
June 2, 2003
Soil borings north of Daniels Parkway.

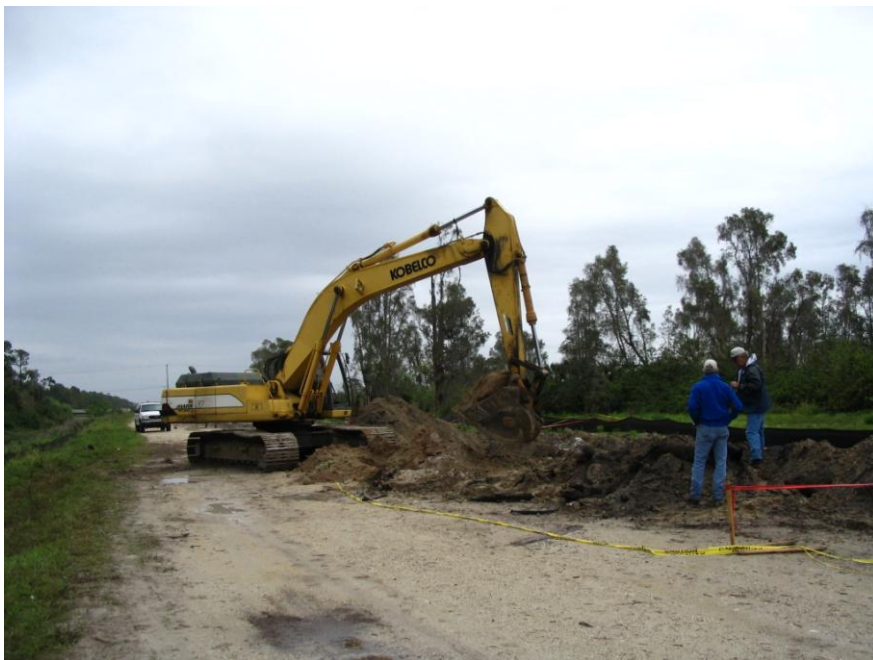
March 28, 2005
Excavation of filter marsh cells and discovery of buried debris.
Looking north. Ten Mile Canal is to the left.

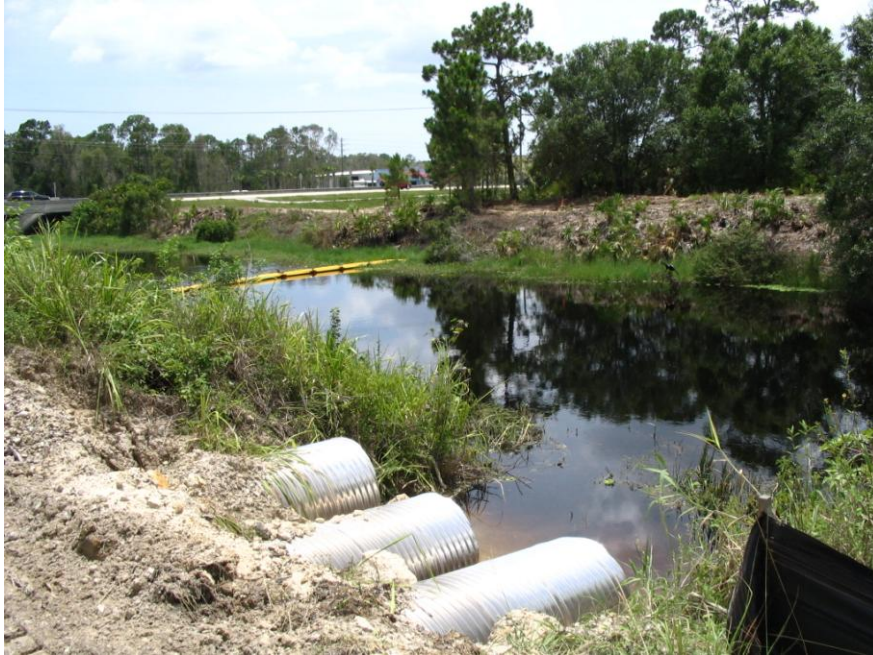
June 6, 2005
Filter Marsh discharge back into canal through 3 pipes from Cell No.4.
Looking southwest.

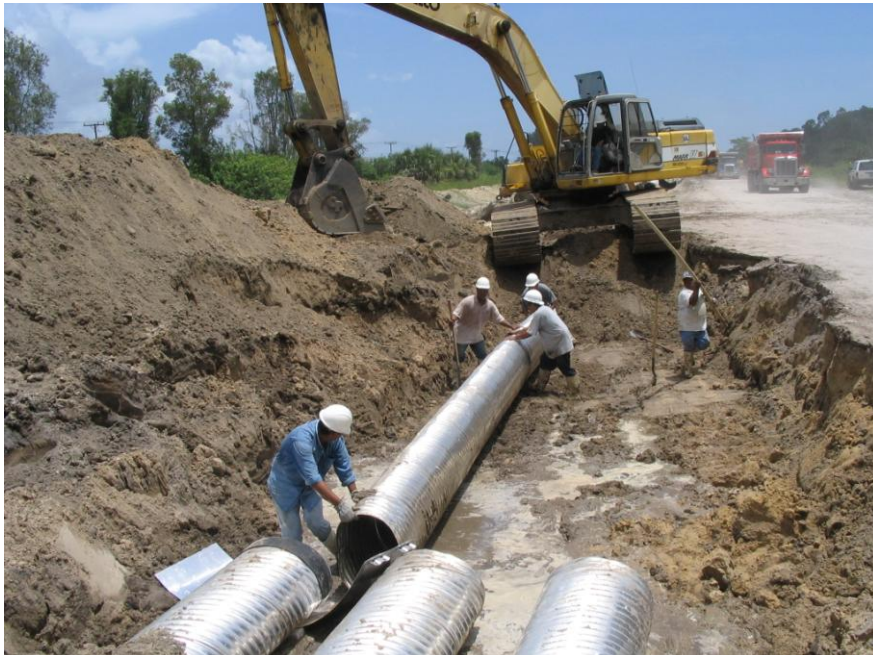
July 11, 2005
Laying pipes that convey water from one cell to the other.
Looking south.

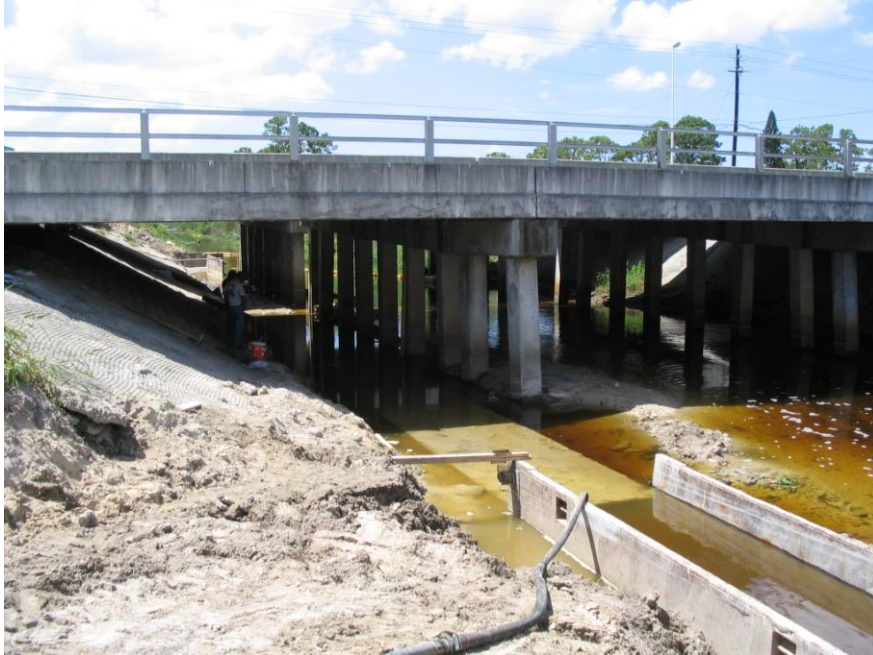
August 17, 2005
Foundation for two (2) 30-inch diameter pipes under the bridge, being constructed to support the pipe. Looking south under Daniels Parkway Bridge.

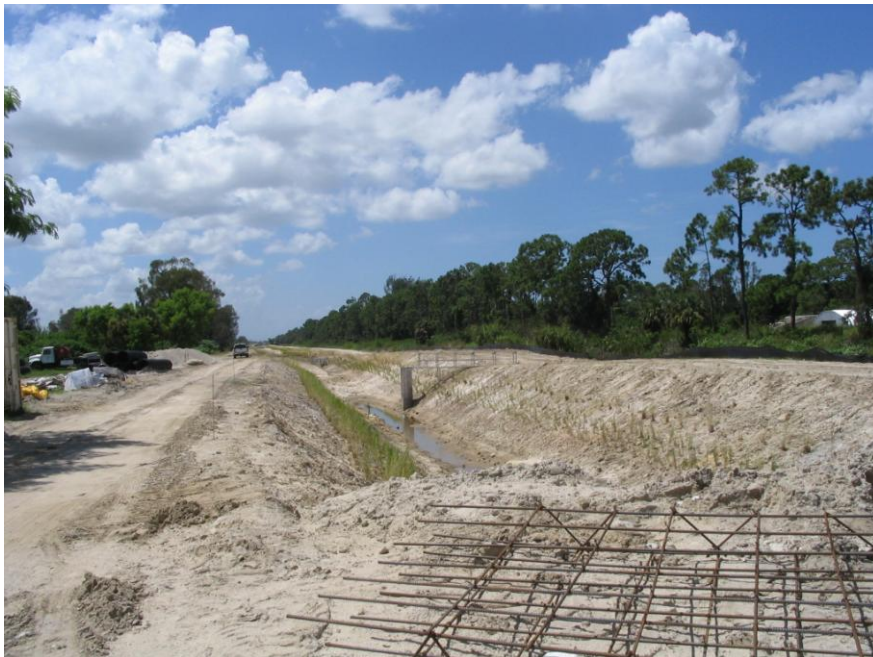
August 17, 2005
Settling basin to the south with over flow riser in the foreground, which discharges to the west into Ten Mile Canal.

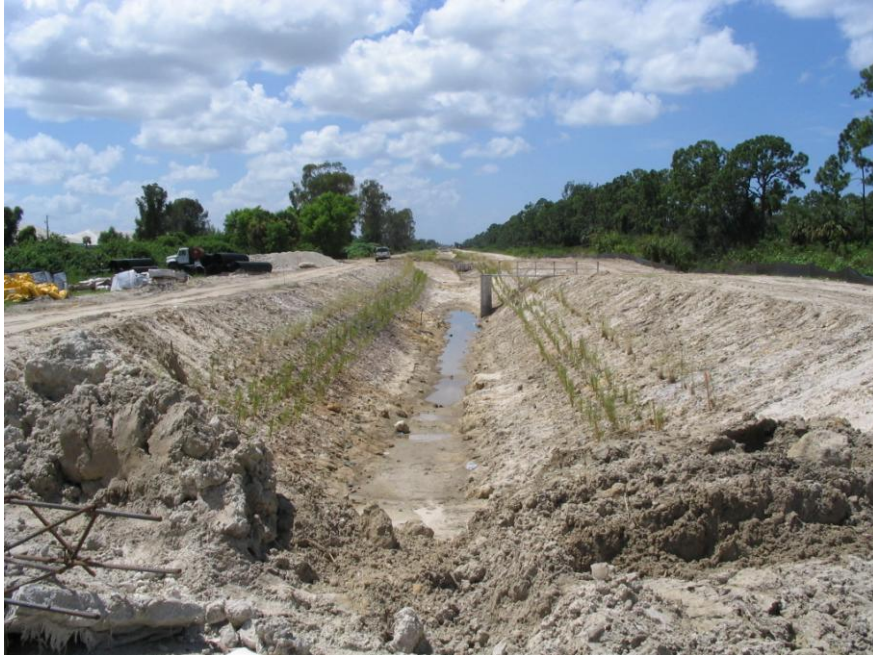
August 17, 2005
First Cell looking south with over flow riser to the west.
Note side slope plantings of spartina bakeri. (sand cordgrass)

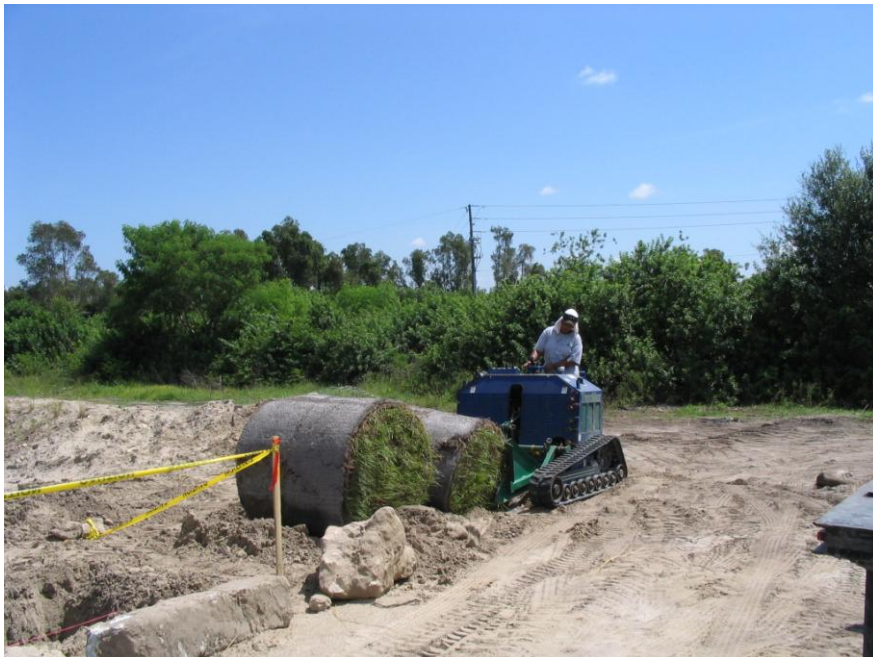
August 18, 2005
Laying sod on side slopes (typical) to stabilize excavation.

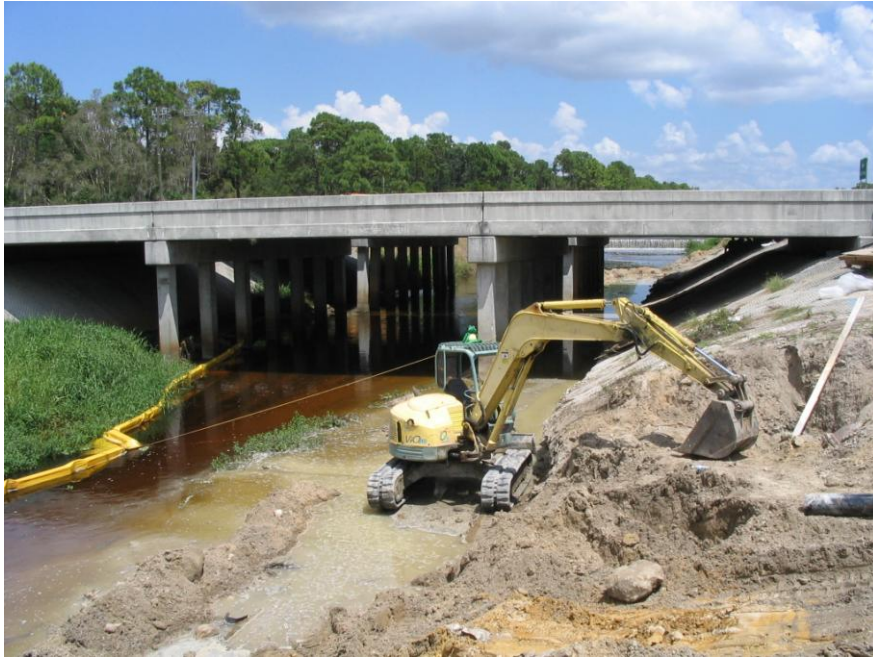
August 18, 2005
Turbidity control in the canal. A clear difference from canal water from turbid water around construction area. Looking north towards Daniels Parkway Bridge.

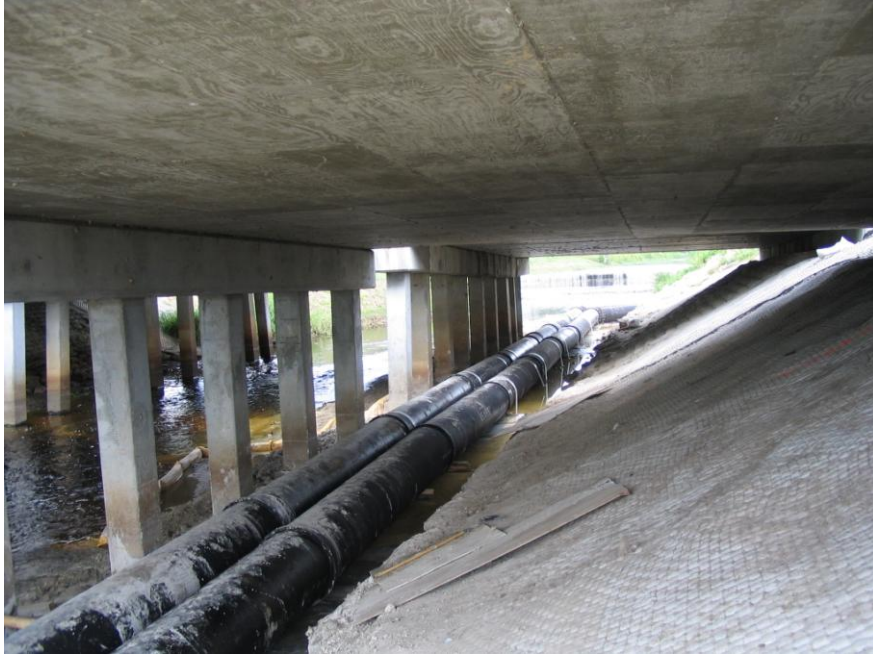
August 24, 2005

Two (2) 30-inch pipes installed on top of concrete foundation under the Daniels Parkway Bridge. Tie down straps are in place prior to securing pipes in concrete.

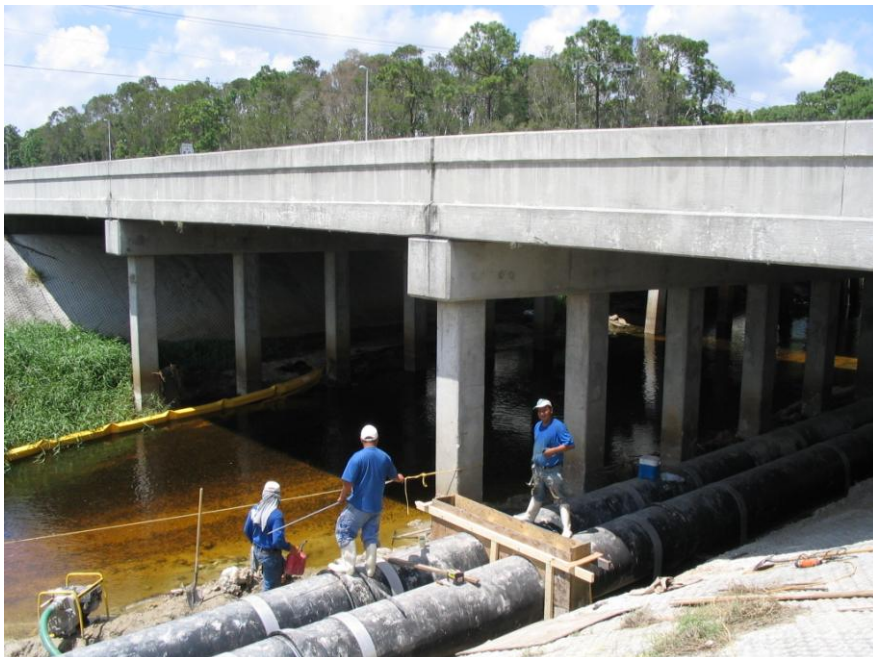
August 30, 2005
Preparing concrete forms to secure two (2) 30-inch diameter pipes
on the foundation.

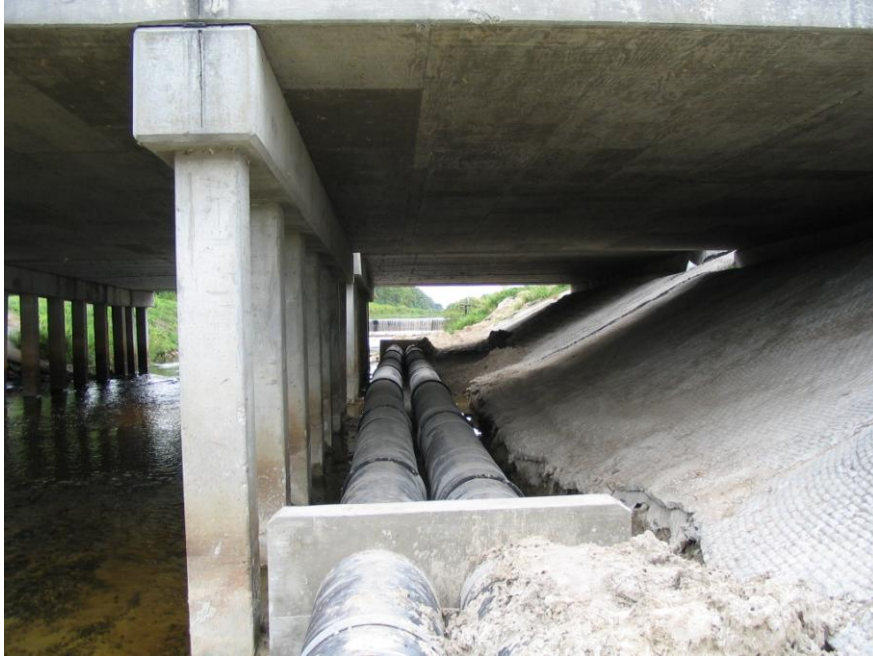
September 7, 2005
Construction of the two (2) 30-inch diameter cast iron steel pipes completed under the Daniels Parkway Bridge. Looking north.

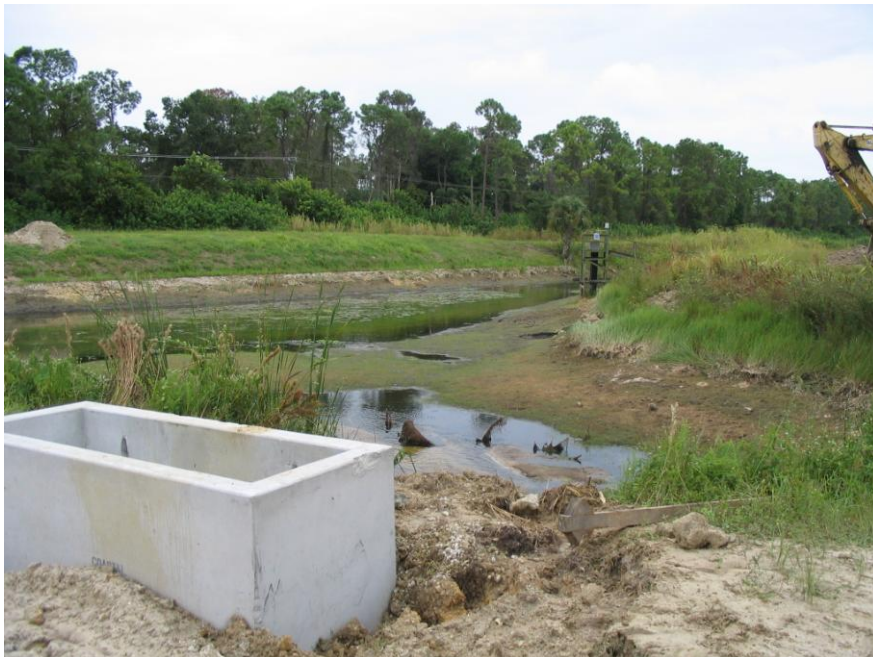
September 21, 2005
Controllable screw type sluice gates under construction. Looking northwest north of Daniels Parkway.

Currently, approximately 8 to 10 cfs is permitted through the controllable screw type gate system.

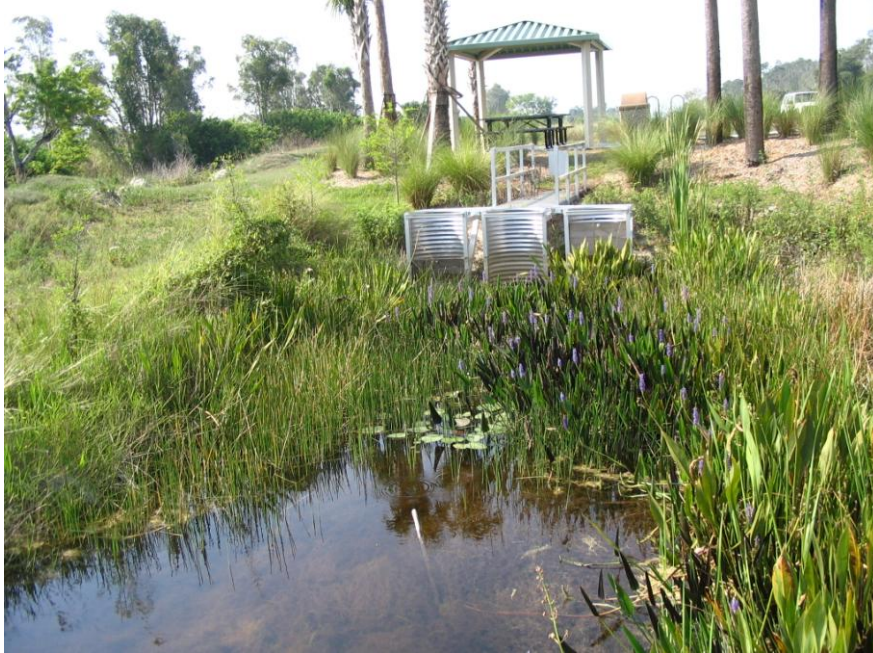
October 24, 2005
The control structure connecting Cell No. 2 to Cell No. 3.
Looking south. The maintenance ramp to Cell No.2 is on the left.

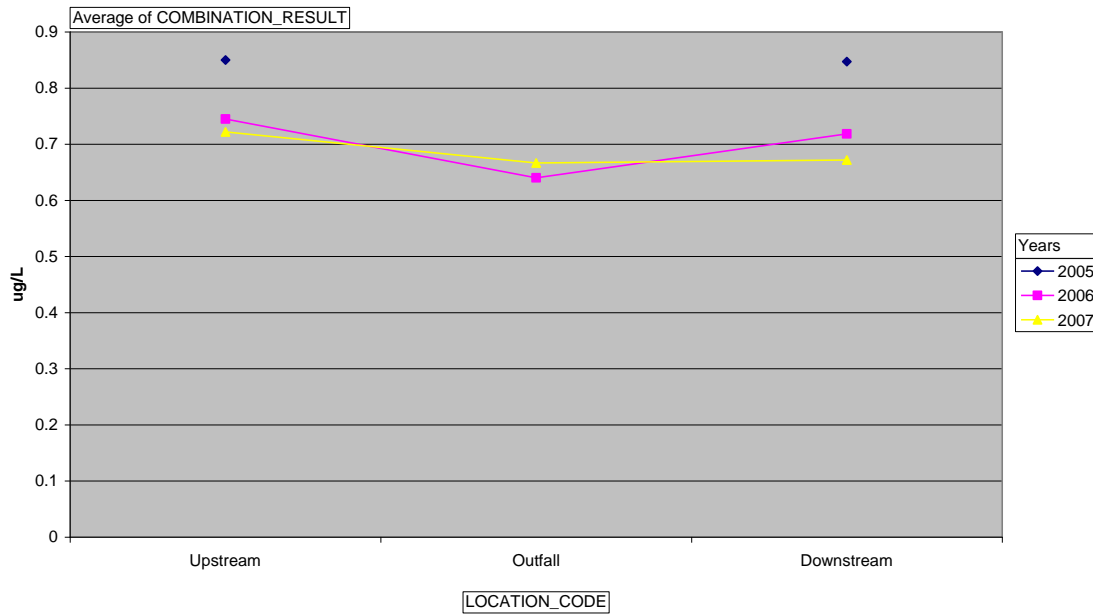
Figure 3. Comparison of Annual Averages from Upstream (10MIGR50) of Filter Marsh to Downstream (10MIGR20).

The performance of the filter marsh system is difficult to quantify at this time due to the fact that while monitoring has been underway for one and ½ years, there are data gaps present due to seasonal water levels as well as unexpected shortfalls in data collection. Ongoing monitoring will yield enough data to have a better assessment of performance within a few years. Upon inspection of the January 2006 to May 2007 dataset it appears that there is a decrease in concentration of TP, NOX and NO3. Data graphs for OPO4, NO2 and TKN are flat showing no trend and TN and NH3 are very slightly increasing at the downstream station (10MIGR20) from the filter marsh system. These same trends hold true of the filter marsh outfall. This overall decrease in nutrients is not a uniform pattern at all stations upstream to downstream within the filter marsh. A comparison of the annual averages from the station immediately upstream of the filter marsh (10MIGR50), the filter marsh outfall (10MIFM06) and the immediate downstream station (10MIGR20) show a decrease in nutrients across the board from upstream to downstream as well as visible decreases in most nutrients when comparing 2005 to 2007. The results thus far seem promising, however this is most likely not the peak efficacy for the filter marsh system due to aquatic vegetative density that should increase over time, slowing flow, increasing nutrient uptake as well as binding nutrients in sediment. This of course is dependent upon many variables, but primarily inflow quality and growing conditions. The nutrient trend analysis is available in graphical form in Appendix F, Figures 1 through 4.

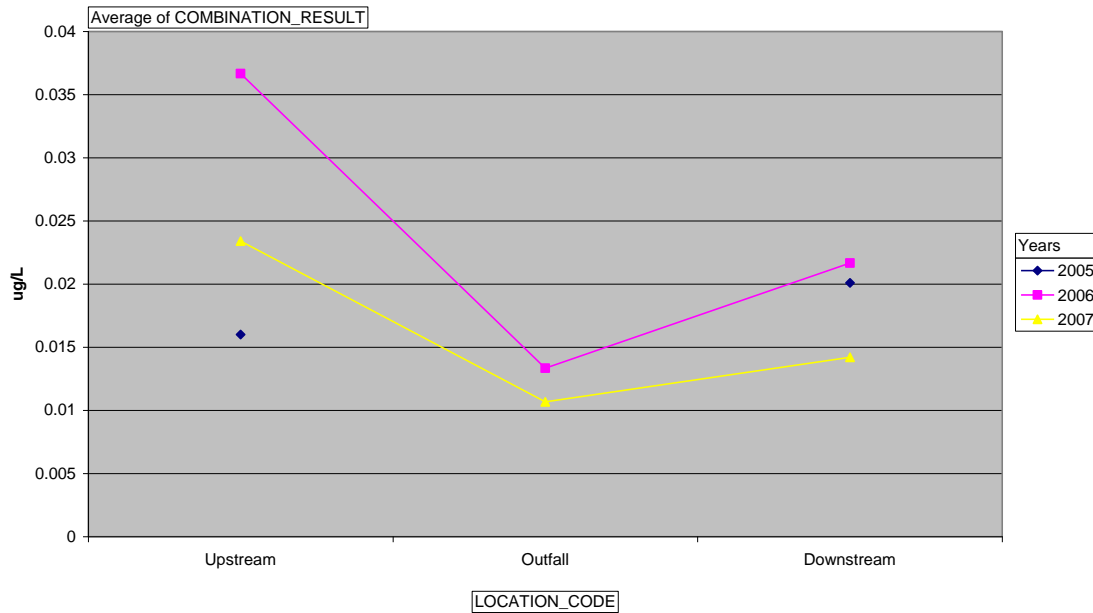
Figure 4. Comparison of Annual Averages from Upstream (10MIGR50) of Filter Marsh to Downstream (10MIGR20).
