**NORTHWEST LEE COUNTY
SURFACE WATER MANAGEMENT PLAN
Volume 1 – Watershed Report**

March 2005

**Boyle Engineering Corporation
4415 Metro Parkway, Suite 404
Fort Myers, FL 33916**

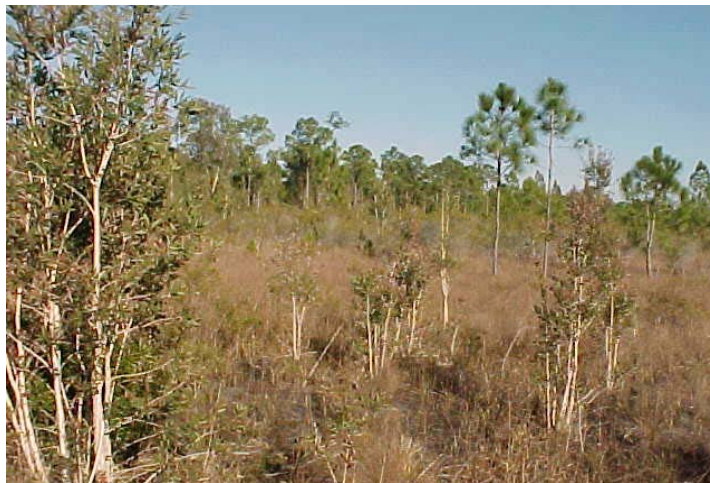
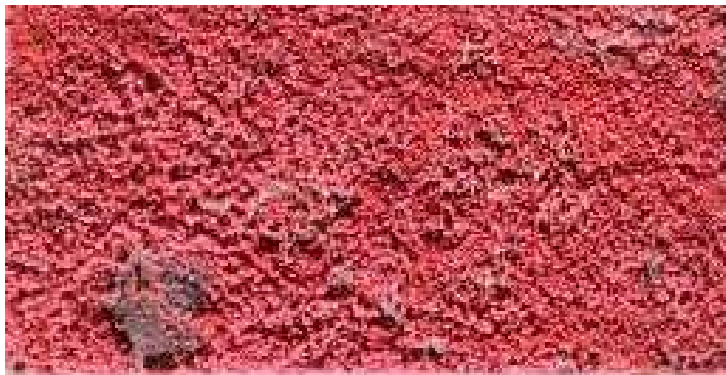
A. Heavy wooded upland vegetation (includes palmetto, pine with under story of brush): Classic Infrared image color: Dappled Pink; Manning's "n": 0.10-0.12

Actual Ground Shot

Infra-red Aerial

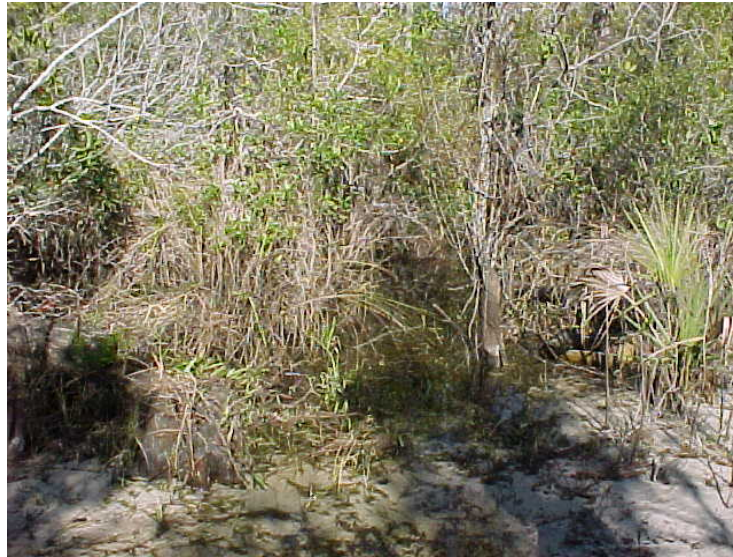
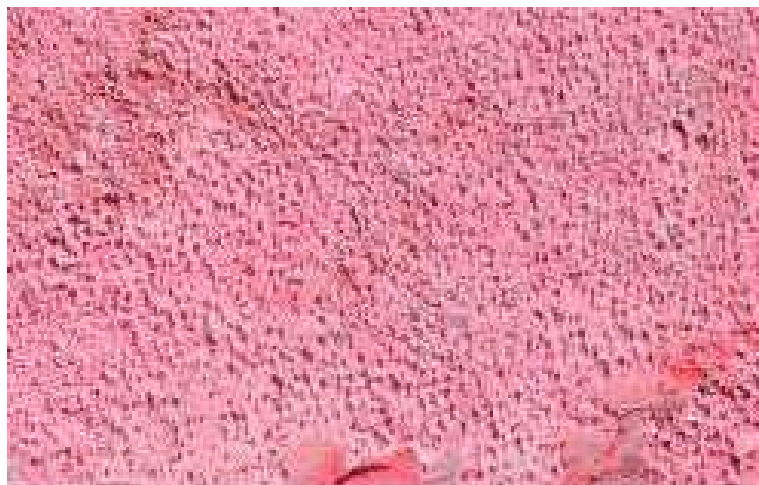
B. Upland vegetation (includes sparse palmetto and prairie grass)

Classic Infrared image color: Pale Pink; Manning's "n": 0.07-0.08

Actual Ground Shot

Infra-red Aerial

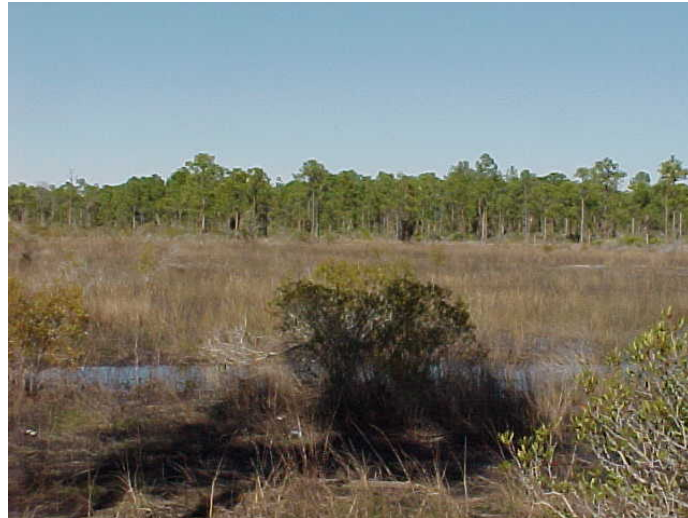
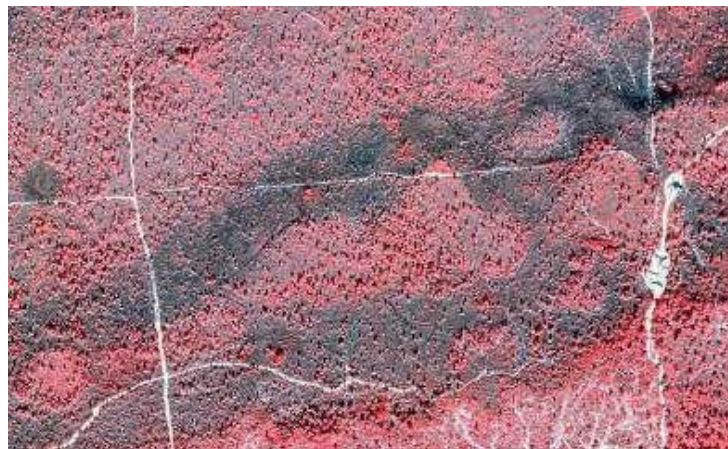
C. Intermittent marsh (includes seasonally wet areas with prairie grass and transitional wetland vegetation)

Classic Infrared image color: Pale Pink to Pale Gray; Manning's "n": 0.05-0.06

Actual Ground Shot

Infra-red Aerial

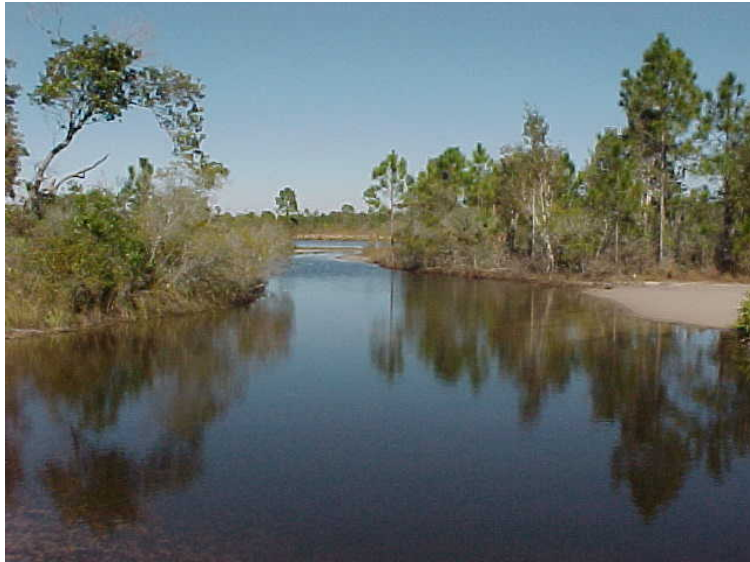
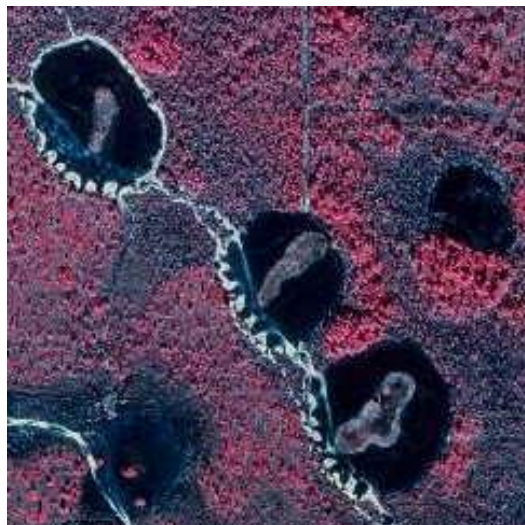
D. Standing water marsh (includes wet areas with prairie grass and wetland vegetation)

Classic Infrared image color: Pale Gray to Black; Manning's "n":0.04-0.045

Actual Ground Shot

Infra-red Aerial

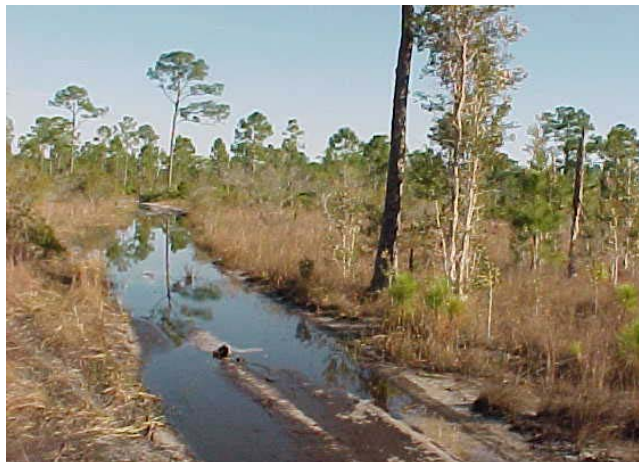
A Typical Shallow Flow Path/Vehicular Access Way Acting as a “Conveyance Channel”

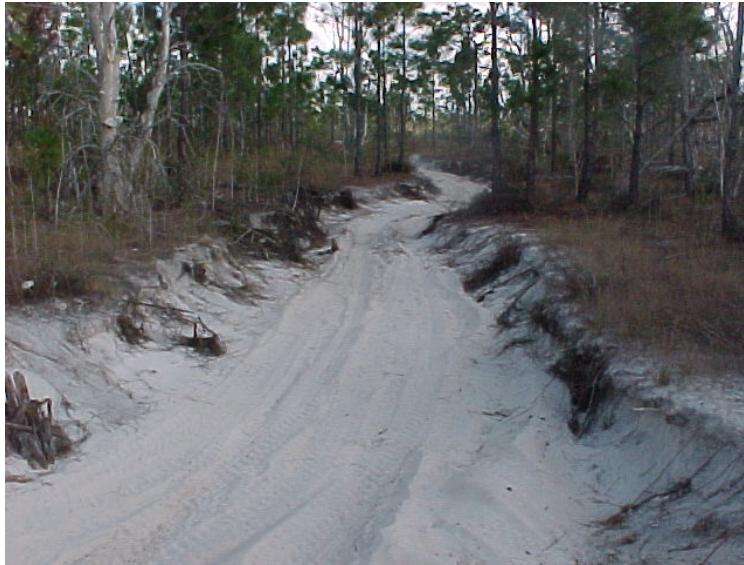
Vehicular Access Way East of Burnt Store Road Acting as a “Conveyance Channel”

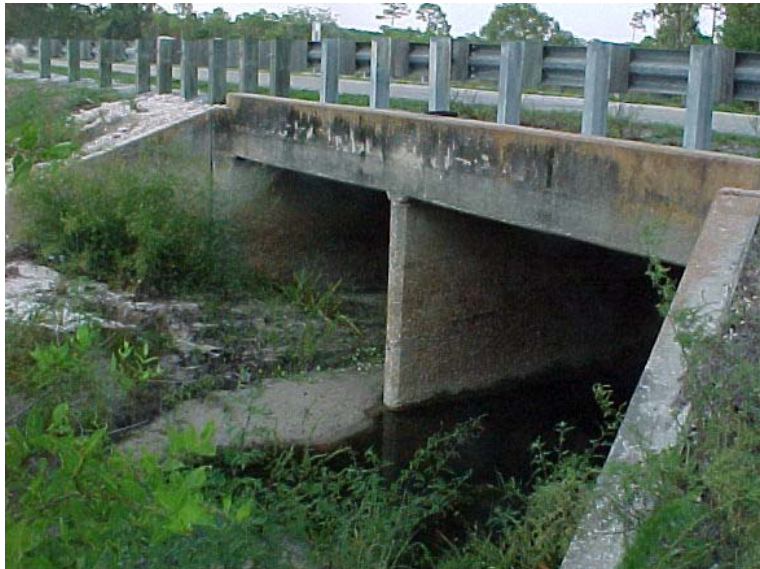
Culvert #1 – Yucca Pen Creek at Burnt Store Road

Culvert #1 – Yucca Pen Creek at Burnt Store Road: This is the northern most culvert of the study area located approximately 0.85 miles south of the Lee-Charlotte county line. This is a double 7-ft x 10-ft concrete box culvert. There is some minimal sedimentation within the channel upstream and downstream of this culvert and the channel has minimal vegetation growth.

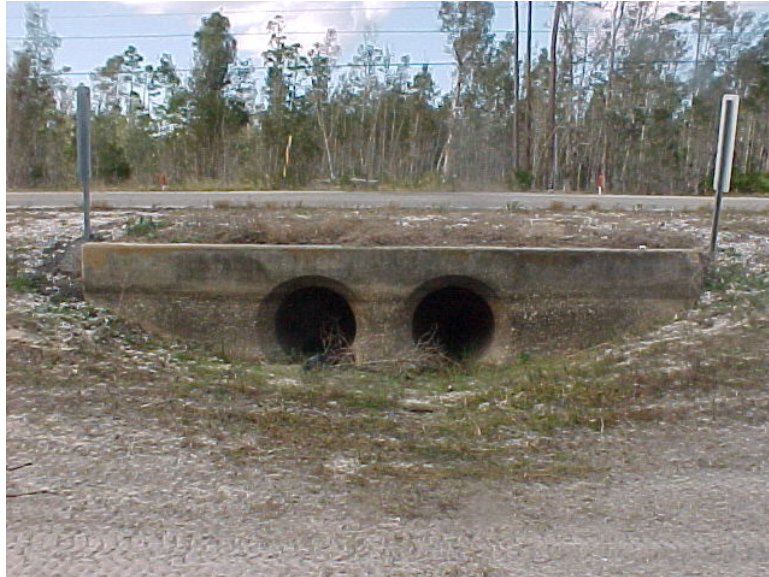
Culvert #2 – Durden Creek North Branch at Burnt Store Road

Culvert #2 – Durden Creek North Branch at Burnt Store Road: This is a double 30-inch RCP culvert crossing in the northern branch of Durden Creek. This branch joins the main channel of Durden Creek west of Burnt Store Road at NW 34th Avenue. Culvert #2 is located approximately 0.57 miles south of Culvert #1.

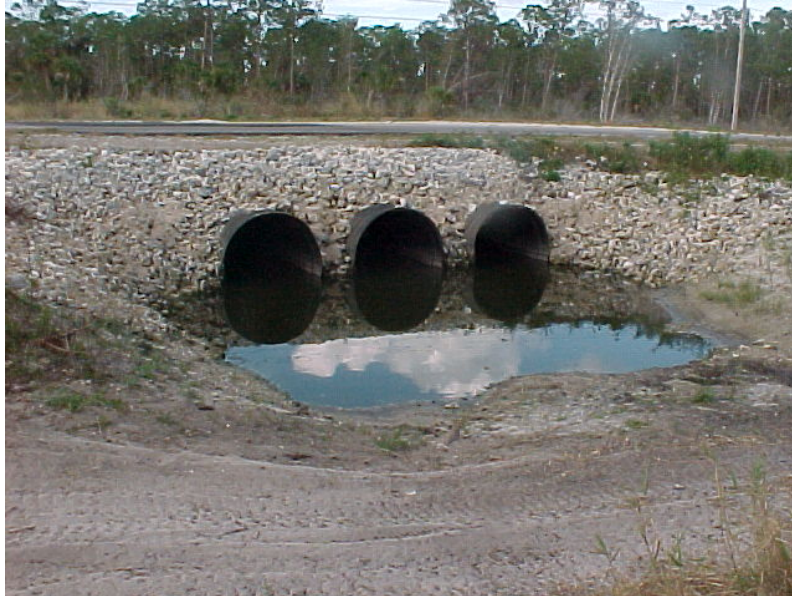
Culvert #3 – Durden Creek Main at Burnt Store Road

Culvert #3 – Durden Creek Main at Burnt Store Road: This is a triple 48-inch HDPE pipe culvert crossing in the main channel of Durden Creek. This culvert is located approximately 0.31 miles north of the intersection of Durden Parkway at Burnt Store Road. This was previously a 3-ft x 10-ft concrete box culvert which was replaced with HDPE pipes following the failure of the box culvert during a major rainfall event in June 2003.

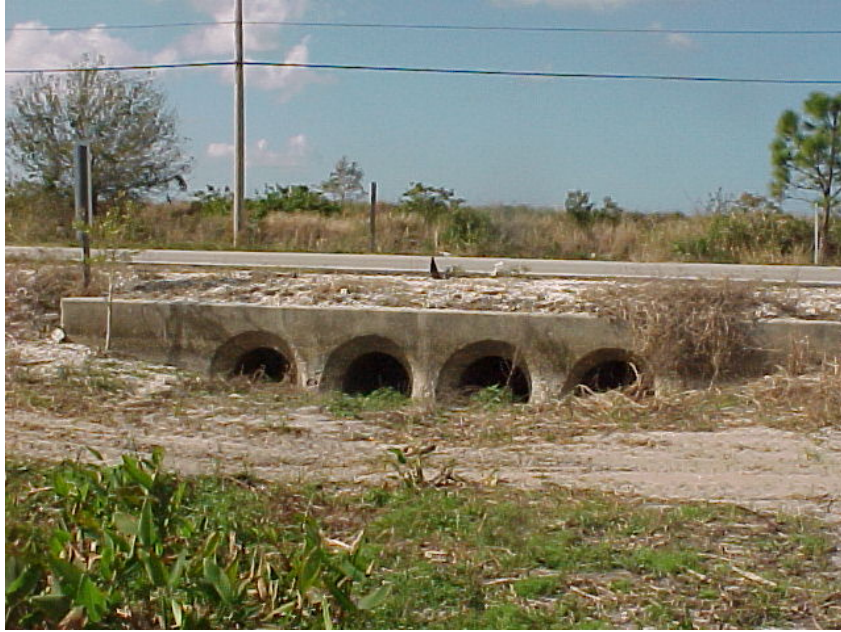
Culvert #4 – Greenwell Branch North at Burnt Store Road

Culvert #4 – Greenwell Branch North at Burnt Store Road: This is a 4-24” RCP culvert crossing in the northern branch of Greenwell Branch. This culvert is located approximately 0.19 mile south of the intersection of Durden Parkway at Burnt Store Road. This culvert is located across the Kodii Mine pit and is north of the Fire Station. The downstream side headwall of this culvert is made of “cement bag riprap” and is damaged as shown in the photograph below. Severe sedimentation and trash accumulation has occurred in the pipes, thereby significantly reducing the flow capacity.

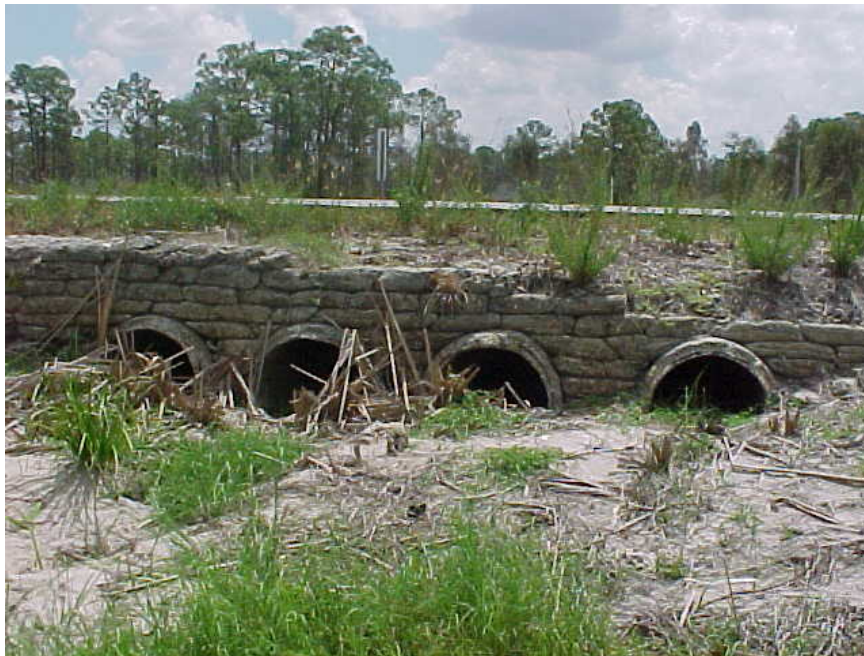
Culvert #4 – Downstream Side Headwall

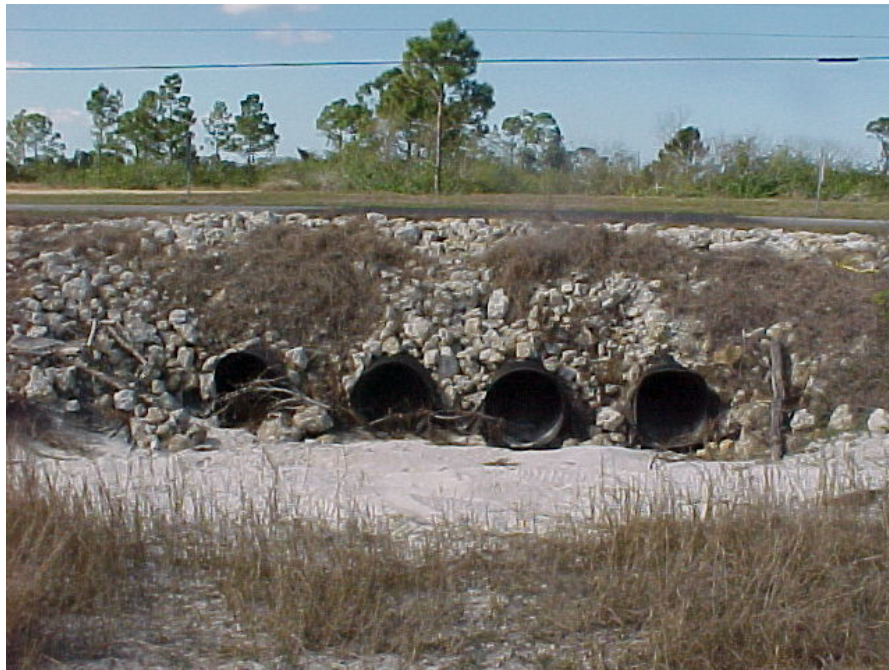
Culvert #5 – Greenwell Branch Main at Burnt Store Road

Culvert #5 – Greenwell Branch Main at Burnt Store Road: This is a 4-24” HDPE pipe culvert crossing in the main channel of Greenwell Branch south of the Fire Station. This culvert is located approximately 0.57 miles south of Culvert #4. This was previously a 4-24” RCP culvert and was replaced with HDPE pipes after the June 2003 rainfall event. This culvert discharges directly into the Cape Coral canal system. Severe erosion of the rubble riprap was observed at this culvert on the upstream and downstream sides. Erosion and failure of the northern bank was also observed on the downstream side as shown in the photographs below.

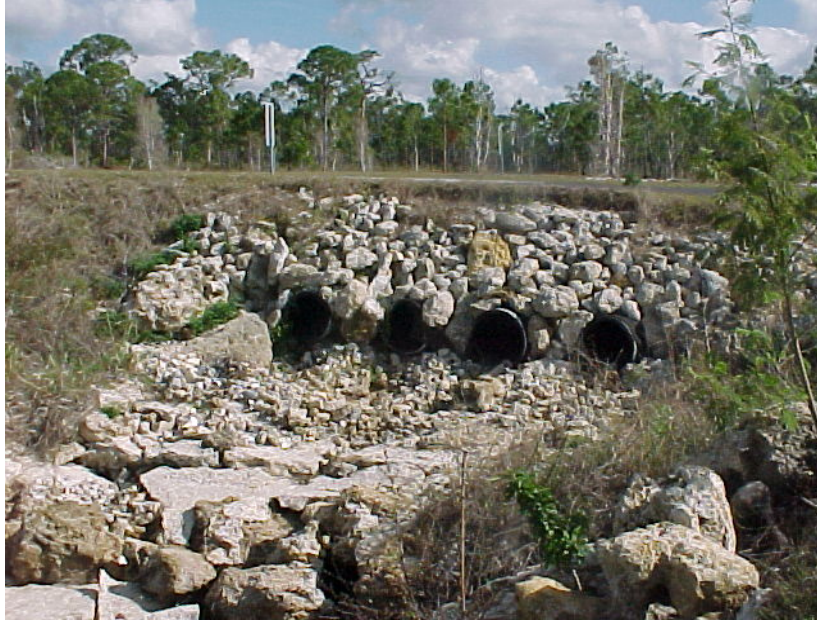
Culvert #5 – Downstream Face

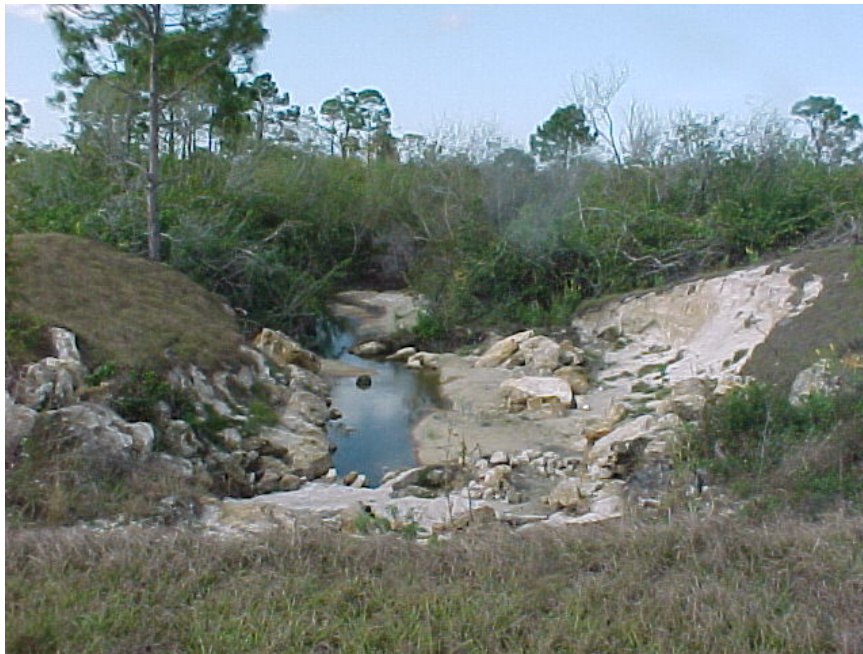
Culvert #5 – Failure of Bank on the Downstream Side

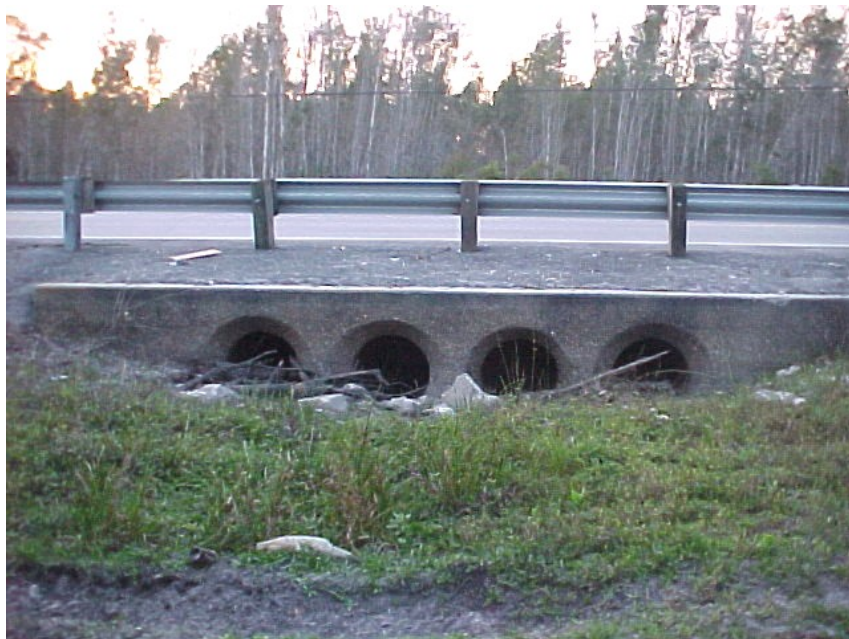
Culvert #6 at Burnt Store Road

Culvert #6 at Burnt Store Road: This is a 4-24” RCP culvert across the Lee County Mine. This culvert joins the east and west side ditches running parallel to Burnt Store Road. This culvert is located approximately 1 mile south of Culvert #5. Roadway flooding occurs at this culvert during major rainfall events. Significant sediment accumulation has occurred at this culvert.

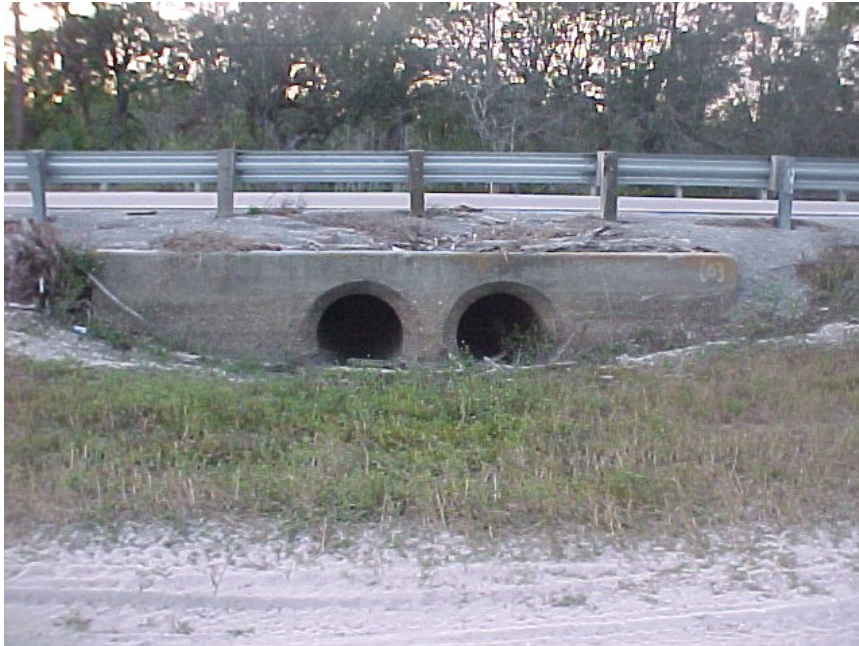
Culvert #7 at Burnt Store Road

Culvert #7 at Burnt Store Road: This is double 30-inch RCP culvert joining the east and west side ditches running parallel to Burnt Store Road across the Lee County Mine. This culvert is located approximately 0.6 mile south of Culvert #6. Minimal sedimentation was observed at this culvert.

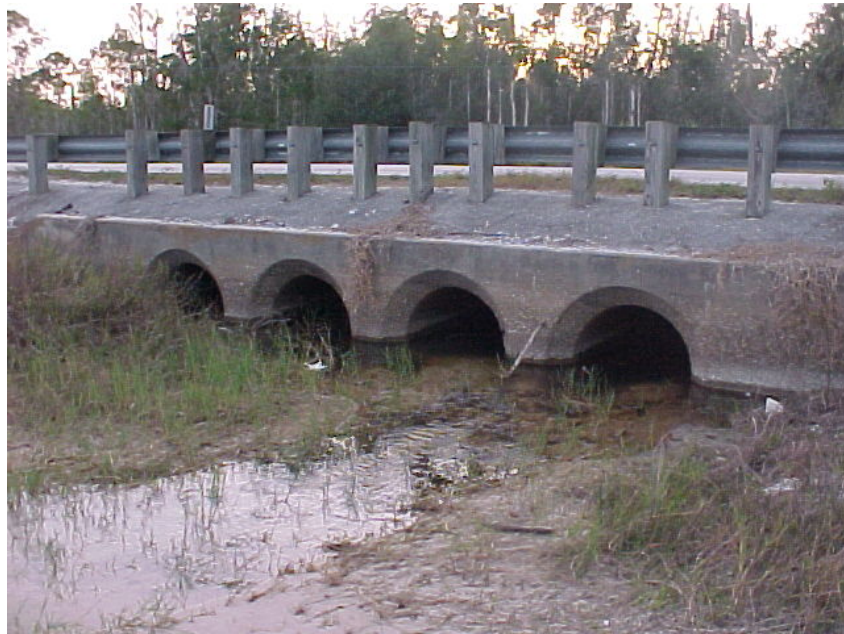
Culvert #8 at Burnt Store Road

Culvert #8 at Burnt Store Road: This is a 4-36" RCP culvert joining the east and west side ditches running parallel to Burnt Store Road. This culvert is located approximately 0.47 miles north of Gator Slough bridge. Severe sedimentation was observed at the upstream and downstream sides of this culvert that could greatly reduce the conveyance capacity. Dense vegetation growth was observed on the downstream side of this culvert.

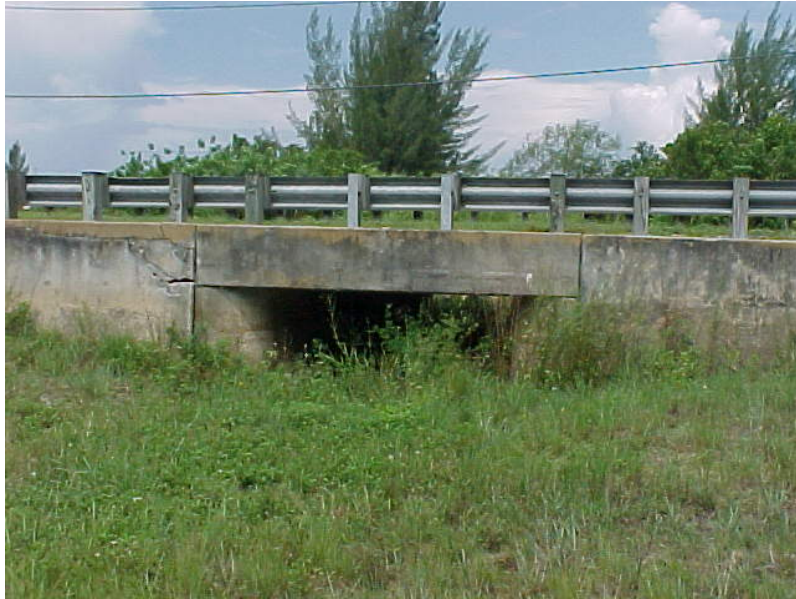
Culvert #9 South of Gator Slough Bridge at Burnt Store Road

Culvert #9 at Burnt Store Road: This is a 4-ft x 8-ft box culvert crossing located approximately 0.13 miles south of Gator Slough bridge. This culvert discharges directly into the Cape Coral canal system. Some vegetation growth was observed on the upstream and downstream sides of this culvert.

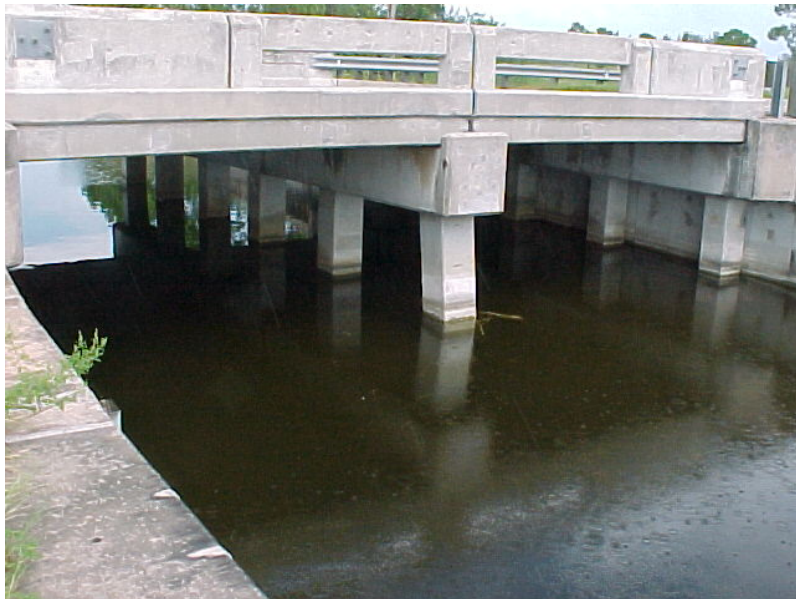
Culvert #10 (Bridge) at Burnt Store Road

Culvert #10 at Burnt Store Road: This is a bridge located in Arroz Canal of the Cape Coral canal system approximately 0.18 miles south of Culvert #9. The dimensions of the flow section beneath the bridge are 11-ft x 34-ft. A concrete weir is located in Arroz Canal approximately 120' upstream of this bridge.

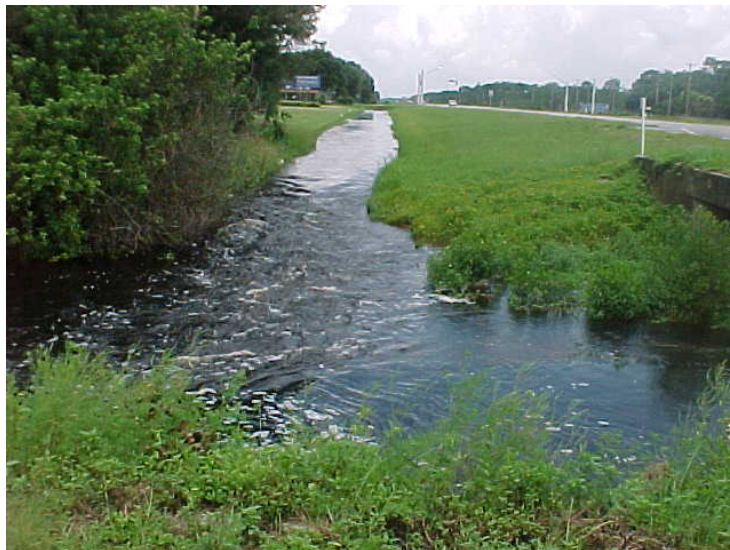
The roadside ditches along US-41 on both sides carry significant flows, but the USGS streamgage located on the east side of US-41 does not account for this flow. Lee County obtained flow measurements in US-41 side ditches and in Gator Slough downstream of US-41 culvert for two rainfall events during July-August 2004. These measured flows were compared with the flows reported by USGS. It was determined that the USGS flows were approximately half of the flows measured by Lee County in Gator Slough downstream of US-41. The photograph below shows the flow in the west side ditch along US-41 immediately north of Gator Slough for a rainfall event in August 2004. Hence a multiplication factor of 2 was applied to the 15-minute flows recorded by USGS to develop a rating curve for Gator Slough inflow. Moving the USGS streamgage from its current location to approximately 500-ft downstream of US-41 culvert is essential to properly monitor the total flow in Gator Slough canal downstream of US-41 culvert.

Flow in the West Side Ditch along US-41 at Gator Slough for August 2004 Rainfall Event

The USGS streamgage located east of US-41 in Gator Slough canal does not account for all the flows west of US-41. This streamgage should be moved from its current location to approximately 500' downstream of US-41 culvert. This is essential to properly monitor the total flow in Gator Slough canal. Since there is only one raingage available for the entire study area, installation of a weather station in the vicinity of Burnt Store Road is recommended to aid in future studies.

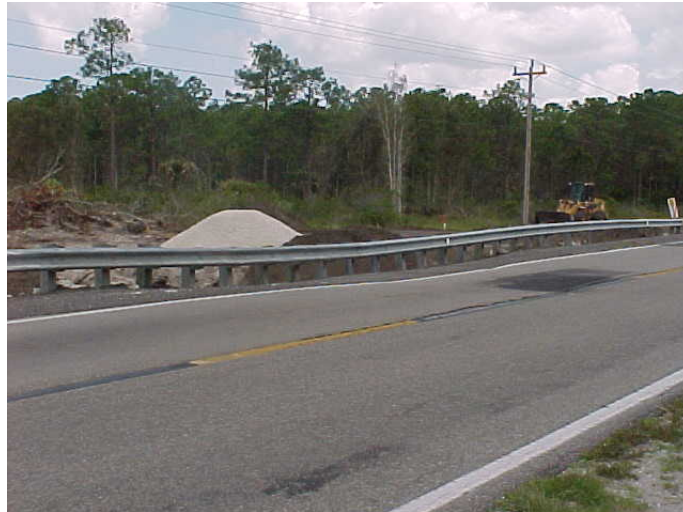
A roadway flooding of about 4'-6" was observed by Lee County at Durden Creek Main culvert (Culvert #3) and at Culvert #6 along Burnt Store Road; a flood stage of 7.3' was measured in subbasins LV-2 and LV-3 along Old Burnt Store Road. Flooding was extensive in areas east of Burnt Store Road. Excessive flows at Durden Creek Main culvert caused erosion problems and this culvert failed during this rainfall event. The photograph below shows the depression formed in the southbound lane of Burnt Store Road at this culvert.

Failure of Durden Creek Main Culvert at Burnt Store Road during the June 2003 Event
