Lee County

Critically Eroded Beaches In Florida

**Division of Water Resource Management
Florida Department of Environmental Protection
June 2015**

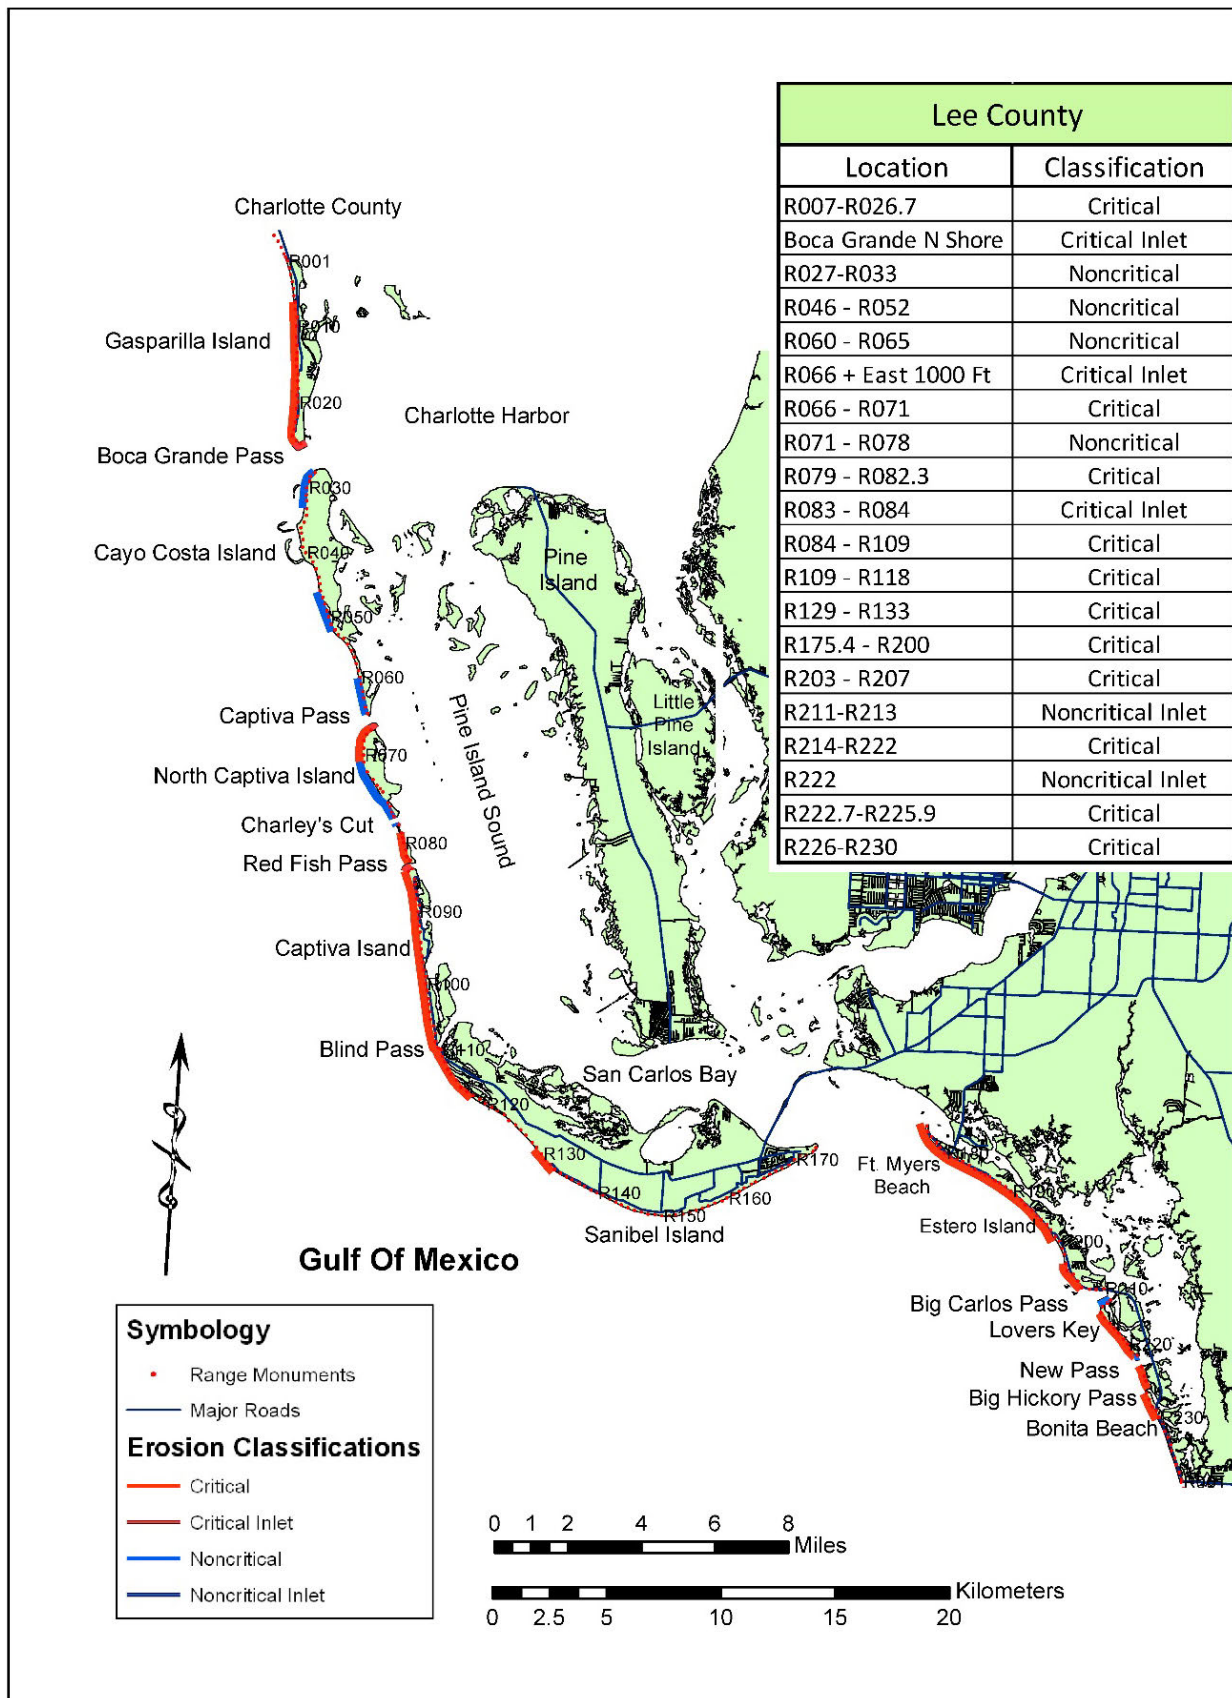
Figure 29. Critically eroded shoreline within Lee County.

There are eleven critically eroded beach areas (22.4 miles), four non-critically eroded beach areas (5.3 miles), three critically eroded inlet shoreline areas (0.6 mile), and two non-critically eroded inlet shoreline areas (0.4 mile) in Lee County (Figure 29).

The southern 4.0 miles of Gasparilla Island (R7-R26.7) is critically eroded threatening development and recreational interests in the town of Boca Grande and the Gasparilla Island State Park. Much of this area has bulkheads, and inlet sand transfer has been conducted using Boca Grande Pass dredge material. The north shoreline of Boca Grande Pass within the Gasparilla Island State Park (0.2 mile) is also critically eroded.

Three areas on Cayo Costa Island are non-critically eroded. The northern segment (R27-R33) extends for 1.1 miles, the central segment (R46-R52) extends for 1.2 miles, and the southern segment (R60-R65) extends for 1.0 mile.

All of North Captiva Island is eroded. The north shore fronting on Captiva Pass (R66, east 1000 feet) has critical inlet shoreline erosion threatening development interests. The northern 1.0-mile of gulf beach (R66-R71) is critically eroded threatening development interests, and from R71 through R78 is 2.0 miles of non-critical erosion. The island was breached between R78 and R79 during Hurricane Charley (2004). The truncated southern 0.8 mile of North Captiva Island extending into Redfish Pass (R79-R82.3) is critically eroded threatening development and losing wildlife habitat.

All of Captiva Island is critically eroded. The south shore of Redfish Pass (R83-R84) has 0.2 mile of critically eroded inlet shoreline. This shoreline has a rock revetment with a terminal groin. The gulf beach from R84 through R109 has five miles that is critically eroded. This entire island segment is a beach restoration project.

Northern Sanibel Island is eroded. From R109 to R118 the beach is critically eroded, extending 1.7 miles south of Blind Pass where the road, development, recreation, and wildlife habitat are threatened. Part of this segment received nourishment from the Captiva Island beach restoration project. Another segment (R129-R133) on northern Sanibel Island has 0.9 mile that is critically eroded threatening development interests. This segment in the neighborhoods of Gulf Shores and Gulf Pines has a beach restoration project.

Most of Estero Island is eroded. From R175 (-.4) to R200, Ft. Myers Beach has 5.0 miles that is critically eroded threatening development and recreational interests. This entire segment is a beach restoration project. Matanzas Pass channel dredge material has been previously placed at the north end on Bowditch Point. A 0.8-mile southern segment of Estero Island (R203-R207) is also critically eroded along the Little Estero Island Critical Wildlife Area. During the 1970's a subaerial portion of the Big Carlos Pass ebb tidal shoal migrated landward and attached to southern Estero Island entrapping an alongshore lagoon. This barrier continued to migrate landward through storm tide overtopping events and has gradually disintegrated through erosion, which threatens development, infrastructure, and wildlife habitat.

Most of Lover's Key is eroded. The north shore of Lover's Key (R211-R213) fronting on Big Carlos Pass has 0.3 mile that is non-critically eroded. Most of the gulf beach extending from R214 to R222 has 1.5 miles that is critically eroded threatening recreational interests and wildlife habitat in Lover's Key State Park. A beach restoration project was constructed in 2004. The south shore of Lover's Key (R222) fronting on New Pass also has 0.1 mile of non-critically eroded inlet shoreline.

Between New Pass and Big Hickory Pass, Big Hickory Island (R222.7-R225.9) has 0.8 mile that is critically eroded where wildlife habitat and recreation has been lost. South of Big Hickory Pass, Little Hickory Island (R226-R230) has 0.9 mile of critically eroded beach threatening development interests in Bonita Beach. This area has a beach restoration project with bulkheads and two terminal groins at the north end.
