**BLIND PASS MAINTENANCE DREDGING PROJECT
2020 THIRD YEAR MONITORING REPORT**

**Lee County Government
1500 Monroe Street 3rd Floor
Fort Myers, FL 33901**

**October 27, 2020
CEC File No. 20.030**

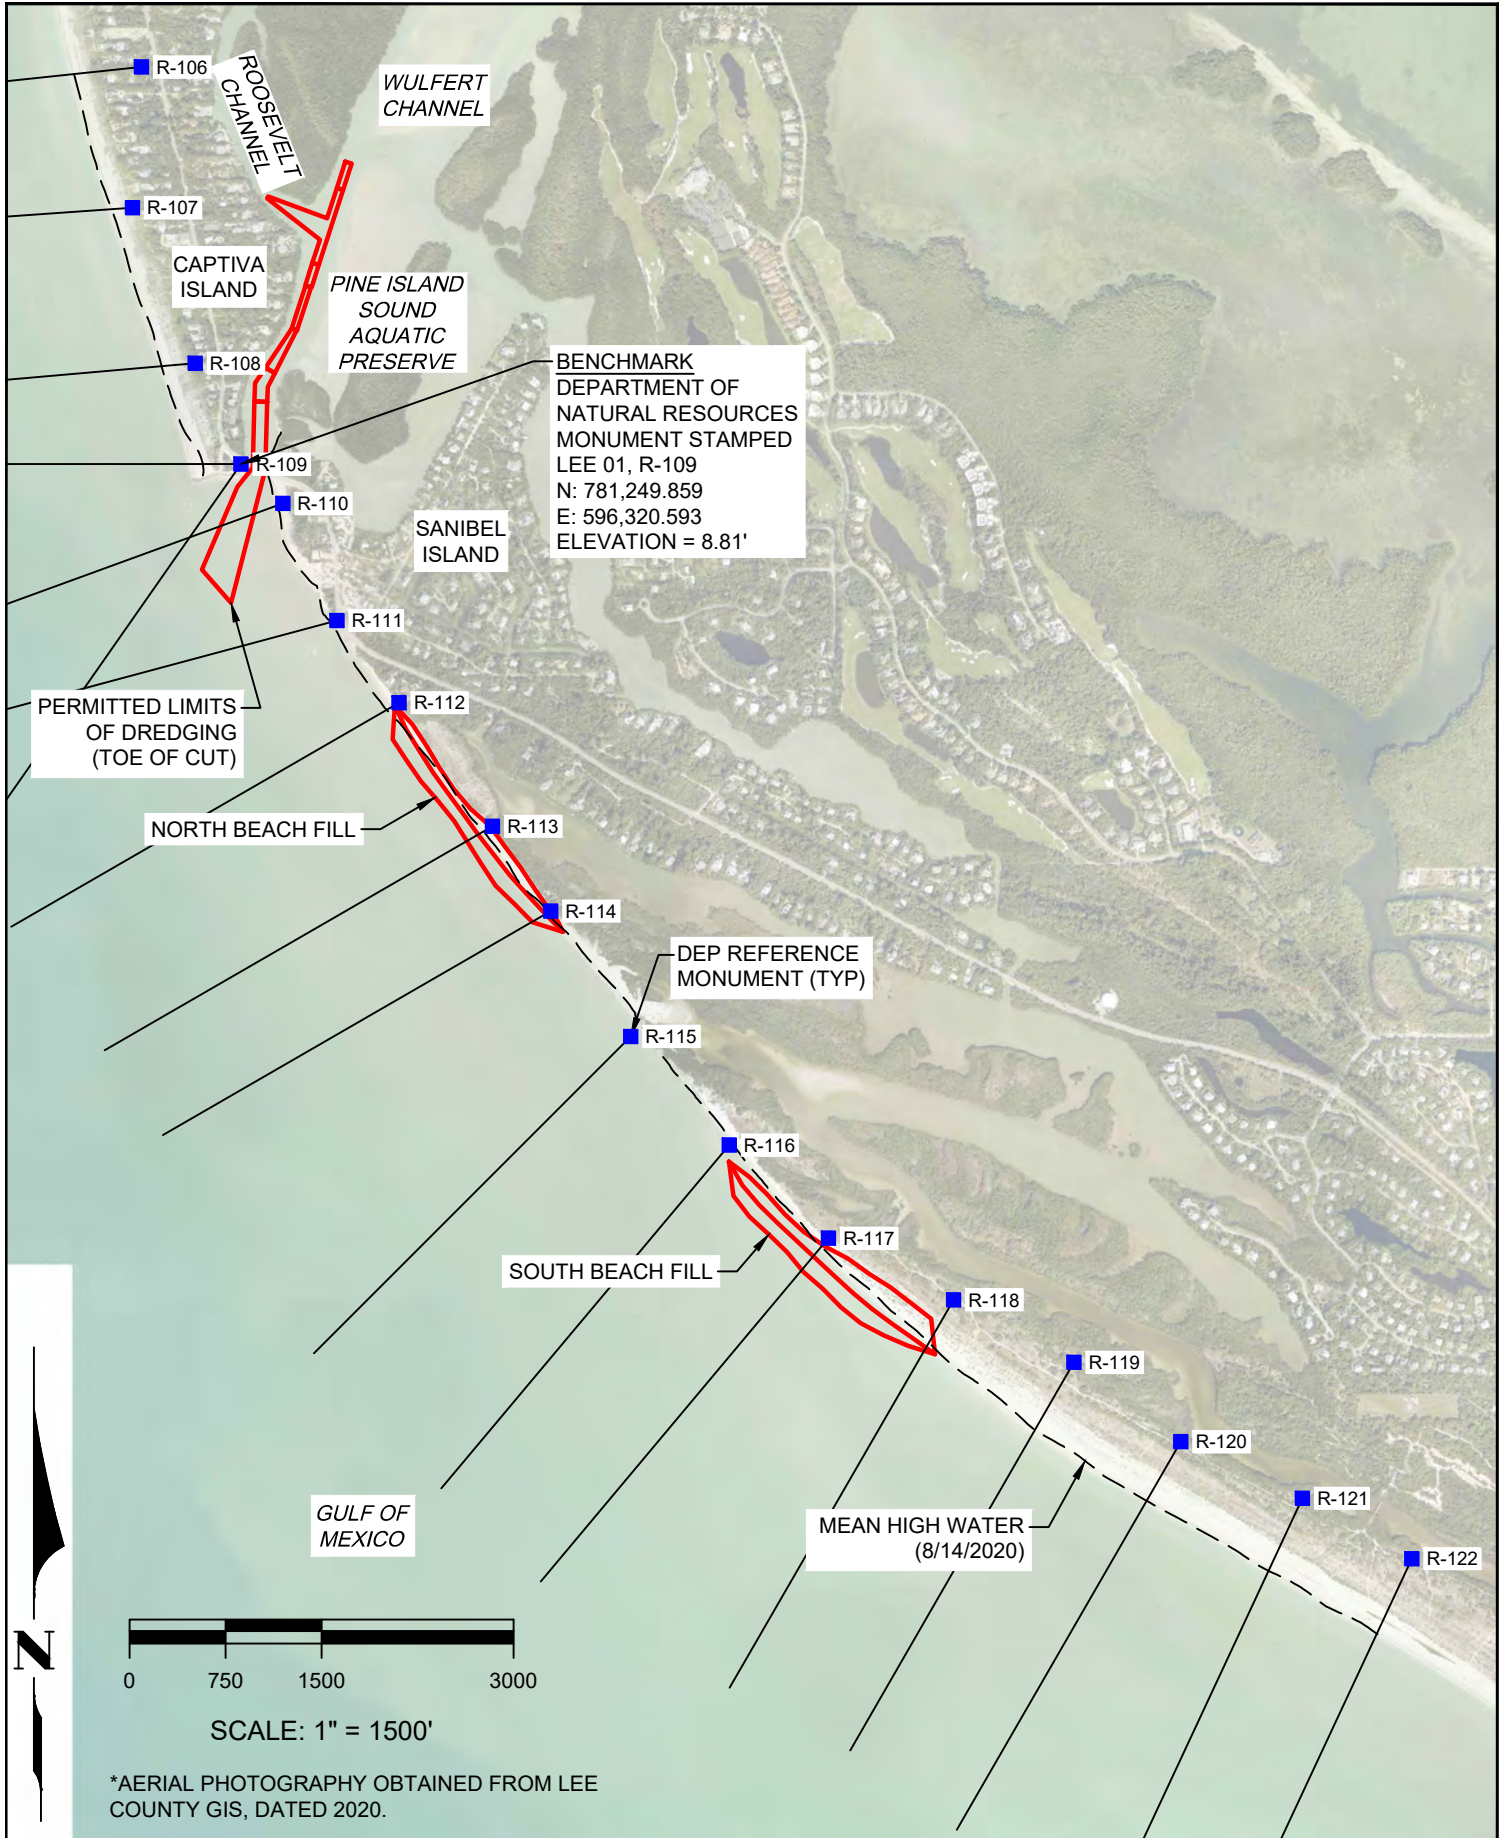
An overall location map of the project area which includes R-monument survey lines is presented in Figure 1. Figure 2 presents a location map of Blind Pass and depicts ebb shoal and dredge template survey lines.

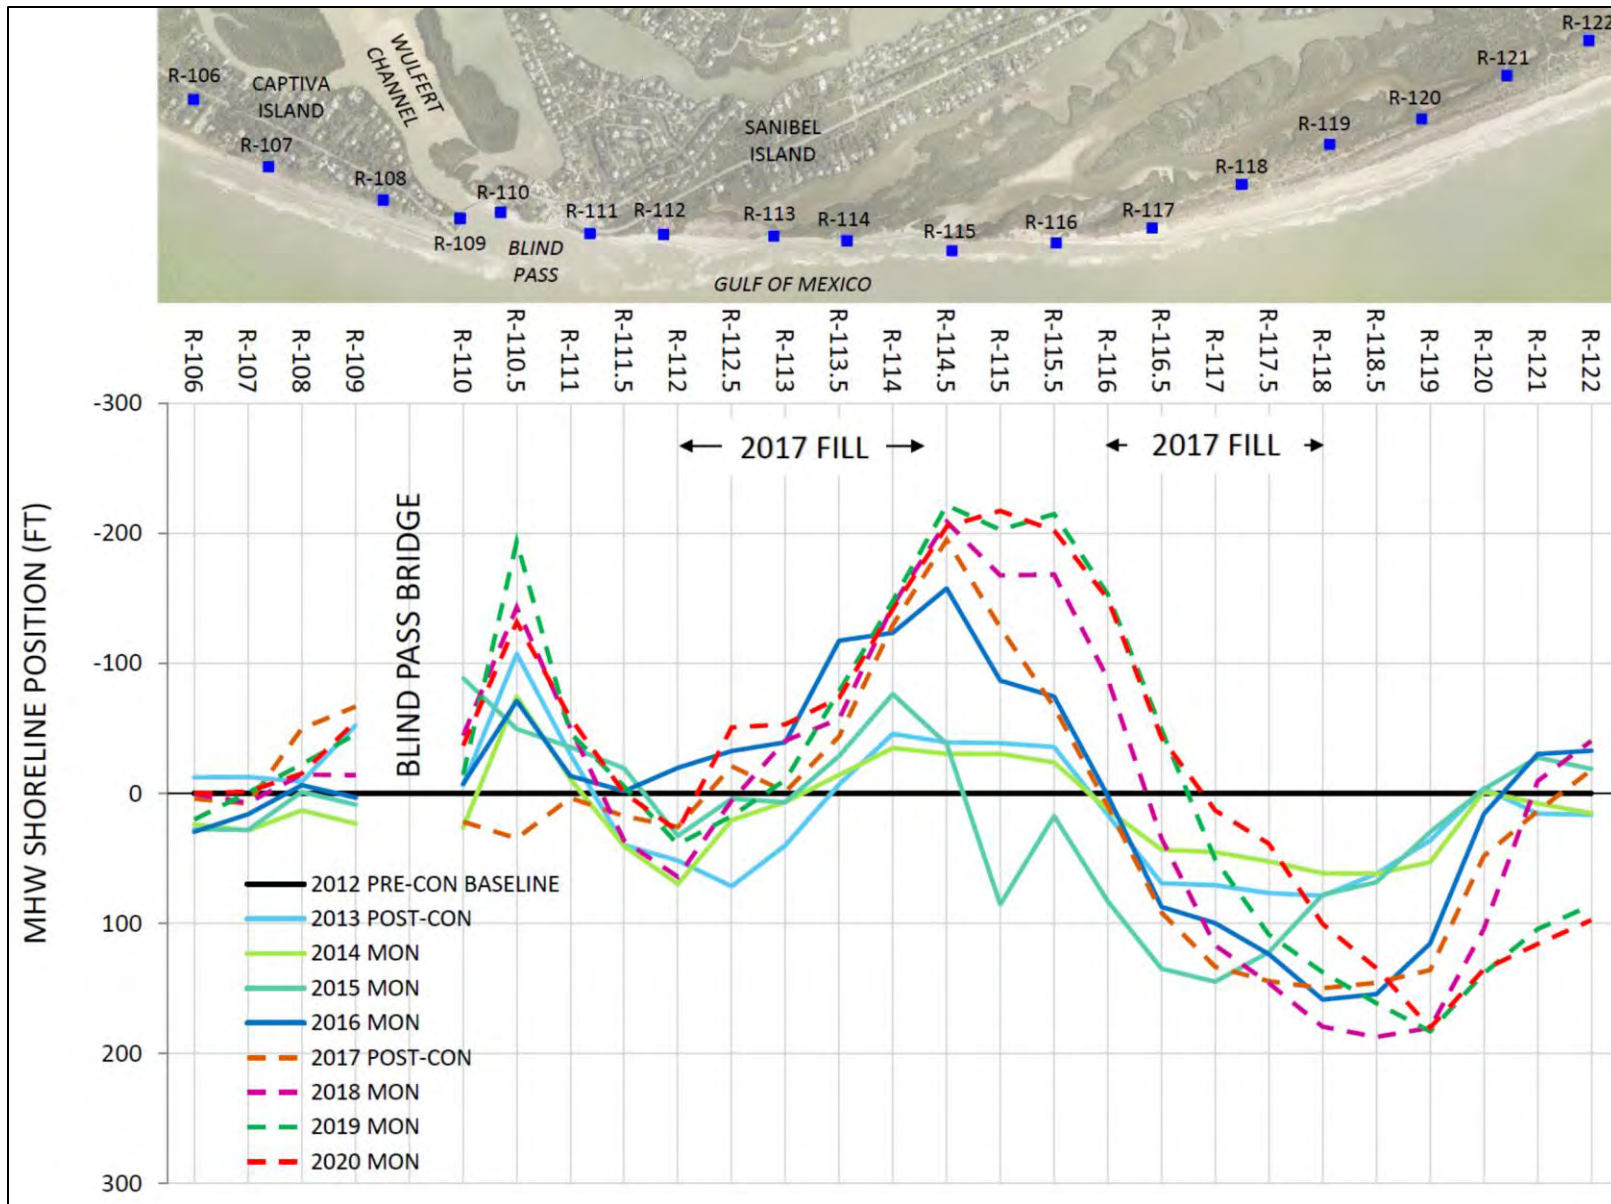
Figure 3. 2020 and Historic MHW Shoreline Positions Relative to 2012 Pre-Construction MHW Shoreline.

Figure 3 presents a schematic of the historic annual MHW shoreline positions relative to the 2012 dredging project pre-construction positions that serves as a baseline.

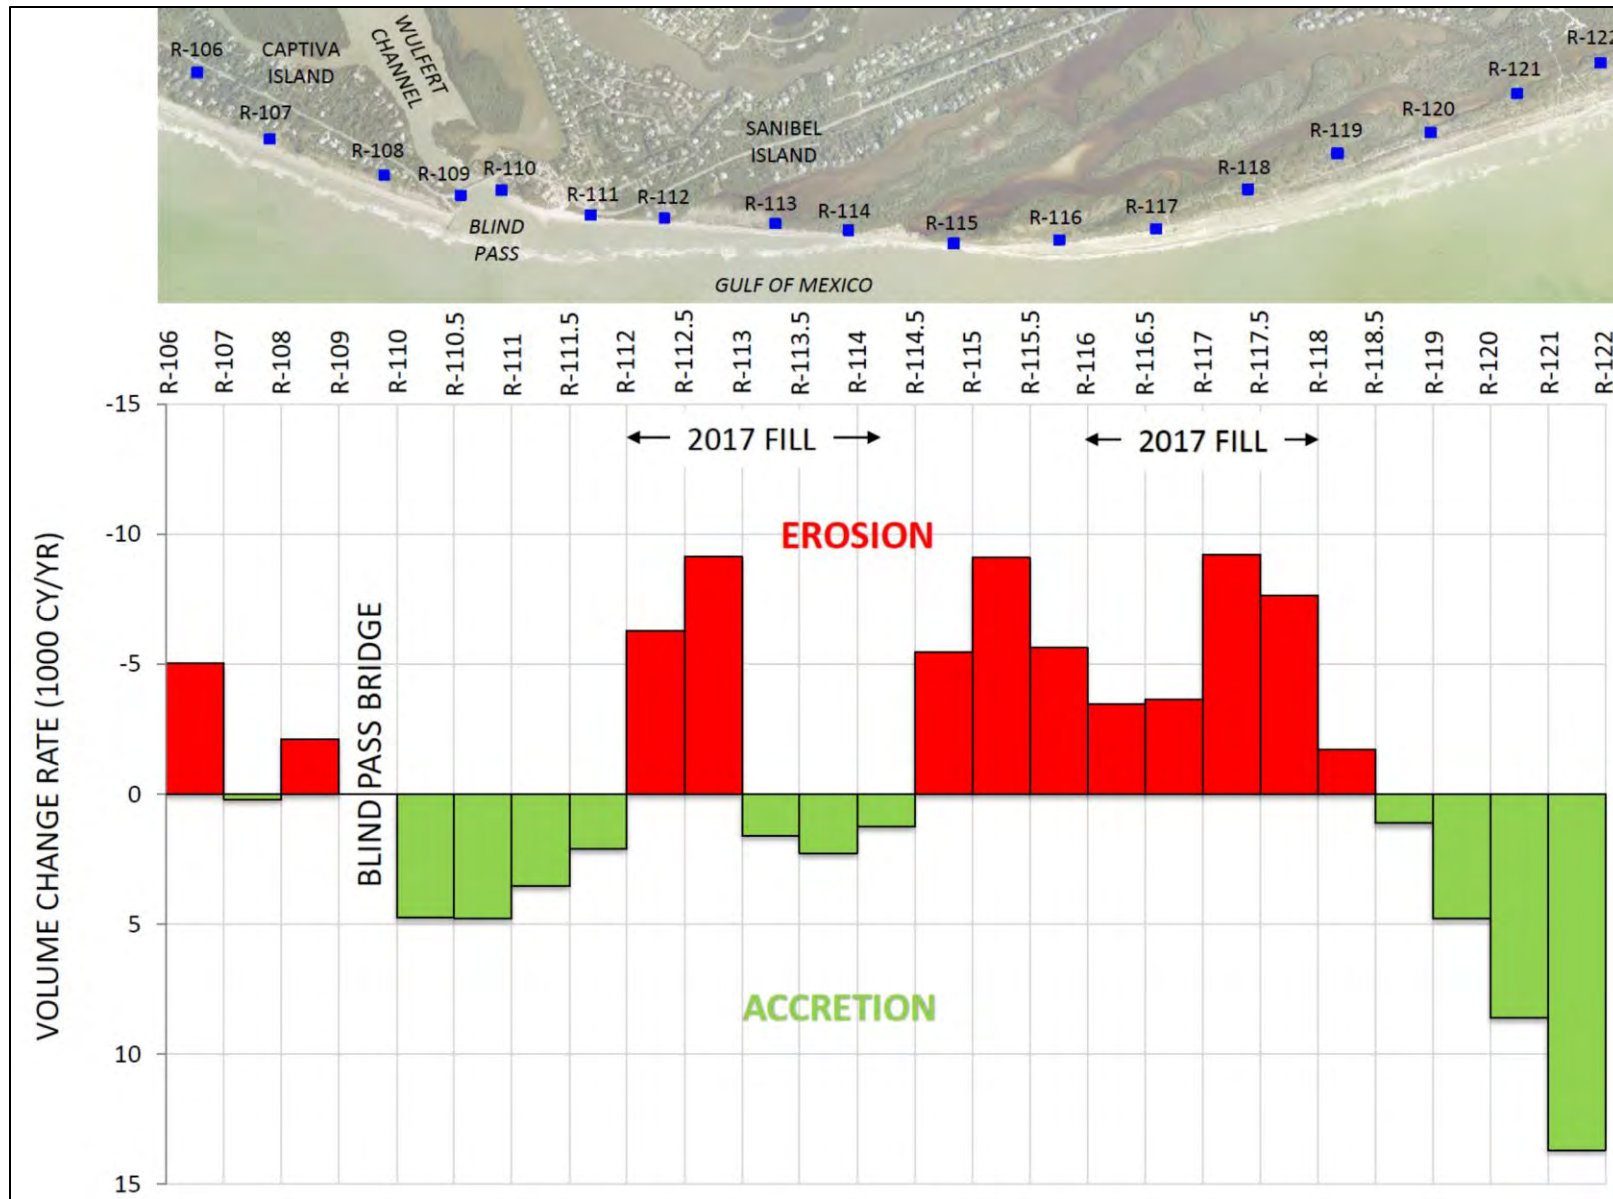
Figure 5. Annualized Volumetric Change Rates to DOC between 2019 and 2020 Surveys.

Figures 4 and 5 present bar charts of the 2019-2020 volumetric change rates to MHW and DOC, respectively, noting that they were annualized to be consistent with prior years' monitoring reports.

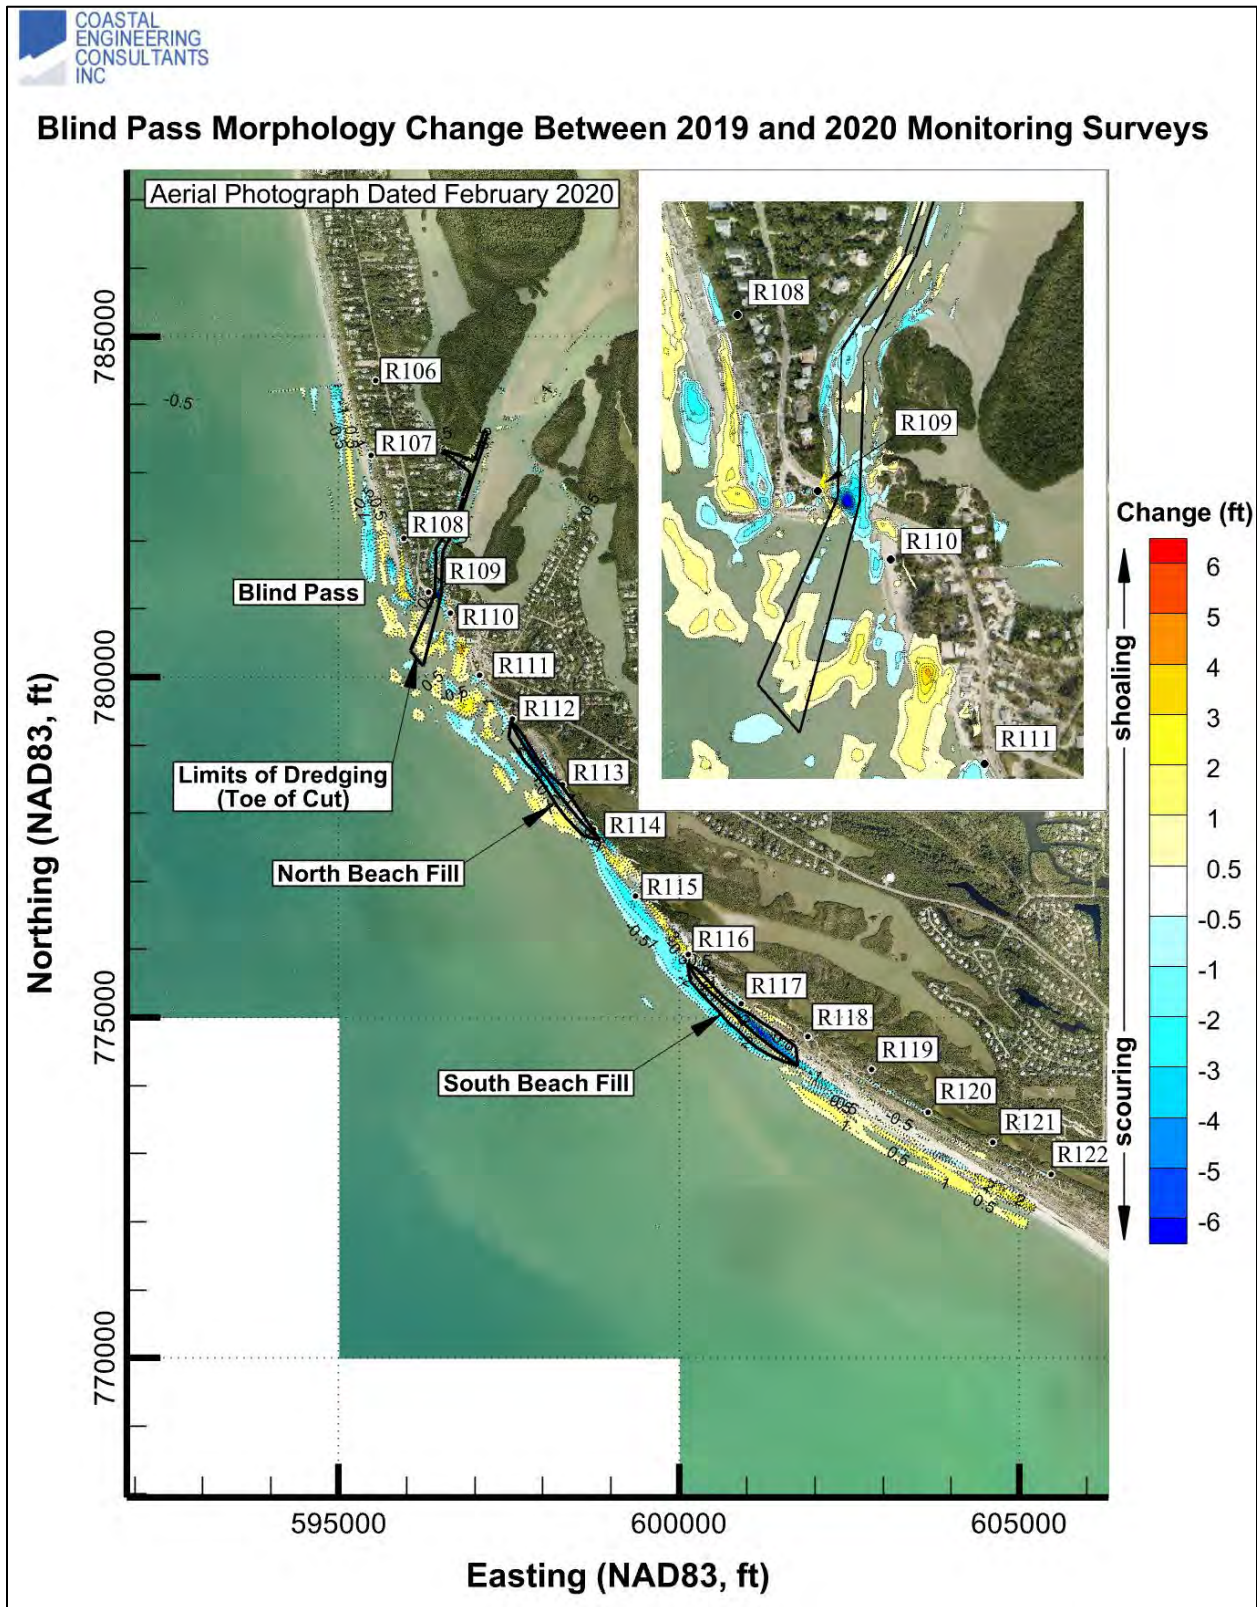
Figure 8. 2019 – 2020 Morphologic Changes.

Figure 8 presents a morphology change map depicting changes in elevations that occurred between the two surveys. It illustrates a slight growth of the ebb shoal, scouring of the channel near the bridge, beach accretion between R-110.5 and R-111 due to the fill placed there in May 2020, beach erosion within the fill limits between R-112 and R-113 and between R-117 and R-118.

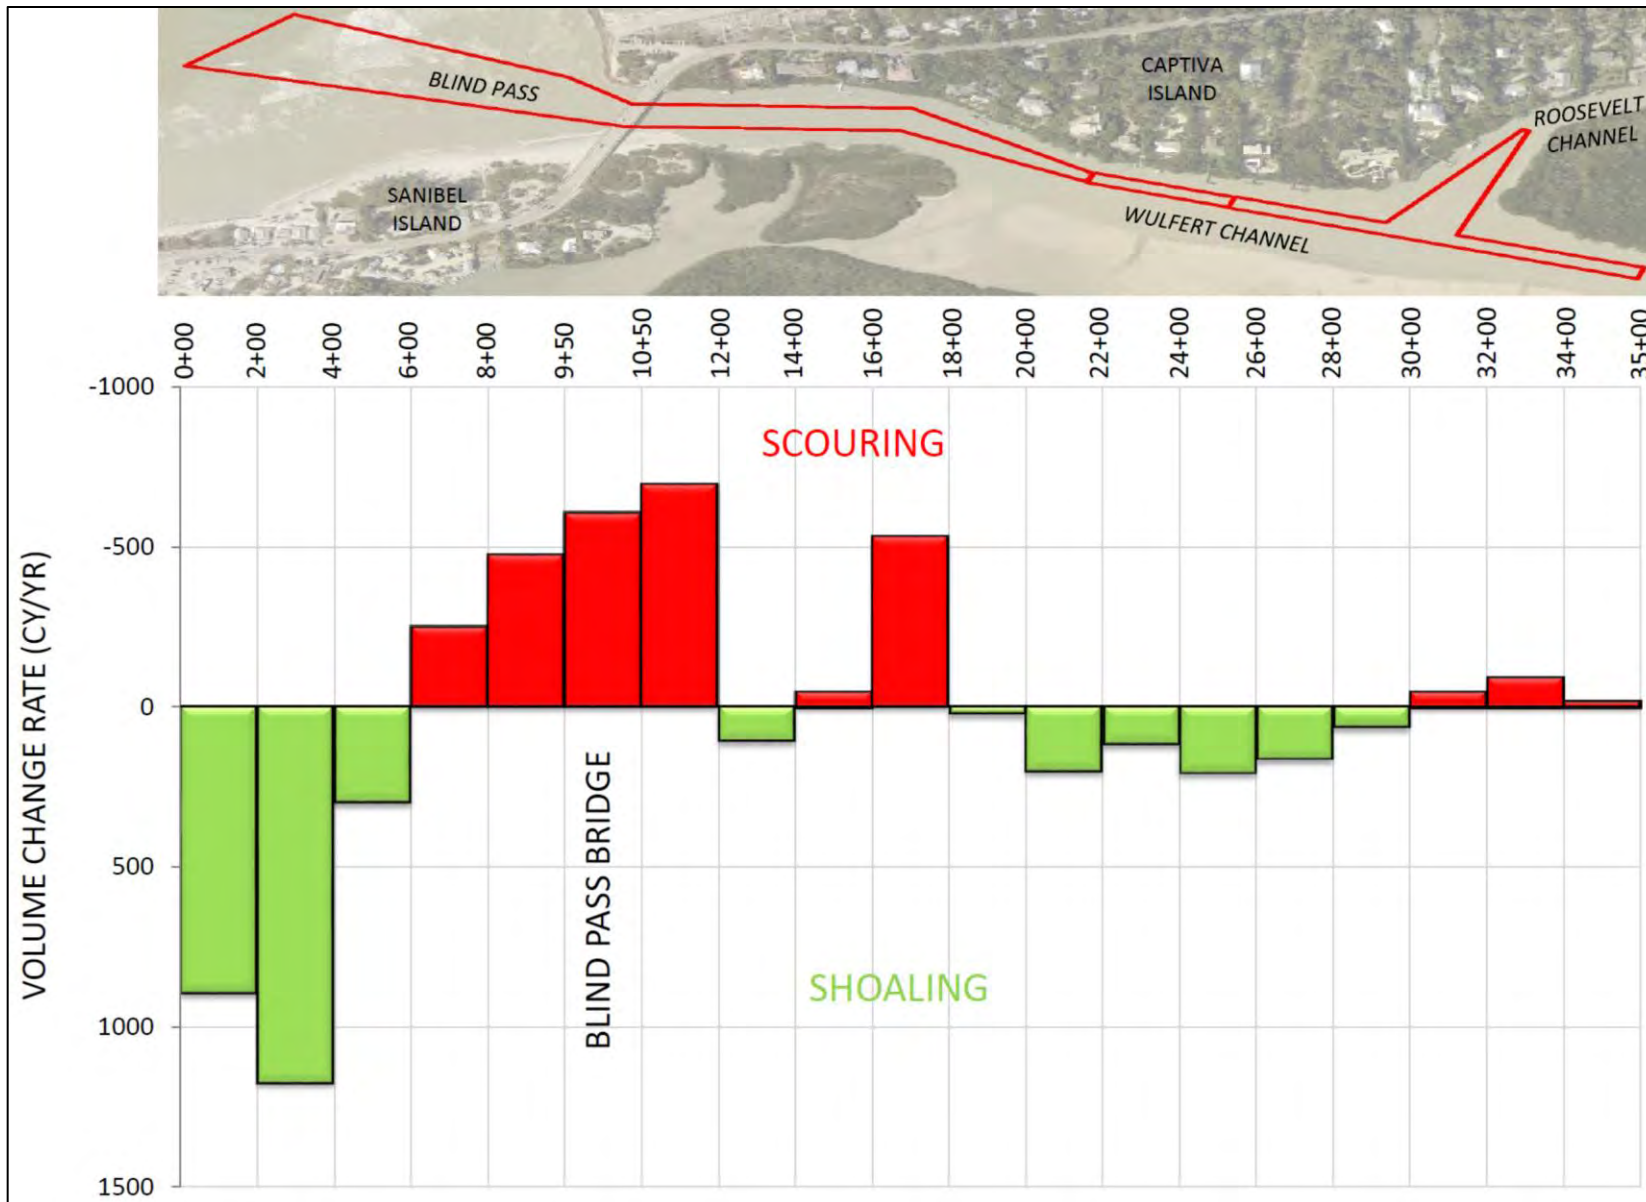
Figure 9. Annualized Volumetric Changes within Dredge Template between 2019 and 2020 Surveys.

Station	Area (cy/ft)	Average Area (cy/ft)	Length (ft)	Volume (cy)
Wulfert Channel				
0+00	1.8			
		5.2	200.00	1,045
2+00	8.7			
		6.9	200.00	1,374
4+00	5.0			
		1.7	200.00	350
6+00	-1.5			
		-1.5	200.00	-291
8+00	-1.4			
		-3.7	150.00	-552
9+50	-6.0			
		-7.1	100.00	-706
10+50	-8.1			
		-5.4	150.00	-811
12+00	-2.7			
		0.6	200.00	126
14+00	4.0			
		-0.3	200.00	-52
16+00	-4.5			
		-3.1	200.00	-621
18+00	-1.7			
		0.1	200.00	27
20+00	2.0			
		1.2	200.00	237
22+00	0.4			
		0.7	200.00	137
24+00	1.0			
		1.2	200.00	243
26+00	1.4			
		1.0	200.00	192
28+00	0.5			
		0.4	200.00	75
30+00	0.2			
		-0.3	200.00	-51
32+00	-0.8			
		-0.5	200.00	-104
34+00	-0.3			
		-0.2	100.00	-20
35+00	-0.1			
Roosevelt Channel				
101+00	1.0			
		1.7	100.00	171
102+00	2.4			
		1.4	200.00	276
104+00	0.4			
		0.3	100.00	26
105+00	0.2			
Total				1,071

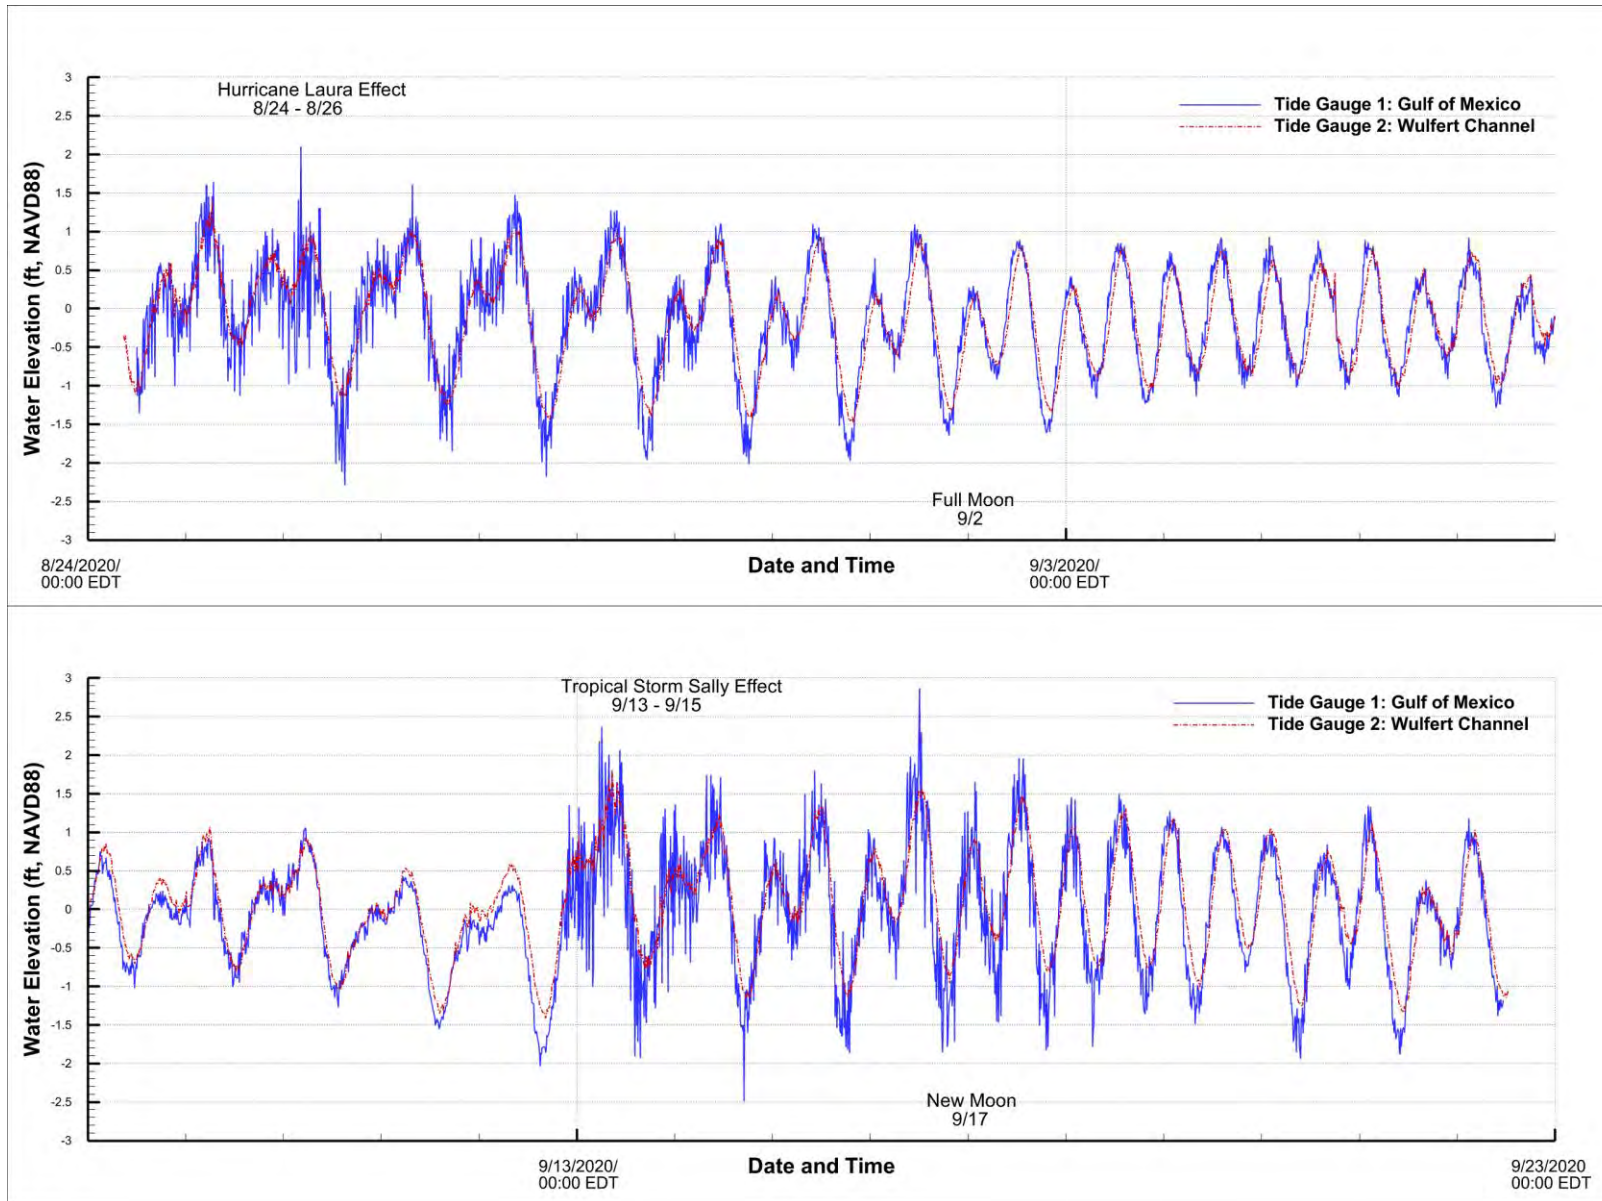
Figure 11. Water Surface Elevations Measured in Gulf of Mexico and Wulfert Channel.

The water level data was converted to the NAVD88 vertical datum and plotted in Figure 11. A Full Moon was observed on September 2, 2020 and a New Moon was observed on September 17, 2020. Two storm events, Hurricane Laura and Tropical Storm Sally, passed the Southwest Florida coast in relative proximity August 24-26, 2020 and September 13-15, 2020. These events resulted in some noise which was mostly evident in the water level measured in the Gulf of Mexico noting that a little noise was also observed in the water level recorded in Wulfert Channel inside Blind Pass. To eliminate the noise, a low-pass filter was applied to both series of water levels. The filtered water levels are presented in Figure 12.

Over the deployment period, the water elevation in the Gulf of Mexico location fluctuated between -1.9 feet NAVD88 to 2.0 feet NAVD88. The maximum tidal range of 3.2 feet was observed on September 16 during the New Moon and after the passage of Tropical Storm Sally. The minimum tidal range of 1.7 feet was observed on September 5. The water elevation in Wulfert Channel inside Blind Pass had similar peaks but higher troughs resulting in smaller tidal ranges. The maximum tidal range of 2.9 feet inside the pass was observed on September 13 during the passage of Tropical Storm Sally. During the New Moon, the range was 2.4 feet. The minimum tidal range of 1.4 feet was observed on September 4.
