Lee Civic Center Facility Condition Assessment Study Summary

Lee Civic Center Facility Condition Assessment Study

Weston & Sampson, on behalf of Lee County, Florida, conducted a condition assessment study of the Civic Center site located at 11831 Bayshore Road, North Fort Myers, FL. The team consisted of local architects and engineers licensed in Florida and specialized to assess the site grounds and fourteen buildings. The existing conditions of the 14 buildings and the site grounds were observed through multiple site visits. Deficiencies, in need of correction, were identified. The information (deficiency data) was further compiled, assessed and evaluated to determine recommendations for repair or replacement along with the associated preliminary construction cost estimates.

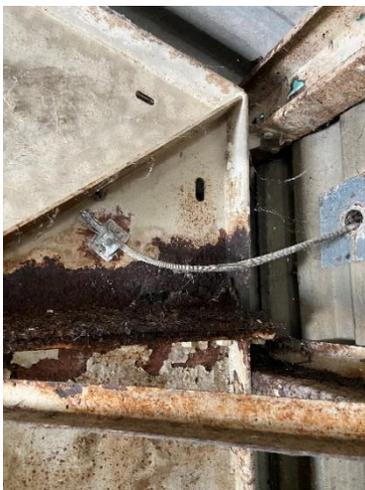
The severely deteriorated portal frame in Maintenance / Shop, pictured below, is an example of arresting a safety risk until repair be performed. This issue was discovered during the field observation in March and the County promptly responded by notifying the Fair Board staff via an on-site meeting and restricting use until repair be performed.

Severely Deteriorated Column -
Maintenance/Shop.

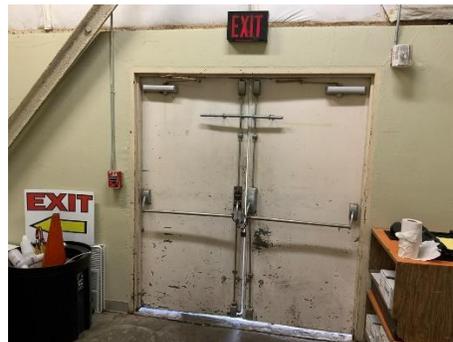
Another life safety example relates to emergency exiting of the Civic Center arena. There are currently four sets of double doors along the egress path that have been permanently locked, typically with padlocks as shown in the photo. Though not all doors would be required given the reduced occupancy demand since 2017 when the bleachers were condemned, the signage and lighting for the egress path and above the doors must be corrected.

Civic Center Arena Locked Doors

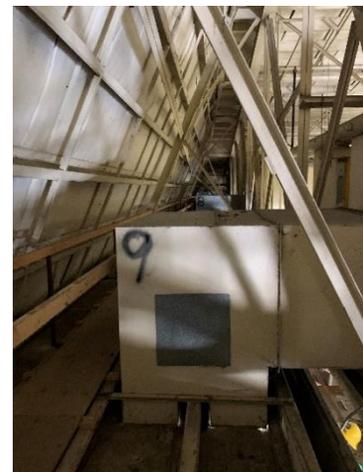
Also at the Civic Center, the path for access and maintenance of each of the 12 large HVAC air handlers is unsafe. The main path lacks a railing in some locations, and from the main path one is pretty much on their own to navigate high above the arena floor into each unit.

Unguarded Access to Air
Handlers
