LEE COUNTY COASTAL STUDY

VOLUME II. TECHNICAL REPORTS AND APPENDICES

FEBRUARY, 1988

"Evaluation of the Lee County Barrier-Island Coastline: Dominant Processes, Shoreline Trends, Past Stabilization Efforts, and Recommendations for Beach Management." (Including Appendices A-G) Albert C. Hine. 1987.

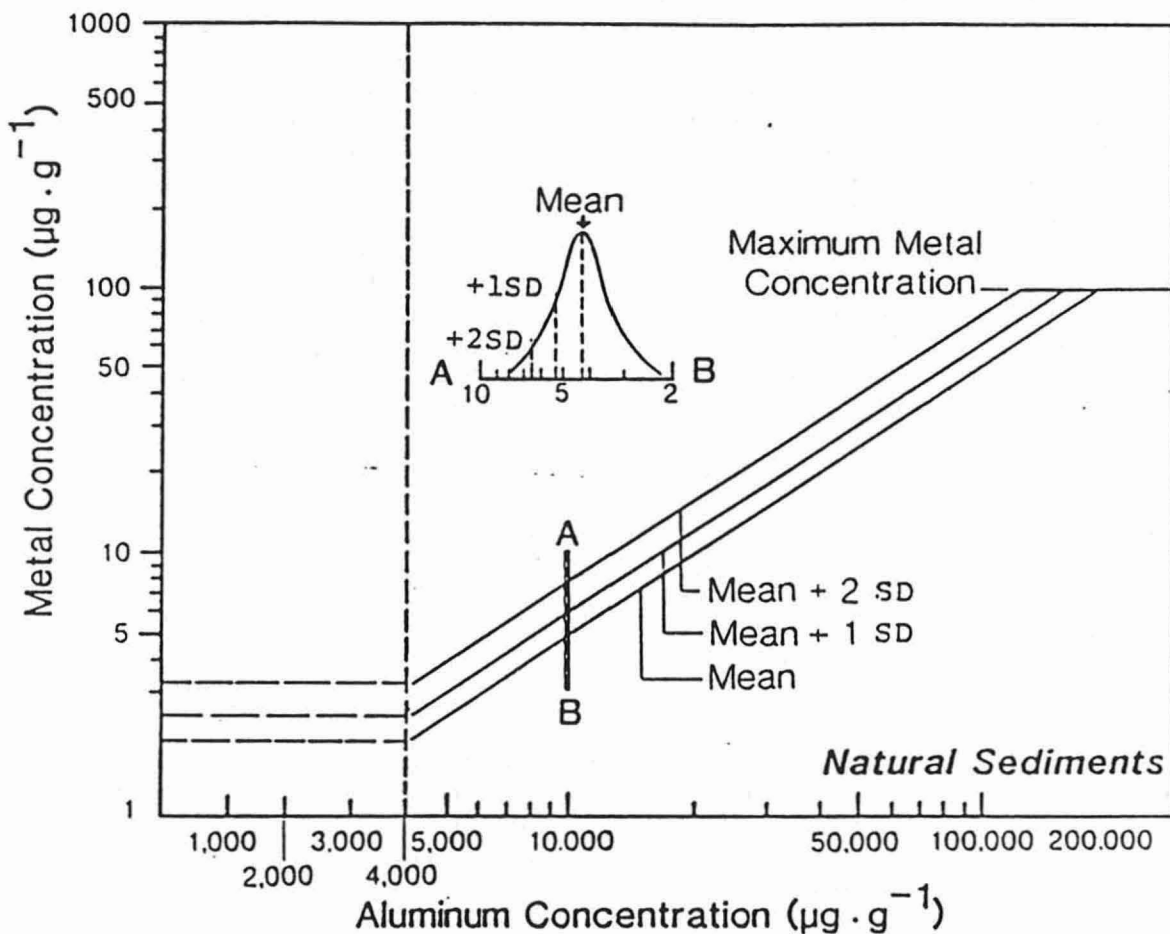
OCM Hypothetical Metal-Aluminum Distribution Graph

Hypothetical metal-aluminum graph showing calculated mean and standard deviations. The graph can be used to interpret absolute concentrations of a hypothetical metal at different aluminum concentrations. The line AB depicts the mean, and plus one and two standard deviations (SD) for the metal at 10,000 ppm aluminum. The horizontal line at the right side of the graph represents the highest metal concentration observed in clean sediments.

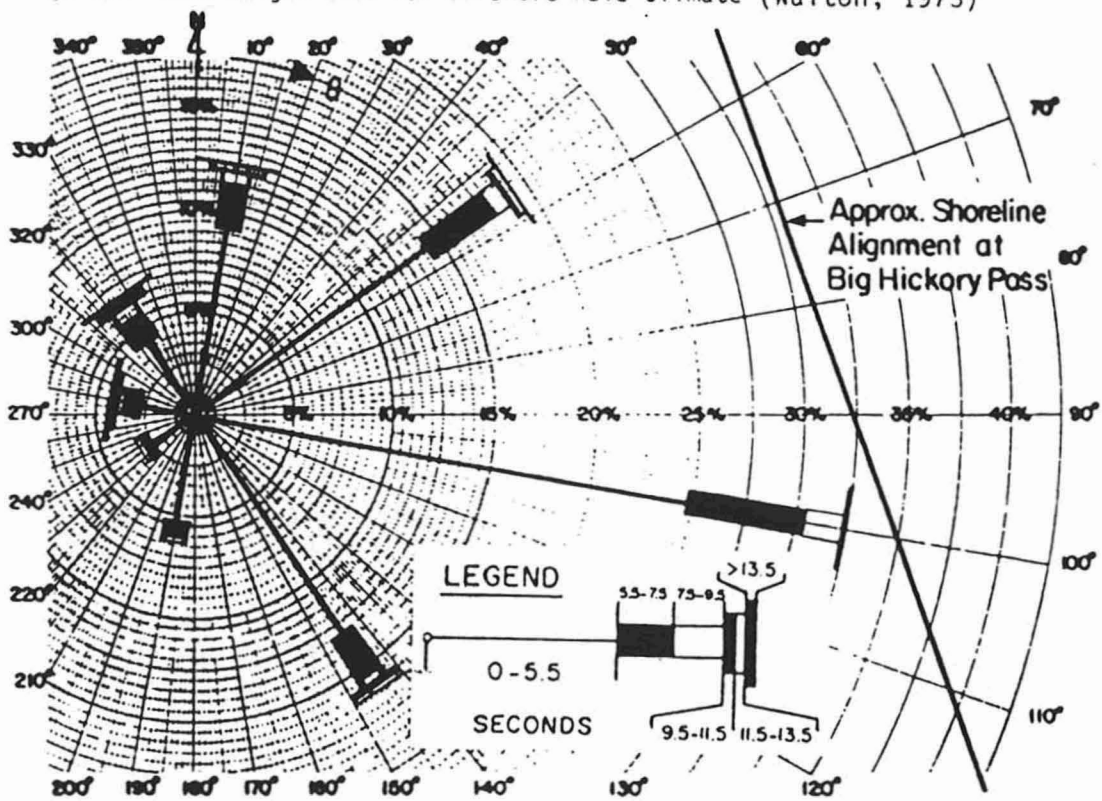
Figure 2. Wave energy diagrams for Lee County. Note that most of the onshore wave energy is from the NW (Walton, 1973).

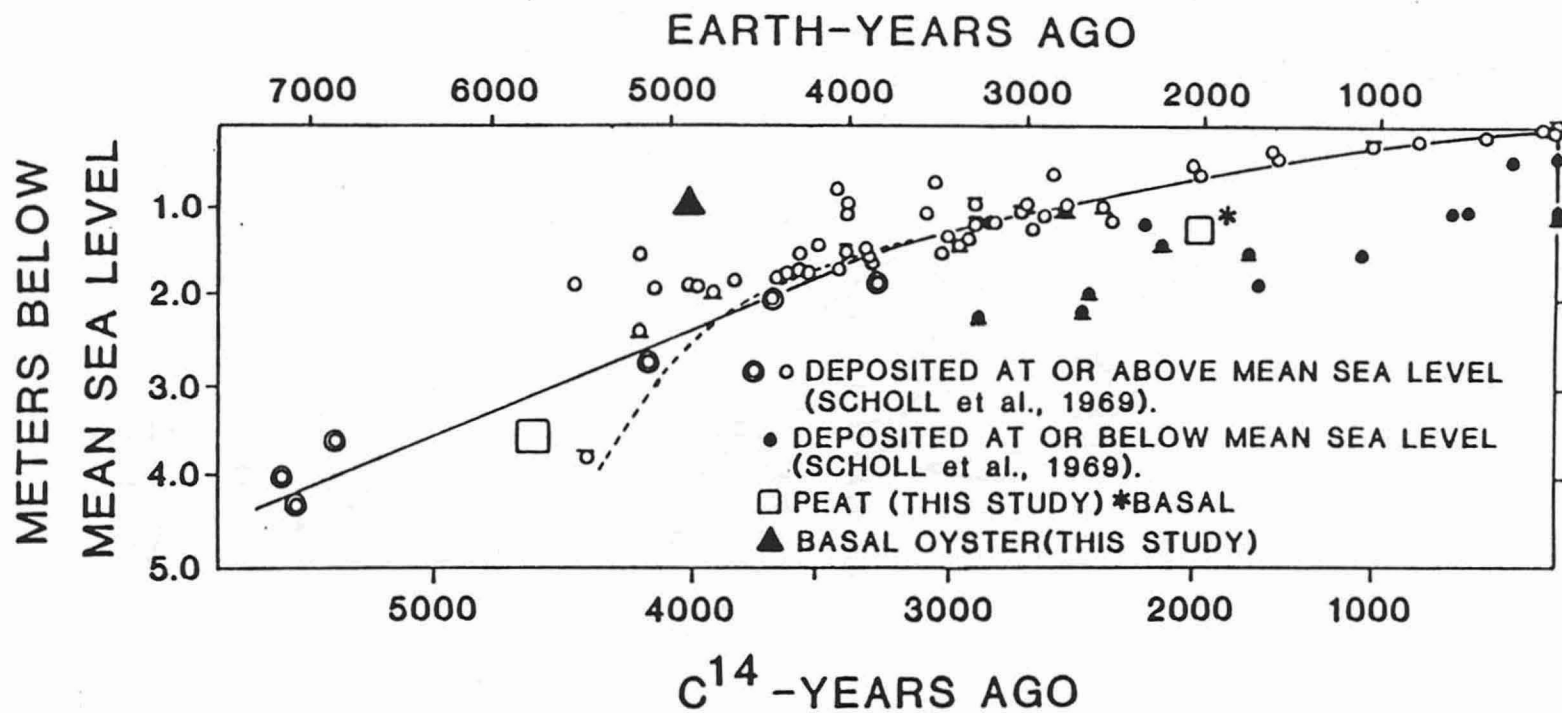
Figure 4. Sea Level curve extending back 7,000 years in time (based upon radiocarbon dating techniques; Hine and Belknap, 1986).

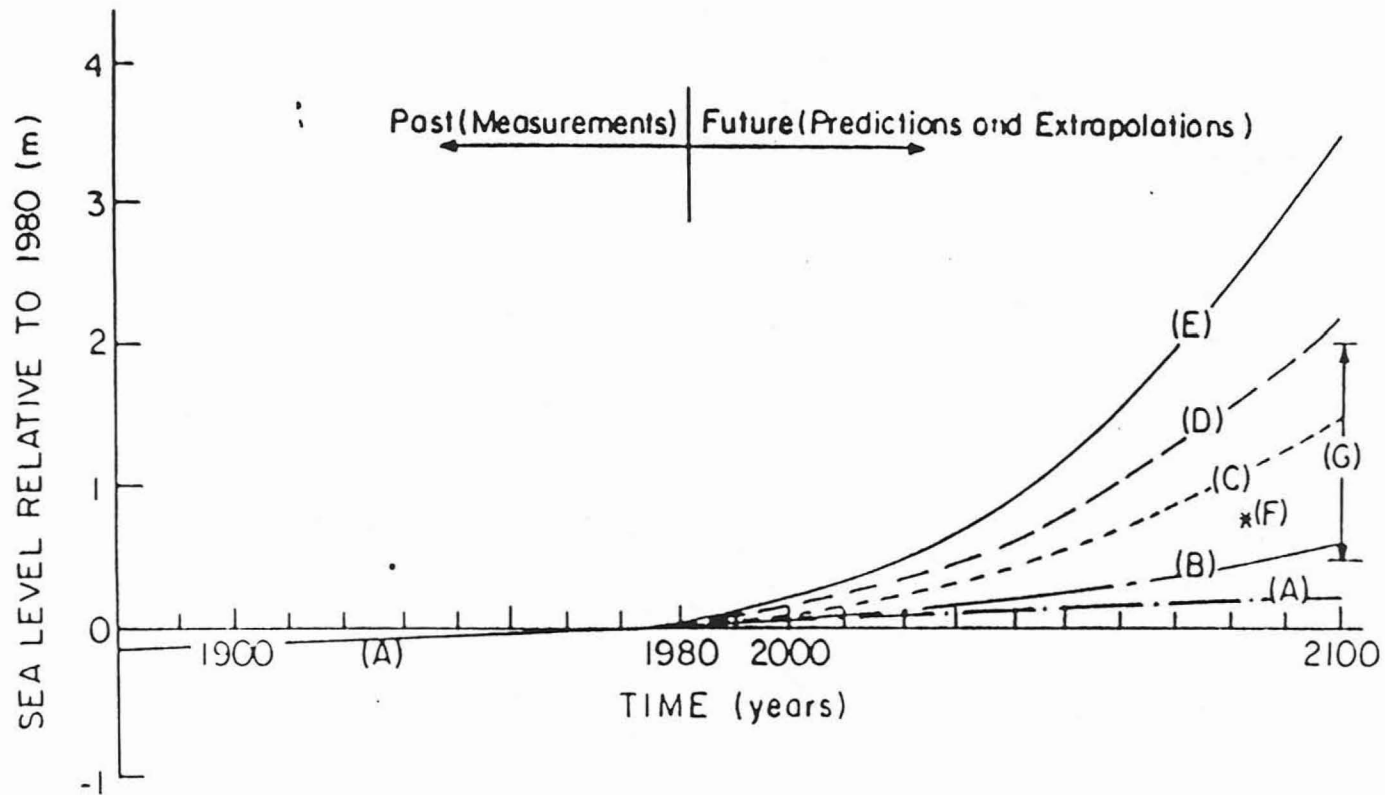
Figure 5B. Eustatic Sea Level Rise. (A) Rate Over Last century or so and Projected into Future. (B), (C), (D) AND (E): EPA 1984 Estimates for Conservative, Mid-Range Low, Mid-Range High and High, Respectively. (F) Revelle Estimate. (G) Polar Research Board Augmented with Revelle Estimate for Thermal Expansion.

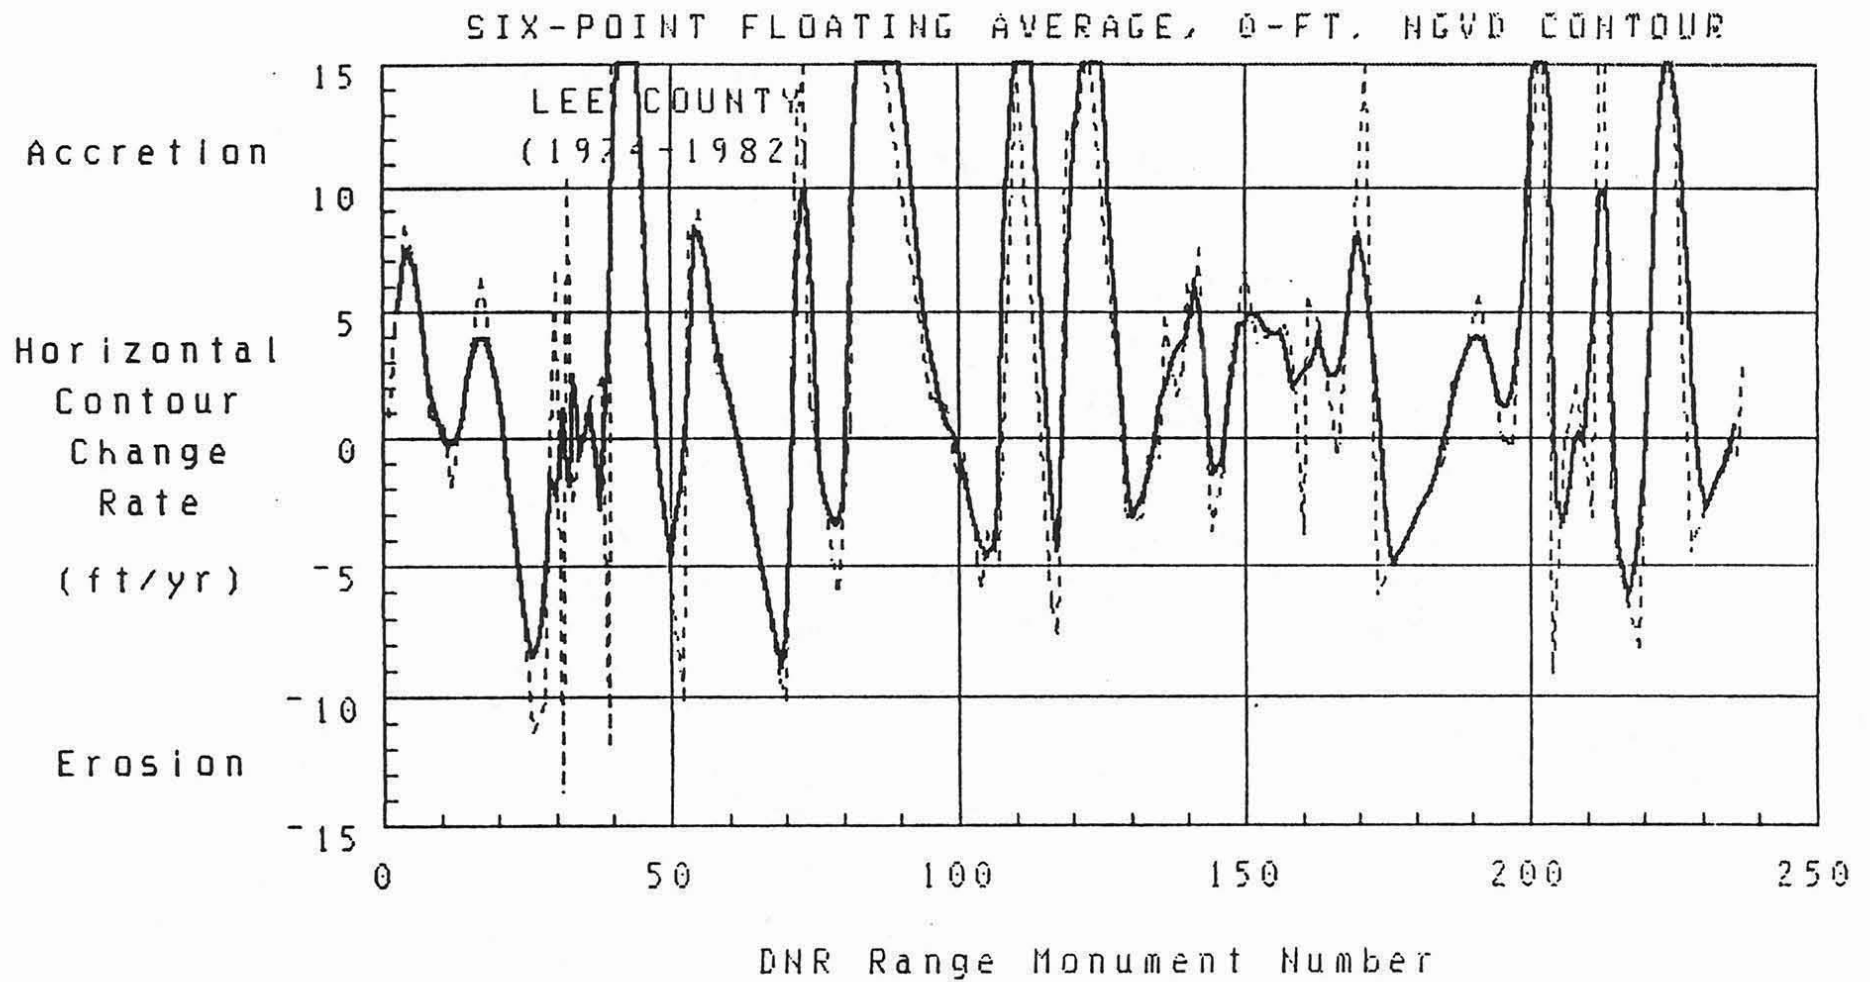
Figure 13. Lateral shoreline movement trend (0' contour) from 1974-1982 based upon beach profile data collected by Florida Division of Beaches and Shores (courtesy of Jim Balsille).

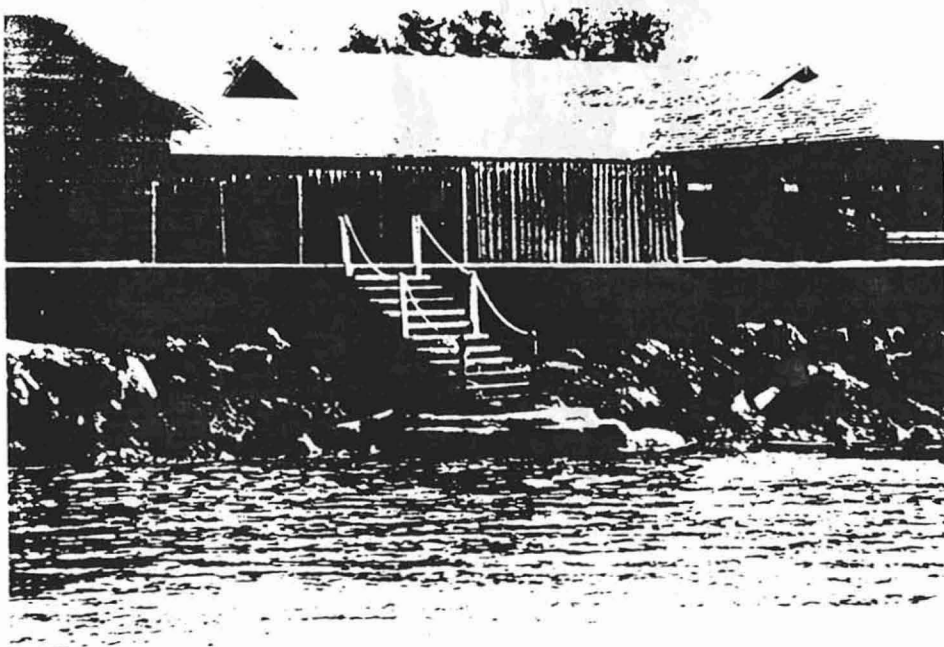
Figure 21A. Aerial photo of southern Gasparilla Island looking south illustrating erosional nature of island. Figs. 21B,C. Continuous seawalls with no beach along central portions of Gasparilla.

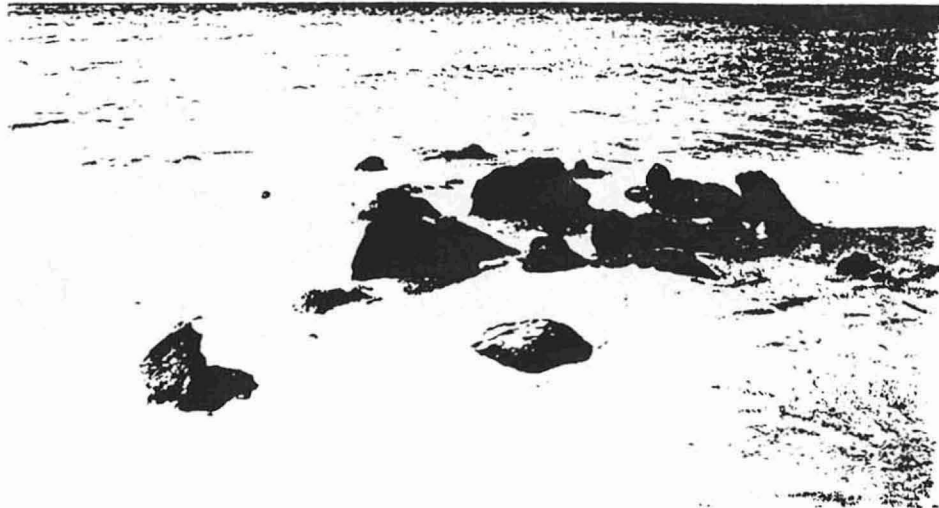
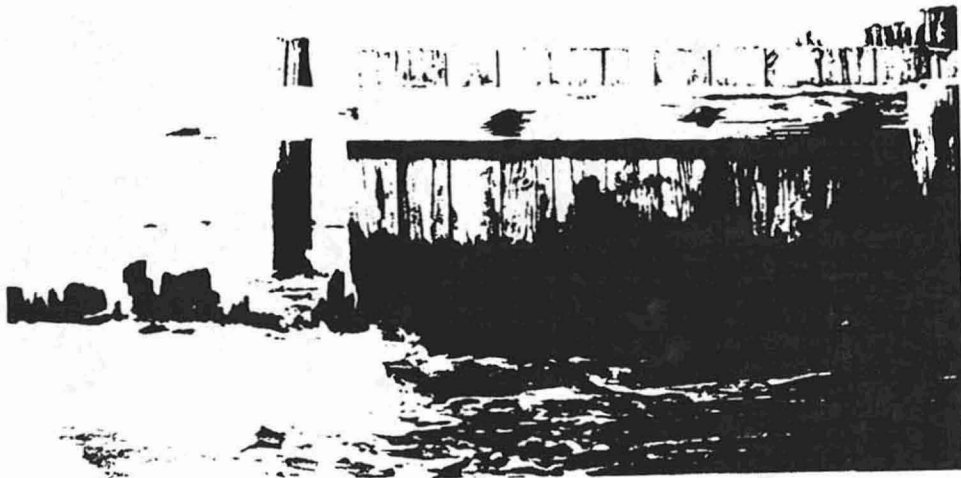
Figure 22C. Unmaintained boulder groin along southern Gasparilla. Fig. 22D. Unmaintained wooded groin along central Gasparilla.

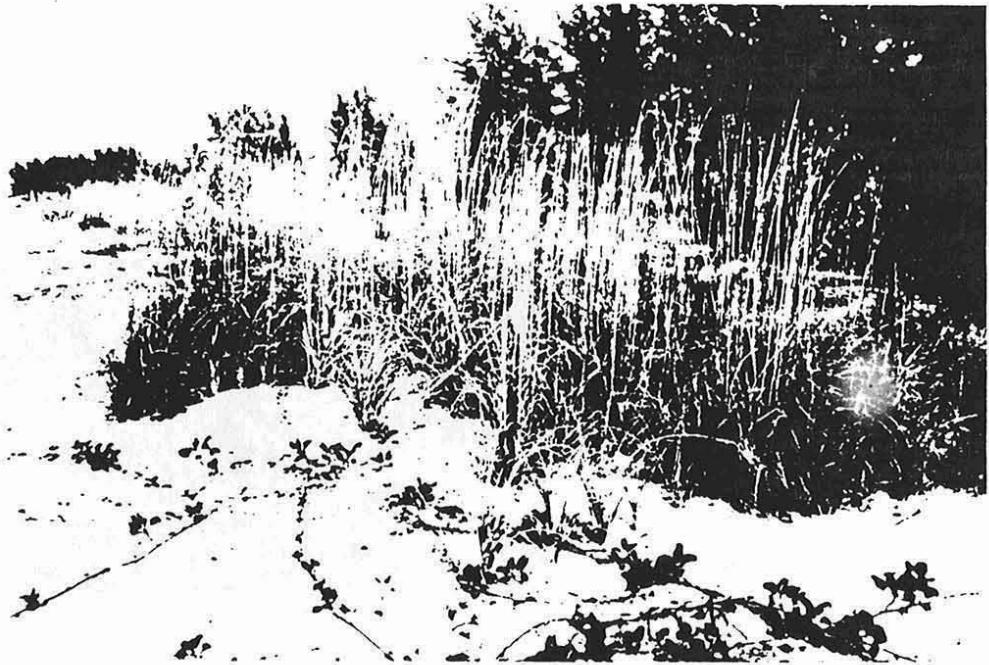
Figure 23A. Trees undermined by erosion along north end of Cayo Costa Island. Fig. 23B. Newly forming sand dune along central portion of Cayo Costa.

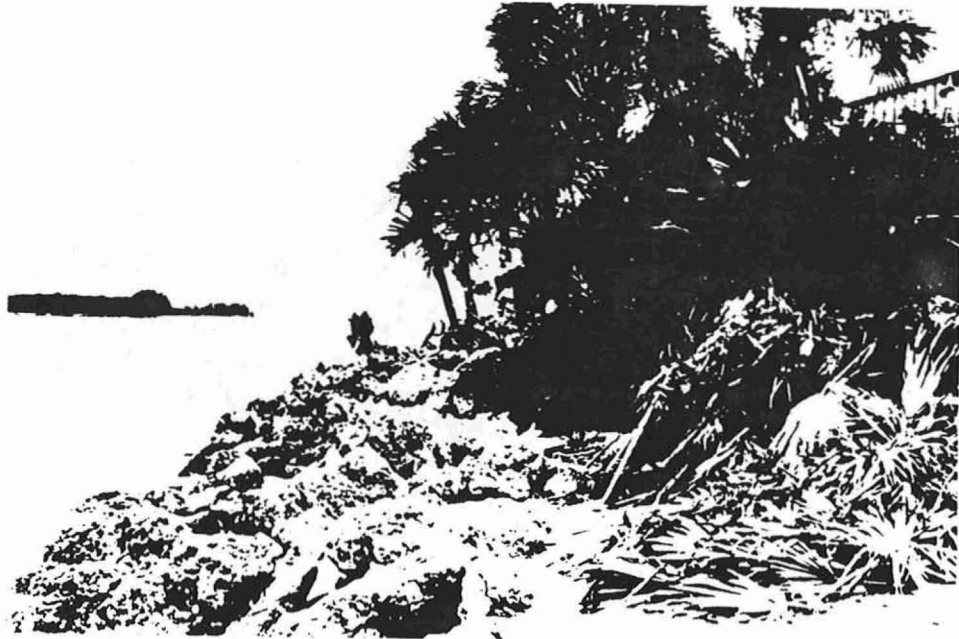
Figure 24A. Boulder revetment (rip rap) along northern North Captiva Island attempting to stem erosion. Fig. 24B. Homemade coastal engineering along northern North Captiva.

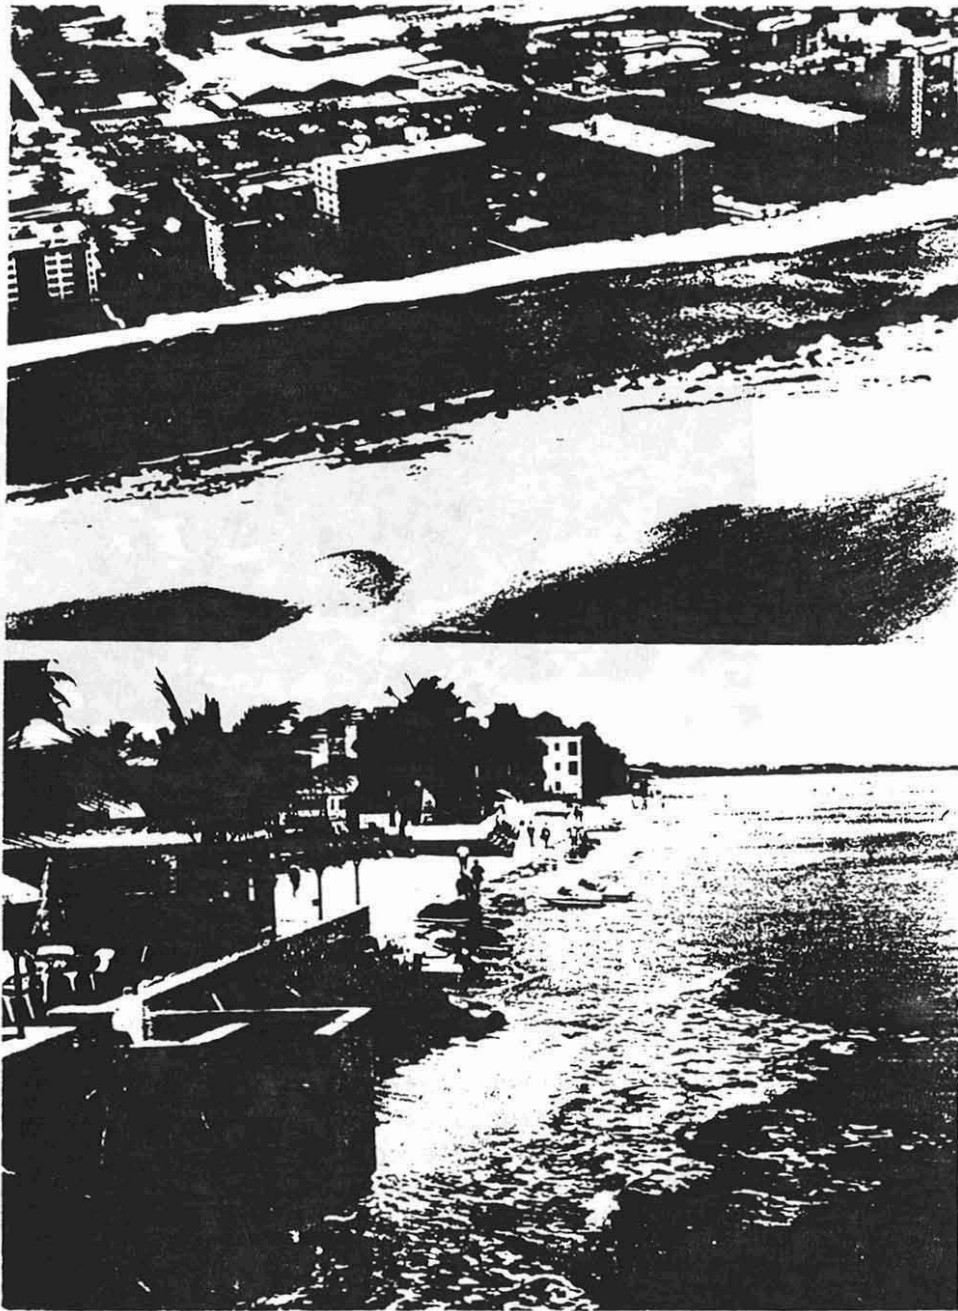
Figure 26A. Incipient barrier-island system located just offshore of southern Estero Island. Fig. 26B. Variety of coastal engineering structures near fishing pier on Estero. Note narrow character of beach.

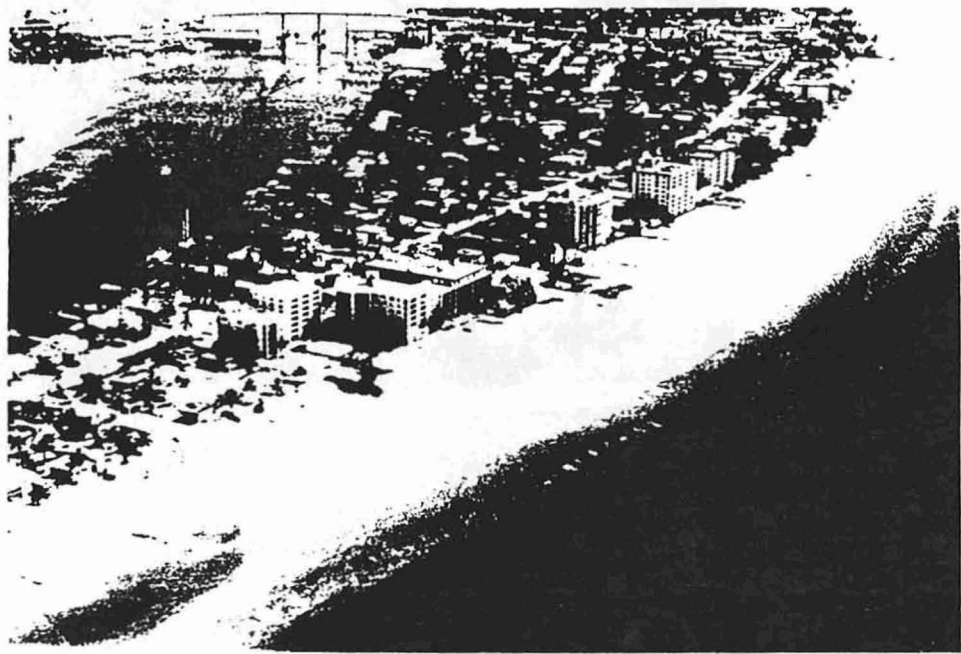
Figure 26C. New development along extreme south end of Estero Island. No beach exists where seawalls have been constructed. Fig. 26D. Partially renourished beach along NW end of Estero.
