LeeTran

# Bus Stop Accessibility Study and Transition Plan

July 29, 2022

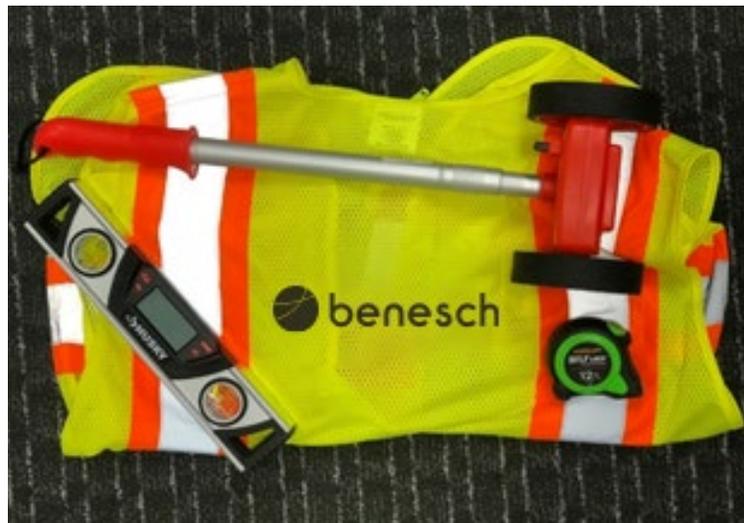
**Figure 2.1: Field Data Collection Equipment**

Primary equipment used by each surveyor to conduct the inventory are illustrated in **Figure 2.1** and includes:

- Mobile tablet or smartphone
- Smart level
- Measuring wheel
- Tape measure
- Safety vest

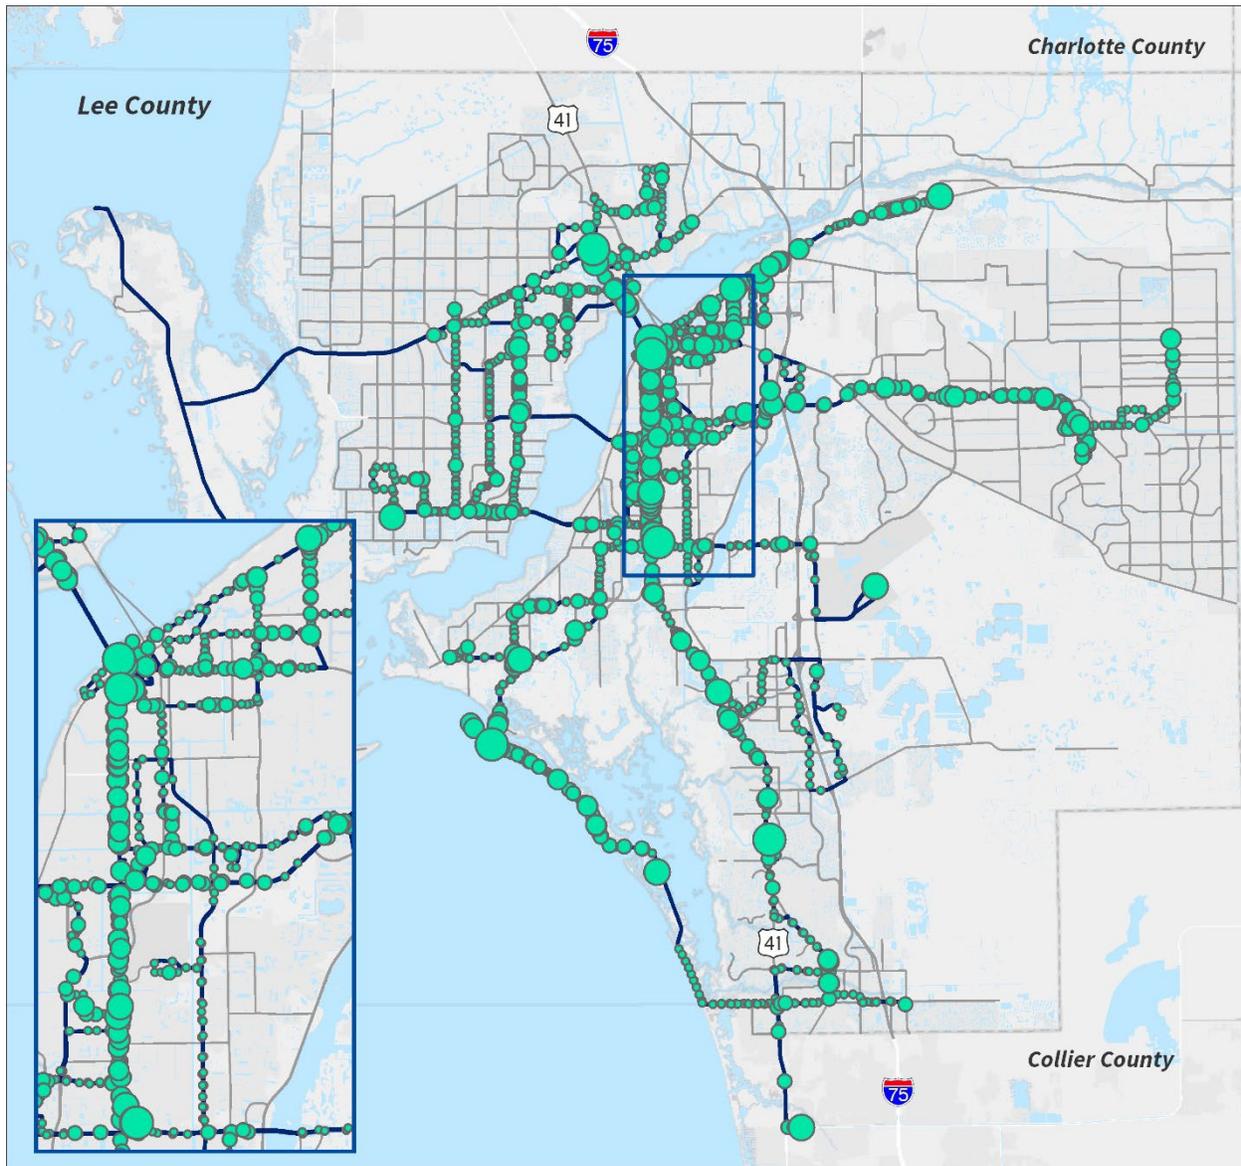
**Map 2-1: Fiscal Year 2019 Ridership Levels (Entire Service Area)**

**Map 2-1** illustrates bus stop activity for LeeTran's entire service area (Fiscal Year 2019). **Map 2-2** illustrates bus stop activity at LeeTran's transfer center for the entire service area.

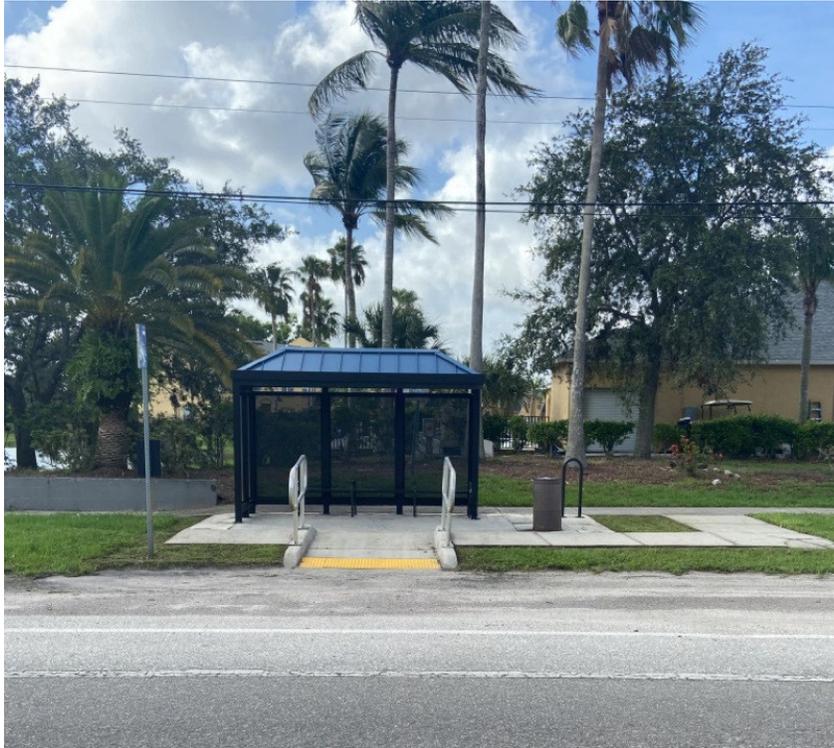
**Figure 3.1: Handrails and Detectable Warning Present at Bus Stop #10019**

- It was noted during the field assessment that detectable warnings and handrails were located at B&A areas. ADAAG does not require these elements at a B&A area, and their presence may be confusing to a patron with disabilities.

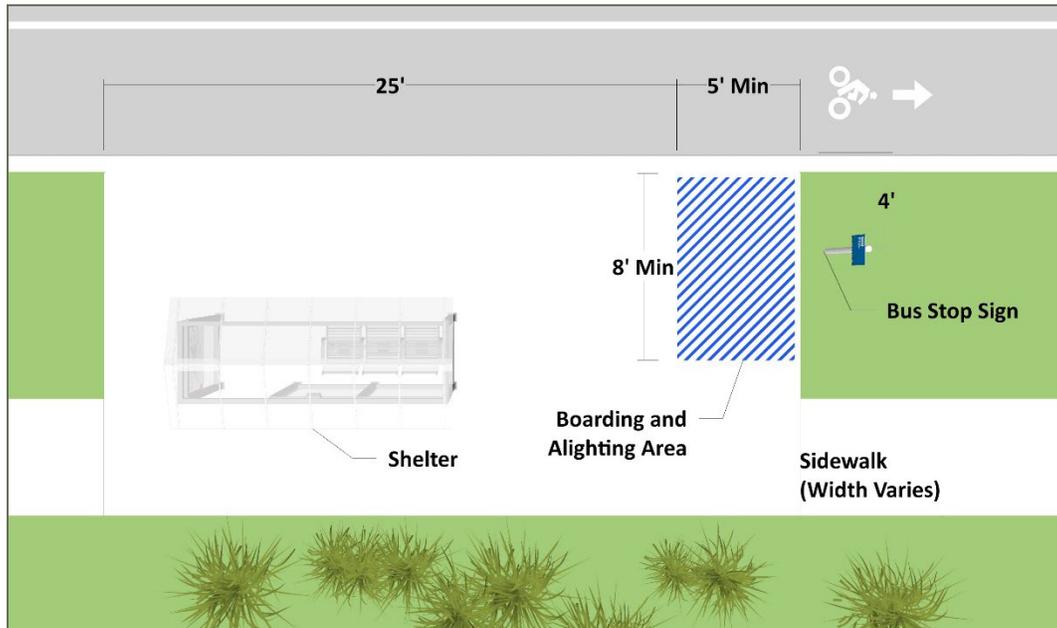
**Figure 3.2: Layout of B&A Area and Standards (Urban Bus Stop)**

Figure 3.1 illustrates some of these standards in the context of an urban bus stop with a continuous curb, Figure 3.2 illustrates the layout of these standards in the context of a suburban bus stop, and Figure 3.3 illustrates the layout of these standards in the context of a rural bus stop.

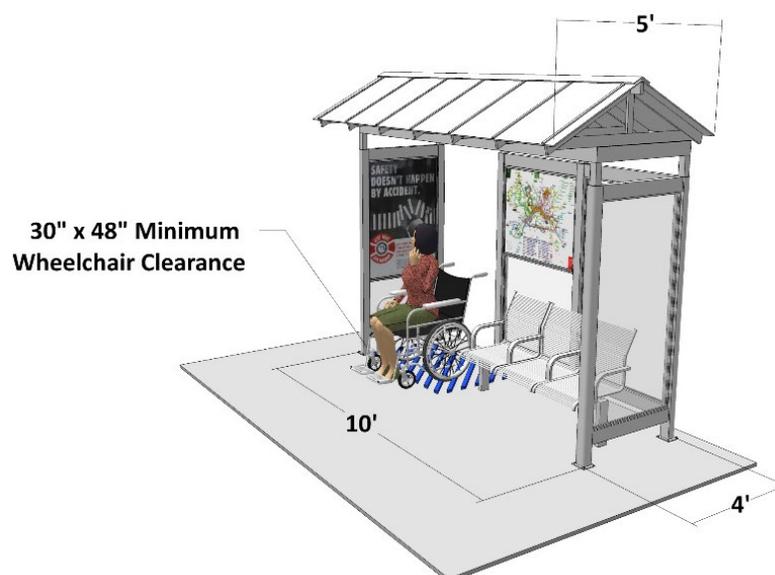
**Figure 3.6: Bus Shelter Typical Dimensions**

Figure 3.6 illustrates the typical dimensions of a bus shelter, including required wheelchair clearance space.

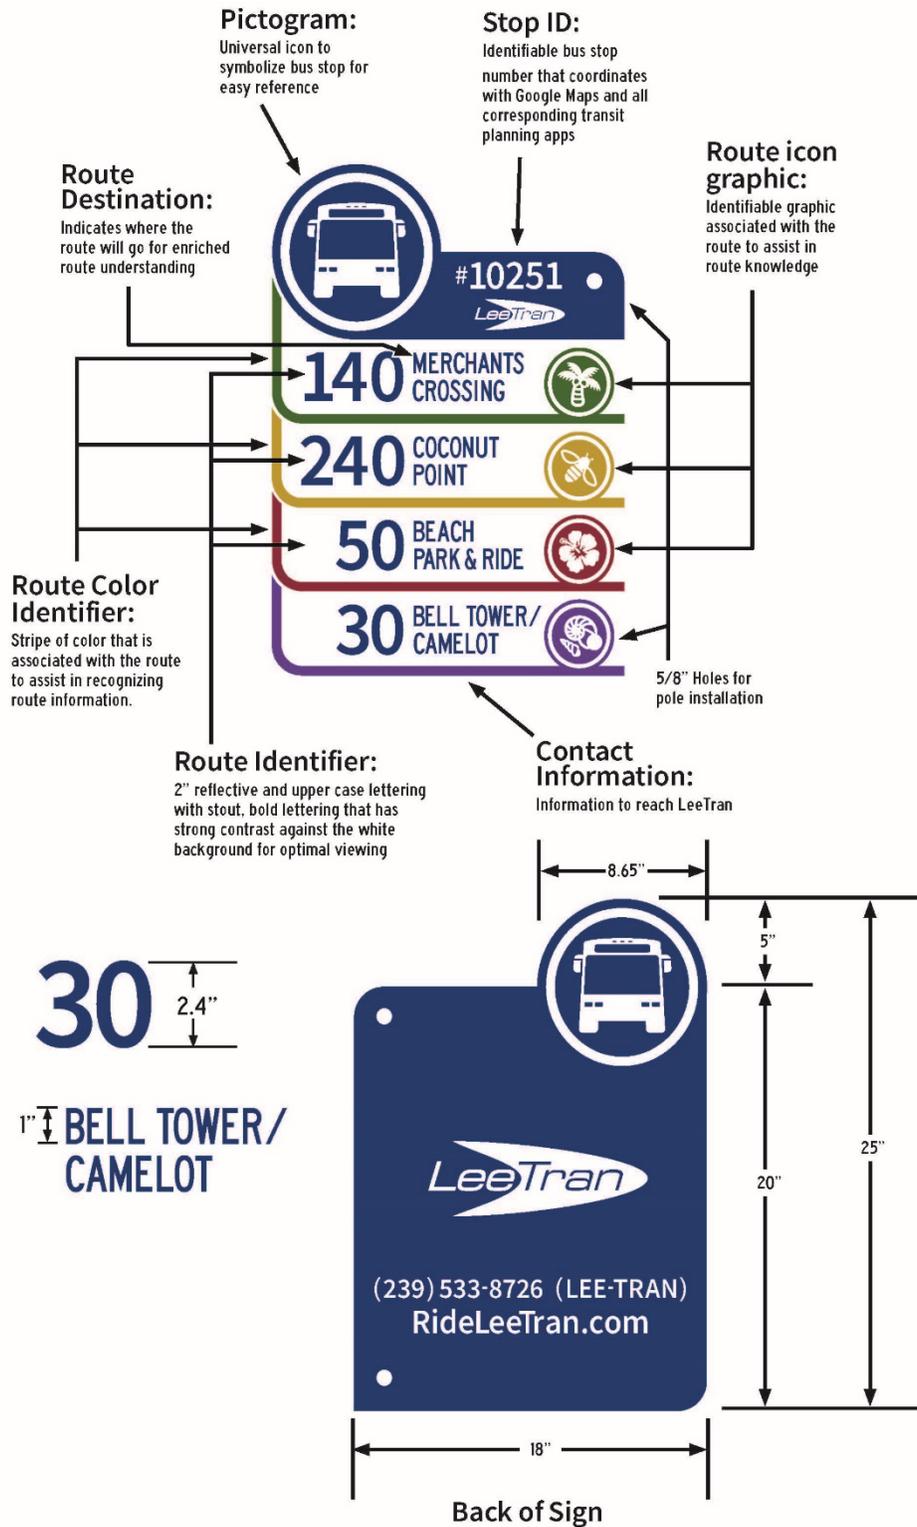
**Figure 3.7: ADA-Compliant LeeTran Bus Stop Sign**

The LeeTran bus stop sign shown in **Figure 3.7** meets these requirements. All bus stops that require updated or relocated signage because of this study must meet applicable ADA requirements.

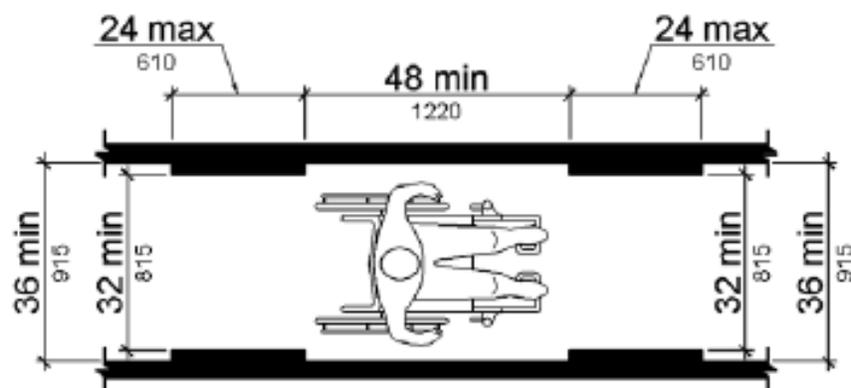
**Figure 3.8: Clear Width of an Accessible Route**

Figure 3.6 illustrates the standards for providing a clear width of an accessible route.

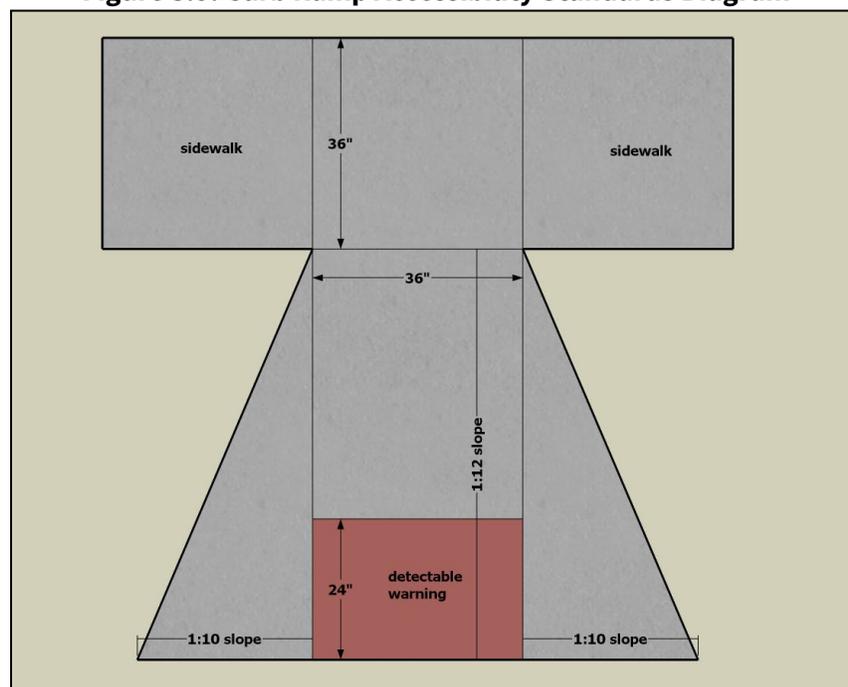
**Figure 3.9: Curb Ramp Accessibility Standards Diagram**

Figure 3.9 illustrates a number of these standards.

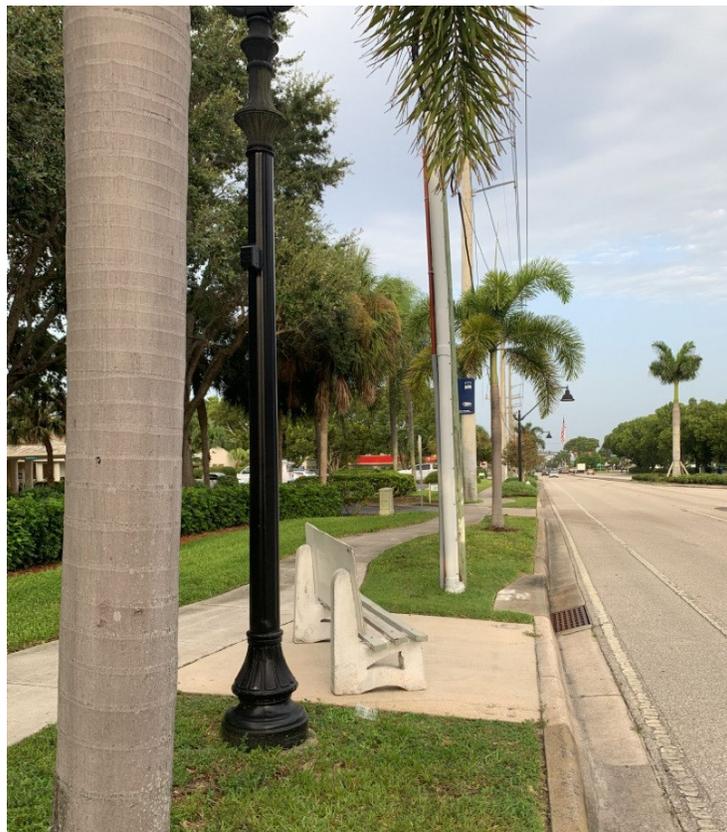
**Figure 3.10: Example LeeTran Boarding and Alighting Area Obstruction**

**Figure 3.10** illustrates an example obstruction observed during the field data collection effort where a bench is obstructing the boarding and alighting area. This obstruction greatly decreases the accessibility of the bus stop and poses a safety concern for patrons with disability.

The modification or removal of third-party amenities is not LeeTran’s responsibility; however, having non-compliant amenities/infrastructure associated with LeeTran’s bus stops could cause issues, and, as such, it is recommended that they be remediated. As previously noted, bus stops that serve more than one route are required to have signs that display the bus routes that serve that stop. Although this attribute was not assessed for all bus stops, in locations where bus route identification signs are missing, they should be (re)mounted.

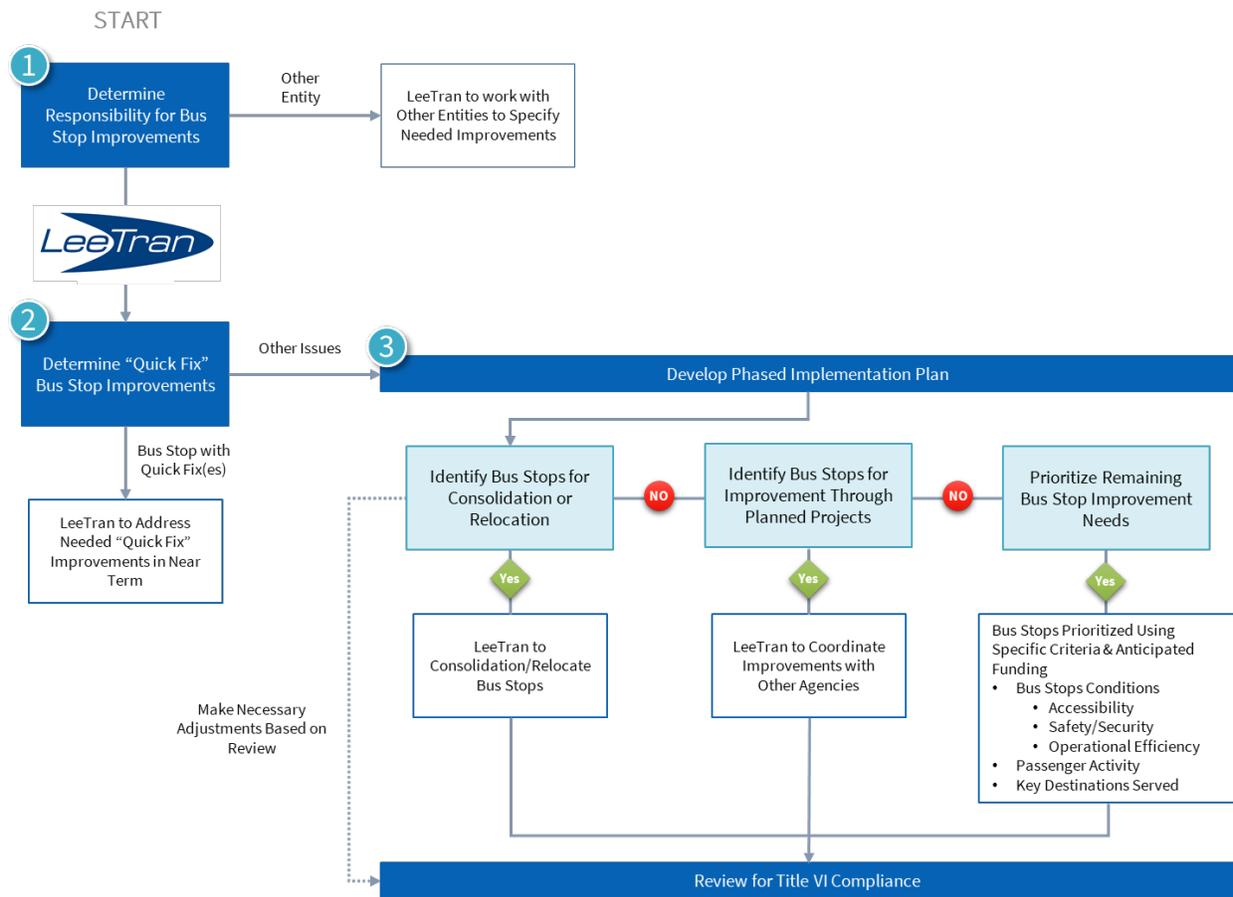
**Figure 4.1: Bus Stop Accessibility Implementation Plan Process**

**Figure 4.1** illustrates the step-by-step process used to prioritize bus stop improvements to be included in the phased implementation plan. The steps are discussed in the remainder of this section.

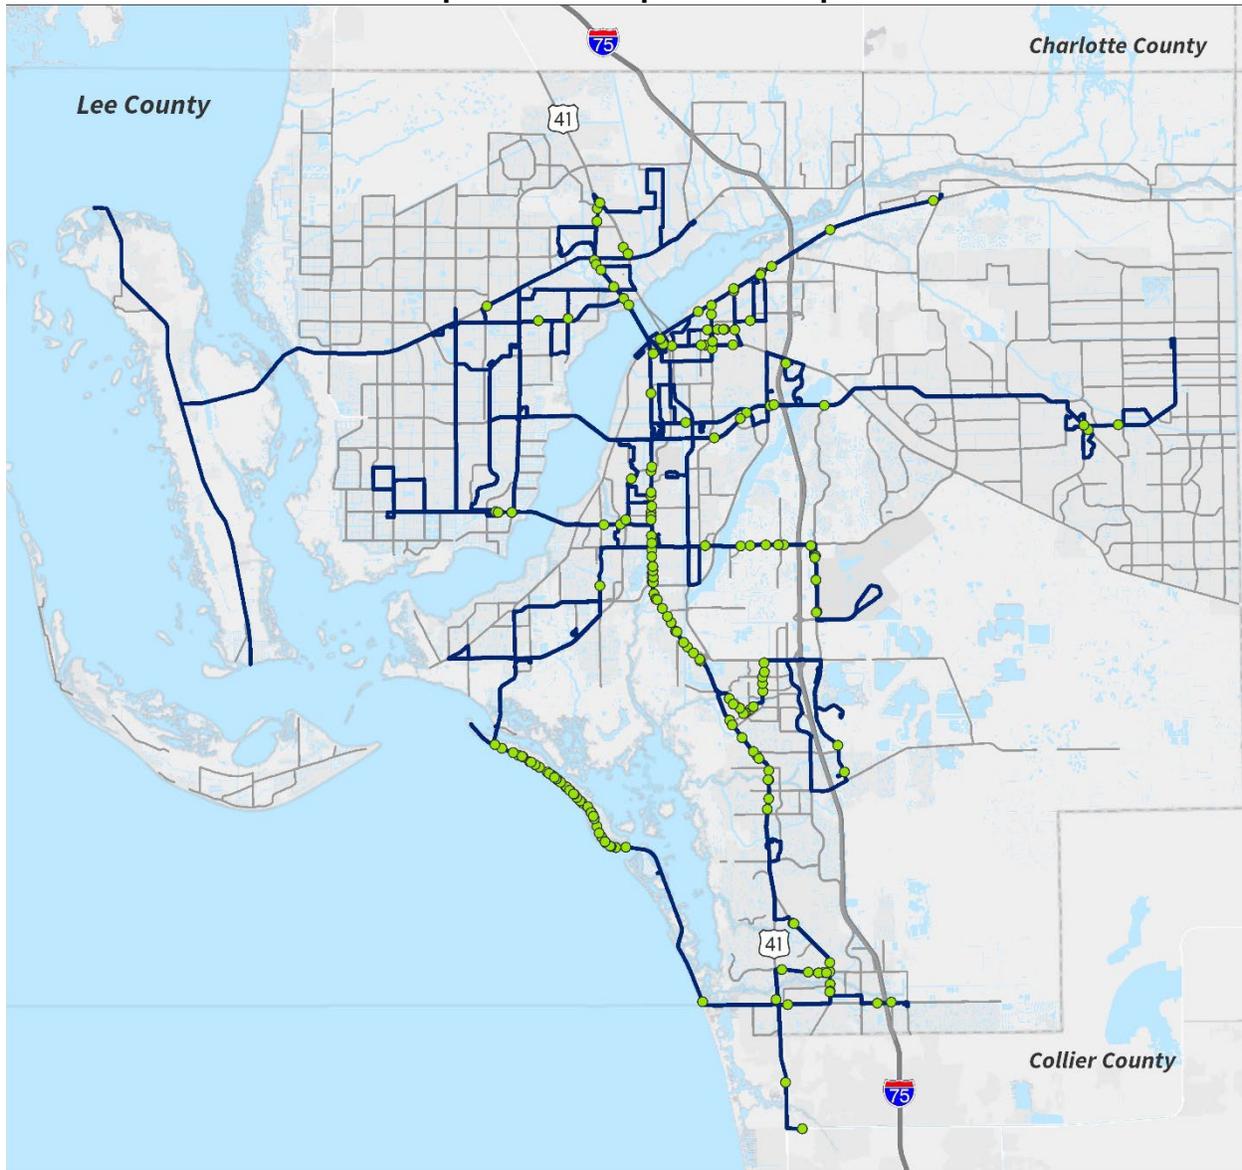
Map 5-1: ADA-Compliant Bus Stops

As shown in **Table 5-4** and **Map 5-1**, a total of 201 bus stops and their adjacent routes were found to be ADA-compliant. The B&A area, signage, and amenities were found to be accessible at additional bus stops; however, in some cases, barriers to accessibility were found in the connecting pedestrian infrastructure, thereby classifying the entire stop as non-compliant. It is important to note, as described in Section 4, that the mitigation of these barriers to accessibility are not fully the responsibility of LeeTran.
