BLIND PASS MAINTENANCE DREDGING PROJECT 2018 FIRST YEAR MONITORING REPORT

> September 4, 2018 CEC File No. 18.030

BLIND PASS, SANIBEL-CAPTIVA LEE COUNTY, FLORIDA 2018 MONITORING SURVEY REPORT

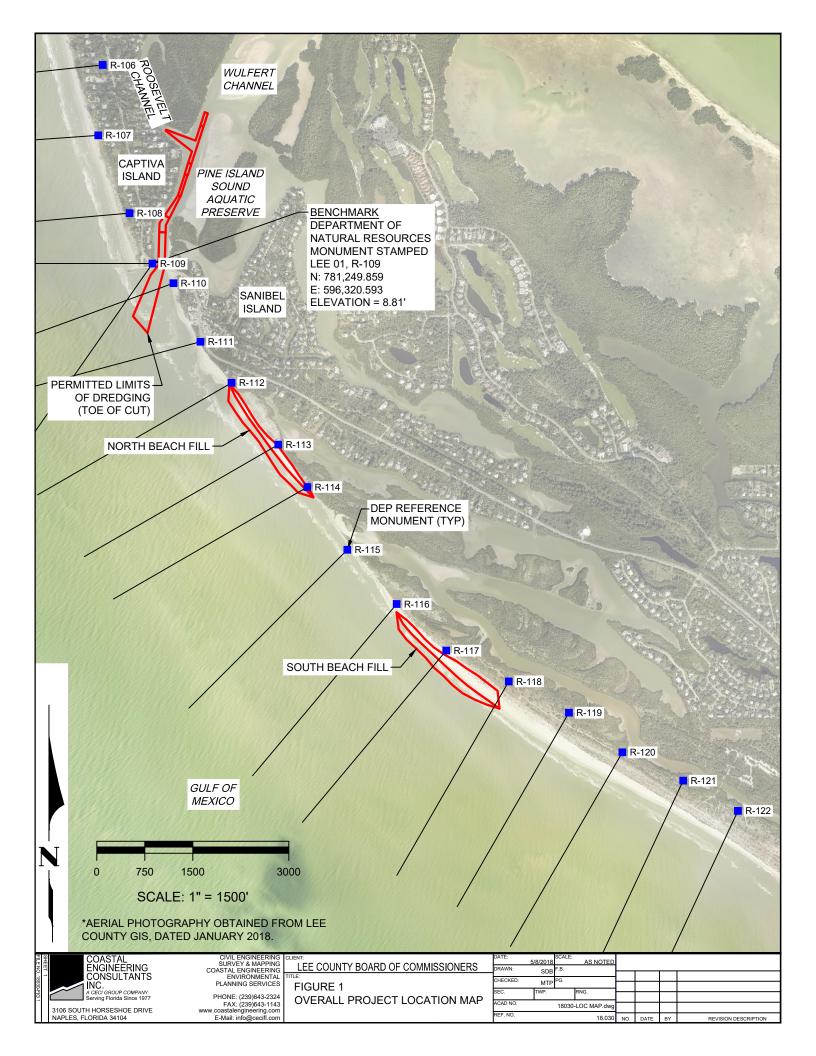
An overall location map of the project area which includes R-monument survey lines is presented in Figure 1. Figure 2 presents a location map of Blind Pass and depicts ebb shoal and dredge template survey lines.

North Beach Fill: This fill segment extended from R-112 to R-114+200 (Figure 1), within which approximately 67,060 cubic yards were placed during the 2017 construction project. The segment's shoreline measured at MHW receded on average approximately 0.6 feet. The range of shoreline change was from 39.2 feet of recession at R-113 to 38.2 feet of advancement at R-112.

South Beach Fill: This fill segment extended from R-116 to R-118 (Figure 1), within which approximately 22,640 cubic yards were placed during the 2017 construction project. The segment's shoreline measured at MHW receded on average approximately 28.1 feet. The range of shoreline change was from 98.0 feet of recession at R-116 to 29.6 feet of advancement at R-118.

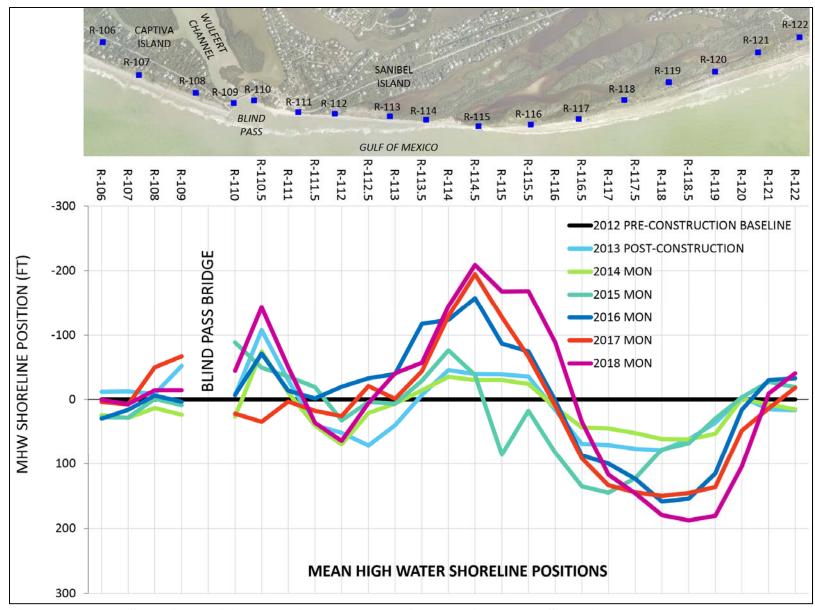
Figure 3. MHW Shoreline Positions Relative to 2012 Pre-Construction MHW Shoreline.

Figure 3 presents a schematic of the historic annual MHW shoreline positions relative to the 2012 dredging project pre-construction positions that serves as a baseline.

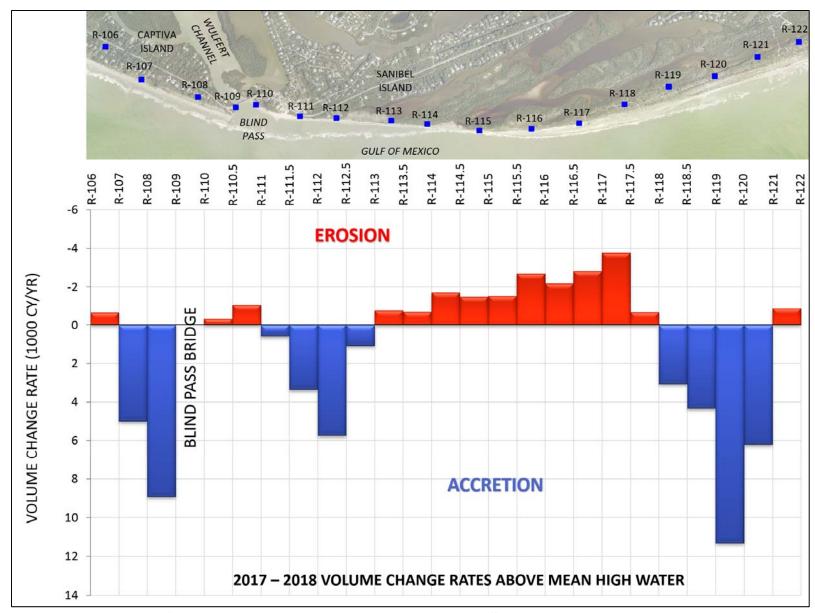
Figure 4. Volumetric Change Rates to MHW between 2017 and 2018 Surveys.

Figures 4 and 5 present bar charts of the 2017-2018 volumetric change rates to MHW and DOC, respectively, noting that they were annualized to be consistent with prior years' monitoring reports.

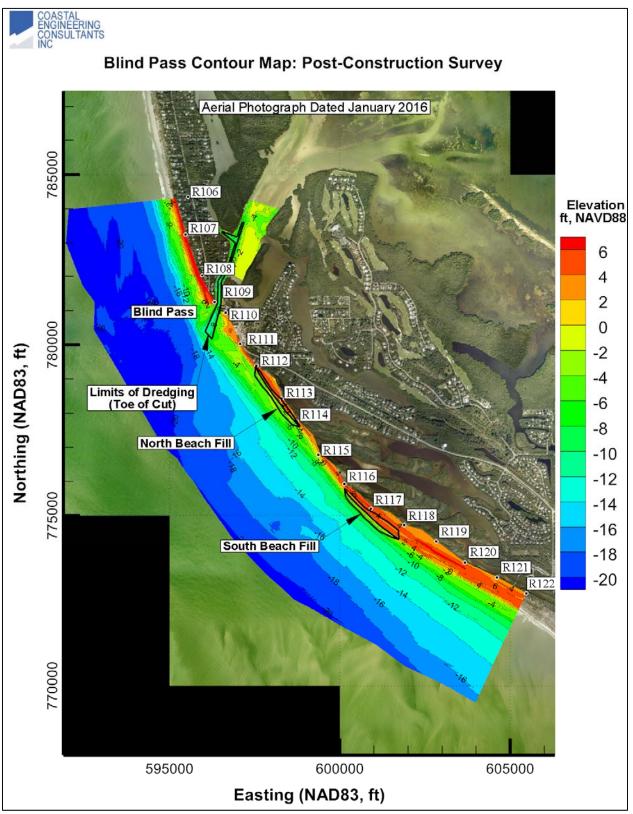
Figure 6. 2017 Post-construction Survey Contour Map.

Figures 6 and 7 present contour maps based on the 2017 post-construction and 2018 monitoring survey data, respectively. The figures depict the limits of dredging and fill placement.

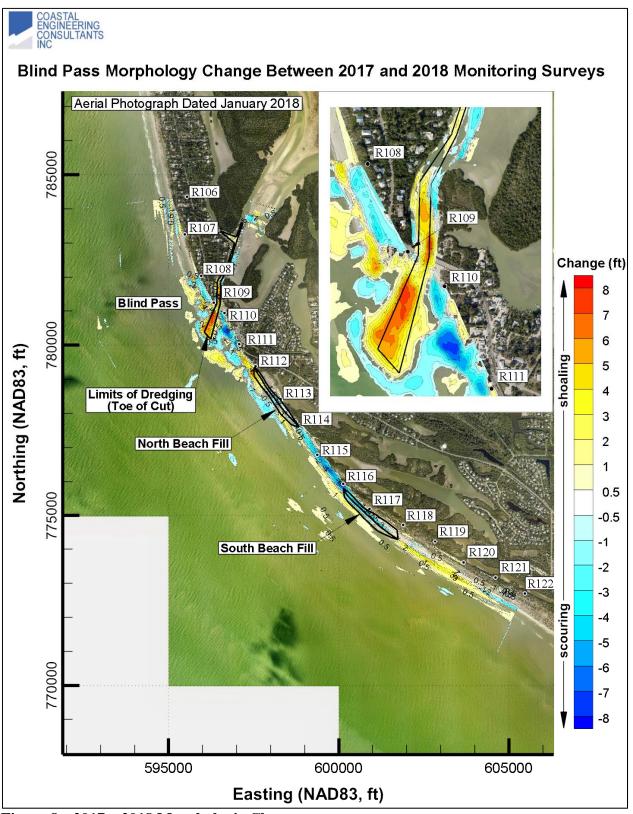
Figure 8. 2017 – 2018 Morphologic Changes.

Figure 8 presents a morphology change map depicting changes in elevations that occurred between the two surveys. It illustrates infilling of the channel dredged in 2017, nearshore erosion immediately south of the pass between R-110 and R-111, erosion between the two fill areas between R-114 and R-116, erosion within the South Beach Fill Area, and accretion between R-118 and R-121.

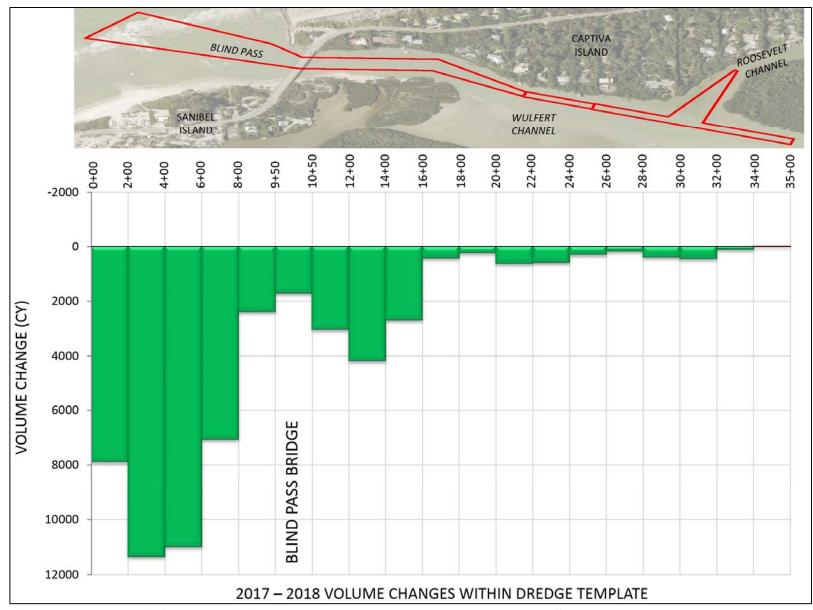
Figure 9. Volumetric Changes within Dredge Template between 2017 and 2018 Surveys.

Table 4 presents the volume change within the channel which was calculated from comparing the June 2017 post-construction and June 2018 monitoring surveys. The total volume change within the dredge template including the 1-foot tolerance indicated channel infilling and was computed to be approximately 55,680 cubic yards utilizing the 200-foot station survey lines with the addition of Stations 9+50 and 10+50 due to the presence of the bridge. For comparison, the volume of material excavated from the template during the 2017 construction project was 89,700 cubic yards.

Figure 9 presents a bar chart of the volumetric changes within the dredge template between the 2017 post-construction and 2018 monitoring surveys.

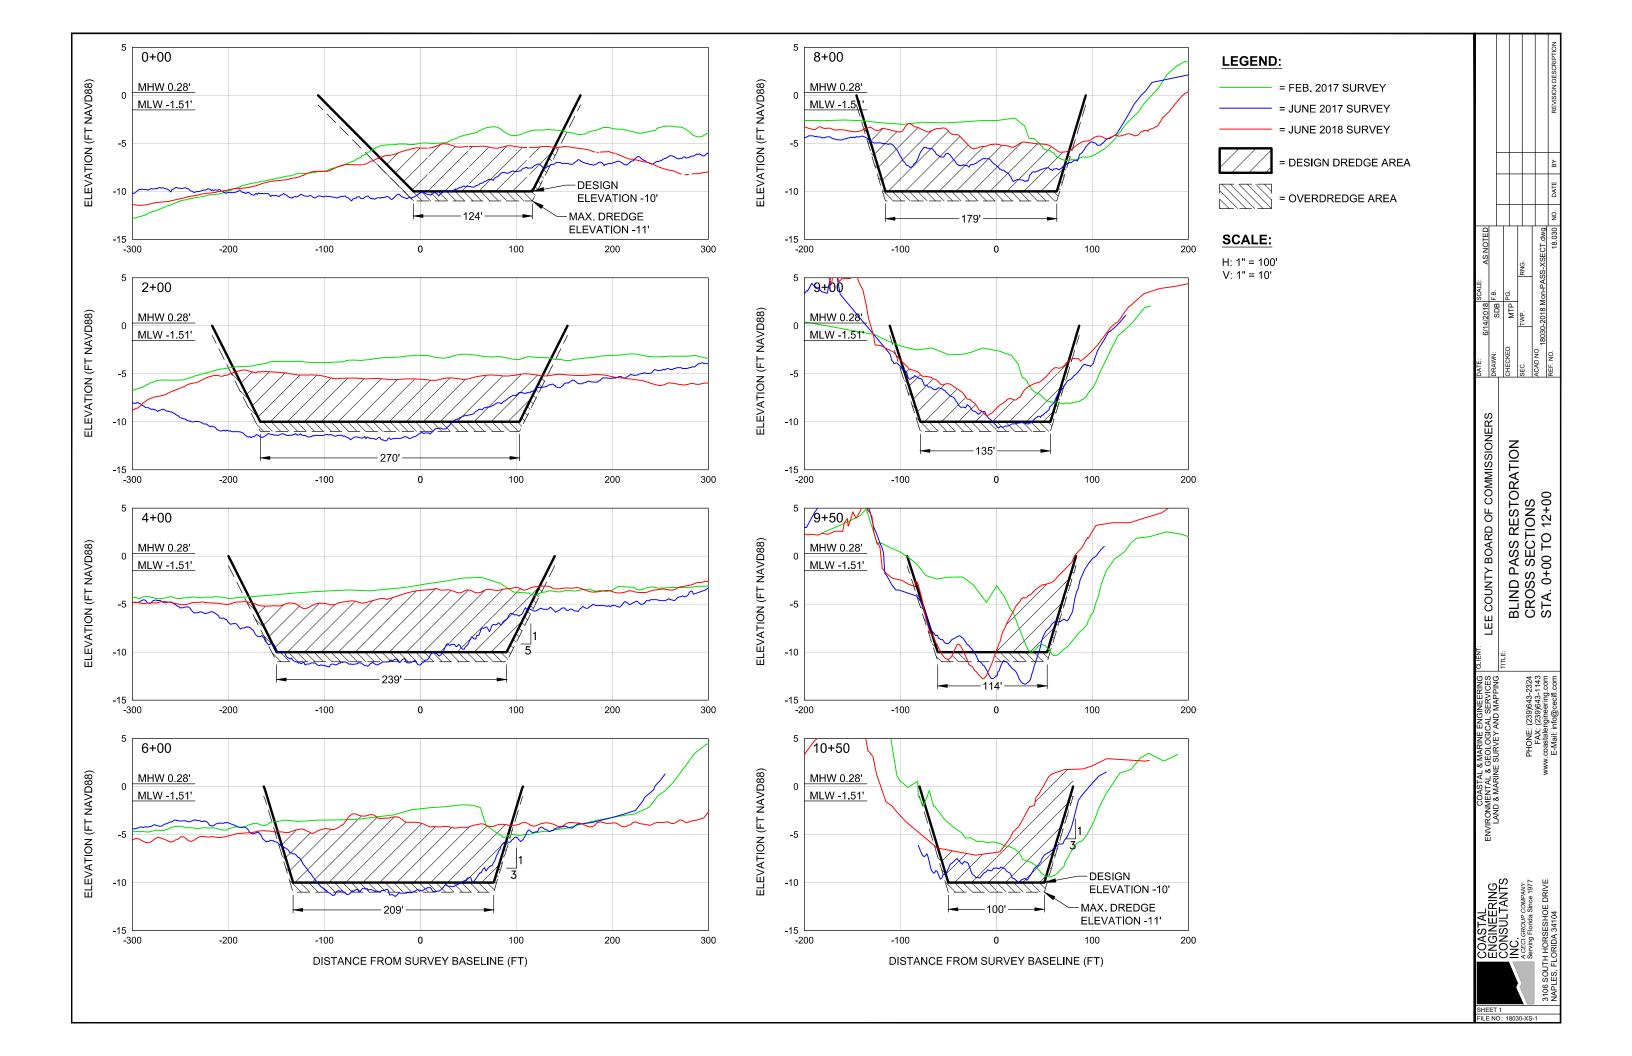
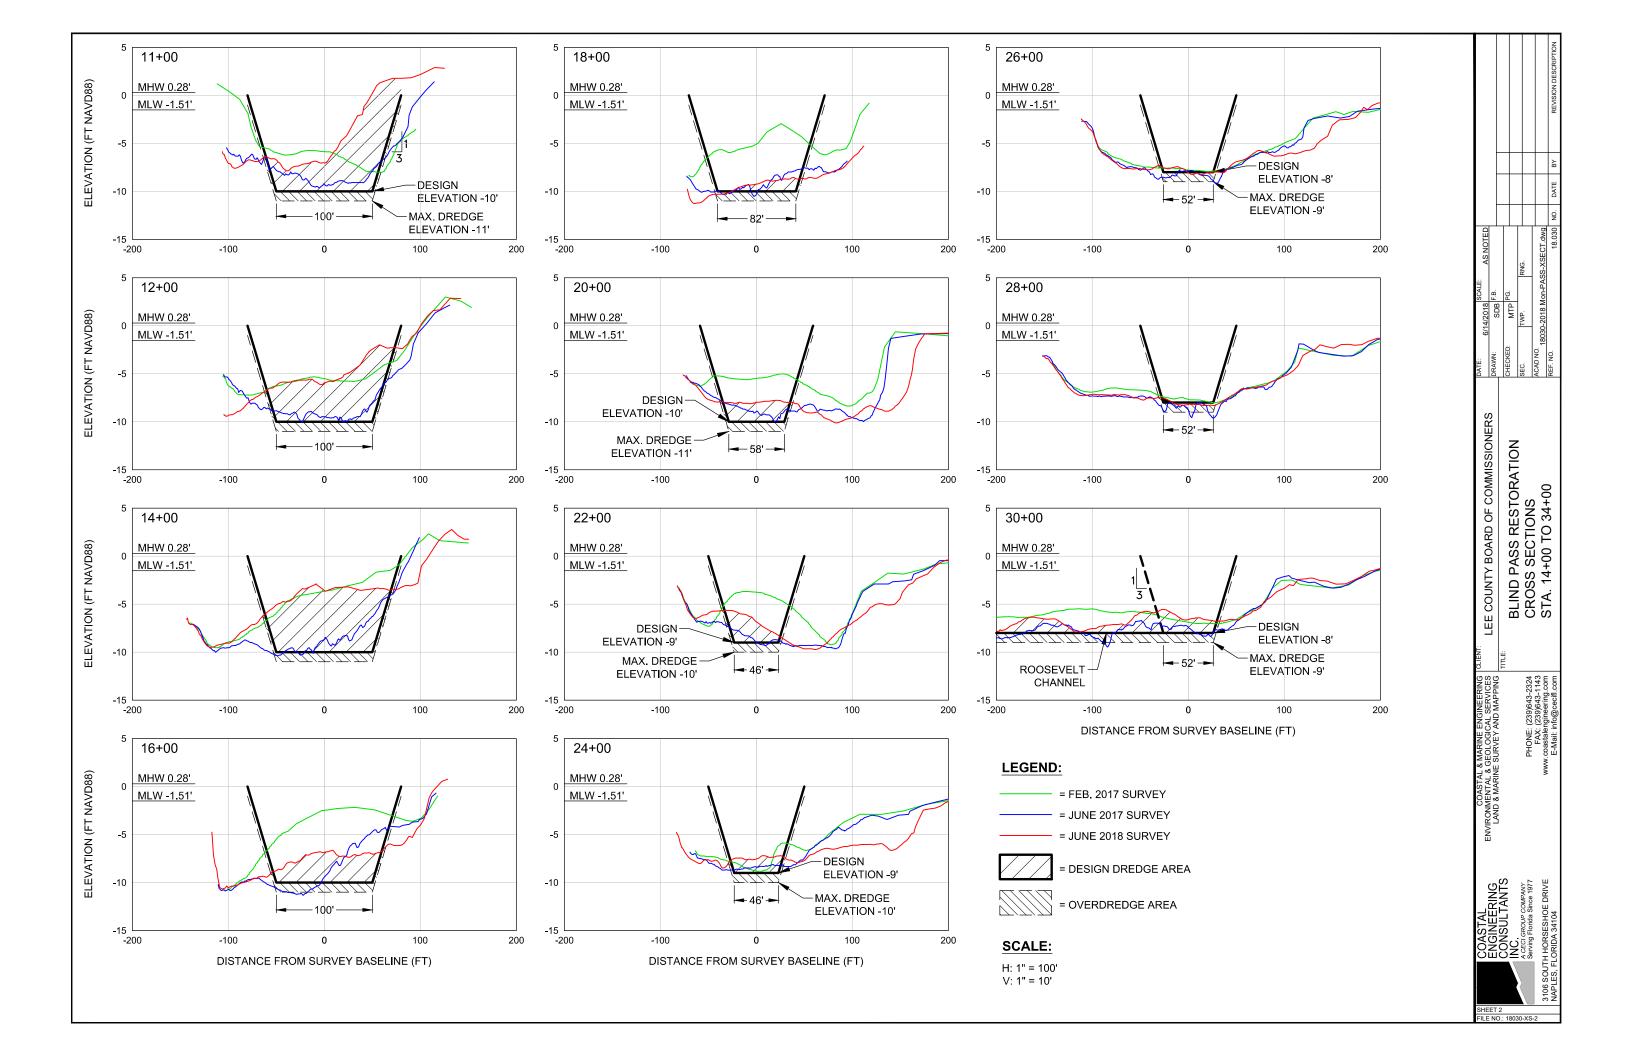
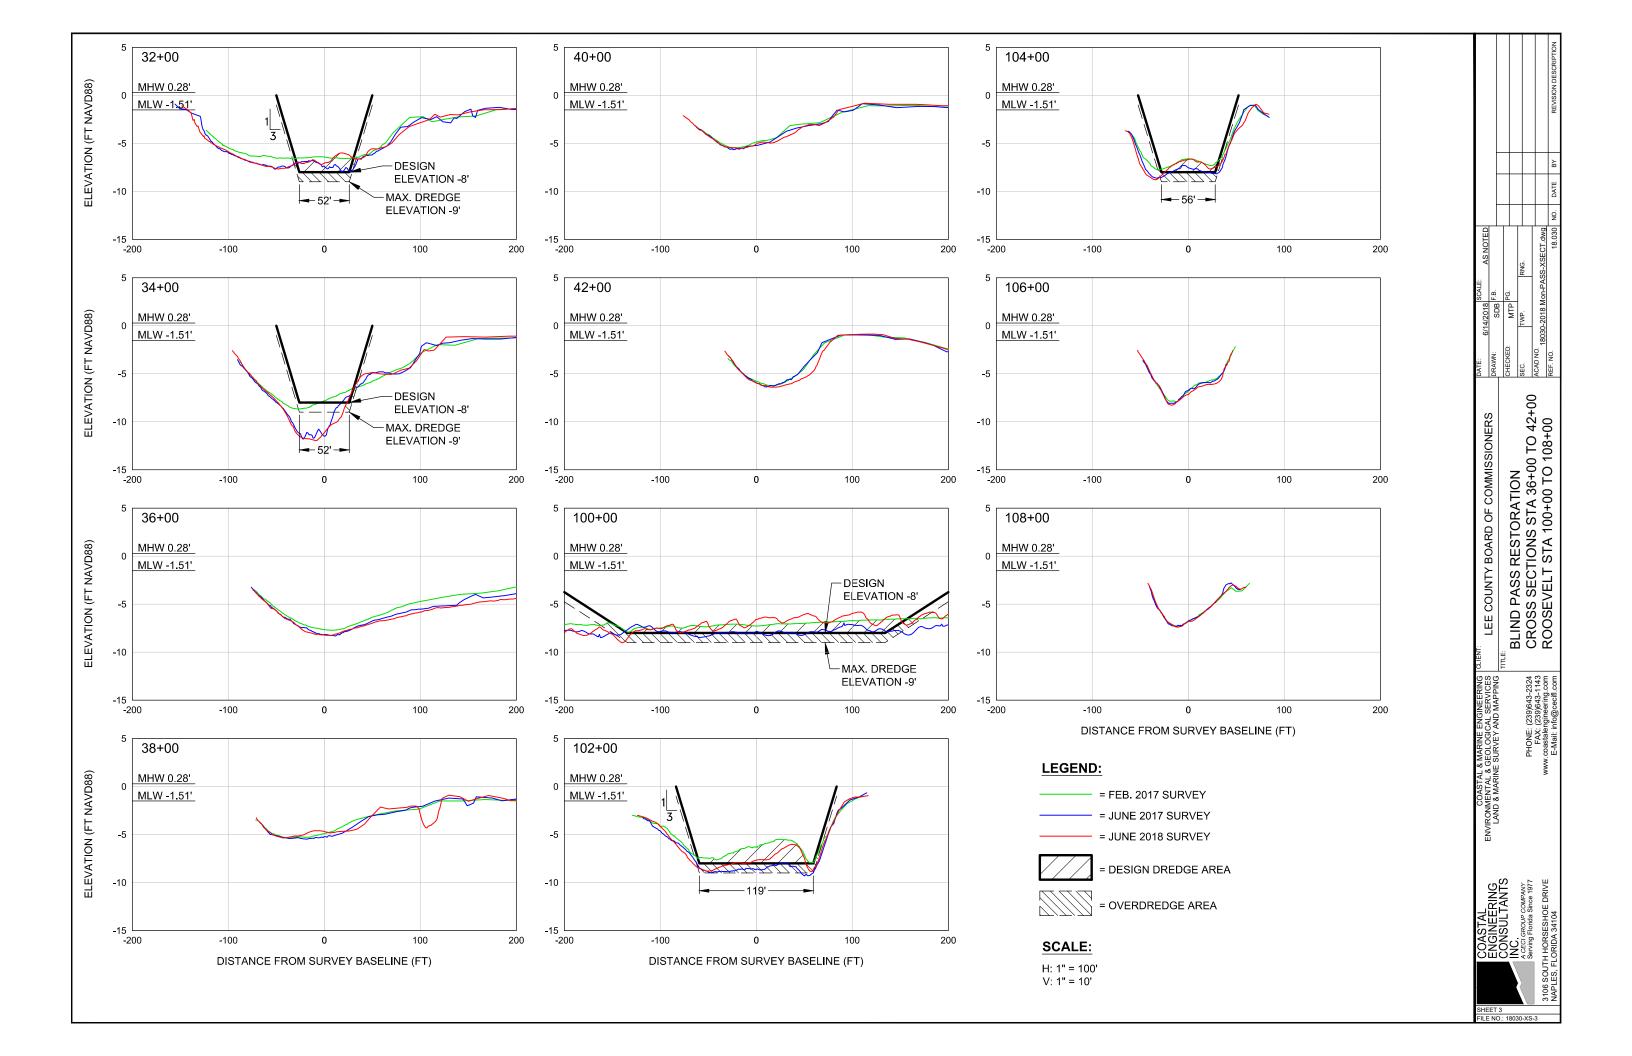
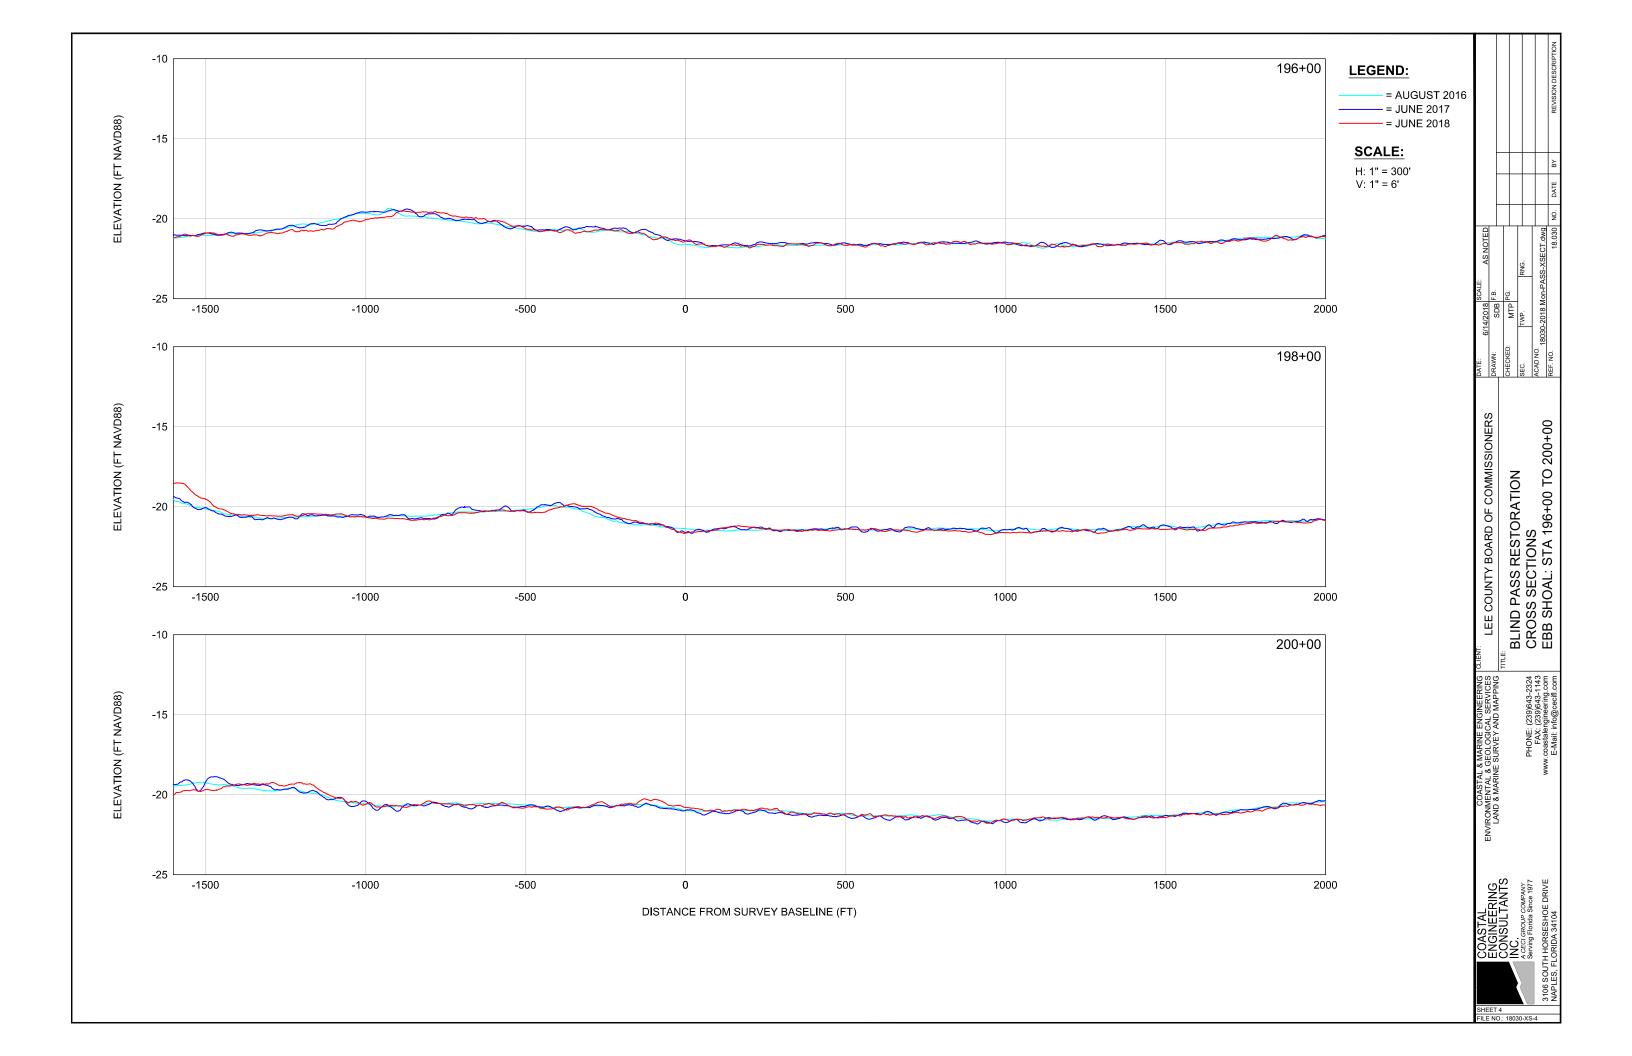
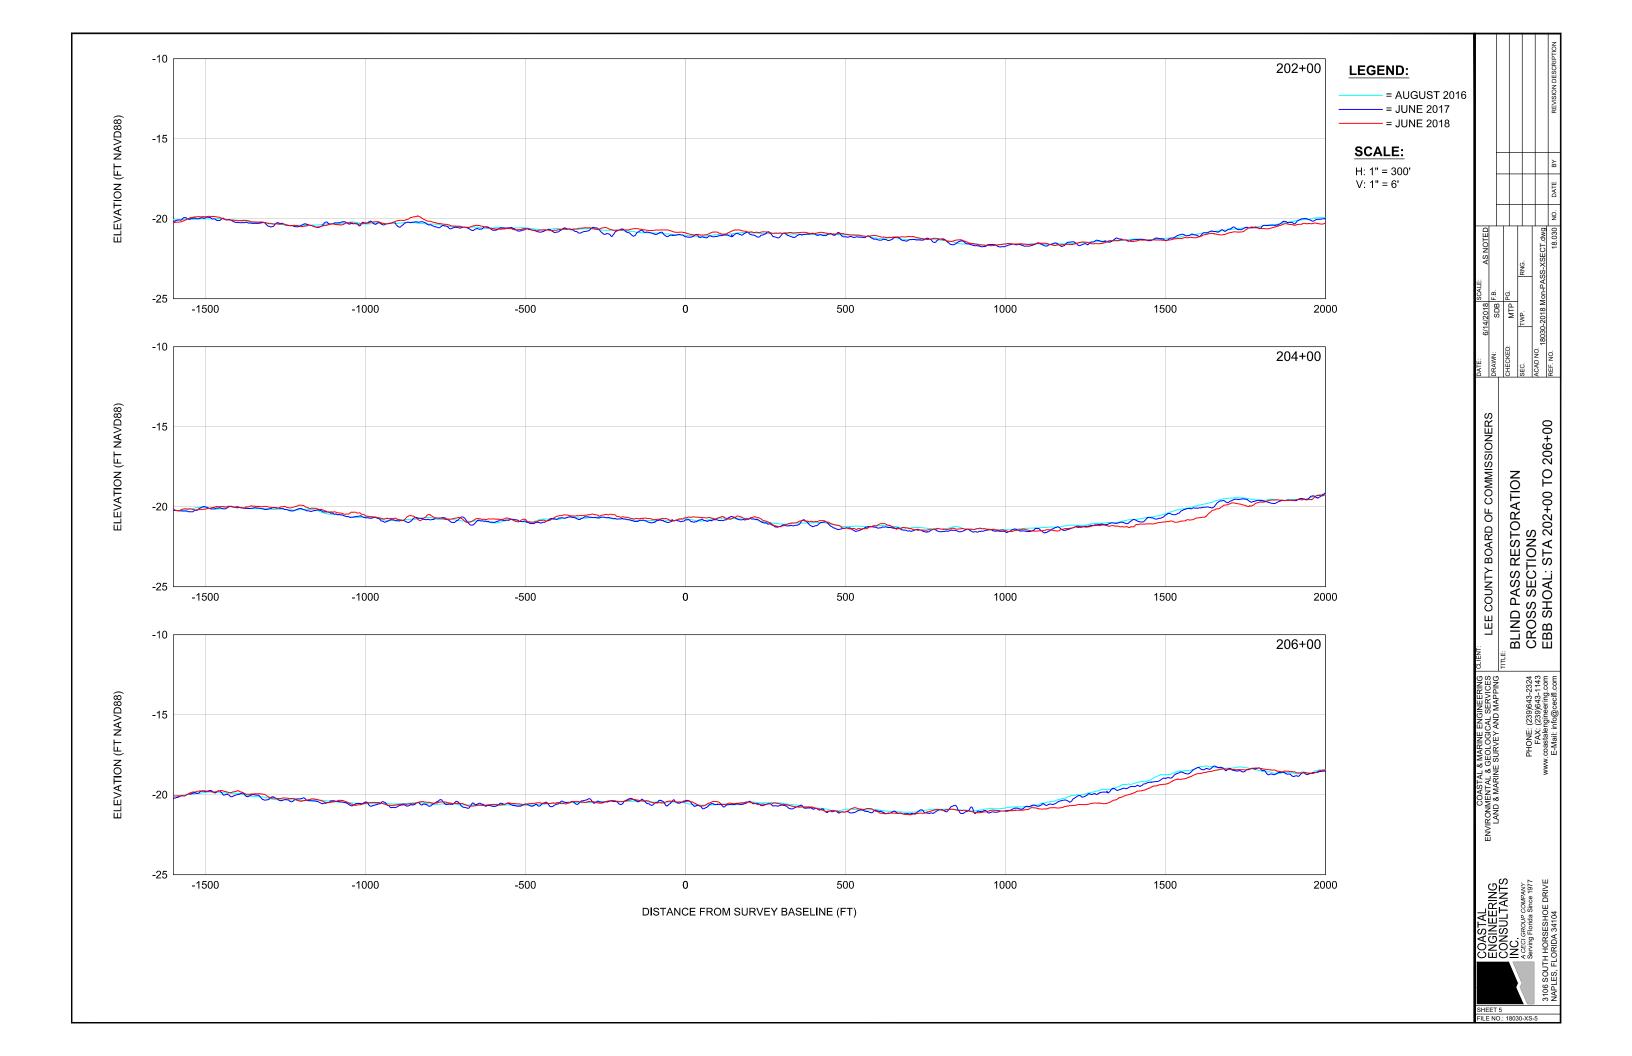
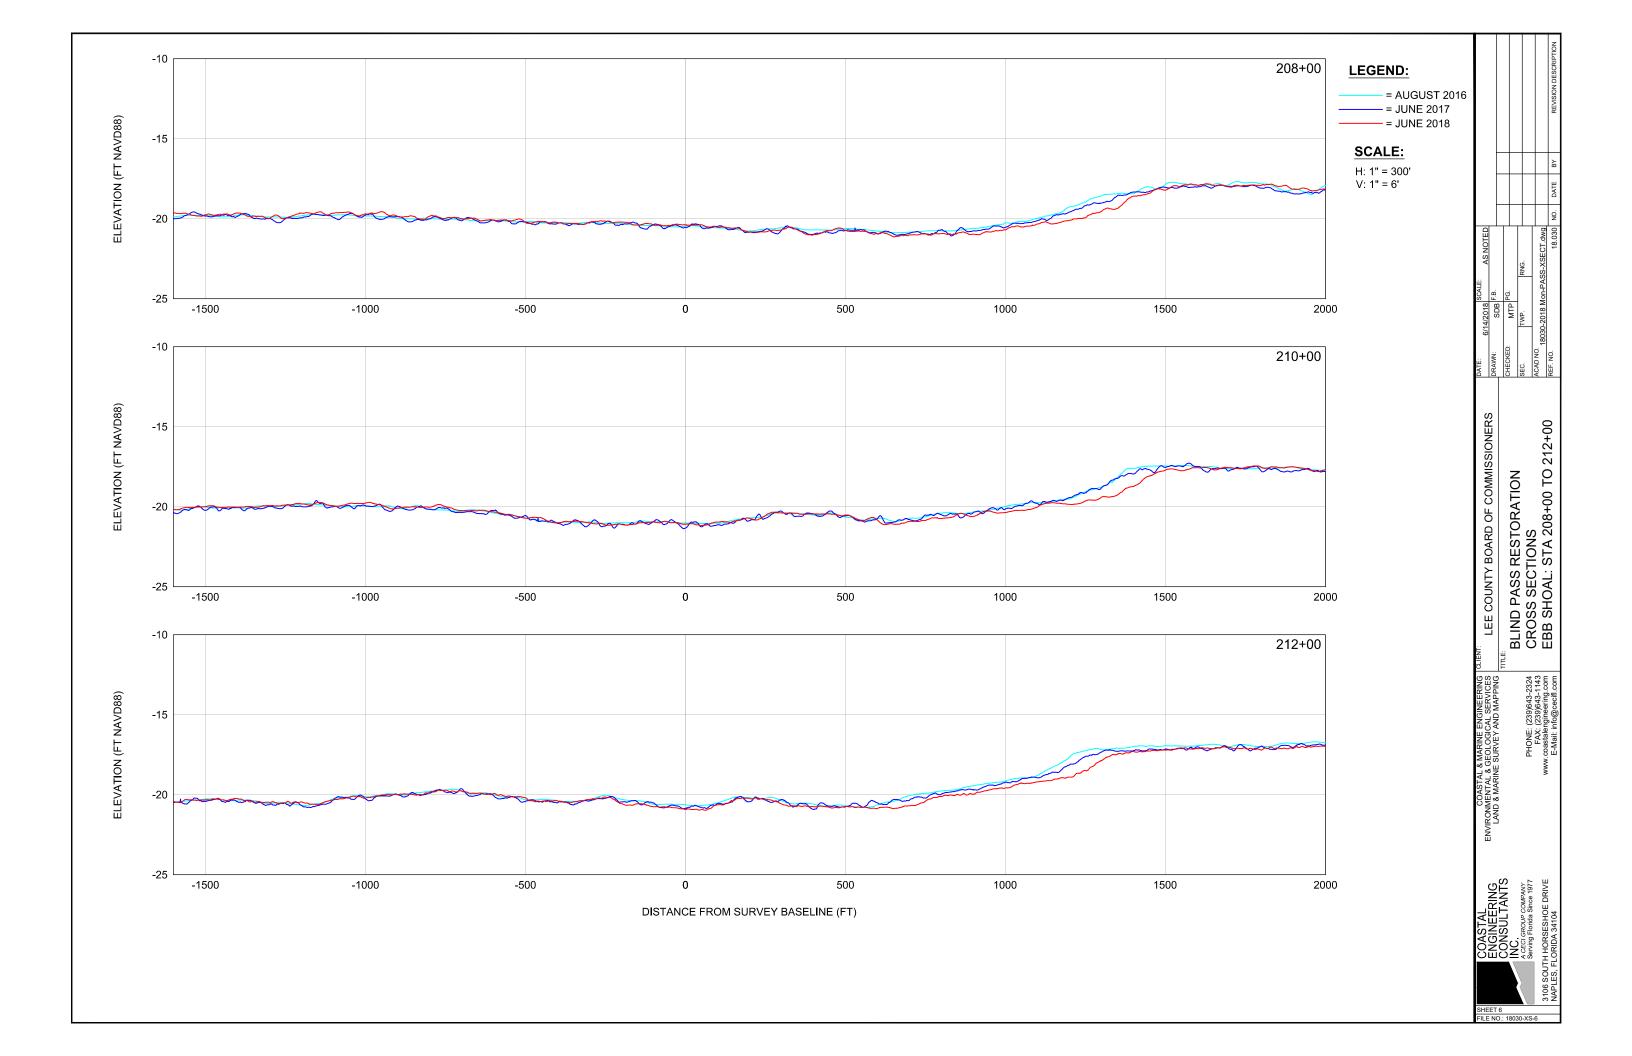
BLIND PASS AND EBB SHOAL CROSS SECTIONS

Appendix 3 presents the Blind Pass cross sections surveyed in February 2017 (pre-construction survey), June 2017 (post-construction survey), and June 2018 (monitoring). The dredge template and stations are depicted in Figure 2. It should be noted that the bridge precludes accurate surveying of Station 10+00 due to its orientation, instead two offset stations were surveyed, Stations 9+50 and 10+50, to monitor changes near the bridge.
