# BONITA BEACH AND LOVERS KEY BEACH RENOURISHMENT 2018 ANNUAL MONITORING REPORT

## DEP Permit 0311811-001-JC

October 19, 2018

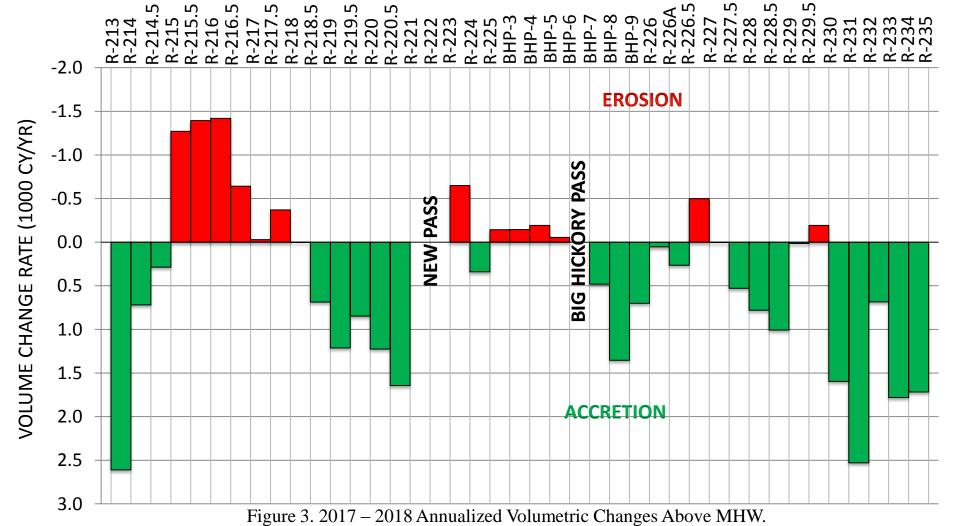
Table 3 presents the volumetric changes landward of MHW and Figure 3 presents the annualized volumetric change rate landward of MHW calculated by comparing the 2017 and 2018 monitoring surveys and annualizing the changes to be consistent with prior year monitoring reports. For the purpose of monitoring and reporting, the cell boundary was set equal to the 2018 MHW line. Table 4 presents the overall volumetric changes calculated to the depth of closure and Figure 4 presents the annualized volumetric change to the depth of closure for this period.

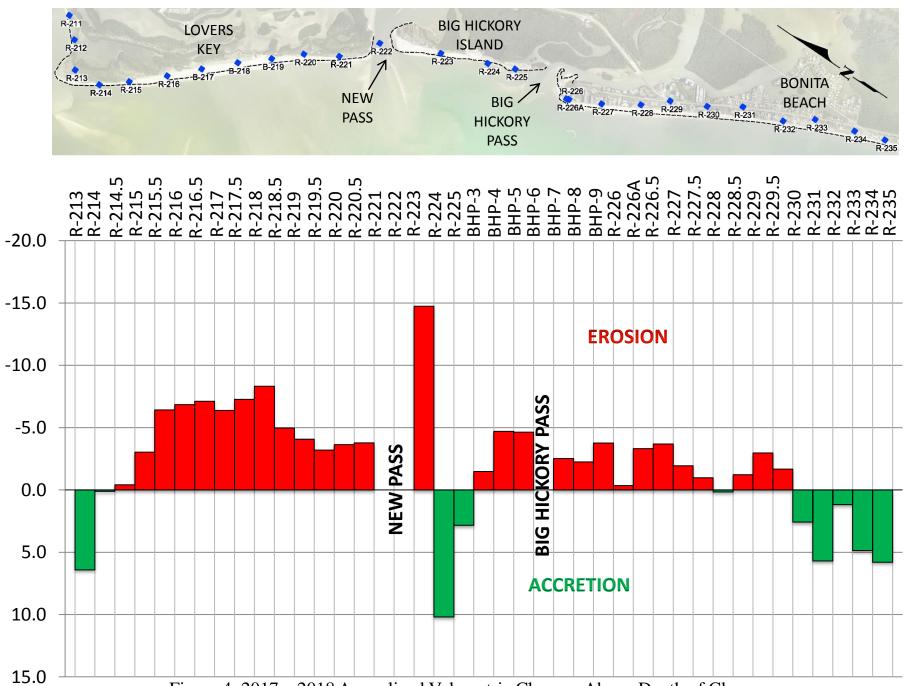
Figure 4. 2017 – 2018 Annualized Volumetric Changes Above Depth of Closure.

Monument	Area (YD³/FT)	Avg Area (YD³/FT)	Length (FT)	Volume (YD³)	Total Volume Change (YD3)			
<b>Big Carlos Pass (R-211 - R-212)</b>									
e t 5	R-213	9.7	4.0	1083	4,281				
LK North Adjacent Shoreline	R-214	-1.8	4.0	1003	4,201	4 000			
K N dja hor			0.2	405	77	4,080			
Z A Z	R-214.5	2.1	-0.6	457	-278				
	R-215	-3.3	-0.0	437	-210				
			-3.7	540	-2,024				
	R-215.5	-4.2	77	550	4 202				
	R-216	-11.2	-7.7	559	-4,282				
			-9.9	462	-4,565				
Eill	R-216.5	-8.6	0.6	407	A 77 A 1				
Ch ]	R-217	-10.5	-9.6	496	-4,741				
Lovers Key Beach Fill	1 21/	10.5	-8.3	513	-4,260				
[ey ]	R-217.5	-6.1				-38,428			
S K	R-218	-12.0	-9.0	536	-4,849				
ver	K-210	-12.0	-10.5	528	-5,549				
$\Gamma_0$	R-218.5	-9.0							
	D 210	<i>c</i> 1	-7.5	440	-3,315				
	R-219	-6.1	-5.3	512	-2,712				
	R-219.5	-4.5		312	2,712

VOLUME CHANGE RATE (1000 CY/YR)

Comparing the 2017 and 2018 monitoring surveys of the R-monuments, the entire monitoring area (R-211 to R-235) experienced a net loss, measured above depth of closure, of approximately 50,700 cubic yards. This loss is comprised of individual losses of approximately 39,200 cubic yards, 8,500 cubic yards, and 3,000 cubic yards within Lovers Key, Big Hickory Island, and the Bonita Beach segments, respectively.

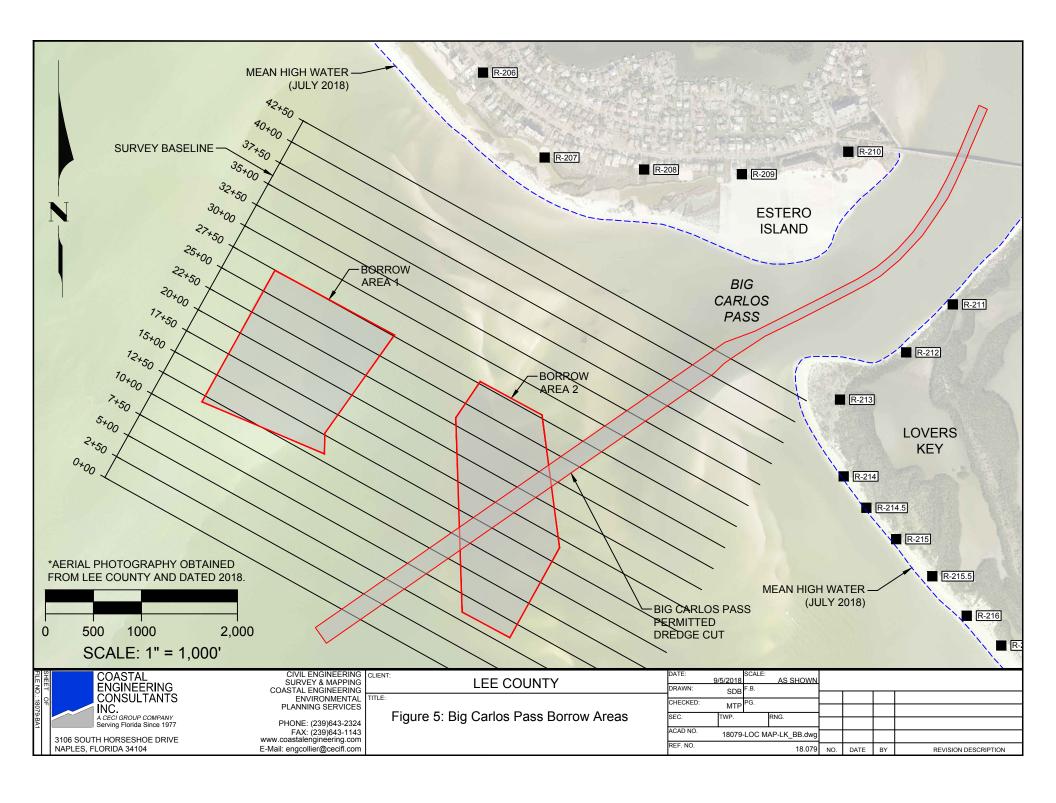
Appendix 3 presents the cross sections of Borrow Areas 1 and 2 for the 2015 post-construction, and 2016 and 2018 monitoring surveys, noting that the Borrow Areas survey was not required by the PMP in 2017. Figure 5 shows the layout for Borrow Areas 1 and 2. Tables 7 and 8 present the volume change within Borrow Areas 1 and 2, respectively, calculated from comparing the 2016 and 2018 monitoring surveys. Table 9 presents the volume remaining within the two borrow areas based on the 2018 monitoring survey. The cross sections for the end stations and points of inflection within the borrow area boundary employed in the volumetric change analysis were generated using interpolated survey data to more accurately model the borrow area.

Comparing the 2016 and 2018 monitoring surveys, the net volume change within Borrow Area 1 between Stations 5+87 and 27+74 was approximately 3,200 cubic yards of shoaling. Borrow Area 2 experienced approximately 22,400 cubic yards of shoaling. Based on the 2018 monitoring survey, the volume remaining within the permitted dredge templates for Borrow Areas 1 and 2 was approximately 156,500 cubic yards.

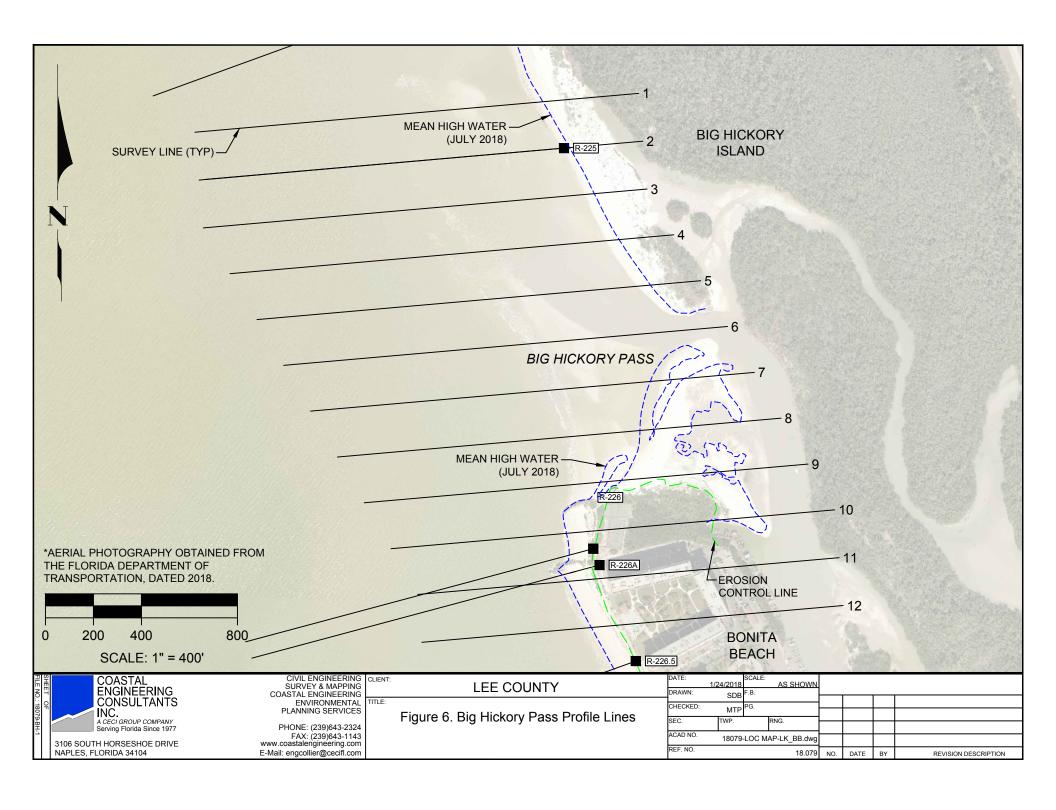
Appendix 4 presents the Big Hickory Pass Ebb Tidal Shoal cross-sections measured at the profile lines spaced 200 feet apart from R-225 to R-226 for the 2014 pre-construction, 2015 post-construction, and 2016, 2017, and 2018 monitoring surveys. The profile line locations are depicted in Figure 6.

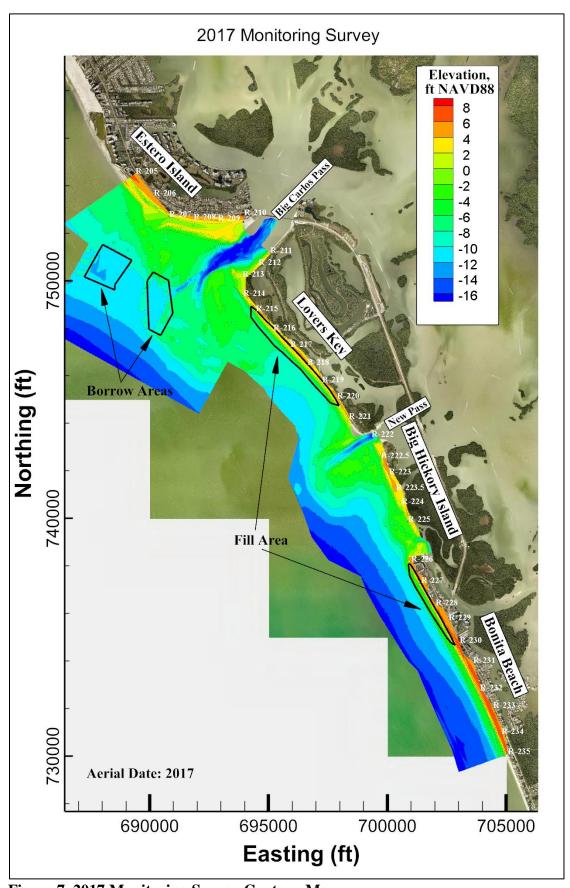
Figure 7. 2017 Monitoring Survey Contour Map.

Figures 7 and 8 present elevation contour maps based on the 2017 and 2018 monitoring surveys, respectively. The morphologic changes that occurred between the two surveys are presented in Figure 9. The changes within the Big Carlos Pass inlet system ranged from 4 feet of scour to 5 feet of deposition. The Lovers Key fill area experienced nearshore erosion within a 1-to-2-foot range. The New Pass inlet system and its ebb shoal experienced mixed changes within  $\pm 2$ -to-3-foot range, mostly erosion on the north side of the pass and accretion on the south side of the pass. Big Hickory Island experienced nearshore and beach erosion within a 3-to-4-foot range. The Bonita Beach fill area experienced minor nearshore changes within a  $\pm 1$ -foot range.
