**ESTERO ISLAND RESTORATION  
2018 ANNUAL MONITORING REPORT  
(DEP Permit 0173059-001-JC)**

**Lee County Board of County Commissioners  
P.O. Box 398  
Fort Myers, FL 33902-0398**

**August 22, 2018  
CEC File No. 18.079**

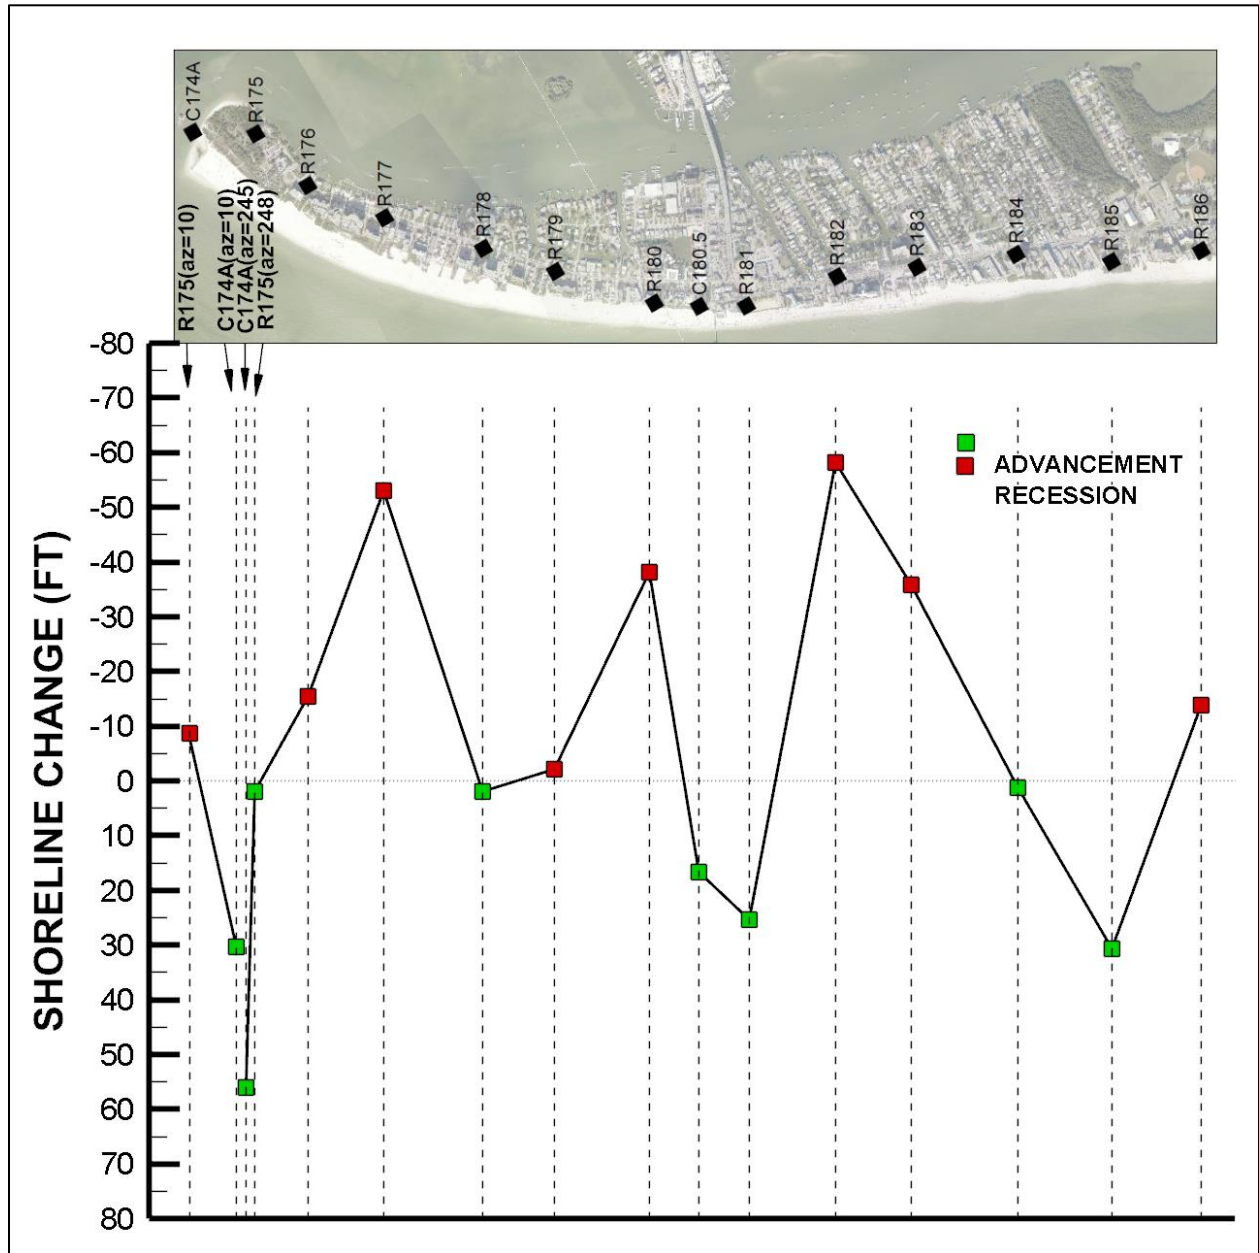
Figure 2. 2017-2018 Shoreline Migration at MHW.

Table 2 presents the 2017 and 2018 monitoring survey shoreline positions at MHW (= +0.21 feet NAVD88), and the 2017 to 2018 shoreline changes. The table also shows the weighted average which is calculated by using the effective distance. The effective distance is the sum of half the length measured at MHW between the adjacent R-lines. Figure 2 presents the shoreline changes between 2017 and 2018.

The Project Area from R-175 to R-182 experienced an average recession of 13.4 feet between the 2017 and 2018 monitoring surveys. The range of shoreline change varied from 58.2 feet of recession at R-182 to 25.4 feet of advancement at R-181. Within the Project Area, the beach experienced erosion of approximately 40,210 cy above DOC. Volumetric changes above DOC ranged from 15,540 cy of erosion between R-179 and R-180 to 14,530 cy of accretion between R-174A (az=245°) and R-175 (az=248°). The Project Area experienced net accretion above MHW of approximately 7,590 cy. The changes above MHW ranged from 1,460 cy of erosion between R-177 and R-178 to 3,150 cy of accretion between R-181 and R-182. The accretion in the vicinity of R-181 may be attributed in part to the truck haul project.

The north adjacent shoreline begins at the terminal groin and wraps around the north side of Estero Island into Matanzas Pass to R-175 (az=10°). On average, the shoreline advanced 25.9 feet. The shoreline change ranged from 8.7 feet of recession at R-175 (az=10 °) to 56.1 feet of advancement at C-174A (az=245°).

The south adjacent shoreline begins at R-182 and extends south to R-186. This stretch of beach experienced average recession of approximately 4.5 feet between 2017 and 2018. The shoreline change ranged from 35.9 feet of recession at R-183 to 30.6 feet of advancement at R-185.

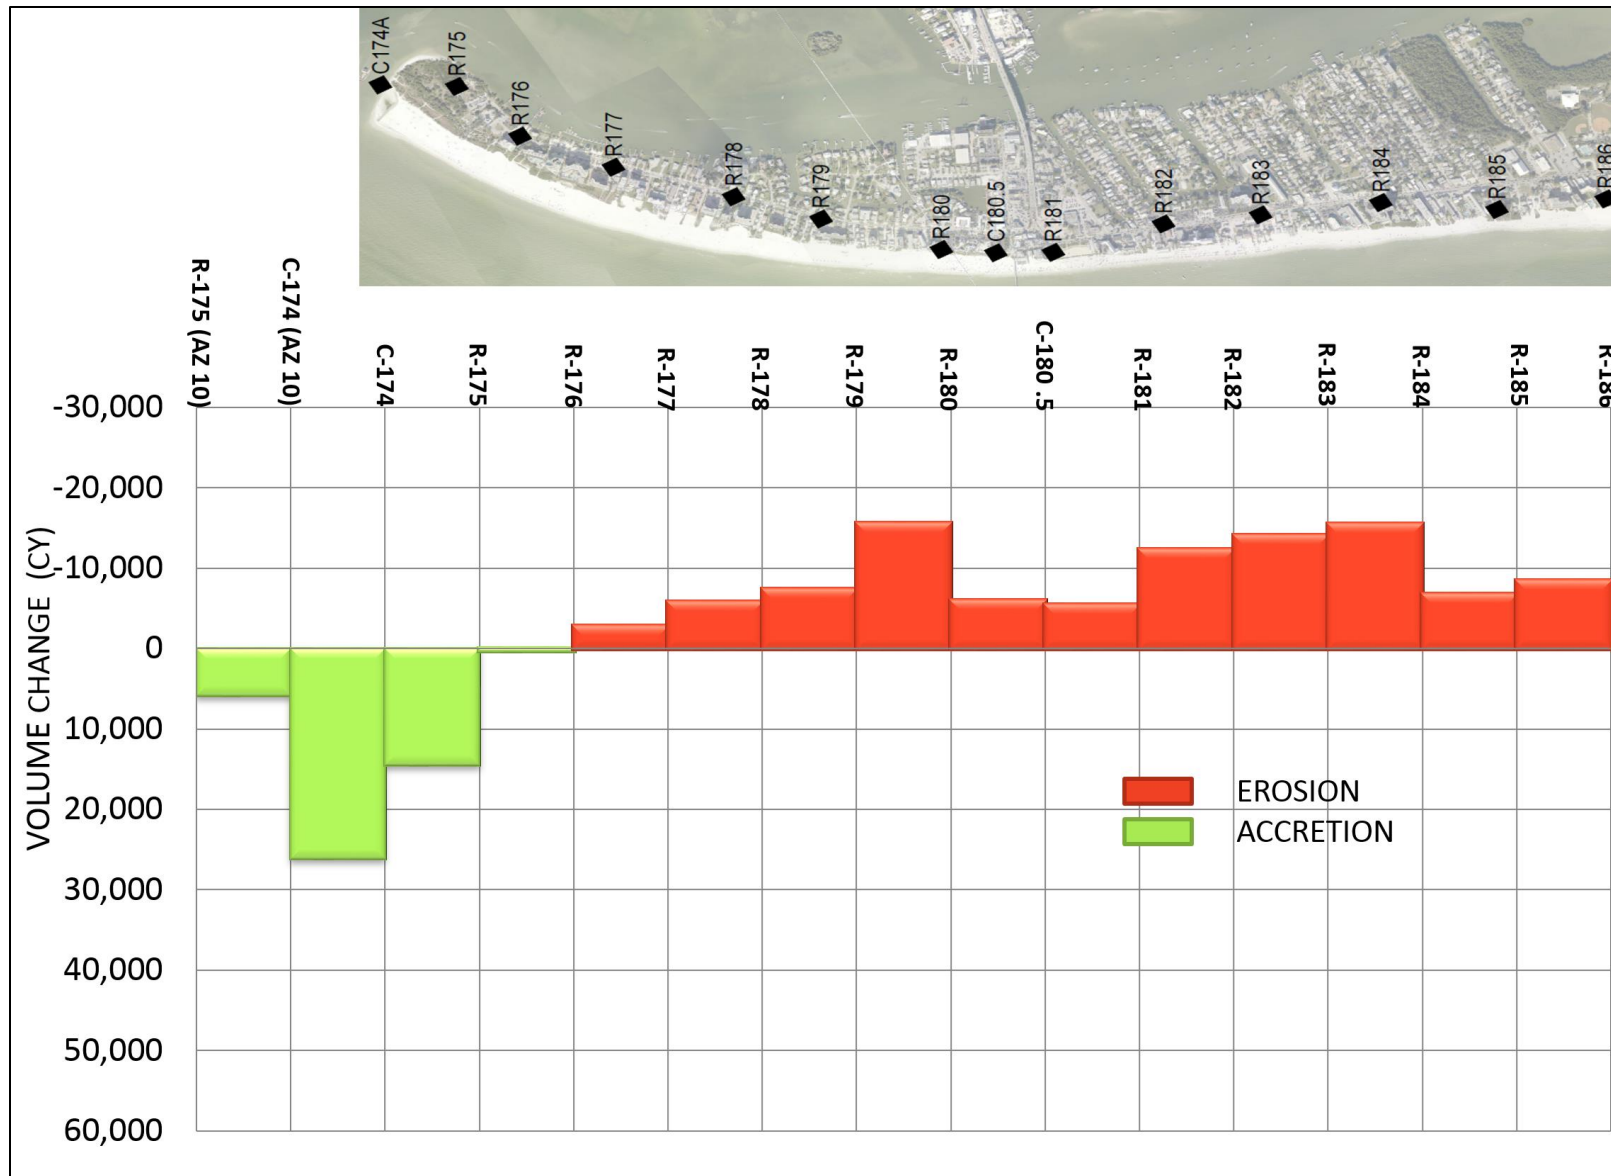
Figure 3. 2017-2018 Volumetric Changes Above Depth of Closure.

Table 3 and Figure 3 present the overall volumetric changes calculated to DOC from comparing the 2017 and 2018 monitoring surveys. Table 4 and Figure 4 present volumetric changes calculated above MHW for this period.

The net volume change above DOC between 2017 and 2018 was approximately 32,060 cy of accretion. Above MHW, the net change was approximately 2,780 cy of accretion. During the 2016 USACE's maintenance dredge project approximately 25,000 cy were removed from the North Adjacent Shoreline Monitoring Area (CEC, 2018). Figure 5 presents a plan view of the North Adjacent Shoreline Monitoring Area between C-174A (az=10°) and R-175 (az=10°) along with the 2016 dredge project (bottom of cut) and survey lines. The 2015-2017 volumetric analysis yielded approximately 33,710 cy of erosion above DOC (CEC, 2018). The 2017-2018 volume changes indicate the area recovered since completion of the dredging project.

The net volume change above DOC between 2017 and 2018 was approximately 44,660 cy of erosion. Above MHW, the net change was approximately 2,630 cy of accretion.

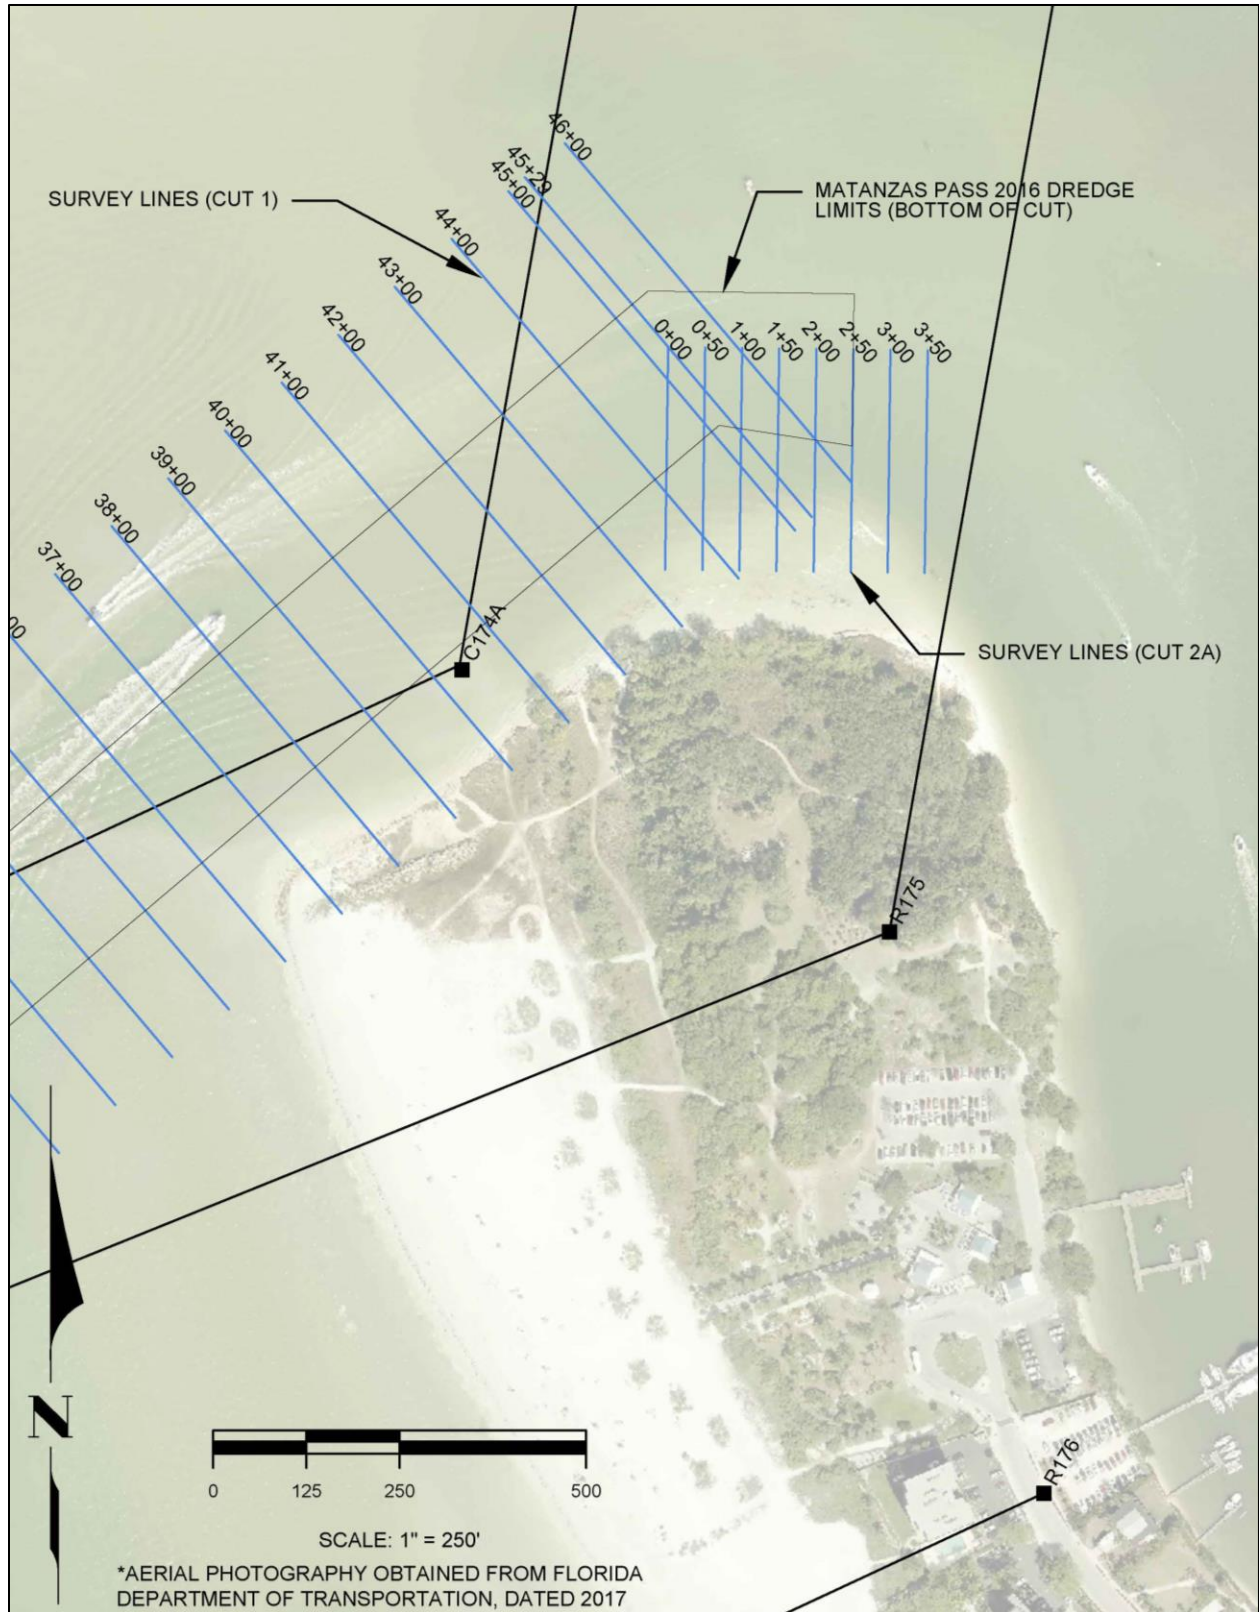
Figure 5. Plan View of North Adjacent Shoreline and 2016 USACE Dredging Project.

In 2016, the U.S. Army Corps of Engineers (USACE) dredged Matanzas Pass and placed dredge material (estimated quantity was 130,000 cy based on USACE Project Plans) in the nearshore area between R-182 and R-187. This USACE project is reflected in the analysis presented in this Report. In 2017, the County imported approximately 2,100 cy via truck haul to address erosion due to Hurricane Irma along the Crescent Beach shoreline in the vicinity of R-181.

During the 2016 USACE's maintenance dredge project, approximately 130,000 cy were placed in the nearshore between R-182 and R-186 (CEC, 2018). The 2017-2018 volume change analysis indicates that some of the placed material was lost due to fill equilibration noting that these losses were, in general, below MHW.

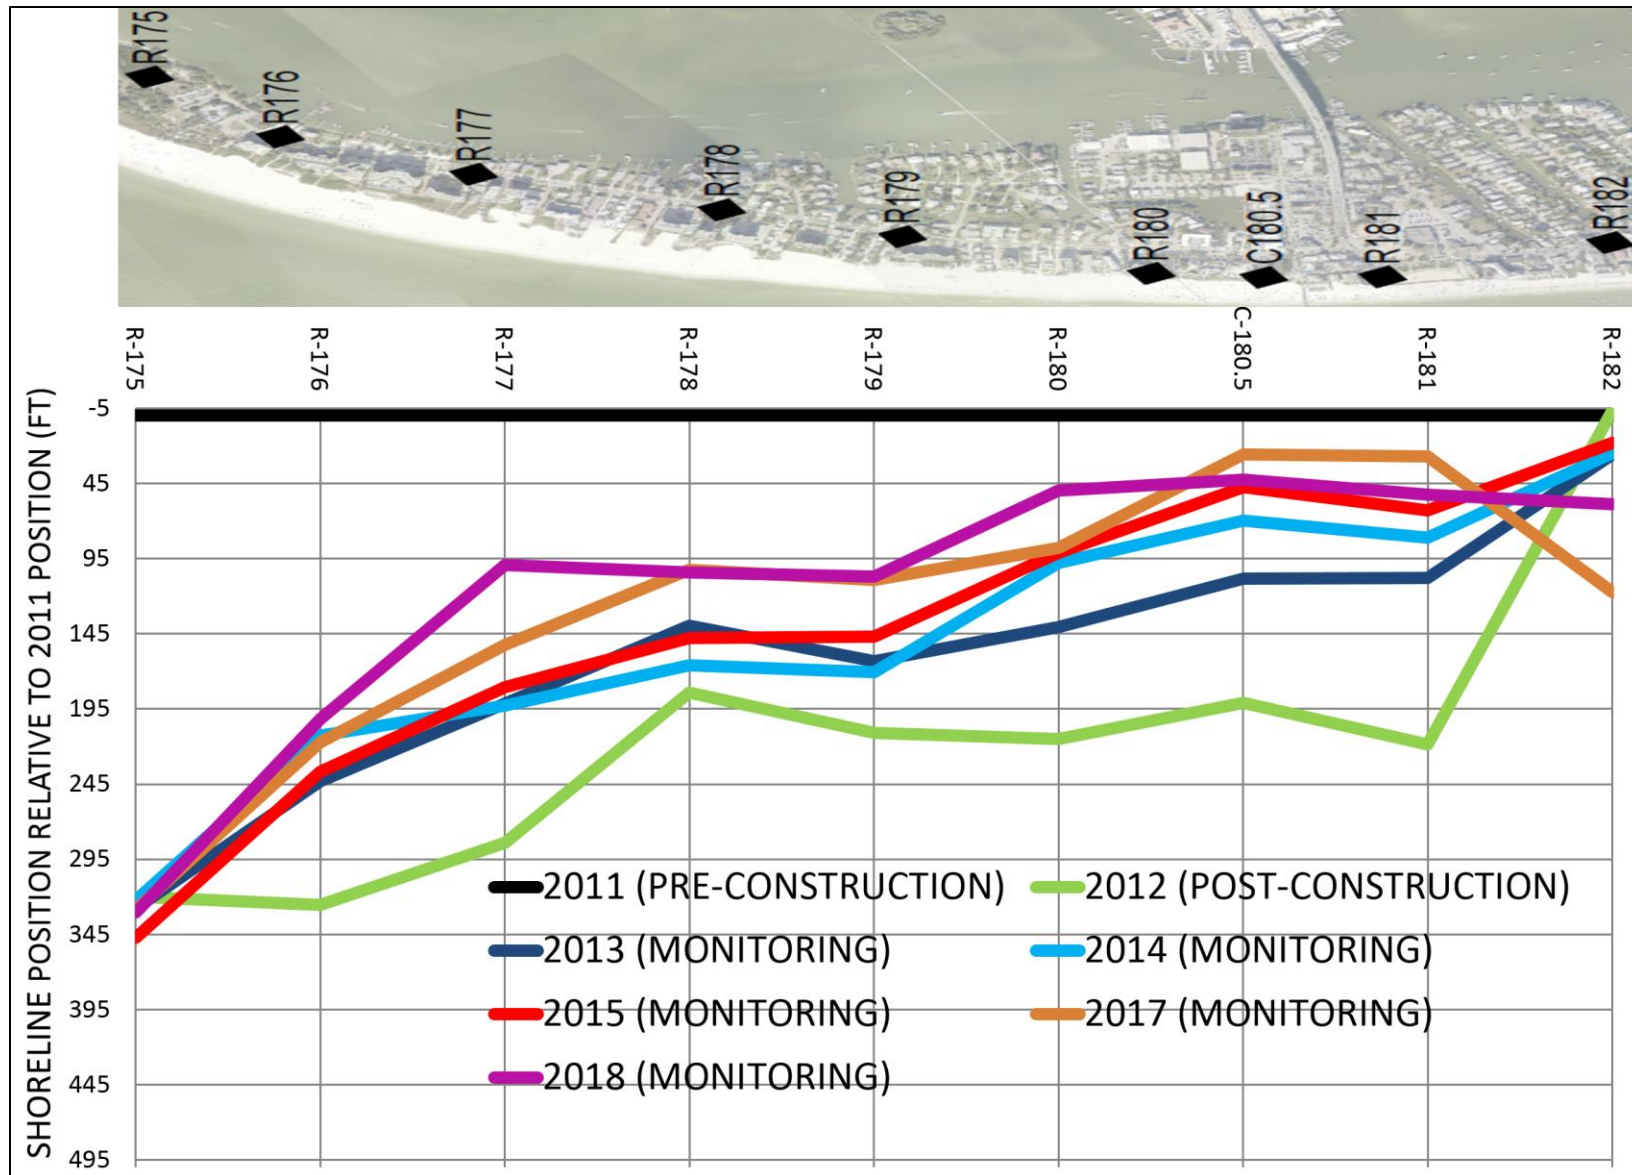
Figure 6. 2012-2018 Shoreline Positions within Project Area Relative to 2011 Pre-Construction Shoreline Position.

Table 5 presents the 2011 through 2018 monitoring survey shoreline positions at MHW for the monitoring area. In addition to the positions, the table includes shoreline change rates calculated for the 2012-2018 time period representing the six-year post-construction monitoring period. For consistency, the same effective distances as in Table 3 were utilized to determine the weighted average. Between 2012 and 2018, the Project Area shoreline experienced an average recession of 15.5 feet. The areas adjacent to the Project Area have both experienced advancement, 3.2 feet on the north and 9.5 feet on the south. The weighted average shoreline change rate for the entire monitoring area between 2012 and 2018 equated to 6.9 feet per year of recession.

Figure 6 presents the 2012, 2013, 2014, 2015, 2017, and 2018 MHW positions relative to the 2011 pre-construction MHW positions which were utilized as the baseline for the Project Area.

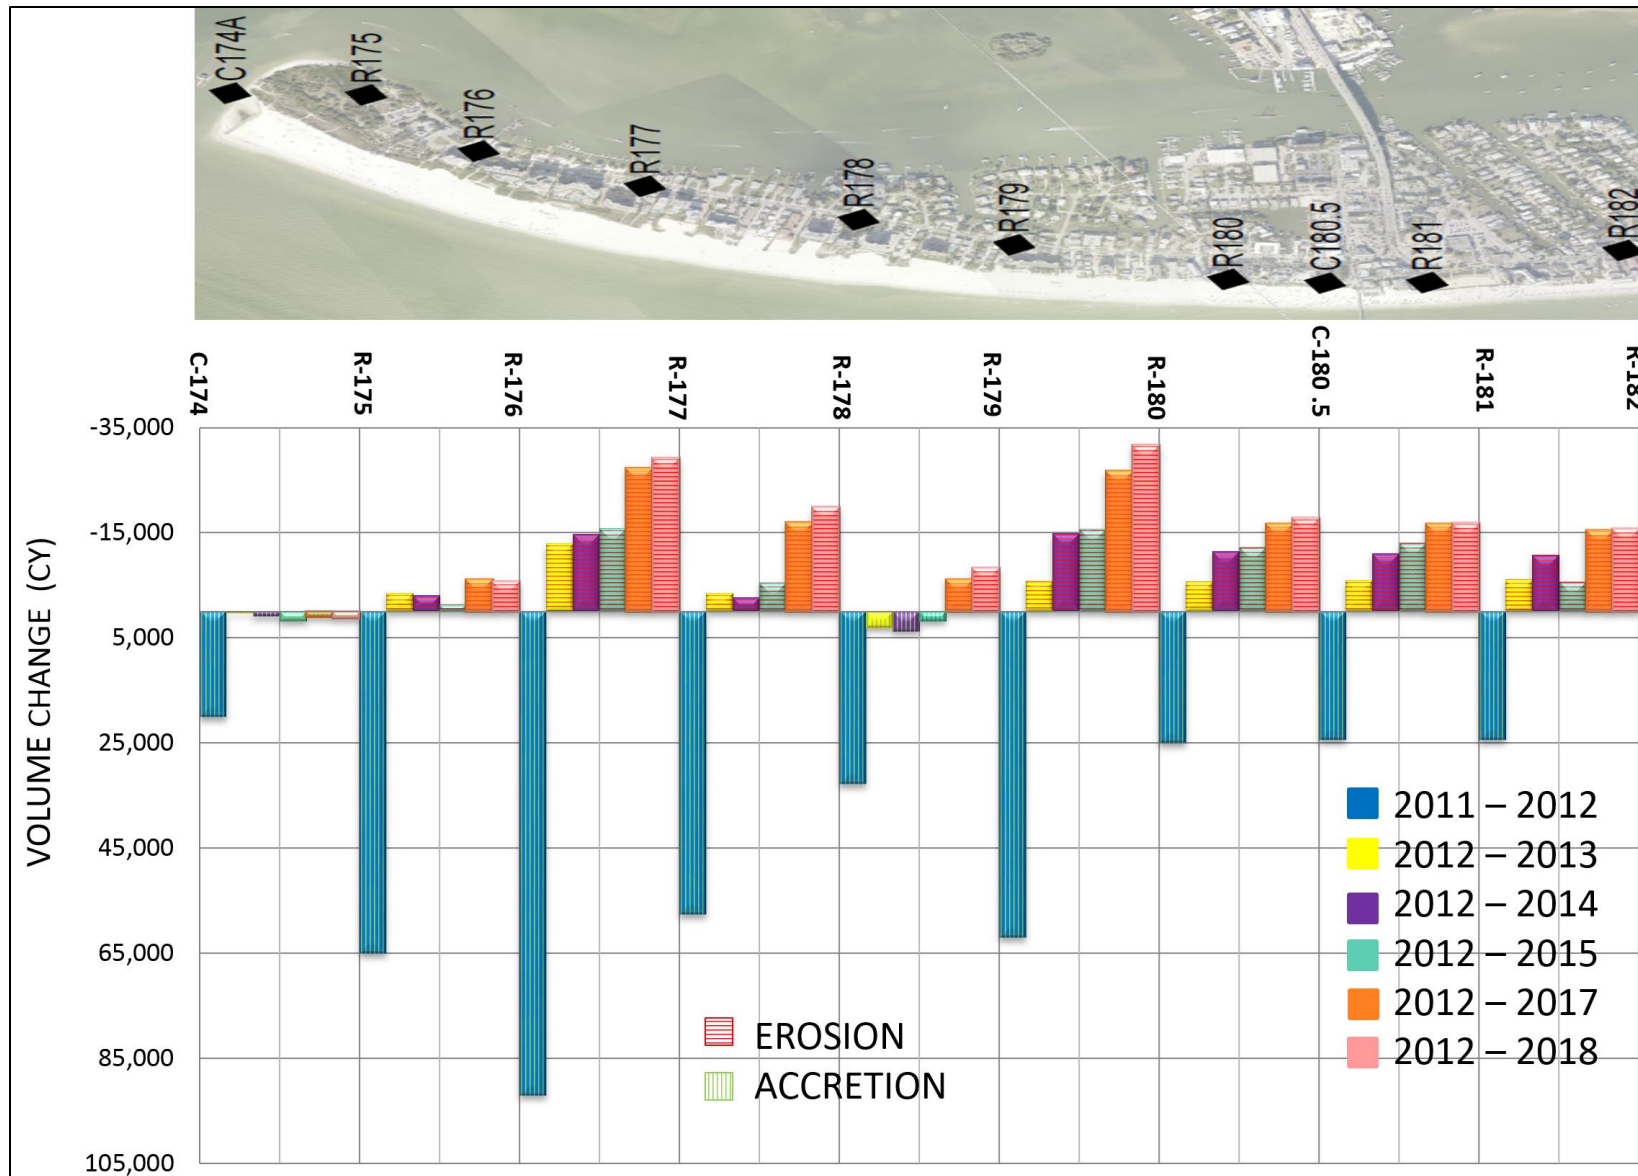
Figure 7. 2012-2018 Volumetric Changes within Project Area.

Table 6 and Figure 7 present the volumetric changes from the pre-construction survey in 2011 to the post-construction survey in 2012 within the fill footprint. In addition, the table presents the volumetric changes between 2012 post-construction and each of the 2013, 2014, 2015, 2017 and 2018 monitoring surveys. In summary, the net volume change between 2012 and 2018 within the fill footprint was approximately 144,110 cy of erosion.

In order to calculate the percent loss and remaining fill within the Project Area, CEC calculated the volume placed by comparing the 2011 pre-construction survey to the 2012 post-construction survey. The limits of the volume calculations were from the landward extent of the 2011 pre-construction survey to the toe of fill of the 2012 post-construction survey. In addition, some 2012 post-construction lines were shifted from an adjacent azimuth by holding a control point at the elevation of +4 feet NAVD88 to enable volume computations due to varying profile azimuths measured over time. These lines are denoted with an asterisk (\*) in Tables 5 and 6. The volume placed between the 2011 pre-construction and 2012 post-construction survey was calculated to be approximately 404,550 cy. This volume was then compared to the volume recorded in the pays surveys during construction (Lee County, 2013), approximately 403,000 cy, which is within one percent, which confirms the profile adjustments employed and analysis performed herein.

The volumetric changes for 2013, 2014, 2015, 2017 and 2018 were then calculated by comparing the monitoring surveys to the 2012 post-construction survey maintaining the 2012 toe of fill as the seaward limit. Between 2012 and 2013 (15 months), the Project Area experienced erosion of approximately 40,090 cy. Between 2012 to 2014 (30 months), the Project Area experienced approximately 63,860 cy of erosion. Between 2012 and 2015 (41 months), the Project Area experienced approximately 72,750 cy of erosion. Between 2012 and 2017 (69 months), the Project Area experienced approximately 131,230 cy of erosion. Between 2012 and 2018 (78 months), the Project Area experienced approximately 144,110 cy of erosion. The percent remaining in the Project Area in 2018 equates to approximately 64.0%.

Accounting for the time period between the surveys, the annualized erosion rates for the Project Area for the 2012-2013, 2013-2014, 2014-2015, 2015-2017, and 2017-2018 monitoring periods equate to approximately 32,070 cy/year, 19,020 cy/year, 9,700 cy/year, 25,060 cy/year, and 19,110 cy/year, respectively.
