BONITA BEACH AND LOVERS KEY BEACH RENOURISHMENT 2021 ANNUAL MONITORING REPORT

DEP Permit 0311811-001-JC

September 21, 2021

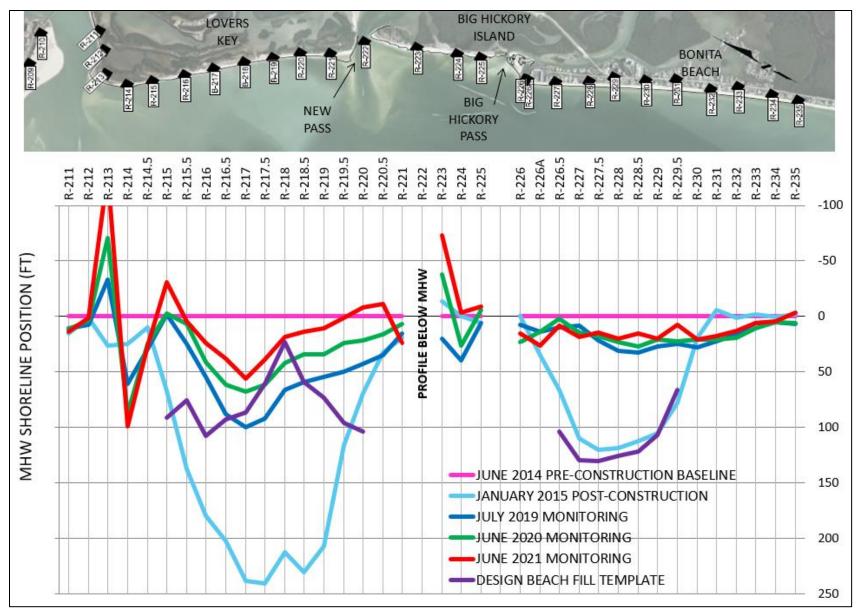
Figure 2. MHW Shoreline Positions Relative to 2014 Pre-Construction MHW Positions.

Table 2 presents the 2020 and 2021 monitoring survey shoreline positions at MHW (MHW = 0.3 feet NAVD88) and the shoreline changes that occurred between the surveys. The unweighted average shoreline change for individual beach segments was calculated based upon these changes. Figure 2 presents the permitted beach fill templates, 2015 post-construction, 2019 monitoring, 2020 monitoring and 2021 monitoring surveys relative to the 2014 pre-construction survey. It should be noted that the 2014 pre-construction survey was utilized as the baseline for comparative purposes. The design templates (without advanced maintenance) were specifically depicted for tracking fill diffusion and evolution over time in support of future funding requests and evaluating renourishment needs.

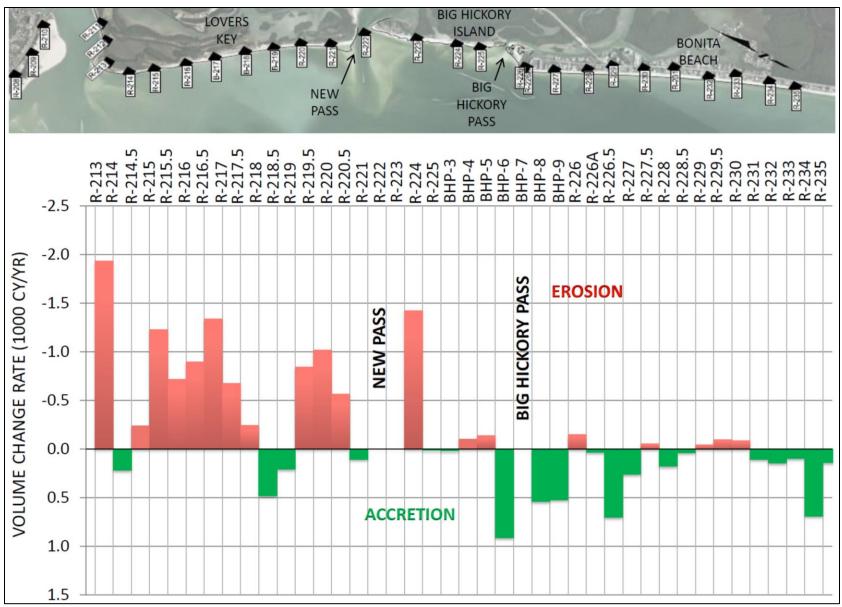
Figure 3. 2020 – 2021 Annualized Volumetric Changes Above MHW.

Table 3 presents the volumetric changes landward of MHW and Figure 3 presents the annualized volumetric change rate landward of MHW calculated by comparing the 2020 and 2021 monitoring surveys and annualizing the changes to be consistent with prior year monitoring reports. For the purpose of monitoring and reporting, the cell boundary was set equal to the 2021 MHW line. Table 4 presents the overall volumetric changes calculated to the depth of closure and Figure 4 presents the annualized volumetric change to the depth of closure for this period.

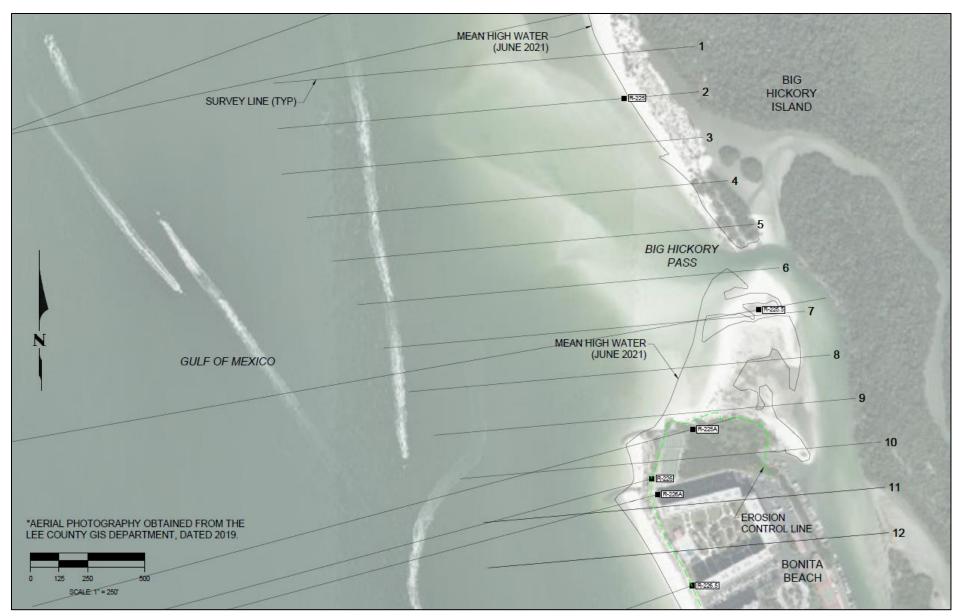
Figure 5. Big Hickory Pass Profile Lines.

Appendix 3 presents the Big Hickory Pass Ebb Tidal Shoal cross-sections measured at the profile lines spaced 200 feet apart from R-225 to R-226 for the 2014 pre-construction, 2015 post-construction, and 2019, 2020, and 2021 monitoring surveys. The profile line locations are depicted in Figure 5.

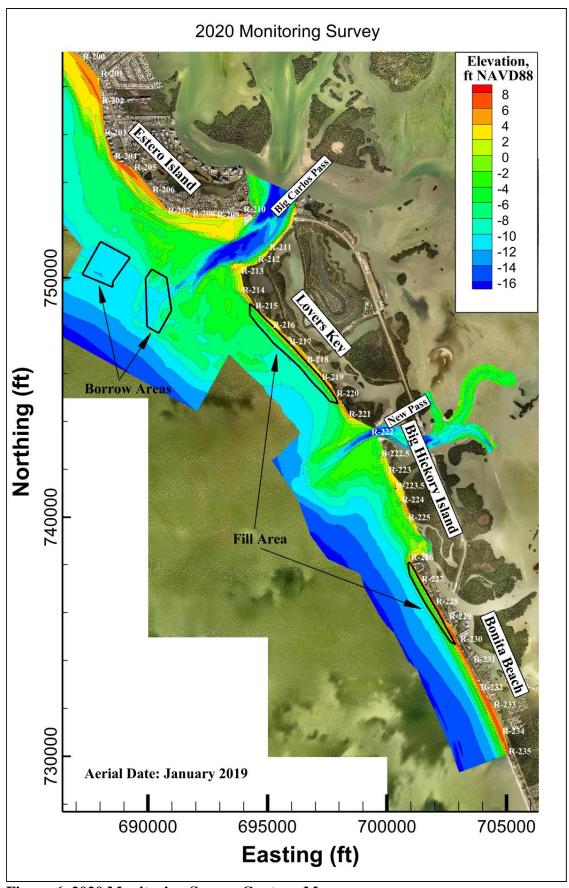
Figure 6. 2020 Monitoring Survey Contour Map.

Figures 6 and 7 present elevation contour maps based on the 2020 and 2021 monitoring surveys, respectively, noting that they include additional survey data at Big Carlos Pass and New Pass collected concurrently with this Project as part of other Lee County survey projects. The morphologic changes that occurred between the two surveys are presented in Figure 8.

Because the Big Carlos Pass ebb shoal was not surveyed in detail in 2021, the R-monument survey data were interpolated over the ebb shoal to create the contour map. Because of this, portions of the 2020-2021 morphologic changes over the Big Carlos Pass system may not be representative of actual changes.

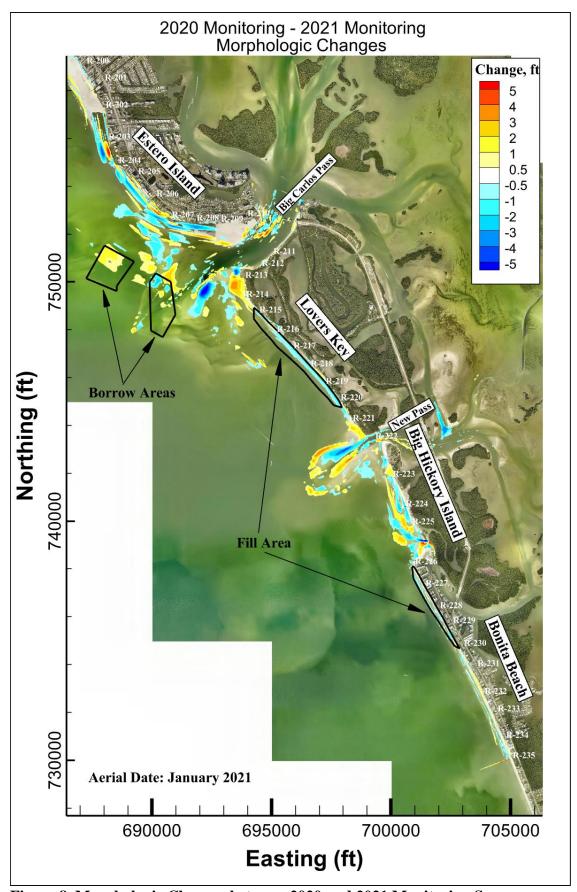
Figure 8. Morphologic Changes between 2020 and 2021 Monitoring Surveys.

The 2020 and 2021 survey coverage was near identical between R-214 and R-235, therefore the morphologic changes over this shoreline segment are accurate.

The Lovers Key fill area experienced nearshore erosion of 1 to 2 feet between R-215 and R-220. Some overwash was observed at R-215.5 and R-218.5. Big Hickory Island experienced 1 to 2 feet of beach erosion between R-223 and R-225, 1 foot of accretion just north of R-223, and up to 4 feet of accretion at the north end of the island. The Bonita Beach fill area experienced minor nearshore erosion within a 1-foot range.

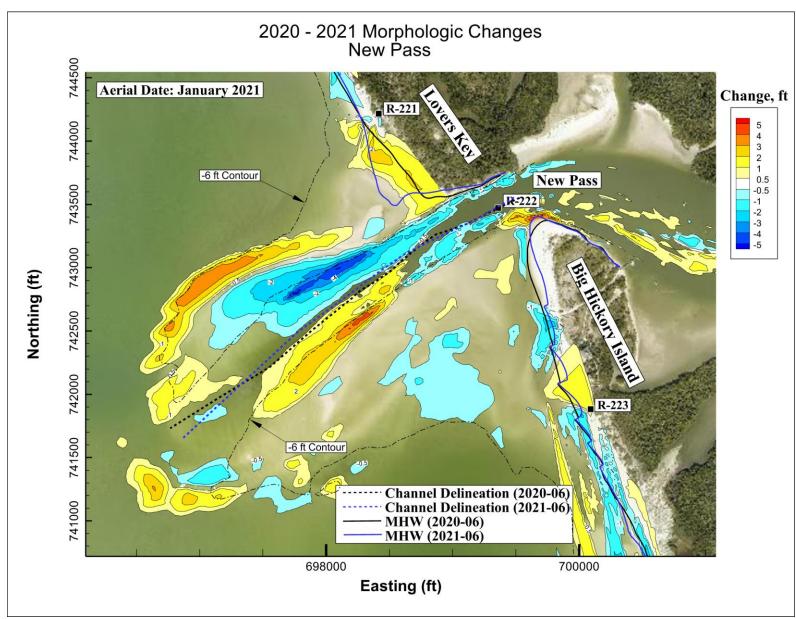
Figure 9. Morphologic Changes Within New Pass Ebb Shoal.

Morphologic changes within the New Pass ebb shoal are presented in Figure 9. The figure also depicts MHW positions and channel delineations based on the 2020 and 2021 surveys. The channel was delineated using the deepest path connecting the Gulf of Mexico and New Pass.

Comparing the 2020 and 2021 MHW positions, the north end of Big Hickory Island adjacent to the pass experienced shoreline advancement into the pass of approximately 60 feet noting that the shoreline along the gulf immediately south of New Pass receded. The changes over the ebb shoal and New Pass channel ranged from +4 feet to -5 feet. The shoreline at the south end of Lovers Key experienced significant accretion gaining up to 2.5 feet vertically and advancing approximately 250 feet. The morphologic changes indicated the channel alignment was fairly stable. The pattern of the changes also indicated that during this monitoring period the net longshore sediment transport was from north to south moving material off Lovers Key, bypassing the channel around the edge of the ebb shoal, delineated in the figure by the -6-ft contour line, and depositing material on the south side of the channel by wave action.

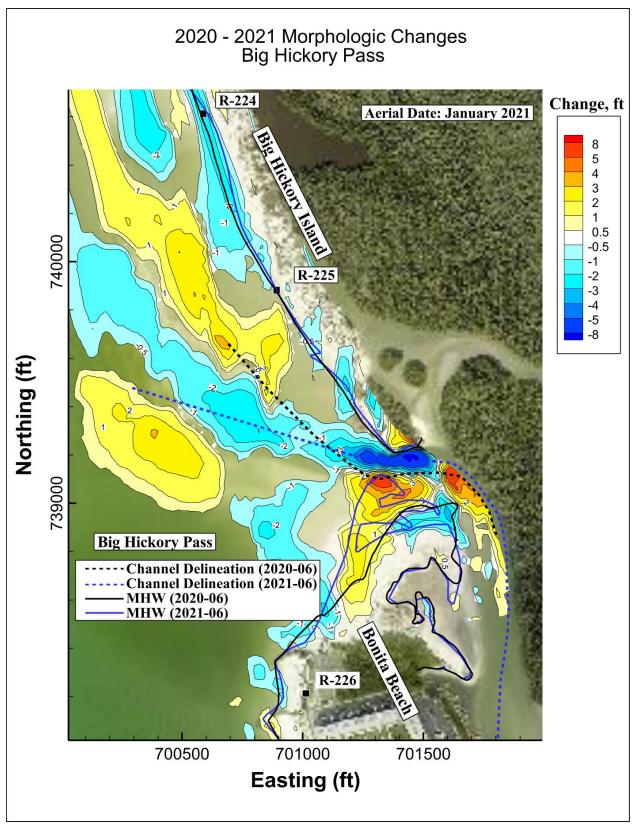
Figure 10. Morphologic Changes Within Big Hickory Pass Ebb Shoal.

Morphologic changes within the Big Hickory Pass ebb shoal are presented in Figure 10. The figure also depicts MHW positions and channel delineations based on the 2020 and 2021 surveys. The channel was delineated using the deepest path connecting the Gulf of Mexico and Big Hickory Pass.

The south end of Big Hickory Island, north of the pass, experienced shoreline recession of approximately 15 feet. The pass experienced scouring of up to 8 feet at the throat of the pass and shoaling of up to 6 feet inside the pass. Also, based on the MHW shoreline comparison between 2020 and 2021, the spit off the north end of Bonita Beach grew in size and migrated towards the pass by approximately 180 feet. This growth area experienced shoaling of up to 6 feet. The entrance into the pass narrowed from approximately 270 feet in 2020 to approximately 100 feet in 2021. The channel alignment turned counterclockwise by approximately 23 degrees. The changes over the ebb shoal were mixed within a ± 3 -foot range. The pattern of the changes indicates that during this monitoring period the net longshore sediment transport was from south to north moving material off Bonita Beach, depositing some of it along the south lobe of the shoal, bypassing the channel around the ebb shoal and transporting the remaining material along Big Hickory Island between R-224 and R-225.

It should be noted that the survey limits were expanded in 2021 to include interior channel cross-sections of Big Hickory Pass at 100-foot intervals. The interior channel will be surveyed again in future monitoring events. This will allow for a more comprehensive analysis of morphologic changes of the pass system.
