NW CAPE CORAL/LEE COUNTY WATERSHED INITIATIVE  
PHASE I  
SUMMARY REPORT

LEE COUNTY, FLORIDA

JUNE 2015

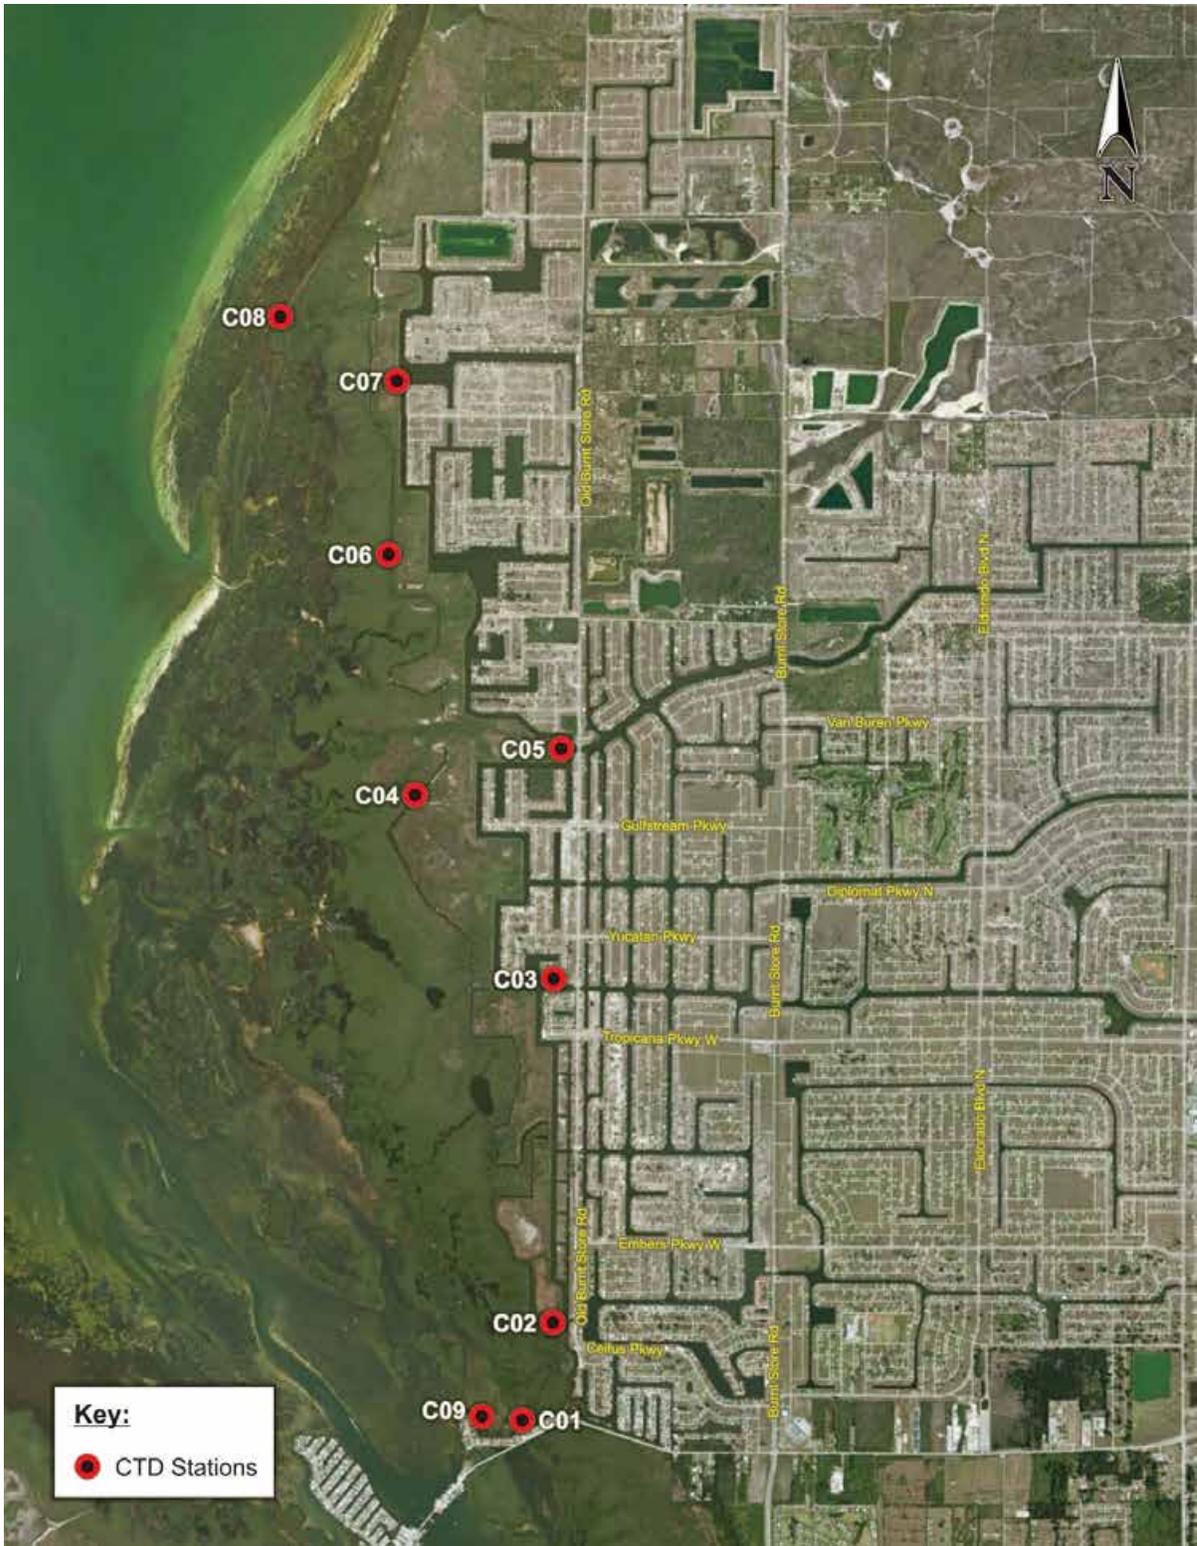
Figure 3-2. Water Level, Salinity, Temperature Station Locations

Data were collected at a total of 28 fixed locations. A total of 19 stations had water level only, the remaining 9 stations had water level, salinity, and temperature. Figure 3-1 presents the locations of the water level only stations, Figure 3-2 the stations with water level, salinity, and temperature, and Figure 3-3 the stations upstream of the weir structure which collected water level. The stations recorded water level measurements every 6 minutes to provide a continuous record. The water level measurements upstream of the weir structures were collected to supplement flow gaging data collected by the U.S. Geological Survey (USGS). This was necessary since USGS flow gaging stations were taken off-line during the period of the study.
