LeeTran

Bus Stop Accessibility Study and Transition Plan

July 29, 2022

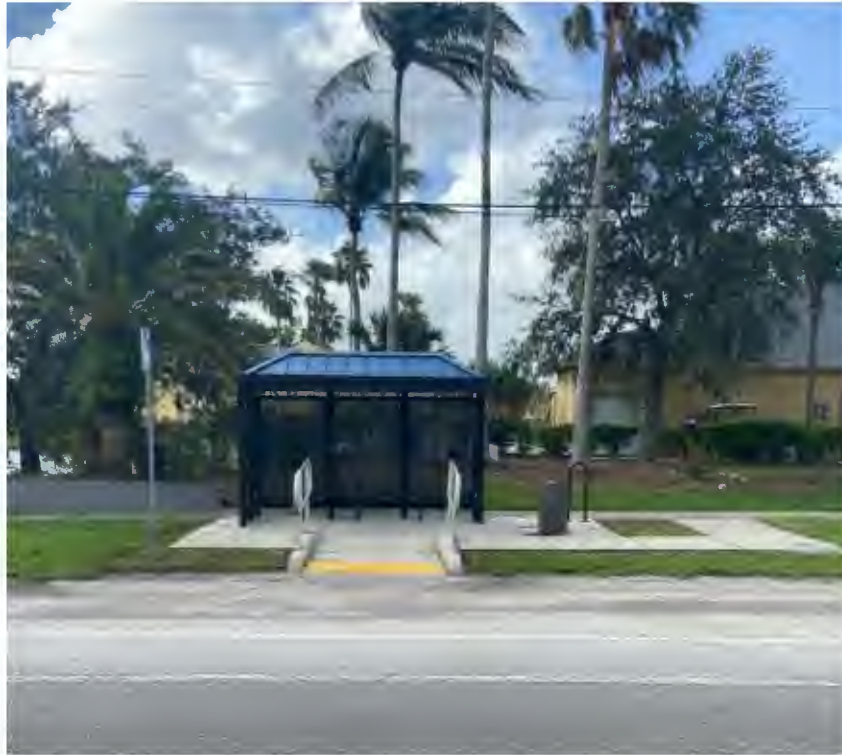
Figure 3.1: Handrails and Detectable Warning Present at Bus Stop #10019

- It was noted during the field assessment that detectable warnings and handrails were located at B&A areas. ADAAG does not require these elements at a B&A area, and their presence may be confusing to a patron with disabilities.

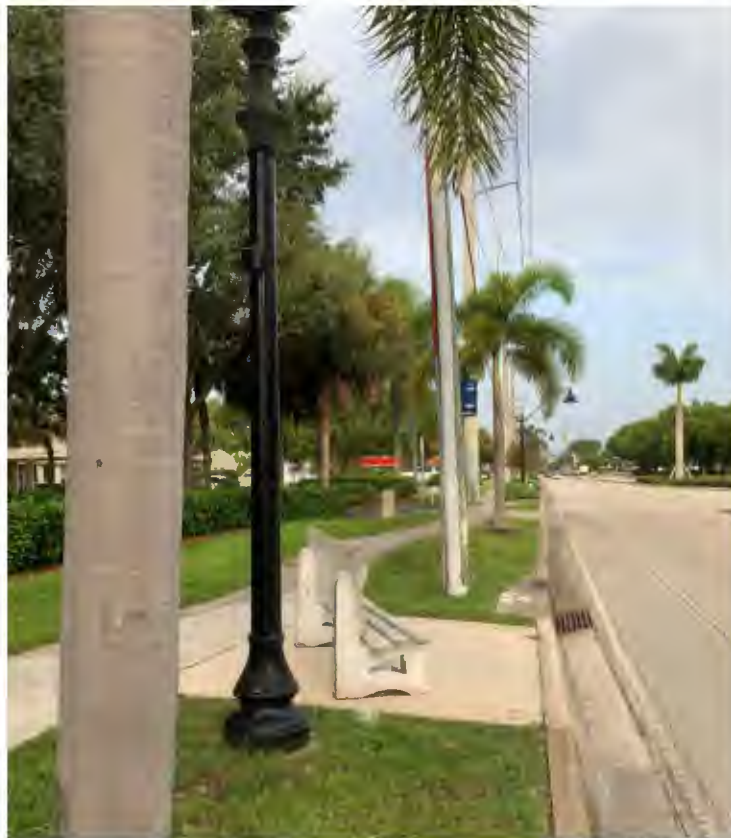
Figure 3.10: Example LeeTran Boarding and Alighting Area Obstruction

Figure 3.10 illustrates an example obstruction observed during the field data collection effort where a bench is obstructing the boarding and alighting area. This obstruction greatly decreases the accessibility of the bus stop and poses a safety concern for patrons with disability.

The modification or removal of third-party amenities is not LeeTran's responsibility; however, having non-compliant amenities/infrastructure associated with LeeTran's bus stops could cause issues, and, as such, it is recommended that they be remediated. As previously noted, bus stops that serve more than one route are required to have signs that display the bus routes that serve that stop. Although this attribute was not assessed for all bus stops, in locations where bus route identification signs are missing, they should be (re)mounted.
