Re: New USACE Section 404 Application (Lee County, Florida)
Lee County Solid Waste Department
SR82 Recovered Materials Processing Facility
Latitude 26.606842° & Longitude -81.770170°
Section 36, Township 44S, Range 25E

SR82 RECOVERED MATERIALS PROCESSING FACILITY ENVIRONMENTAL SUPPLEMENT REPORT

SR 82 Recovered Materials
Processing Facility
Lee County, Florida

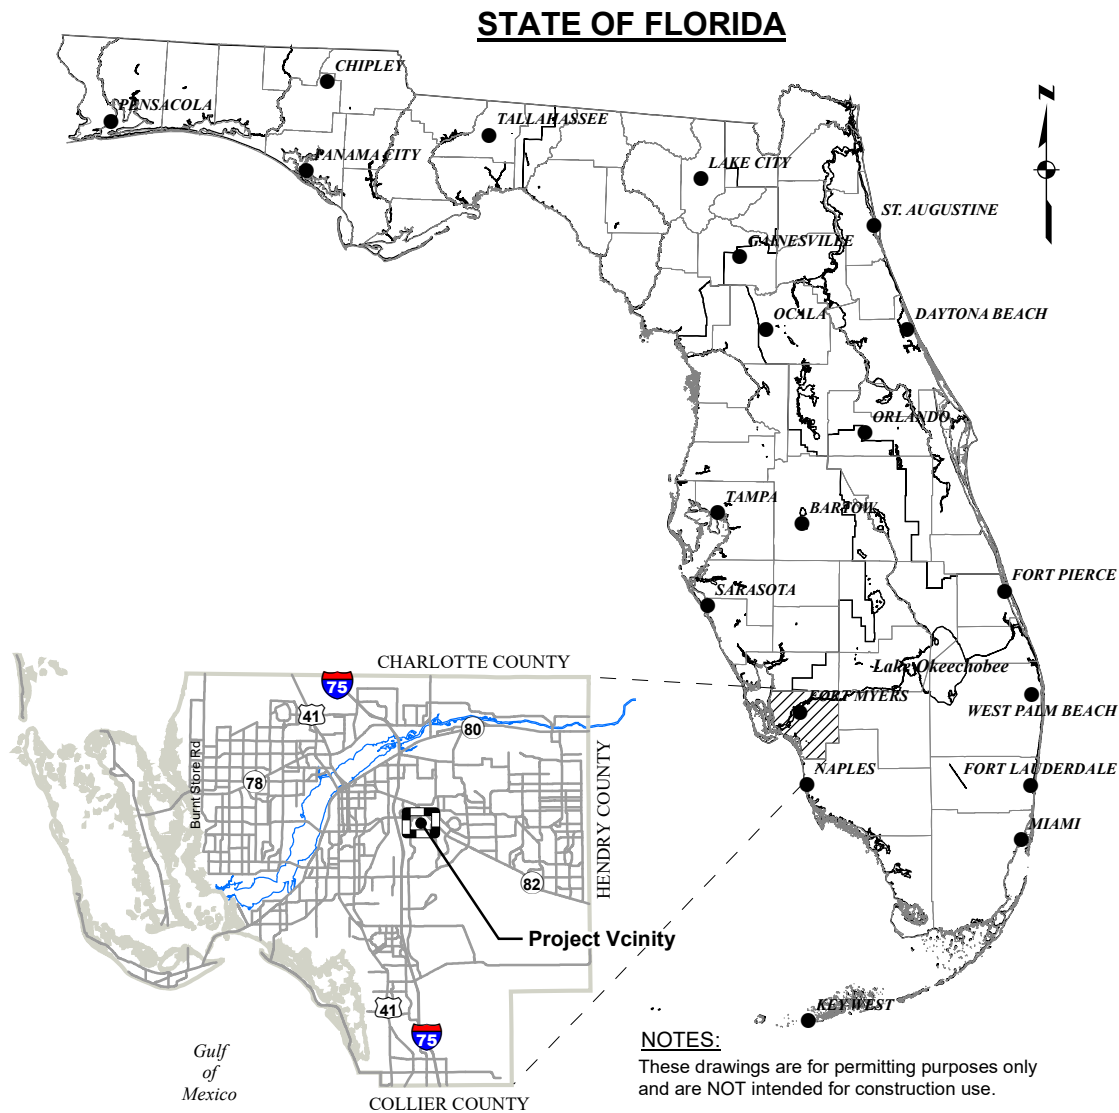
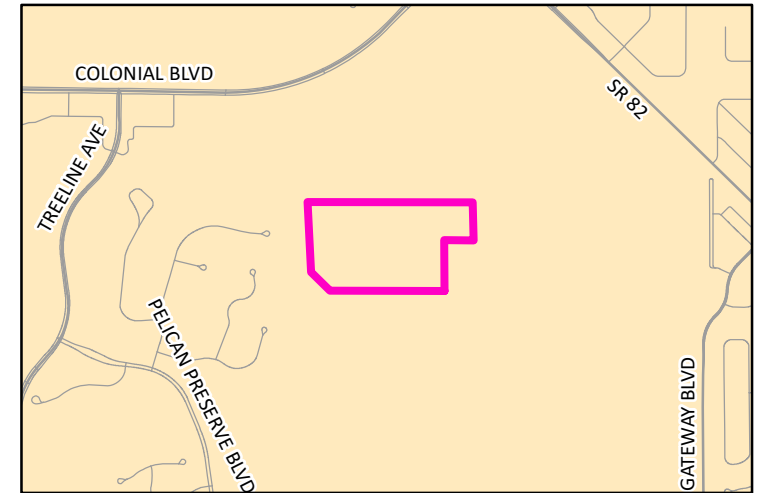
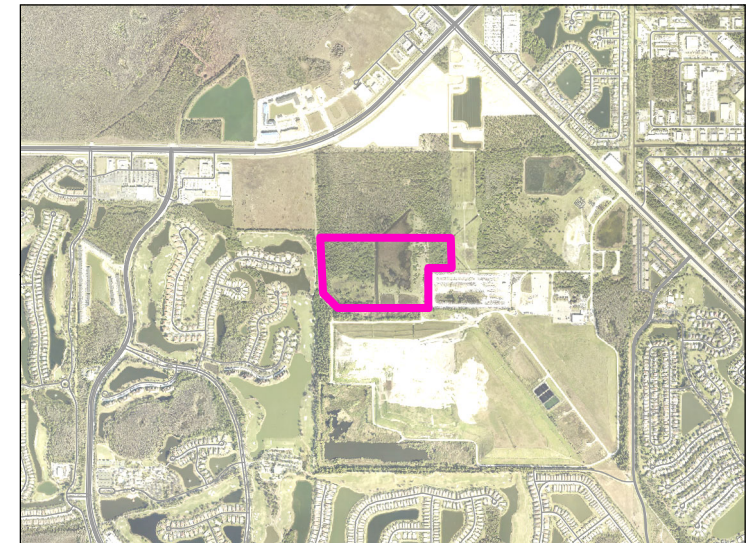
Location Map

STREET MAP
N.T.S.

VICINITY AERIAL
N.T.S.

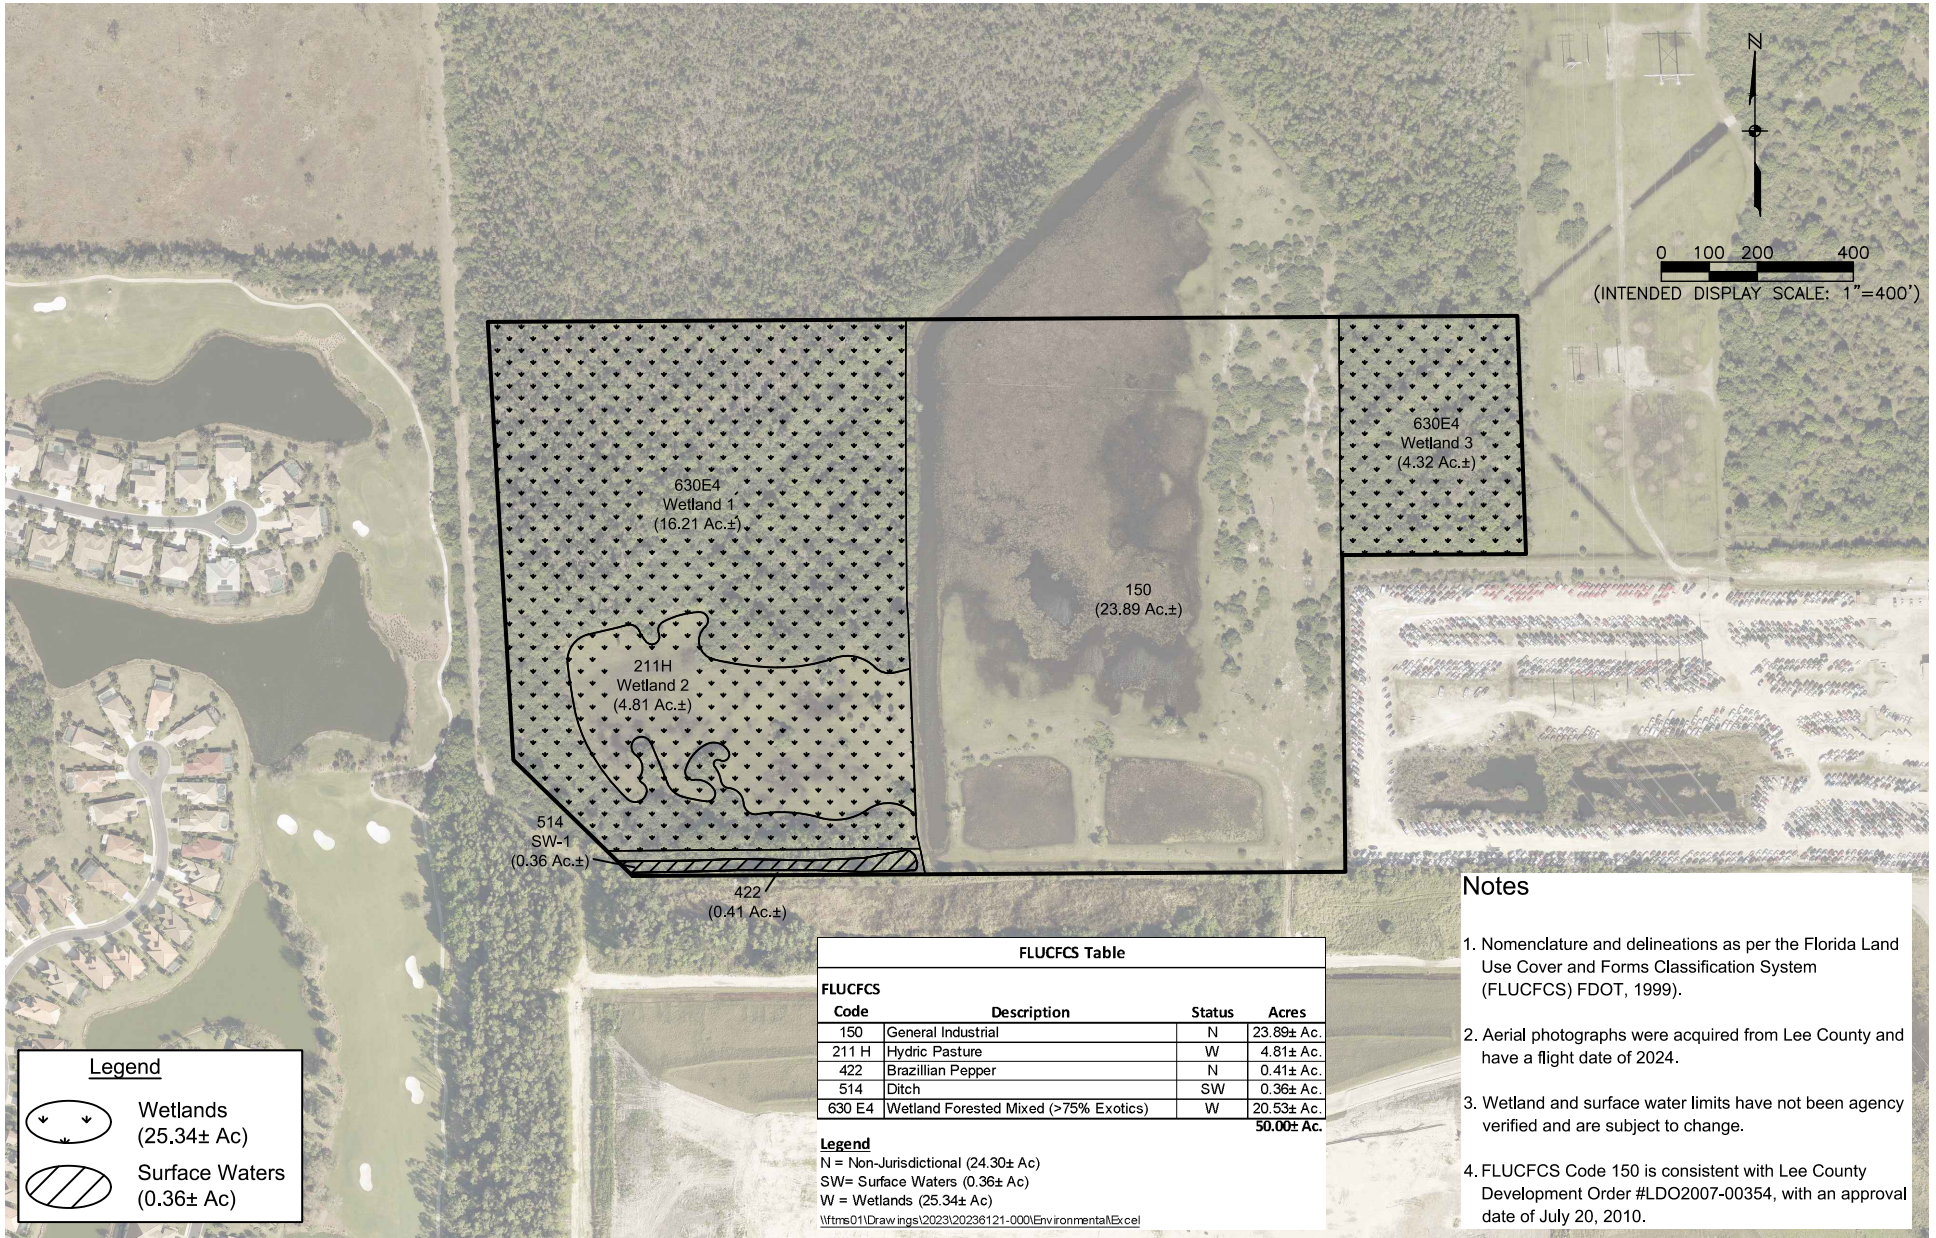
\\fms01\Drawings\2023\20236121-000\Environmental\Exhibits\AOE Env Permit.dwg (FLUCFCS Map) bkm Oct 21, 2024 - 9:04am

Surface Waters
(0.36± Ac)

FLUCFCS Table				
FLUCFCS				
Code	Description	Status	Acres	
150	General Industrial	N	23.89± Ac.	
211 H	Hydric Pasture	W	4.81± Ac.	
422	Brazilian Pepper	N	0.41± Ac.	
514	Ditch	SW	0.36± Ac.	
630 E4	Wetland Forested Mixed (>75% Exotics)	W	20.53± Ac.	
			50.00± Ac.

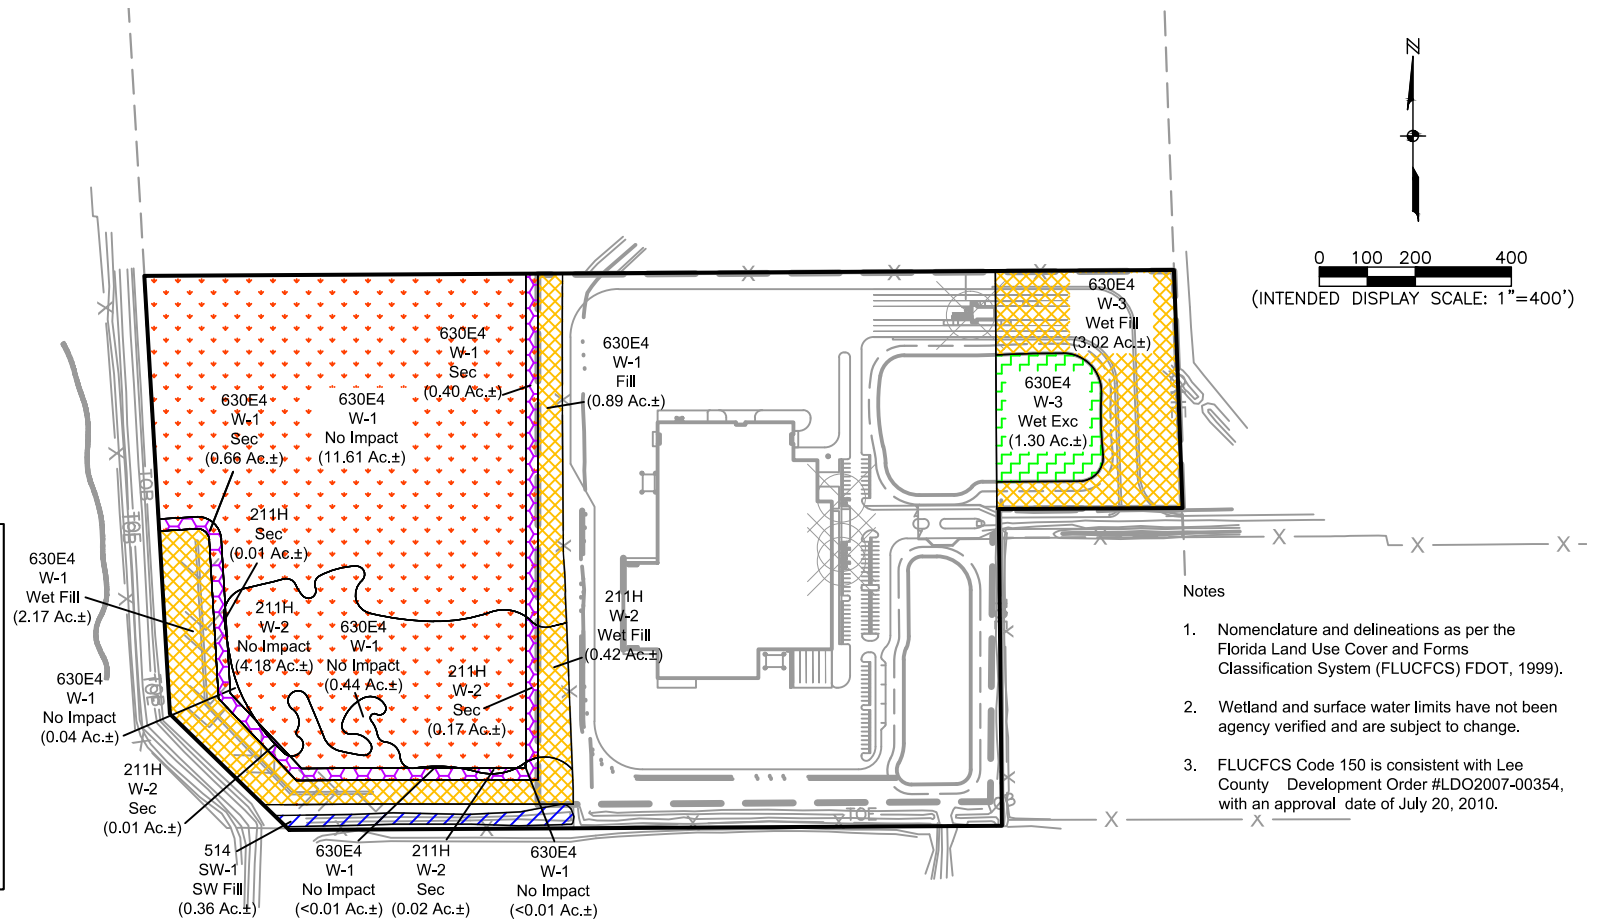
\\ftms01\Drawings\2023\20236121-000\Environmental\Exhibits\A00E Env Permit.dwg (Impact Map) bkm Oct 21, 2024 - 2:52pm

Impact Table							
FLUCFCS Code	Description	Status	Wetland Fill	Wetland Excavate	Wetland No Impact	SW Fill	Secondary Impacts
211 H	Hydric Pasture	W	0.42± Ac.	-	4.18± Ac.	-	0.21± Ac.
514	Ditch	SW	-	-	-	0.36± Ac.	-
630 E4	Wetland Forested Mixed (>75% Exotics)	W	6.08± Ac.	1.30± Ac.	12.09± Ac.	-	1.06± Ac.
			6.50± Ac.	1.30± Ac.	16.27± Ac.	0.36± Ac.	1.27± Ac.
			25.70± Ac.

SW= Surface Waters (0.36± Ac)
W = Wetlands (25.34± Ac)

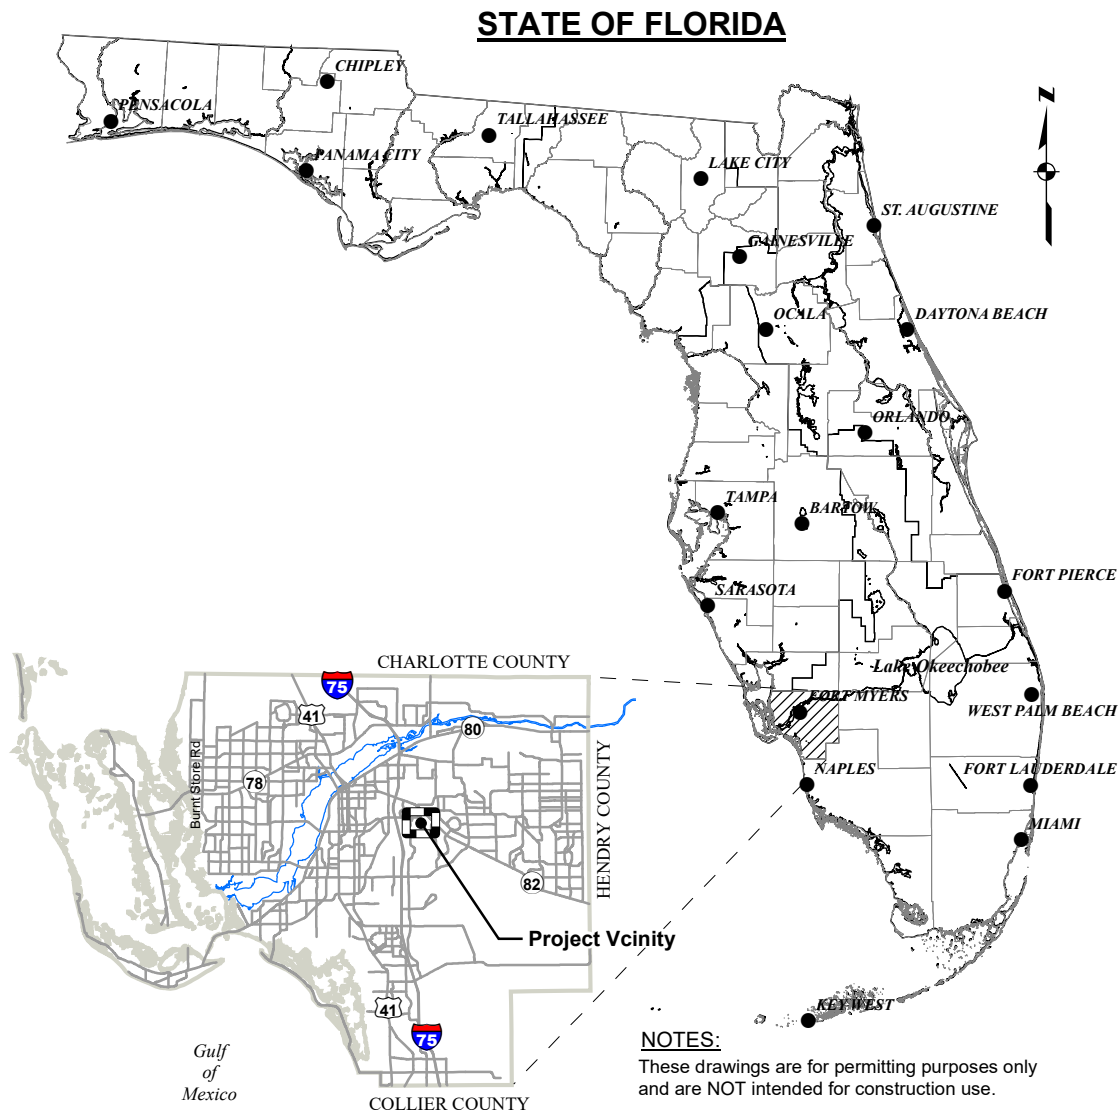
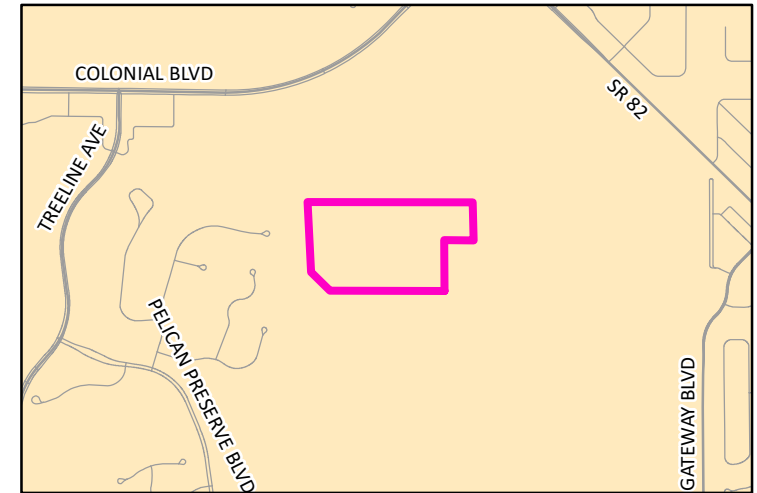
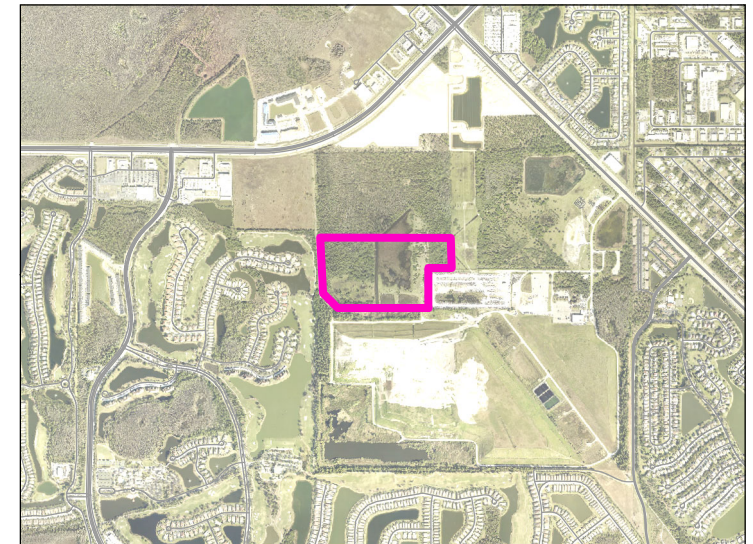
STREET MAP
N.T.S.

VICINITY AERIAL
N.T.S.

Johnson Engineering ecologists conducted a protected species survey (PSS) in the project boundary on August 23, 2024. Pedestrian belt transects were established to cover a minimum of 80% of each suitable habitat. This report represents the results of the PSS prepared in accordance with methodologies outlined by the Florida Fish and Wildlife Conservation Commission (FWC), U.S. Fish and Wildlife Service (FWS) and Lee County Land Development Code, Chapter 10, Article 3, Division 8 (Protection of Habitat). For a Location Map, please see **Figure 1-1**.

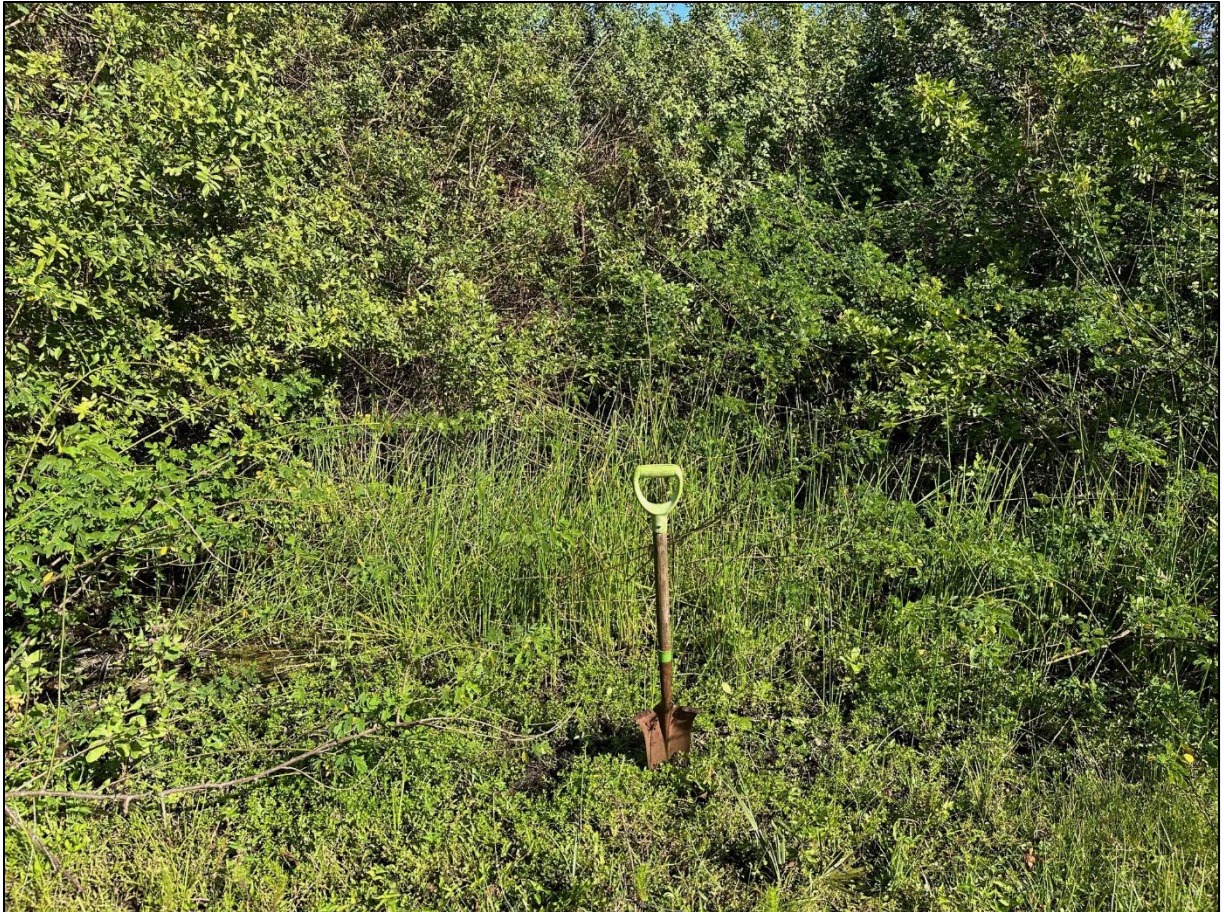
Wetland Data Point “WDP-1” (Wetland Forested Mixed; FLUCFCS 630E4)
See attached map for data point location.

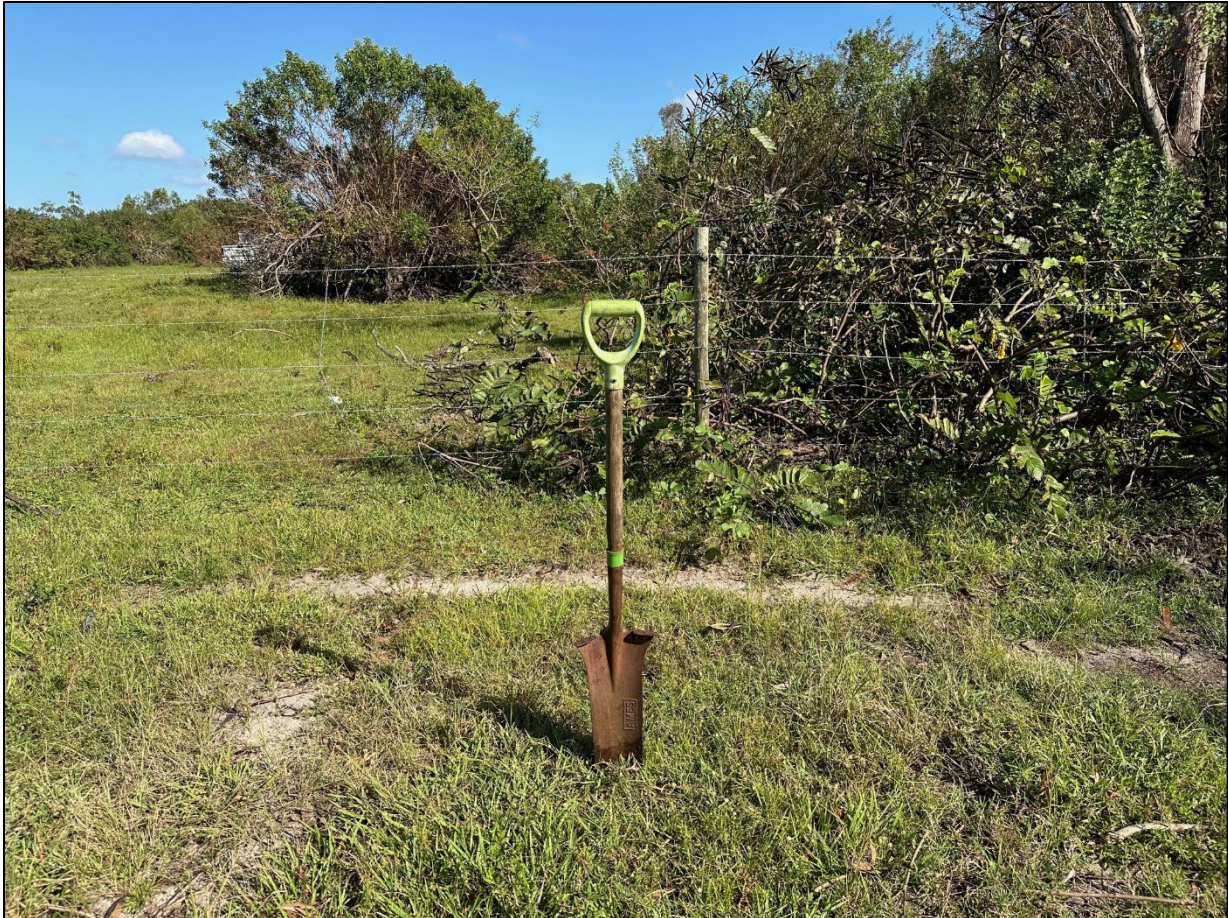
Wetland Data Point “WDP-2” (General Industrial; FLUCFCS 150)
See attached map for data point location.
