Lee County
Southwest Florida

**FINAL
POST STORM FLOOD ASSESSMENT
ANALYSIS**

**Bayshore Creek Watershed
Nalle Grade Road
Popash Creek Watershed
Strouds Creek Watershed
Whiskey Creek Watershed**

FEBRUARY 28, 2018

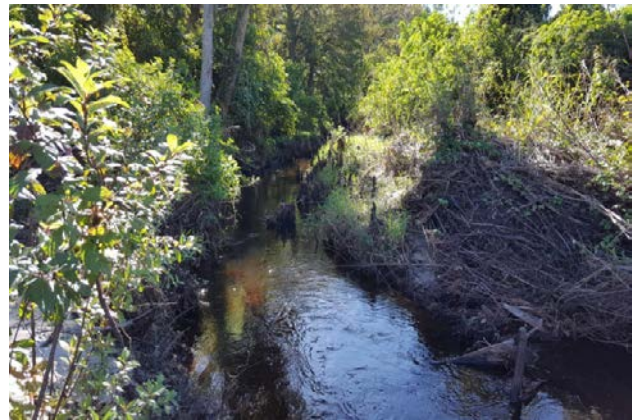
South culvert of Bayshore Road looking downstream.
*Data Point 1495 Lat: 26.71478 Long: -81.8217

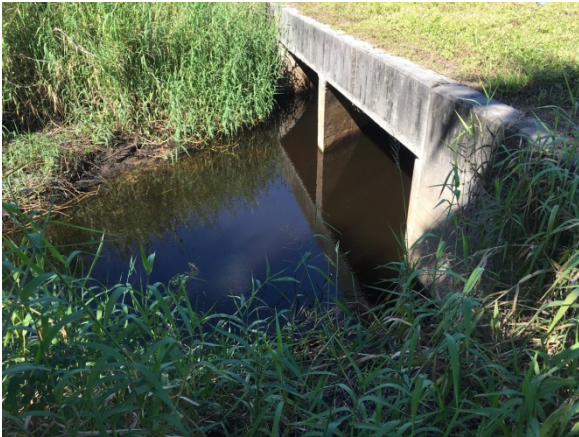
Southern culvert outlet showing 50% blockage due to overgrowth and sediment build up at I-75.
*Data Point 1526 Lat: 26.72235 Long: -81.82409

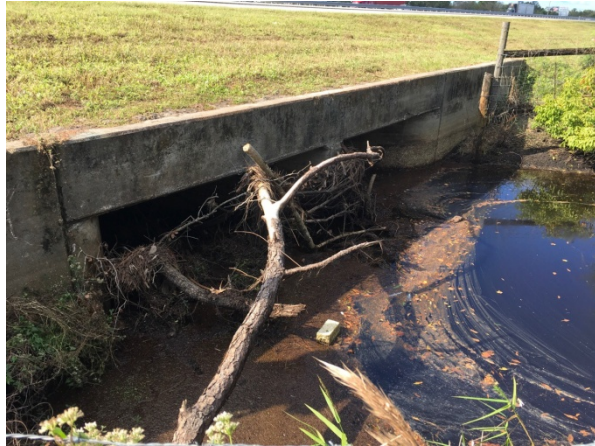
Northern culvert holding debris at I-75.
*Data Point 1525 Lat: 26.72235 Long: -81.82409

- The creek up and downstream views are clear of debris and vegetation. Although, some debris was collected at the culvert and chocking the optimal flow conditions.

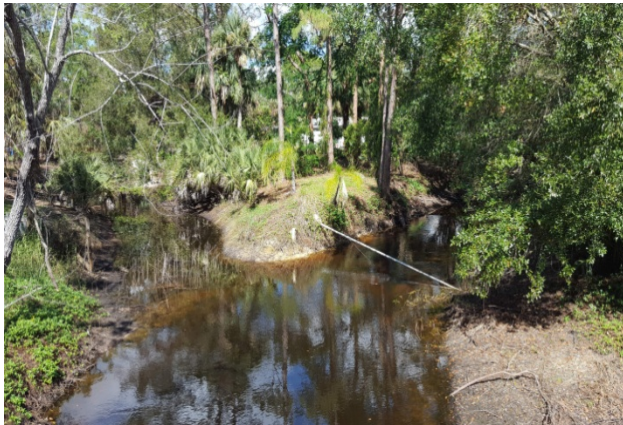
Looking North on Daughtrey's Creek Bridge.
*Data Point 219 Lat: 26.7553 Long:-81.8514

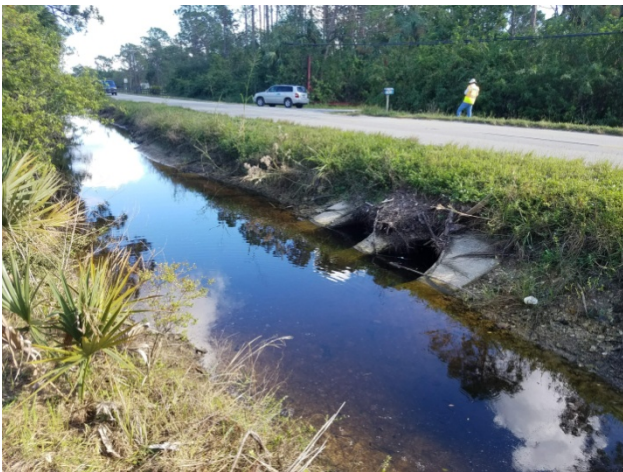
North side of Nalle Grade Road looking West.
*Data Point 1586 Lat: 26.7555 Long: -81.8350

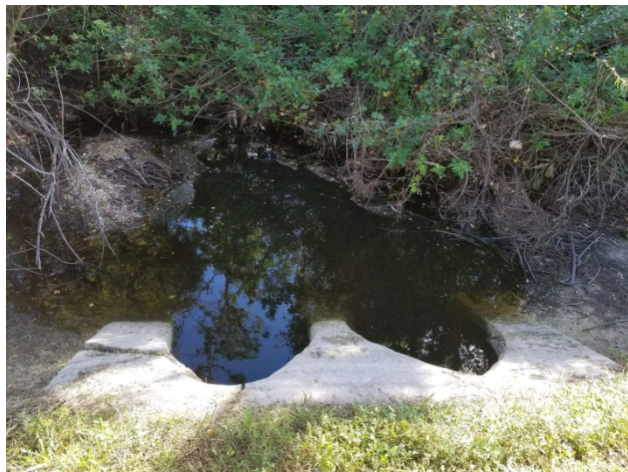
Drainage of Daughtrey's Creek East Branch south of Nalle Grade Rd
*Data Point 1583 Lat: 26.7555 Long: -81.8350

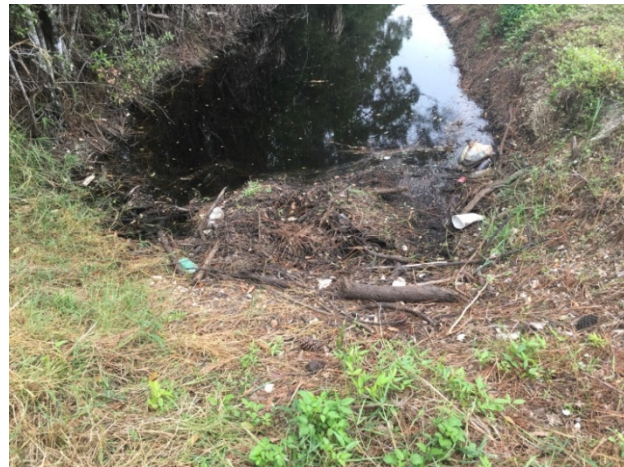
Debris build-up restricting flow on Nalle Grade Road.
*Data Point 1014 Lat: 26.7555 Long: -81.8299

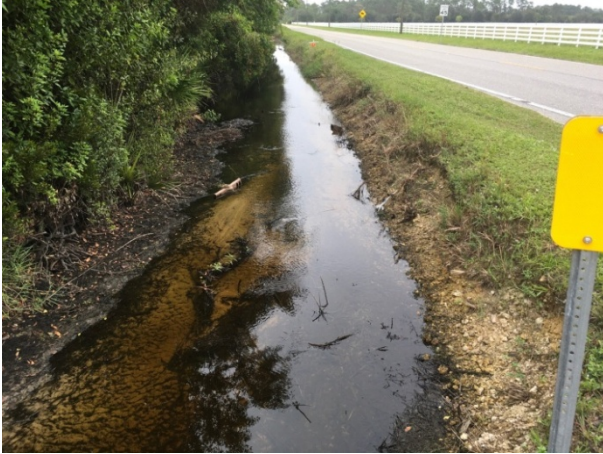
Looking East on East side of Nalle Grade Road and Williams Drive.
 *Data Point 849 Lat: 26.7555 Long: -81.8260

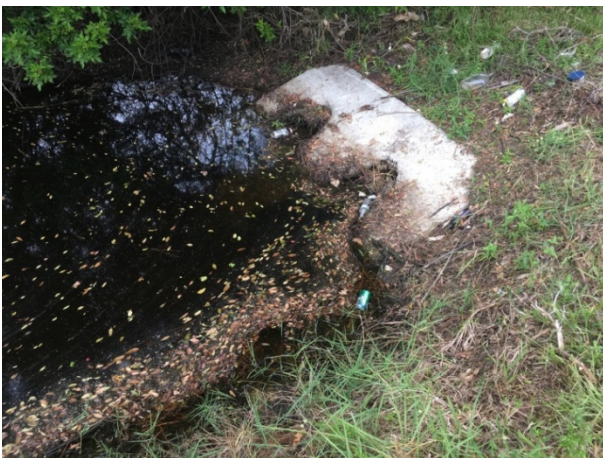
Moving East on Nalle Grade Road from Williams Dr. this is the West side of the next driveway culvert.
 *Data Point 1766 Lat: 26.7554 Long: -81.8251

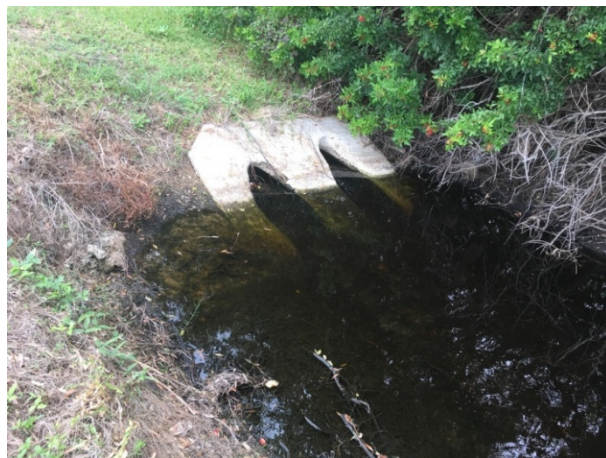
Moving East on Nalle Grade Rd from Williams Dr, this is the East side of the next driveway culvert.
 *Data Point 1766 Lat: 26.7554 Long: -81.8251

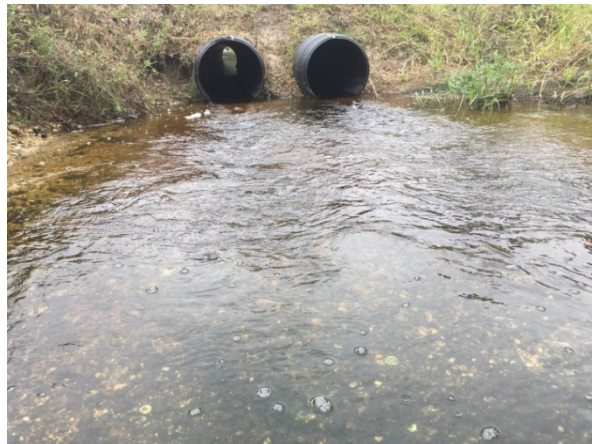
*Data Point 1771 Lat: 26.7554 Long: -81.8221

East side of Nalle Grade Road and Bowen Road.

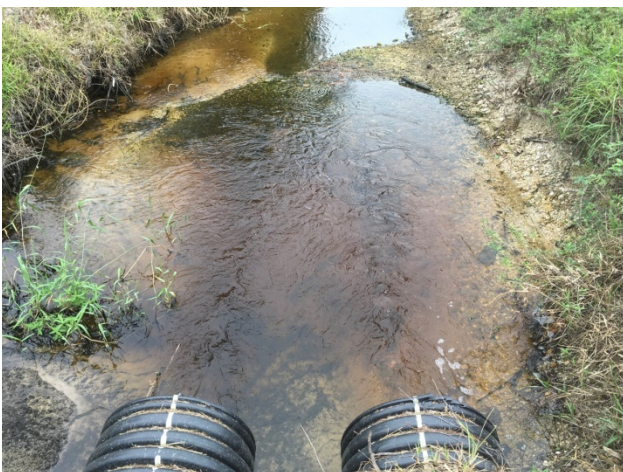
*Data Point 1771 Lat: 26.7554 Long: -81.8221

Sediment builds up creating a weir on East side of Nalle Grade Road and Bowen Road.

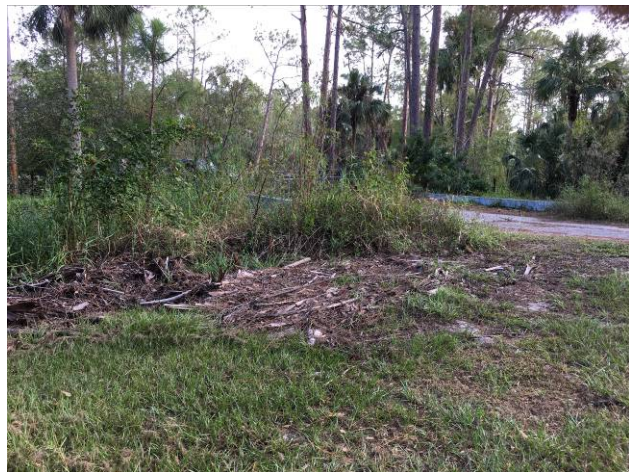
*Data Point 927 Lat: 26.735332 Long: 81.793871

Debris indicating high water elevation

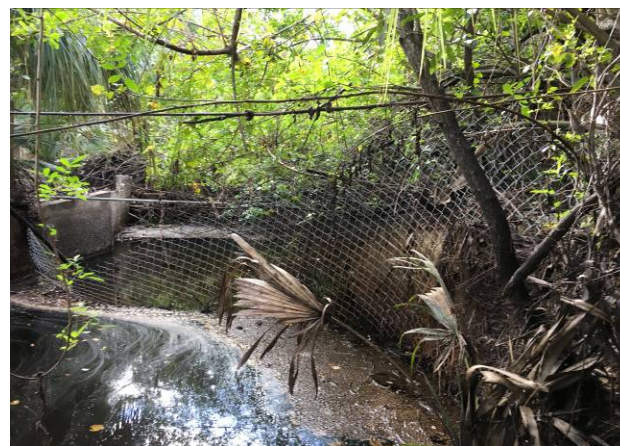
*Data Point 655 Lat: 26.728356 Long: 81.798988

Looking south water gap fence debris behind

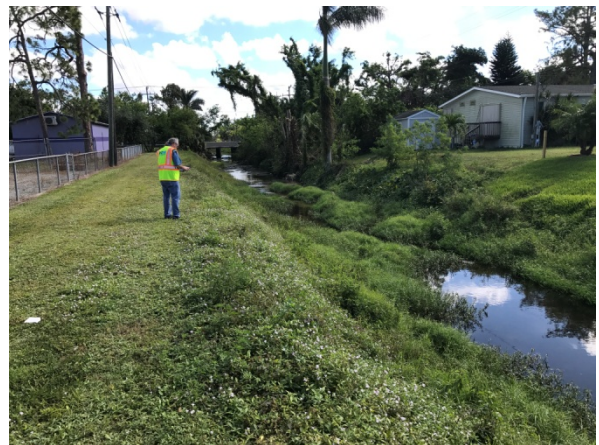
*Data Point A15 Lat:26.57544139 Long:-81.86835359

Looking east, L canal west of Danley Dr.

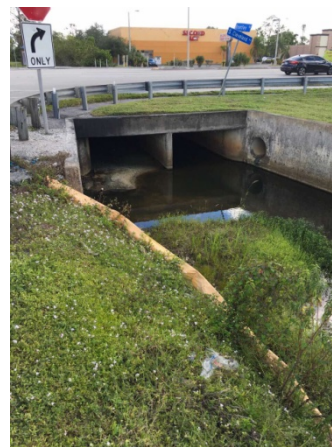
*Data Point A22 Lat:26.56086999 Long:-81.87213511

Brantley canal west of US 41.
