**LEE COUNTY, FLORIDA
SHORE PROTECTION PROJECT**

**GASPARILLA ISLAND SEGMENT
2019 BEACH RENOURISHMENT**

YEAR 1 POST-CONSTRUCTION MONITORING REPORT

**U.S. ARMY CORPS OF ENGINEERS
JACKSONVILLE DISTRICT**

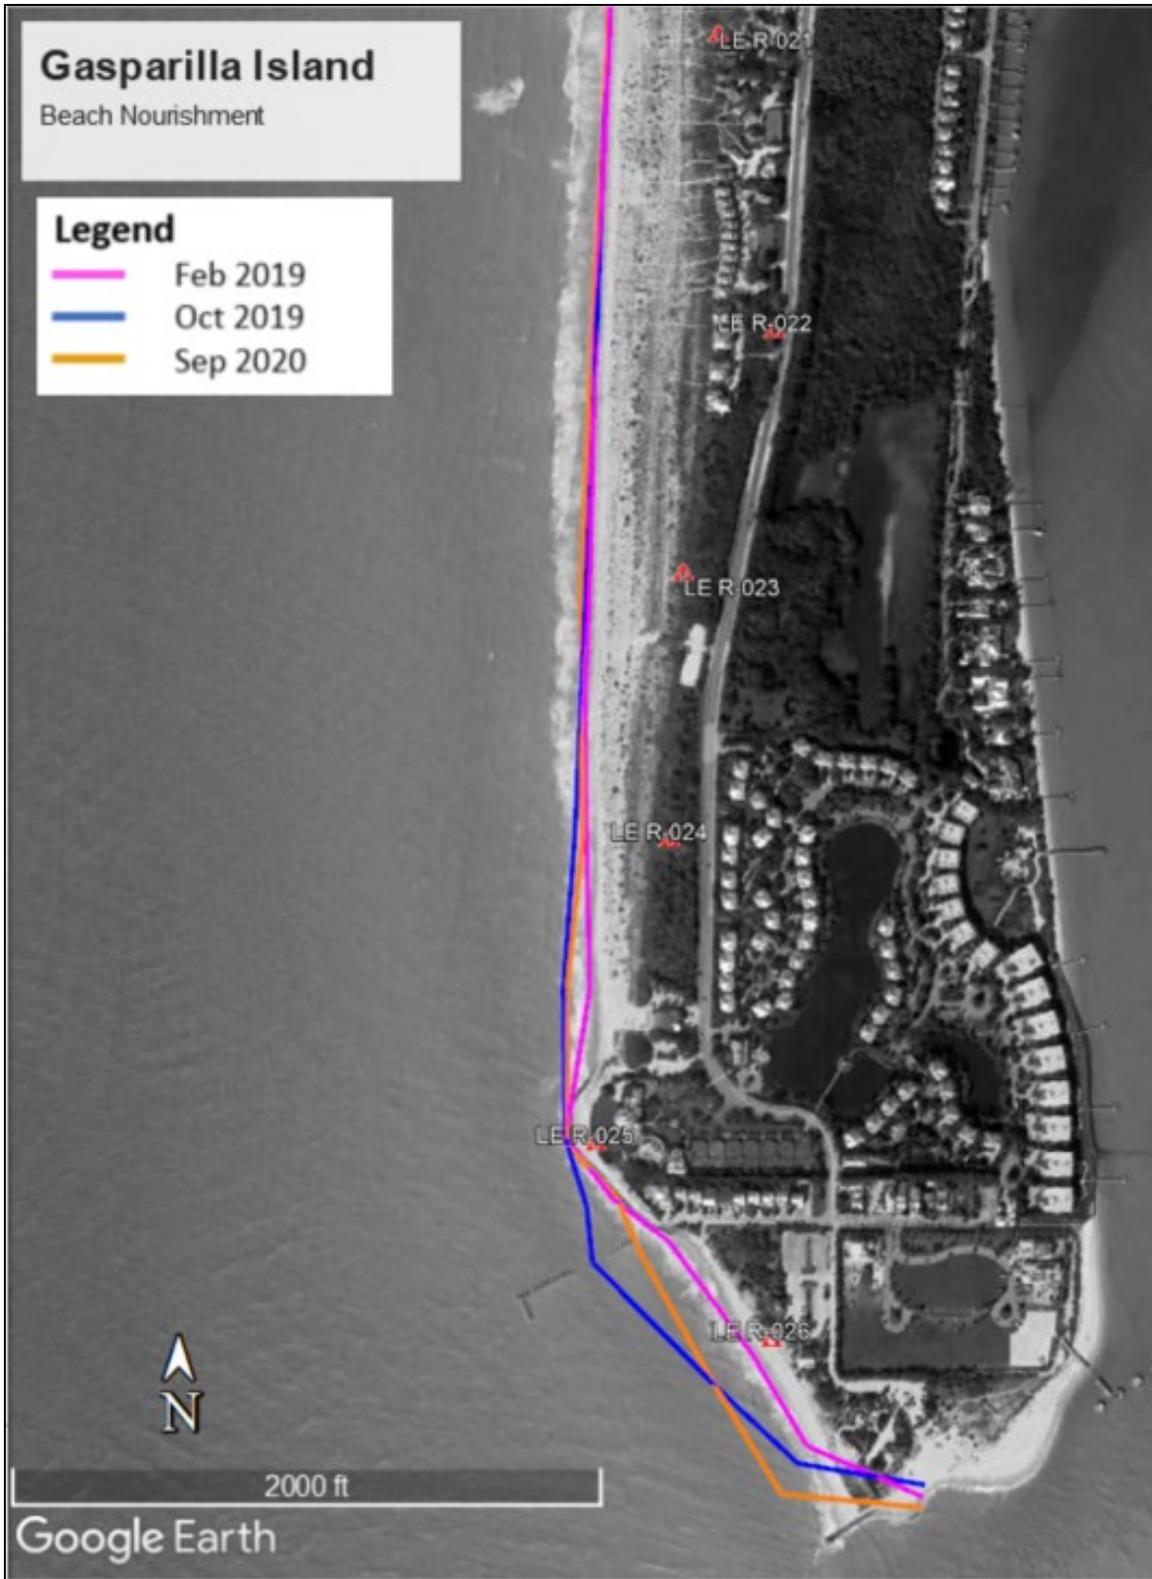
Figure 13: MHW Position from February 2019 to September 2020 from R-21 to R-26 (Aerial Dated 1 Jan 2019)

The non-federal project fill area (R-24 to R-26.5) had MHW position changes ranging from 162 ft of shoreline retreat to 113 ft of shoreline advance. The shoreline retreat was concentrated in one area from R-25.25 to R-25.5. This area is located along the south portion of the revetment and, as seen in **Figure 13**, the shoreline has retreated all the way back to the structure in this location. The material that has eroded in this area has drifted south and gathered between R-26 and the terminal groin at R-26.5. Based on historical patterns, it is likely that this material will slowly erode from this area back into the inlet shoal complex.
