LeeTran Transfer Stations

Fort Myers Beach Park and Ride
Cape Coral Transfer Station
Rosa Parks Transportation Center
Edison Mall Transfer Station

February 2022

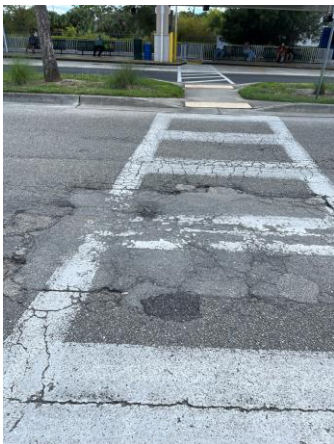
The changes in vertical elevation in the accessible route are tripping hazards for users.

Repave the area of the sidewalk to remove the bump. Ensure that the change in level does not exceed 1/4".

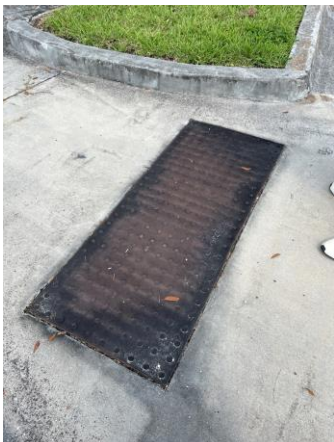
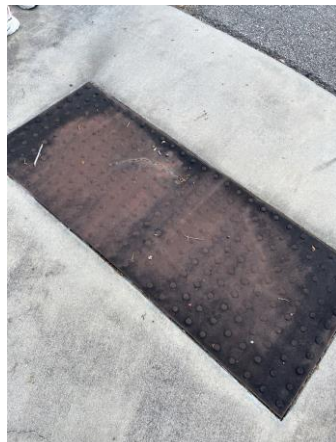
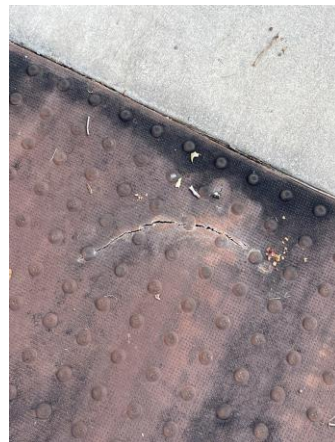
The detectable warnings are cracked and uplifting which may act as a tripping hazard.

Replace the detectable warning. Ensure that it contrasts visually with the adjacent surface with either light-on-dark, or dark-on-light.

Ensure that the change in level does not exceed 1/4" and that the detectable warning is flush with the surface of the sidewalk to ensure that it does not act as a tripping hazard.
