June 2025

Lee County Bridge Inspection Report

Subject: Lee County General Inspection of Transportation Facilities – 2025 Report

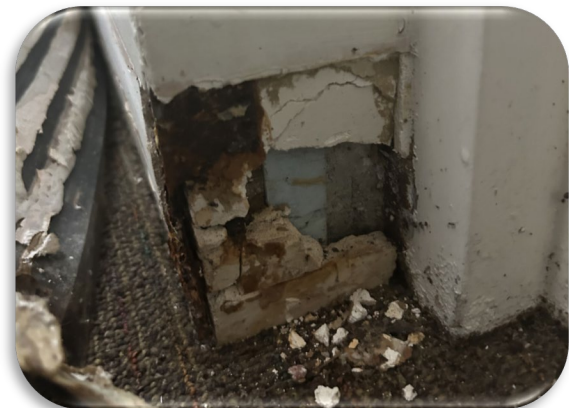
In October 2021 the previous count room located at the west end of the administration building was converted into a meeting room. As a result of the water damage from Hurricane Ian, there is damage to and behind the rubber baseboard at the west end emergency exit of the administrative building, which is scheduled with maintenance to be repaired.

Figure 11: Damaged Baseboard at West End Administration Building Exit

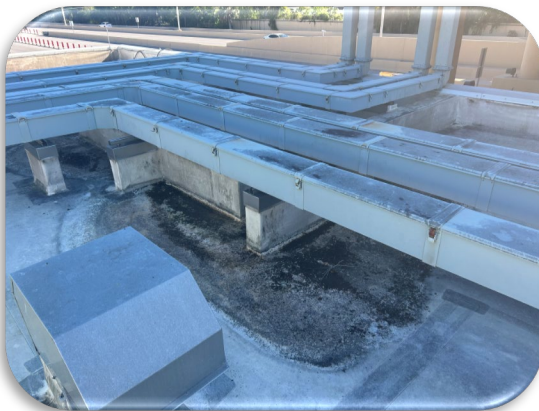
The latex membrane roof of the administrative building appears to be in good condition overall. There are signs of low areas that pond water near the central portion of the roof below the communications wire conduits. However, there were no signs of leakage on the interior of the building associated with these areas. The stagnant water traps debris and promotes algae growth, which can create a slippery walking surface. The portion of the roof above the conference room was resealed in 2015 and is still in good condition.

Figure 12: Administration Building Roof - Signs of Ponding

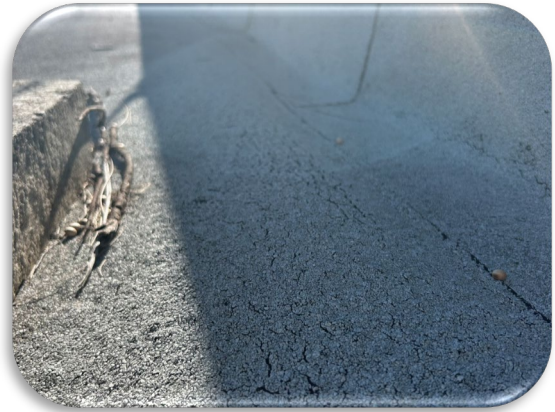
The toll canopy has a rolled asphalt roof covering that appears to be in good condition, though there are several locations where the material has lifted at the seams and is beginning to split. This can create an opening for water intrusion. Additionally, there are areas of the rooftop which exhibit blistering. The roof surface slopes towards the east side of the canopy, where it drains through an interior downspout. The rooftop drains are collecting dirt, debris, and vegetation, and are scheduled to be cleared and unclogged.

Figure 17: Toll Canopy Roof Blister

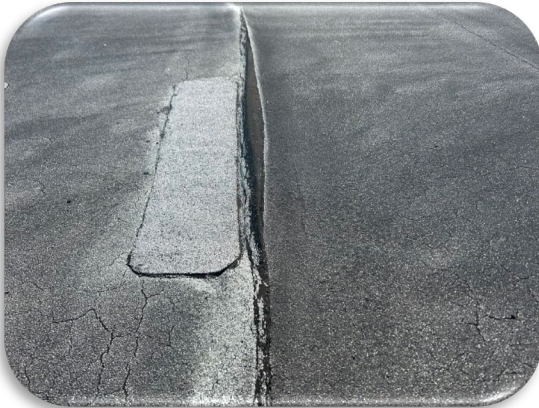
Figure 18: Toll Canopy Roof Covering Lifted at Seams

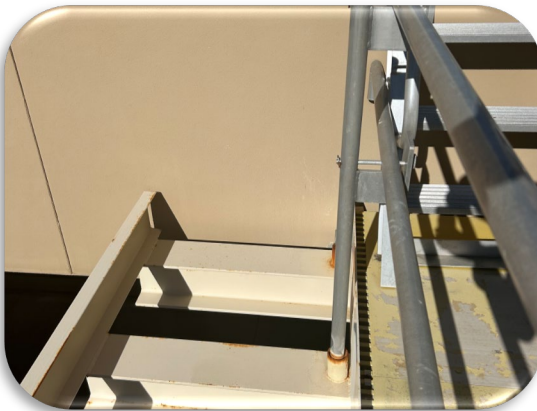
The administration building appears to be in very good structural condition, with no indications of structural distress observed. The concrete toll canopy frame and columns, and the highway-speed toll gantry are in good condition. Minor to moderate surface corrosion exists sporadically throughout the steel toll gantry structure.

Figure 20: Moderate Surface Corrosion at Toll Gantry Handrail Base

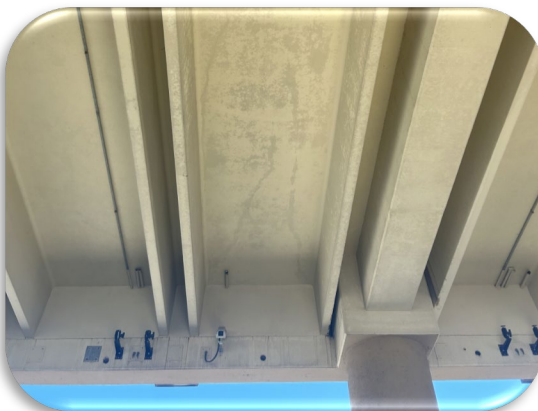
There are moderate cracks at the ends of the concrete traffic barrier islands separating the westbound lanes. The toll canopy precast prestressed canopy double tee beams exhibit longitudinal top flange cracks toward beam ends, observable from underneath the structure, with no sign of efflorescence or rust staining.

Figure 22: Toll Canopy Beam Top Flange Longitudinal Cracks

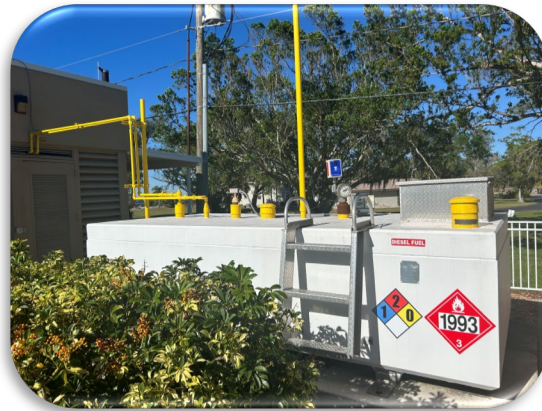
The standby generator for this facility was replaced in 2017. It is tested under load automatically on a weekly basis and is serviced monthly to ensure it is always in working condition. The automatic transfer switch was replaced in 2014 with a Cummins model to correct a problem with the outdated, unsupported switch. The 1,000-gallon capacity above ground diesel fuel tank for the generator appears to be in good condition and was repainted in 2024. Some of the miscellaneous hardware supporting the fuel tank exhibits light surface corrosion.

Figure 27: Recently Painted Diesel Fuel Tank

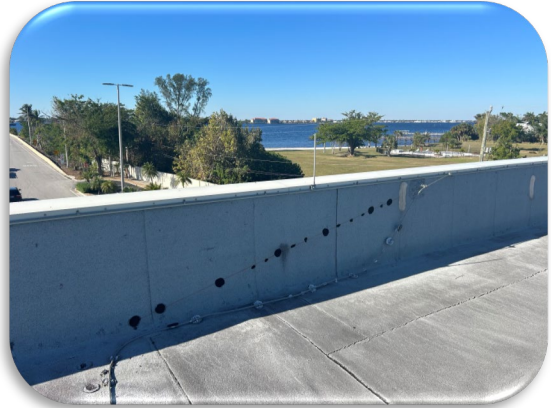
The security camera and monitoring system was in good condition and operating in appropriate areas of the administration building and toll plaza. Previously, ten Closed Circuit Television (CCTV) cameras were upgraded throughout the facility to new digital cameras, including cameras inside the toll booths which have since been removed. The lane monitoring cameras are in like new condition. On the roof of the administration building and toll canopy, lightning rod systems are installed and appear to be functioning properly. Isolated areas of the lightning protection system

have become unmounted from their installation locations, but this does not appear to inhibit performance.

Figure 29: Toll Canopy Roof Lightning Rod System

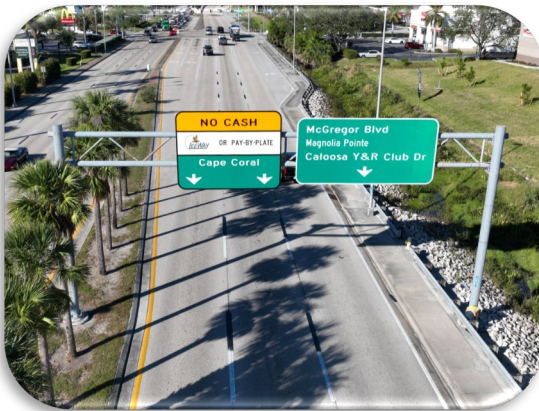
The first miscellaneous structure is a dual-chord overhead span sign structure located approximately 1¼ miles east of the toll plaza. There are areas with minor loss of the galvanizing coating on the uprights, truss chords, and splice connections, as well as moderate to severe corrosion on the electrical conduits and their mounting hardware. The baseplates exhibit minor corrosion at isolated locations. In several locations scratches and small areas of missing coating have been retouched with spray galvanizing paint. Overall, this structure appears to be in good condition.

Figure 39: Cape Coral - WB OSS 1-1/4 Miles from Plaza
– Full Structure

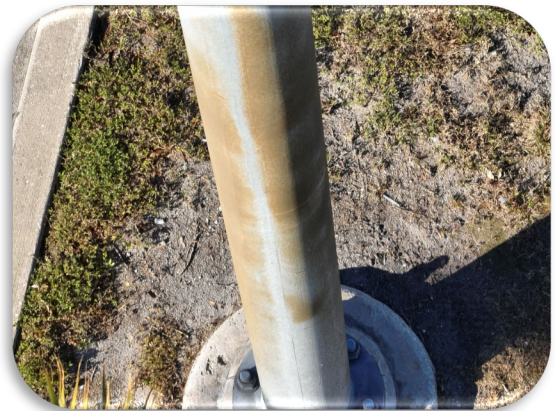
Figure 40: Cape Coral -WB OSS 1-1/4 Miles from Plaza - Loss of Galvanization on Upright

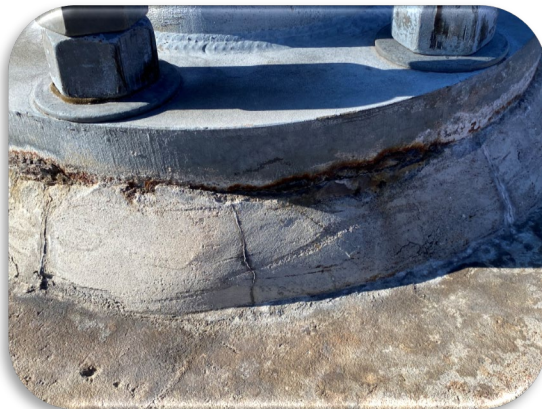
Figure 41: Cape Coral - WB OSS 1-1/4 Miles from Plaza
– Baseplate Corrosion

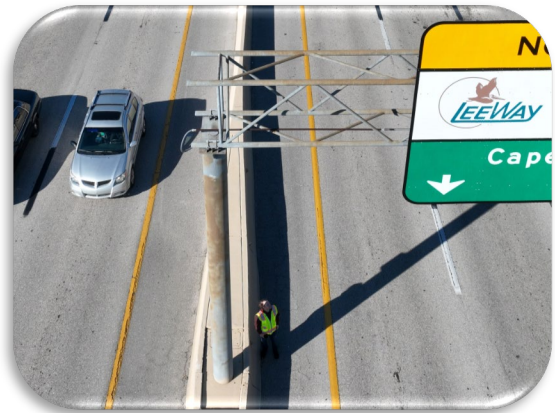
The second miscellaneous structure is a box truss overhead span sign structure located approximately 1 mile east of the toll plaza. There are areas with minor loss of the galvanizing coating on the uprights and truss chords, as well as moderate to severe corrosion on the electrical conduits and their panel boxes. There is corrosion on the upright anchor bolts/nuts and truss chord splice connection bolts/nuts. In several locations scratches and small areas of missing coating have been retouched with spray galvanizing paint. Overall, this structure appears to be in good condition.

Figure 44: Cape Coral -WB OSS 1 Mile from Plaza - Loss of Galvanization on Upright and Truss Chords

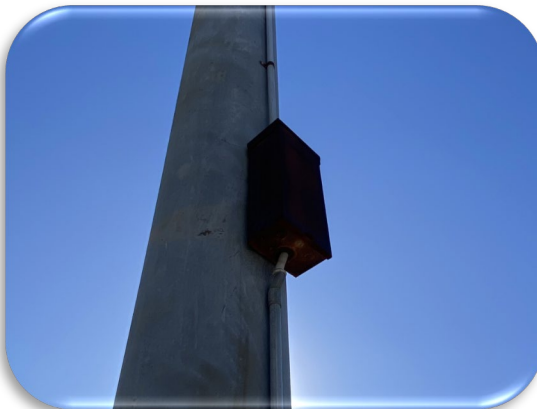
Figure 45: Cape Coral - WB OSS 1 Mile from Plaza – Electrical Panel Box Corrosion

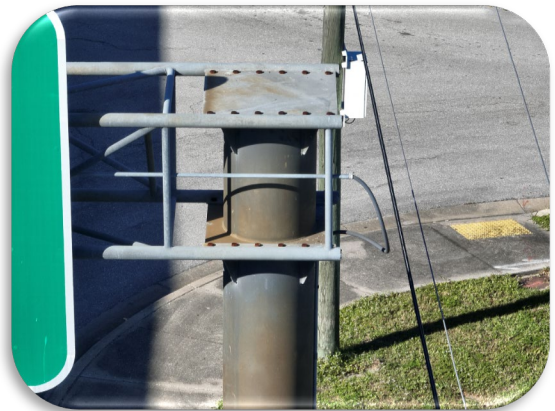
The third miscellaneous structure is a box truss overhead cantilever sign structure located approximately 0.60-miles east of the toll plaza along the service road, parallel to the westbound approach lanes. There are areas with minor loss of the galvanizing coating on the upright and truss chords, as well as light to moderate corrosion on the electrical conduits and their mounting hardware. There is light corrosion on the upright anchor bolts/nuts, top of upright connection bolts, and truss chord splice connection bolts/nuts. At the base of the upright there are scrapes, possibly due to vehicular impact, which appears to be non-structural. Overall, this structure appears to be in good condition.

Figure 48: Cape Coral -WB OSS 0.6 Miles from Plaza - Loss of Galvanization on Upright

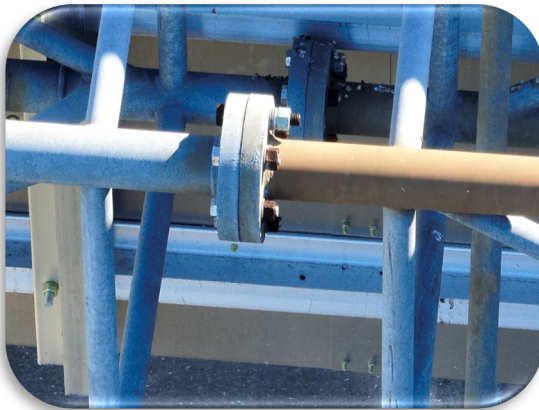
Figure 49: Cape Coral - WB OSS 0.6 Miles from Plaza – Chord Splice Connection Corrosion

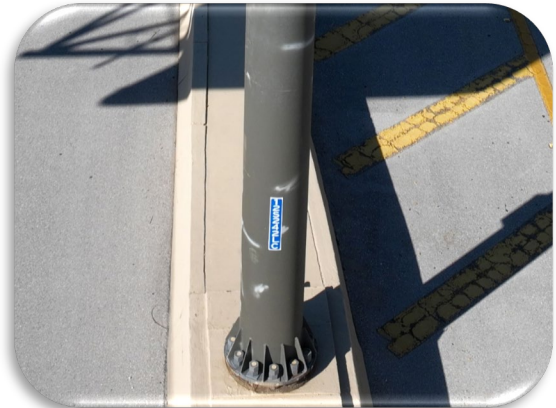
Figure 52: Cape Coral -WB OSS 1/4 Miles from Plaza – Galvanizing Paint Maintenance on Upright

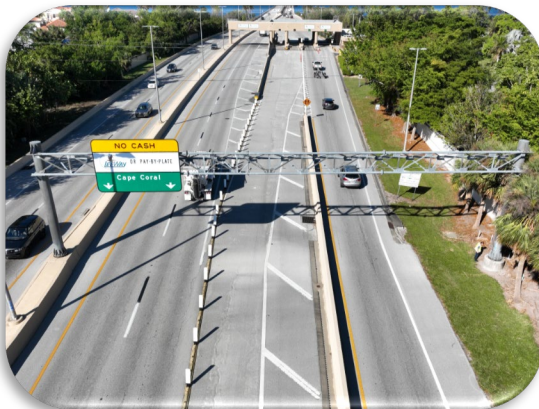
Figure 53: Cape Coral - WB OSS 100 Yards from Plaza – Chord Splice Connection Corrosion

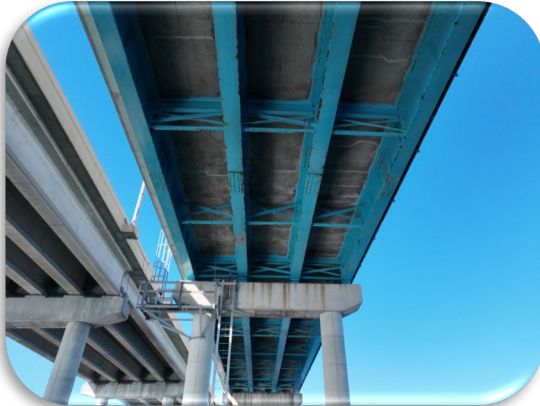
Within the biennial inspection report superstructure deficiencies include isolated areas of concrete spalls, delaminations, cracking, and surface map cracking on the top surface and underside of the deck; aluminum bridge railing and approach curb impact damage; approach slab cracks; precast concrete beam cracks, spalls, and delaminations; minor paint loss and surface corrosion on the steel girders in the main channel span (17, 18, and 19) continuous steel girders with pack rust noted along the bottom flanges at splice locations; and end diaphragm spalling with exposed corroded strands.

Figure 57: Cape Coral Bridge Westbound – Main Span Steel Girder Corrosion

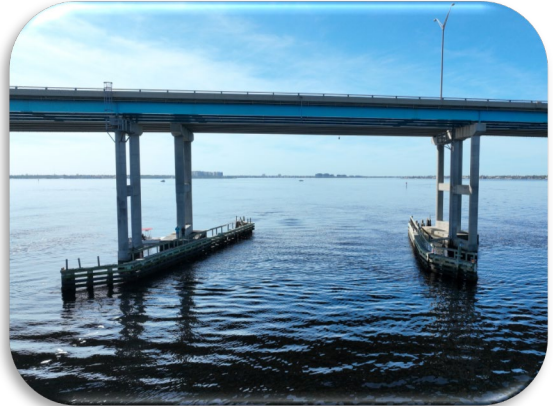
Miscellaneous deficiencies include moderate seawall concrete bulkhead cracks, spalls, and delaminations; cathodic pile jacket missing conduits and anodes; channel degradation; general widespread fender system storm damage, including pile fractures, delaminations, and spalls, missing and decayed timber wales and spacer blocks, and missing navigational clearance gauges; broken navigational light housing; minor to severe corrosion on the main span (at piers 18 and 19) access ladder system; missing safety fall protection cables; and missing traffic barrier reflectors.

Figure 58: Cape Coral Bridge Westbound – Fender System Alignment and General Deterioration

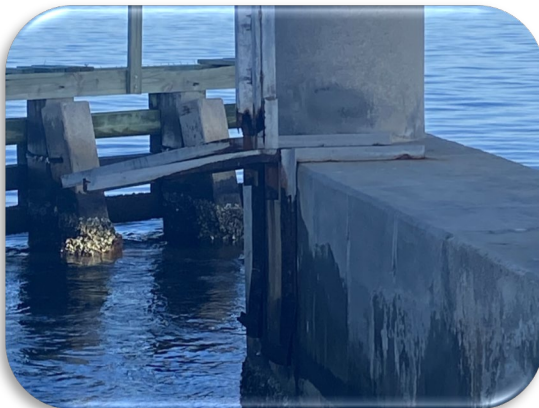
Figure 59: Cape Coral Bridge Westbound – Fender System Access Ladder Corrosion

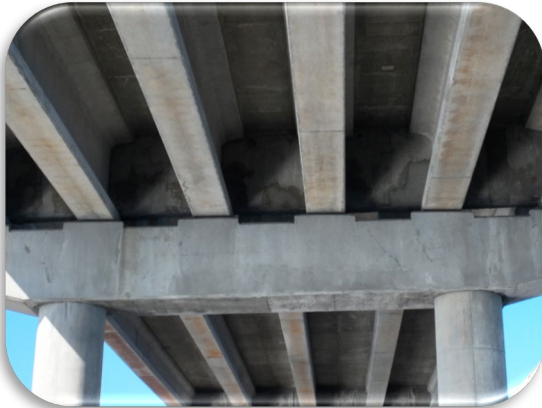
Within the biennial inspection report superstructure deficiencies include isolated areas of concrete spalls and cracks in the deck surface on the top and bottom sides of the deck; concrete bridge railing spalls, delaminations, scuff marks, and missing junction box covers; deck joint seal punctures, holes, and tears; epoxy joint header delaminations; and precast concrete beam cracks and spalls.

Substructure deficiencies include abutment cracks; pier cap and column strut cracks, pier footing cracks, spalls, delaminations, and voids; and footing pile cracks and spalls.

Figure 63: Cape Coral Bridge Eastbound – Typical Diaphragms and Pier Cap Cracking

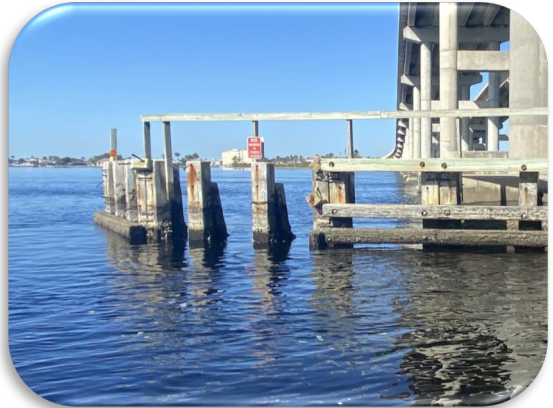
Figure 64: Cape Coral Bridge Eastbound – General Fender System Deterioration

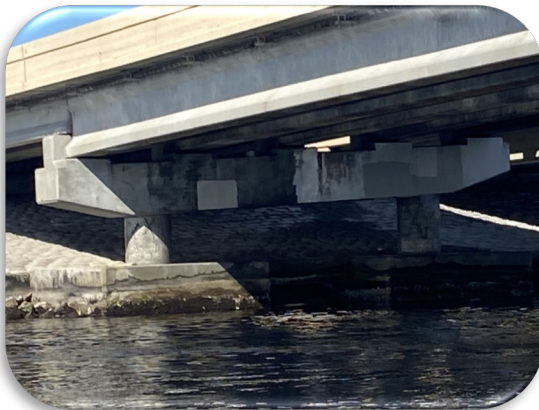
Figure 65: Cape Coral Bridge Eastbound – Painted over Graffiti on Pier Caps

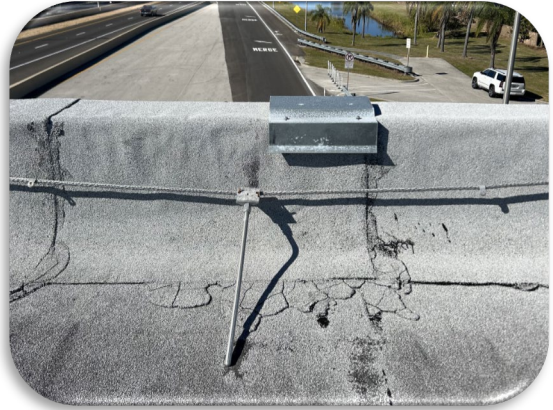
Figure 79: Typical Toll Canopy Roof Lightning Protection System Dismounted

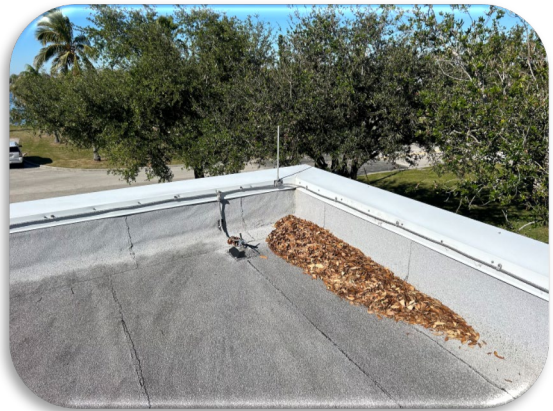
administration building roof to the toll canopy roof. The northwest corner of the administration building roof is collecting fallen leaves from the adjacent trees.

Figure 81: Administration Building Roof Vegetation

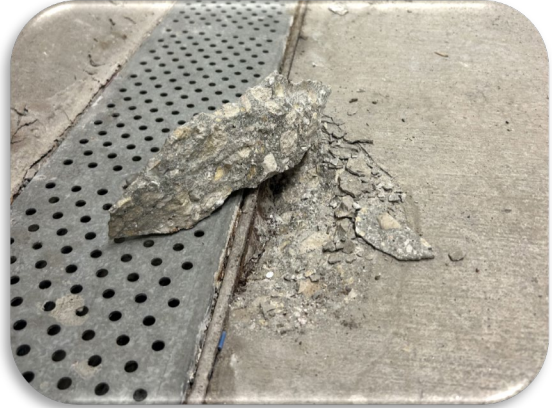
The toll collection controller cabinets are maintained along the east wall of the tunnel. A continuous trench drain runs along the tunnel floor. The trench drain has isolated locations with minor concrete spalling and moderate corrosion. A new air conditioning unit for the tunnel was installed in 2018. The metal conduit chases between each lane controller box are generally in good condition, with areas of moderate corrosion. There are sporadic minor cracks in the concrete ceiling, some with efflorescence.

Figure 83: Concrete Spalling at Trench Drain Edge

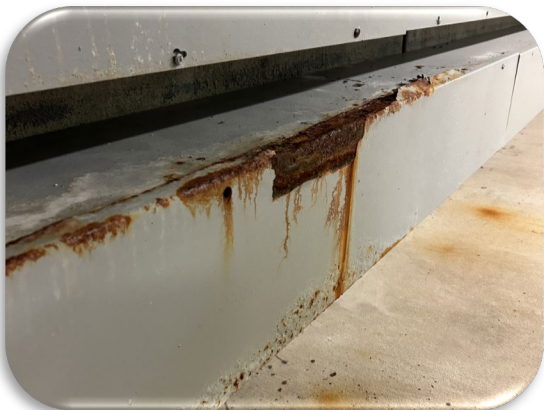
Figure 84: Metal Conduit Chase Corrosion

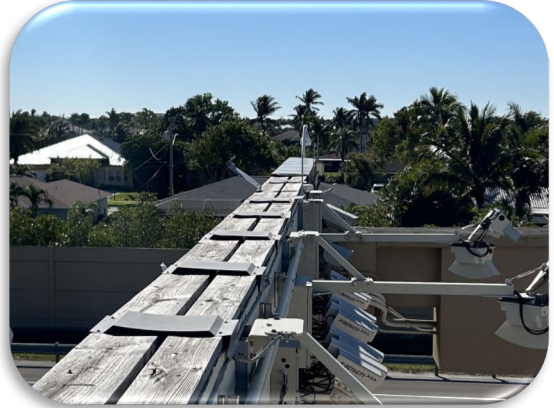
The administration building, tunnel, concrete canopy facade, canopy columns, toll booth, concrete islands and vehicle impact attenuators all appear to be in very good structural condition. No indications of structural distress were observed outside of the tunnel cracking and sporadic concrete island cracking. The tunnel and toll canopy were reconstructed as part of the toll plaza reconfiguration and are both in very good condition. Mild to moderate surface corrosion was noted on the steel girders on the east side of the toll gantry. The west side of the gantry structure has missing and loose flashing at the coping. The loose handrail noted during the last inspection has since been corrected. The metal toll gantry access stairs have moderate corrosion and there is concrete spalling at the lightning protection anchorage near the stairs.

Figure 87: Toll Gantry – West Side Missing and Loose Flashing at Coping

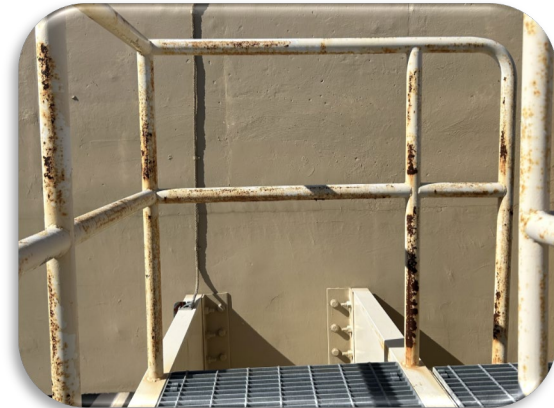
Figure 89: Toll Gantry Stairs Corrosion

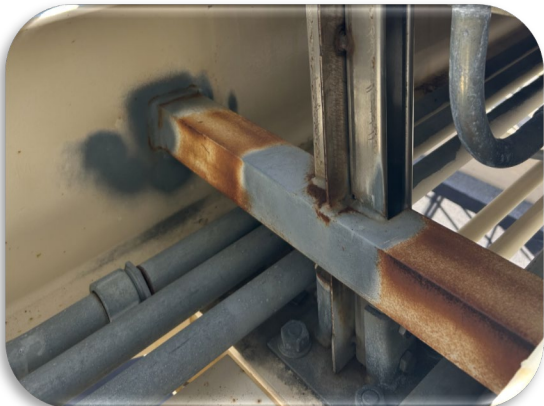
Figure 90: Toll Gantry – East Side Member Corrosion

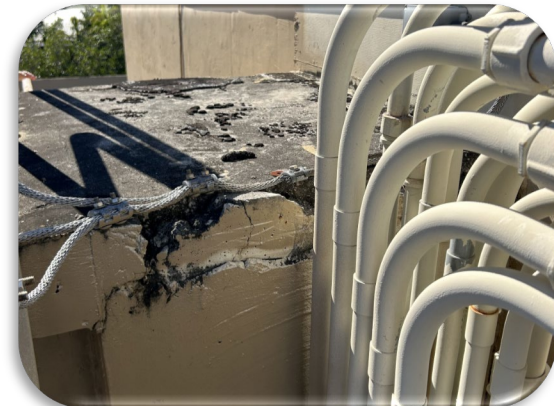
Figure 91: Toll Gantry – East Side Lightning Protection Anchorage Spalling

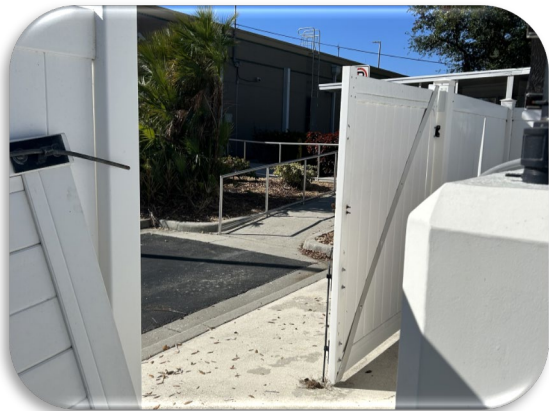
The standby generator for this facility is in good condition and is tested automatically for 30 minutes under load on a weekly basis. In October 2023 an online monitoring service was implemented for the standby generator. A replacement generator has been ordered. Midpoint's generator and transfer switch are scheduled for replacement in 2025. The above ground fuel storage tank is also in good condition. The white vinyl fence enclosure previously encompassing the fuel storage tank was damaged during Hurricane Ian and is scheduled for repair.

Figure 99: Typical Fuel Storage Tank Enclosure Damage

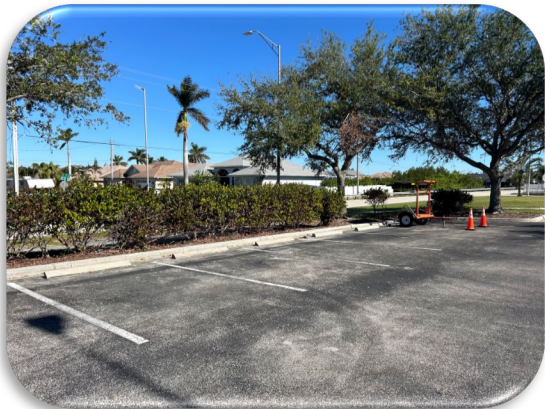
The asphalt concrete employee parking area was resealed in 2017 and appears to be in a reasonable condition, with signs of wear. Striping for the parking spaces is also showing signs of degradation but considered to be in an acceptable retroreflective condition, with 27 regular and 2 handicap-only spaces delineated. Additional street lighting was added to the parking lot in 2018.

Figure 102: Employee Parking Lot Pavement and Striping Condition

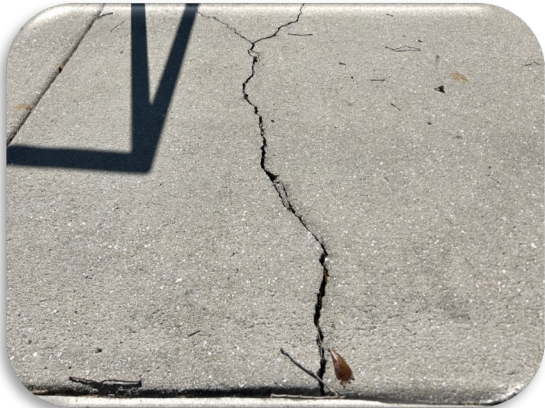
The concrete sidewalk from the employee parking lot to the front entrance is in good condition. The concrete sidewalks in the parking area and at the rear of the building were typically in fair condition, with minor isolated cracks, but no spalling or other serious deterioration. Sidewalk areas adjacent to structural spread footings (e.g., fuel tank) exhibit cracking at reentrant corners. There is minor erosion-based undermining of the west-most concrete sidewalk. Concrete-filled steel bollard posts adjacent to the exterior A/C units were in good condition.

Figure 104: Typical Concrete Sidewalk Cracks

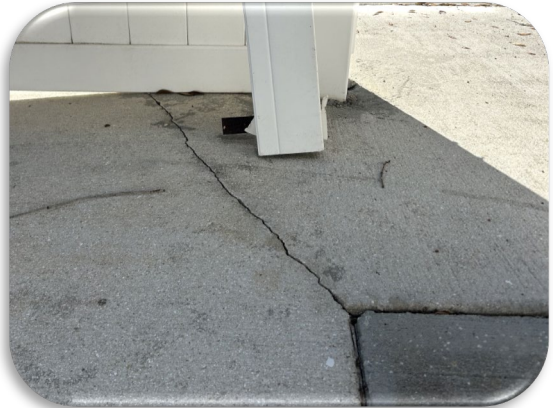
Figure 105: Typical Concrete Sidewalk Cracks at Reentrant Corners

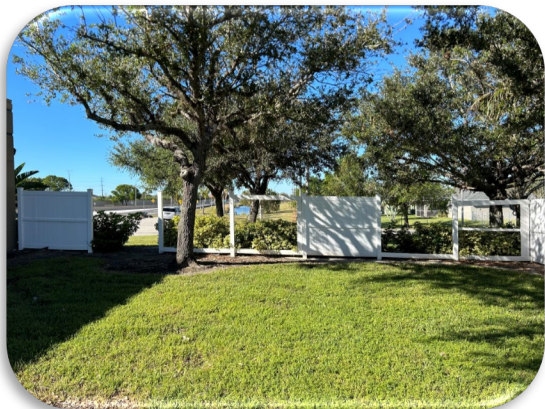
Overall, the landscaping at the site is cared for and properly maintained. The vinyl fencing installed along the north perimeter of the administration building and forming an enclosure around the generator's fuel storage tank and trash dumpsters was damaged during Hurricane Ian and is scheduled to be repaired. The landscaping was updated in 2017, and the mulch was completely replaced with pea gravel around the facility in 2019.

Figure 106: Northwest Vinyl Fencing Hurricane Damage

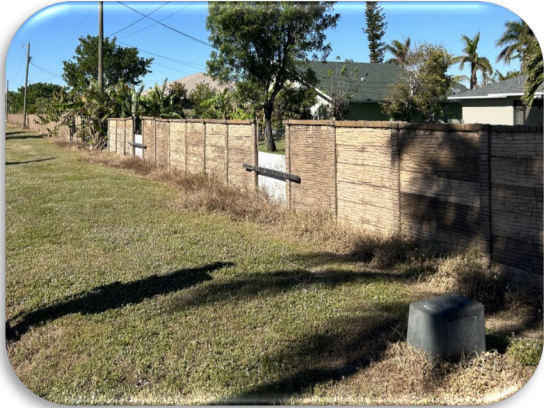
The noise barrier wall on the west approach to the bridge consists of steel H-piles with precast concrete panels. This wall was repainted in 2014 and appears to be in good condition, with only a few small locations of light efflorescence leakage. The architectural soldier pile noise wall at the northwest corner of the toll plaza has storm damage and is scheduled to be replaced in the future.

Figure 110: Northwest Solider Pile Noise Wall Damage

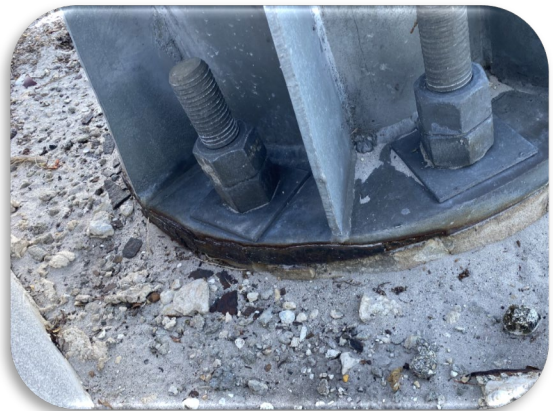
The first miscellaneous structure is a tri-chord overhead span sign structure located approximately 3¼ miles east of the toll plaza, on the west bridge approach, and on the east side of the Caloosahatchee River. There are areas of loss of galvanizing coating and minor corrosion on the truss chord members and upright connection plates. The upright baseplates have isolated areas of delaminative corrosion around their perimeter. In several locations scratches and small areas of missing coating have been retouched with spray galvanizing paint on the uprights and truss. Overall, this structure appears to be in good condition.

Figure 113: Midpoint – WB OSS 3 ¼ Miles from Plaza - Upright Baseplate Corrosion

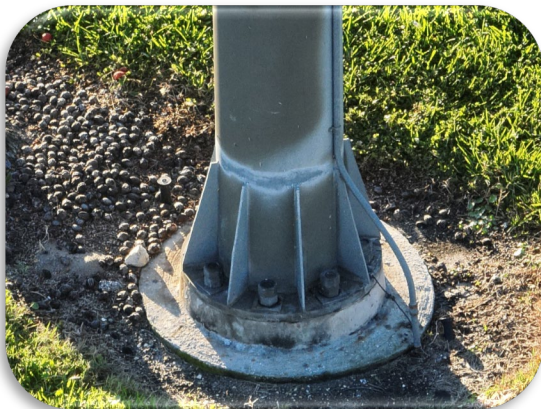
Figure 114: Midpoint - WB OSS 3 ¼ Miles from Plaza – Typical Galvanizing Spray Rehab

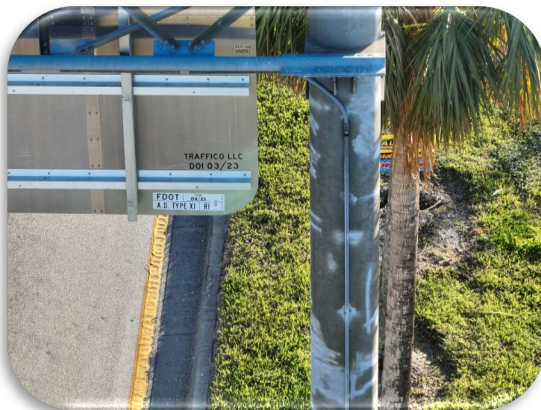
The second miscellaneous structure is a tri-chord overhead cantilever sign structure located approximately 3.125 miles east of the toll plaza, on the west bridge approach, and on the east side of the Caloosahatchee River. There are areas of loss of galvanizing coating on the truss chord members and upright connection plates. At the base of the pole there is a distorted vertical stiffener. There is a large palm tree partially obstructing the sign and upright but does not appear to be obfuscating any of the sign text. In several locations scratches and small areas of missing coating have been retouched with spray galvanizing paint on the upright and truss. Overall, this structure appears to be in good condition.

Figure 118: Midpoint - WB OSS 3.125 Miles from Plaza
– Typical Galvanizing Spray Rehab

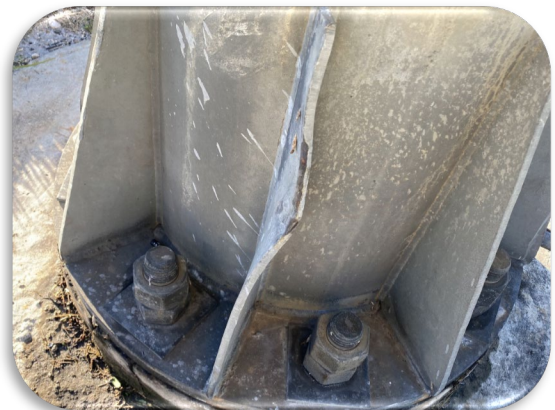
Figure 119: Midpoint - WB OSS 3.125 Miles from Plaza – Distorted Baseplate Vertical Stiffener

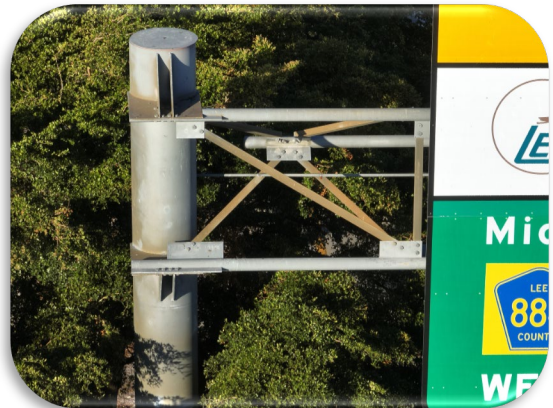
The third miscellaneous structure is a tri-chord overhead span sign structure located approximately 3-miles east of the toll plaza, on the west bridge approach, and on the east side of the Caloosahatchee River. There are areas of loss of galvanizing coating on the uprights, truss chord members, chord splices, and upright connection plates. Several diagonal angles within the truss and the upright connection plates have light surface corrosion. A nearby tree in the median is encroaching on the left upright and equipment cabinets. Similarly, a palm tree is encroaching on the right upright. In several locations scratches and small areas of missing coating have been retouched with spray galvanizing paint on the uprights and truss. Overall, this structure appears to be in good condition.

Figure 121: Midpoint – WB OSS 3 Miles from Plaza – Surface Corrosion on Truss Angles

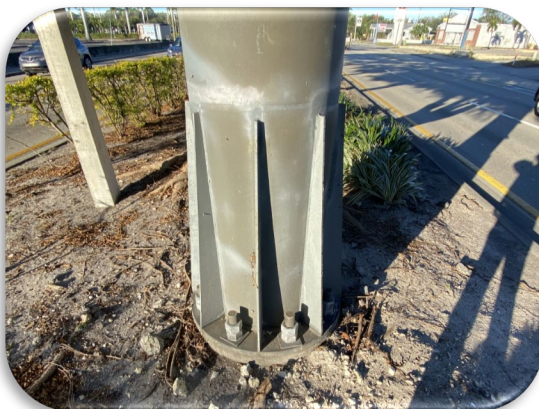
Figure 122: Midpoint - WB OSS 3 Miles from Plaza – Typical Galvanizing Spray Rehab

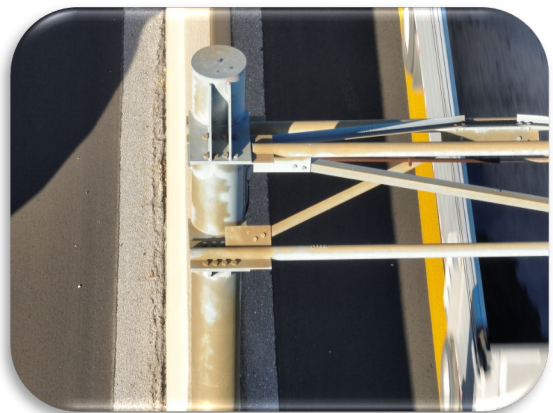
The fourth miscellaneous structure is a tri-chord overhead cantilever sign structure located approximately 1-mile east of the toll plaza, on the west side of the Caloosahatchee River. There are areas of loss of galvanizing coating and minor surface corrosion throughout the entire structure. Abandoned lighting conduits and their mounting hardware have moderate corrosion. The baseplate structural grout pad is compromised and permits standing water to contact the anchor bolts. This should be repaired as soon as possible to prevent deterioration of the anchor bolts. In several locations scratches and small areas of missing coating have been retouched with spray galvanizing paint on the upright and truss. Overall, this structure appears to be in good condition.

Figure 125: Midpoint – WB OSS 1 Mile from Plaza – Surface Corrosion on Upright and Truss Members

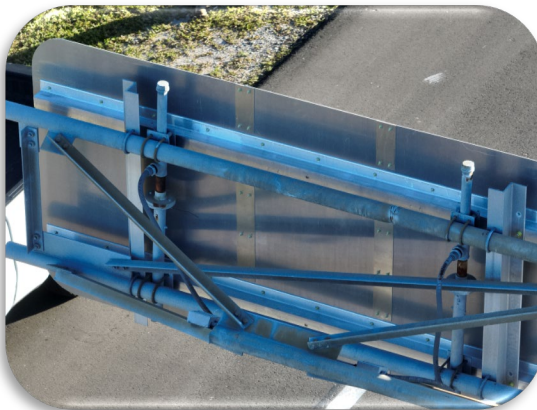
Figure 126: Midpoint - WB OSS 1 Mile from Plaza – Typical Lighting Conduit Corrosion

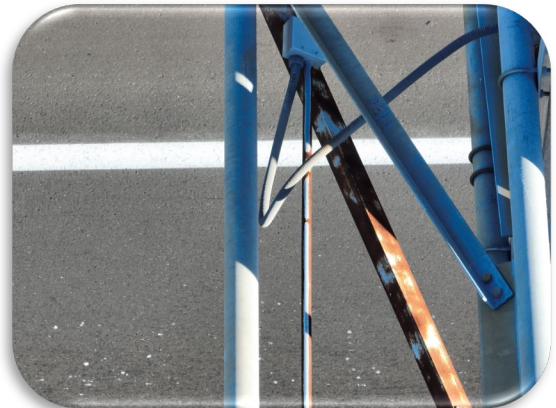
The fifth miscellaneous structure is a tri-chord overhead cantilever sign structure located approximately ½ mile east of the toll plaza, on the west side of the Caloosahatchee River. There are areas of loss of galvanizing coating, minor surface corrosion throughout the entire structure, and isolated areas of moderate corrosion. Abandoned lighting conduits and their mounting hardware have moderate corrosion. The baseplate structural grout pad is compromised and permits standing water to contact the anchor bolts. This should be repaired as soon as possible to prevent deterioration of the anchor bolts. In several locations scratches and small areas of missing coating have been retouched with spray galvanizing paint on the upright and truss. Overall, this structure appears to be in good condition.

Figure 129: Midpoint – WB OSS ½ Mile from Plaza – Moderate Corrosion on Truss Diagonal Angle

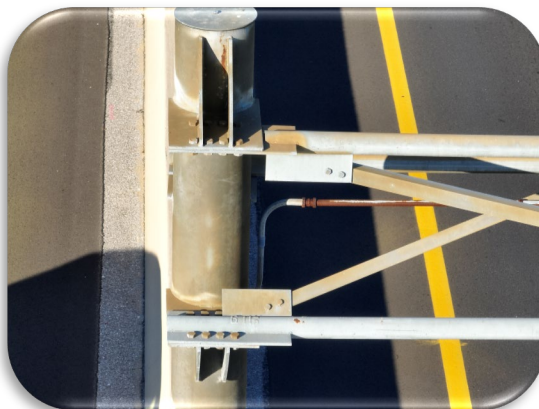
Figure 130: Midpoint - WB OSS ½ Mile from Plaza – Upright Surface Corrosion and Lighting Conduit Corrosion

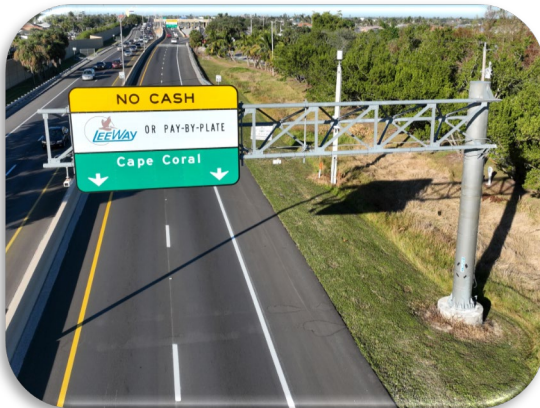
Figure 132: Midpoint - WB OSS ¼ Mile from Plaza – Full Structure

The sixth and seventh miscellaneous structures are tri-chord overhead cantilever sign structures located approximately ¼ mile and 1/8 mile east of the toll plaza, on the west side of the Caloosahatchee River. These structures were installed as part of the ORT reconfiguration in 2011/2012. The sixth sign structure has minor scratches on the upright, minor corrosion on the attached security camera mounting equipment, and compromised baseplate structural grout pad which permits standing water to contact the anchor bolts. This grout pad deterioration should be repaired as soon as possible to prevent deterioration of the anchor bolts. The seventh sign structure exhibits minor surface corrosion on its baseplate. Overall, these structures appear to be in very good condition.

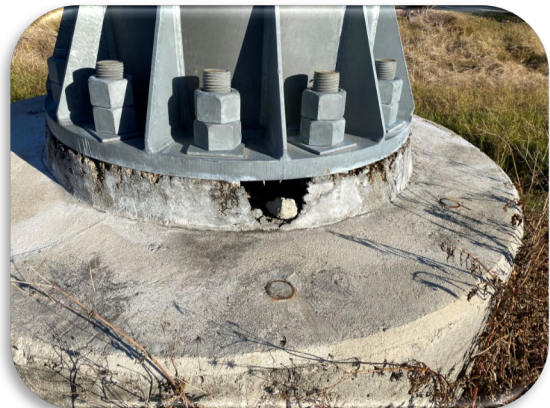
Figure 133: Midpoint - WB OSS ¼ Mile from Plaza – Compromised Structural Grout Pad

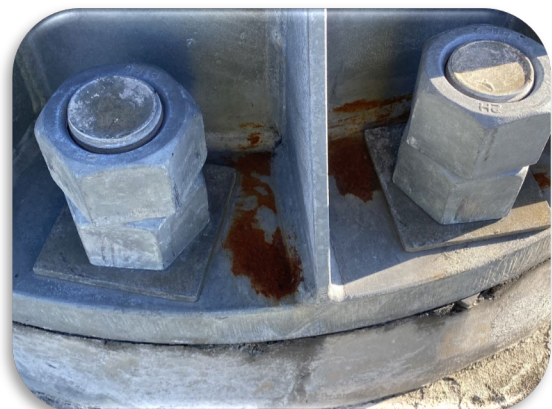
Figure 135: Midpoint - WB OSS 1/8 Mile from Plaza – Baseplate Corrosion

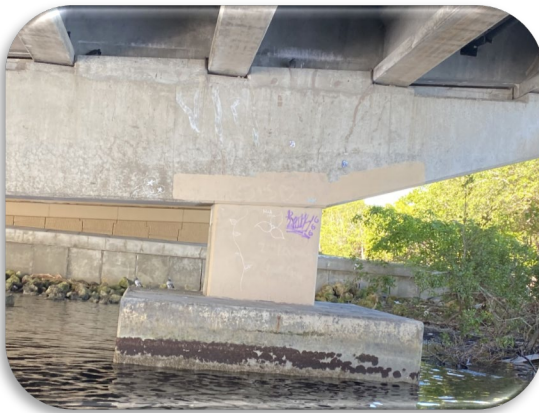
Substructure deficiencies include seawall bulkhead and abutment cracks, spalls, and delaminations; pier caps and columns intermittent cracks and spalls; and footing cracks, spalls, delaminations, and voids, some with exposed rebar and section loss.

Figure 138: Midpoint Bridge – Pier Cap Cracking and Painted Graffiti

Previous maintenance work at the Midpoint Memorial Bridge includes repainting the noise wall along the east approach, milling, and paving the approach lanes in both directions on the west side of the bridge, and epoxy injection of the pier cap cracks. Lee County DOT maintenance personnel made repairs to the fender system such as new rope railing, although corrosion was noted on the fender system hardware and exposed steel on the fender piling. Lee County DOT completed painting of the bridge in June 2019. Lee County replaced the corroded fender system pile cluster wraps in 2021.

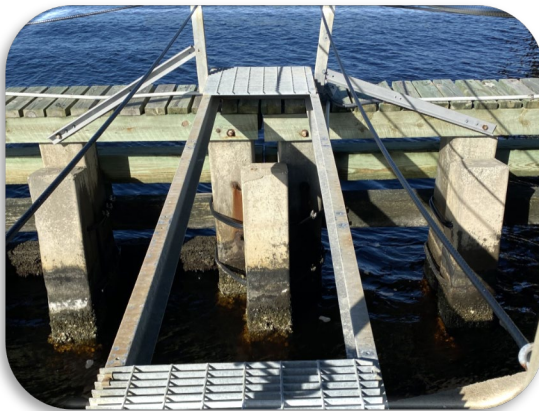
Miscellaneous deficiencies include isolated debris filled shoulder drainage inlets; abutment slope protection moderate cracks and undermining; MSE wall panel offset and spalls; general widespread fender system storm damage, including pile spalls and delaminations, missing and decayed timber members, and navigational clearance gauge section loss, disconnected fender light electrical system; missing/broken navigational lighting equipment; missing median barrier reflectors and raised pavement markers; and substructure graffiti.

Figure 140: Midpoint Bridge – Fender System Access Ladder Missing Grate

In the near future County maintenance will be replacing any fender system timber members that are missing. Lee County DOT also has a contract out for bid for the rehabilitation of approach MSE wall defects, which will also include bridge related defects (i.e., spalls/cracking).

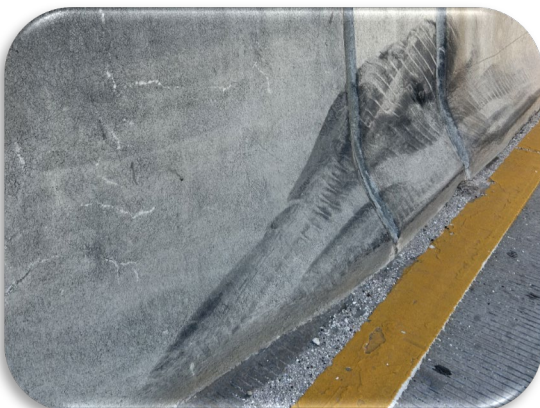
The administration building, concrete canopy, concrete islands and vehicle impact attenuators all appear to be in very good structural condition. Barriers exhibit surface level scrapes and canopy columns show map cracking which is painted to protect from the elements. The yellow bollards within the toll plaza have moderate corrosion. No indications of structural distress were observed.

Figure 149: Typical Traffic Island Barrier Scrape

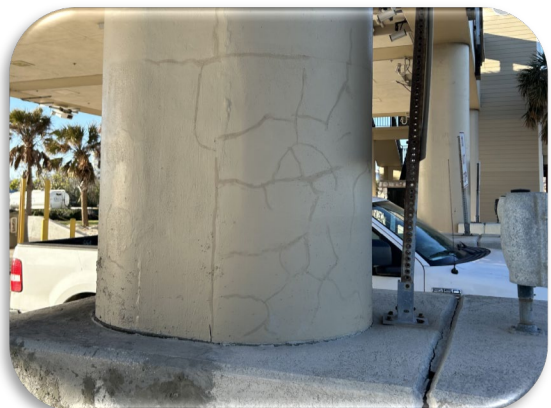
Figure 150: Toll Canopy Column Painted Cracks

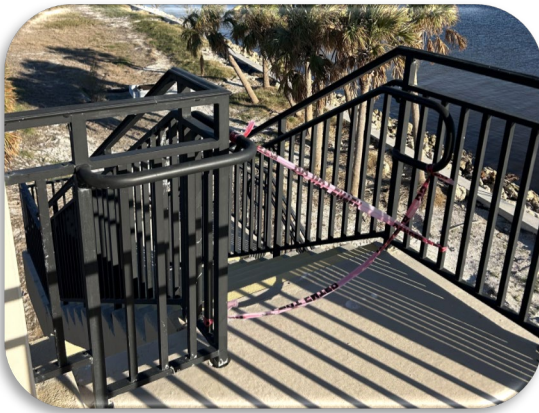
The previous reports noted concrete cracks at each landing in the stair section of the south side exterior stairwell. The cracks were generally hairline to 1/16-inch width present since the 2013 inspection. While these cracks were noted as sealed during the last inspection cycle, the stairwell was damaged during Hurricane Ian and exhibits instability, with differential settlement and rotation. It is deemed unsafe and was only viewed from a distance during inspection. This stairwell is roped off to ensure the safety of the County staff. CEI services are under contract and the construction contractor selection process is underway for the rehabilitation of these stairs, which is expected in 2025.

Figure 151: South Stairwell Restricted Access

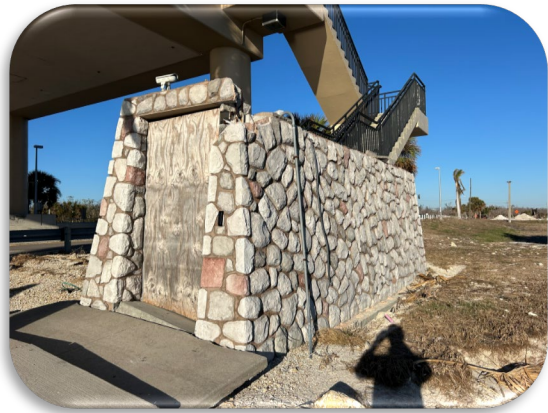
Figure 152: South Stairwell Instability

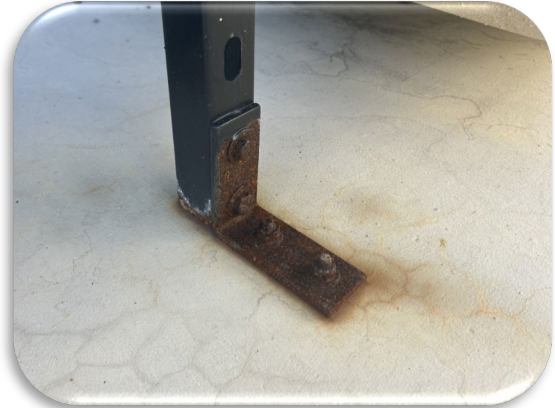
The standby generator for this facility appears to be in good condition and is tested automatically on a weekly basis to ensure it is in working condition at all times. The 1,000-gallon fuel storage tank is located on the second level of the stair tower within a fenced area adjacent to the generator room. Its mounting hardware is experiencing moderate corrosion.

Figure 158: Fuel Storage Tank Support Hardware

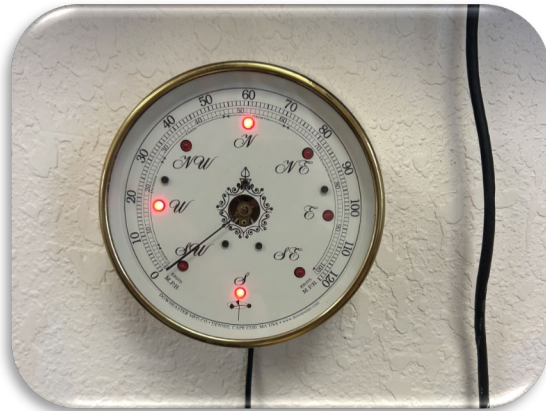
During inspection the installed wind meter appears to be malfunctioning, with potentially inaccurate wind speed readings displayed on a gauge located inside the administration building. Lee County is aware of this concern and has the repair on their maintenance list, to be fixed in the near future.

Figure 159: Wind Gauge Readings

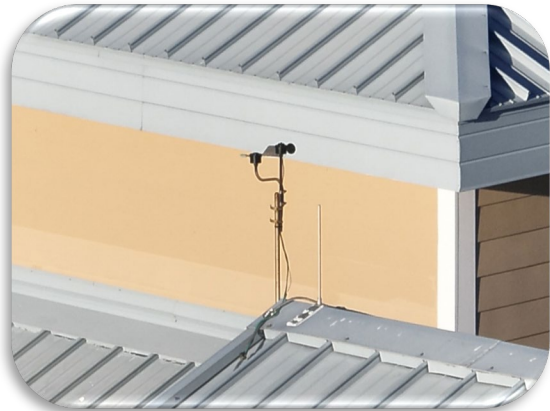
Figure 160: Wind Meter Equipment

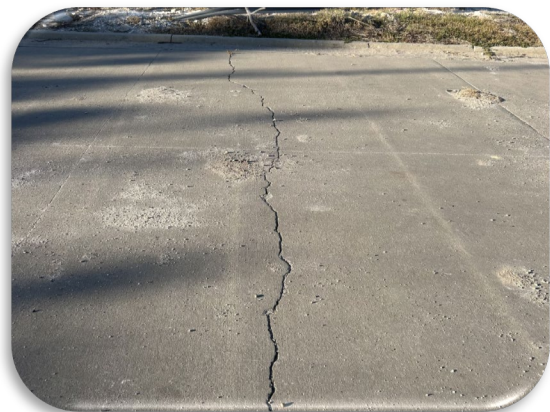
The concrete employee parking area is in a temporary condition as it is adjacent to a material storage site and impacted by FDOT's on-going construction efforts. There is a longitudinal crack within the concrete pavement. There is one handicapped space marked and the toll facility parking striping is diminishing. Sidewalks and curbs appear to be in good working condition with any pertinent restoration to occur following the Department's construction efforts.

Figure 162: Concrete Pavement Crack

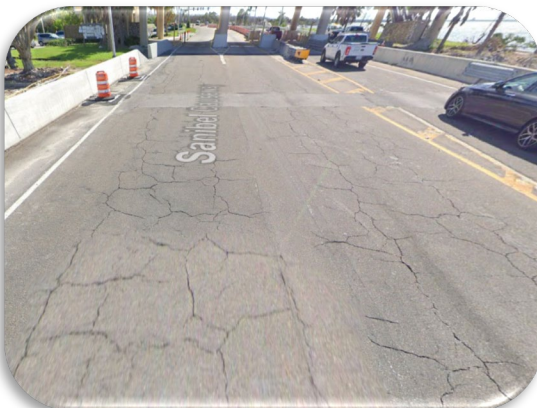
Generally, the asphalt concrete pavement and striping on the approaches to the toll plaza and between each of the causeway bridges appear to be in good condition overall, with some areas of fatigue cracking and degradation. The bridge approaches are under construction to restore and rehabilitate from Hurricane Ian's damage. This includes various phases of striping and lane configurations for maintenance of traffic needs to facilitate construction.

Figure 169: Representative Pavement Distress and Cracking Near Toll Plaza – August 2024

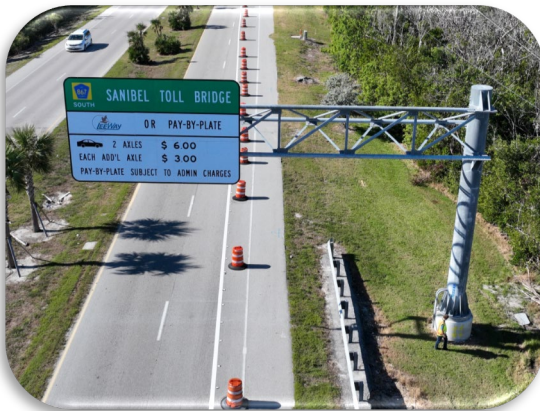
Figure 171: Sanibel - WB OSS 1 ½ Miles from Plaza - Full Structure - Front

The first miscellaneous structure is a tri-chord overhead cantilever sign structure located approximately 1½ miles east of the toll plaza on the westbound bridge approach. The upright has isolated areas of scrapes with minor corrosion. The structural grout pad exhibits sectional cracking. In several locations, scratches and small areas of missing coating have been retouched with spray galvanizing paint on the upright. Overall, this structure appears to be in good condition.

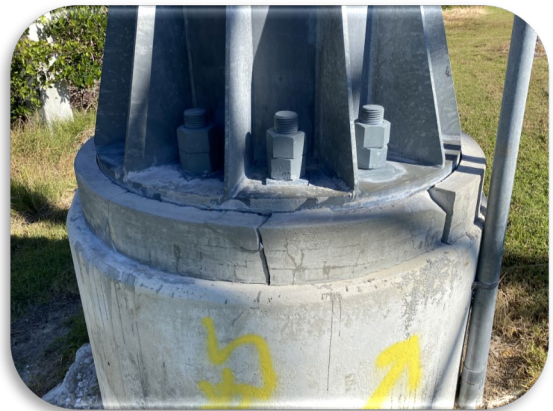
Figure 172: Sanibel - WB OSS 1 ½ Miles from Plaza - Structural Grout Pad Cracking

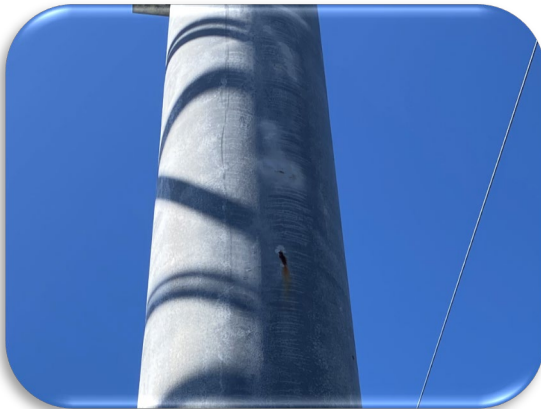
Figure 173: Sanibel - WB OSS 1 ½ Miles from Plaza - Typical Galvanizing Spray Rehab & Spot Corrosion

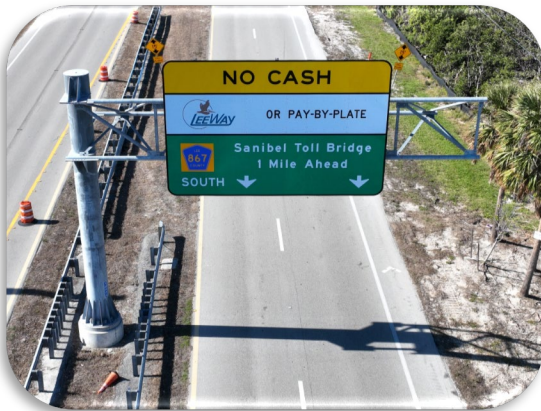
The second miscellaneous structure is a tri-chord overhead cantilever sign structure located approximately 1 mile east of the toll plaza on the westbound bridge approach. The structural grout pad exhibits cracking with efflorescence. In several locations scratches and small areas of missing coating have been retouched with spray galvanizing paint on the upright. Overall, this structure appears to be in good condition.

Figure 175: Sanibel - WB OSS 1 Mile from Plaza - Full Structure - Front

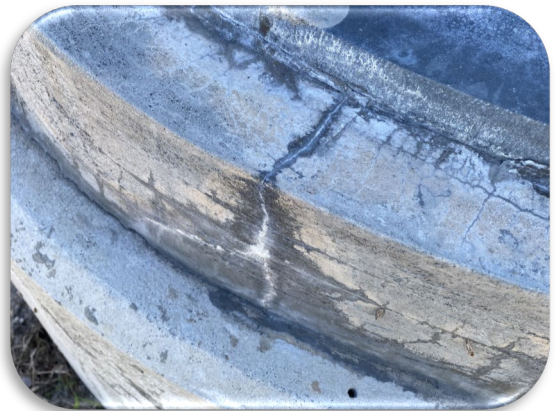
Figure 176: Sanibel - WB OSS 1 Mile from Plaza - Structural Grout Pad Cracking

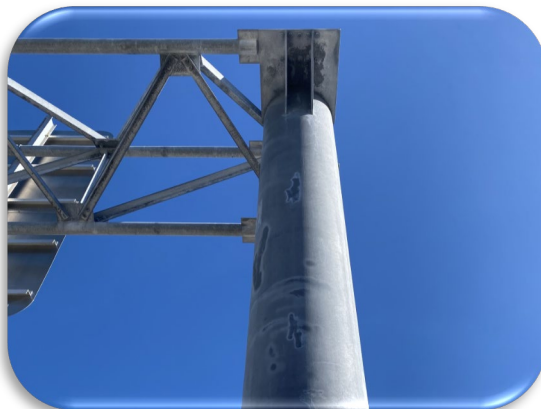
Figure 177: Sanibel - WB OSS 1 Mile from Plaza - Typical Galvanizing Spray Rehab

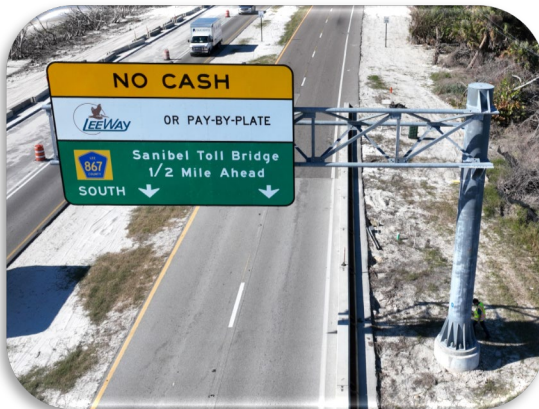
The third miscellaneous structure is a tri-chord overhead cantilever sign structure located approximately ½ mile east of the toll plaza, on the westbound bridge approach. The structural grout pad exhibits cracking with section loss. There are isolated spots of minor corrosion on the baseplate, baseplate stiffeners, and upright. In several locations scratches and small areas of missing coating have been retouched with spray galvanizing paint on the upright. Overall, this structure appears to be in good condition.

Figure 179: Sanibel - WB OSS ½ Mile from Plaza - Full Structure - Front
