June 2025

Lee County Bridge Inspection Report

Subject: Lee County General Inspection of Transportation Facilities – 2025 Report

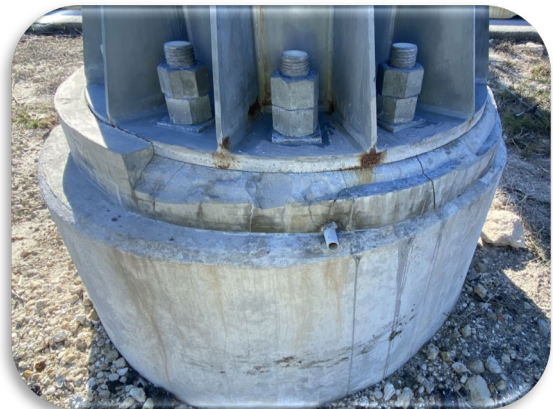
The third miscellaneous structure is a tri-chord overhead cantilever sign structure located approximately ½ mile east of the toll plaza, on the westbound bridge approach. The structural grout pad exhibits cracking with section loss. There are isolated spots of minor corrosion on the baseplate, baseplate stiffeners, and upright. In several locations scratches and small areas of missing coating have been retouched with spray galvanizing paint on the upright. Overall, this structure appears to be in good condition.

Figure 180: Sanibel - WB OSS ½ Mile from Plaza - Structural Grout Pad Cracking and Section Loss

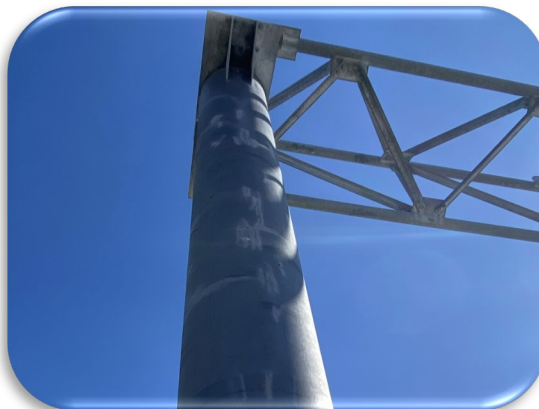
Figure 181: Sanibel - WB OSS ½ Mile from Plaza - Typical Galvanizing Spray Rehab

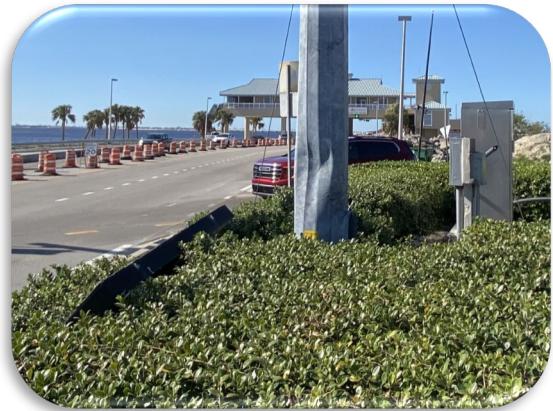
The fourth miscellaneous structure is a single arm mast arm signalization structure which serves the intersection of CR 867 (McGregor Boulevard) and Punta Rassa Road located approximately 100-yards east of the toll plaza on the westbound bridge approach. The mast arm has five 3-head traffic signals, three servicing SR 867 and two servicing Punta Rassa Road. While the signalization is still operational and working, the mast arm upright has been damaged by vehicular impact sometime between July 2022 and August 2024. The structure has been stabilized by guy wires driven into the soil on the opposite side of the damage. The mast arm handhole is missing its handhole cover and the upright mounted McGregor Boulevard luminated street sign is currently uninstalled and sitting at the base of the structure. The arm mounted Punta Rassa Road illuminated street sign shows signs of wear. Foundation anchor bolts have missing or damaged caps. The contractor performing the FDOT rehabilitation has installed a temporary single-wire span wire with driven timber strain poles to facilitate phase construction. During inspection, the temporary traffic signals were found to be covered with black plastic bags to ensure they are not providing conflicting information with the mast arm traffic signals.

Figure 184: Sanibel – Signalization Structure 100-yards from Plaza – Vehicular Impact Damage

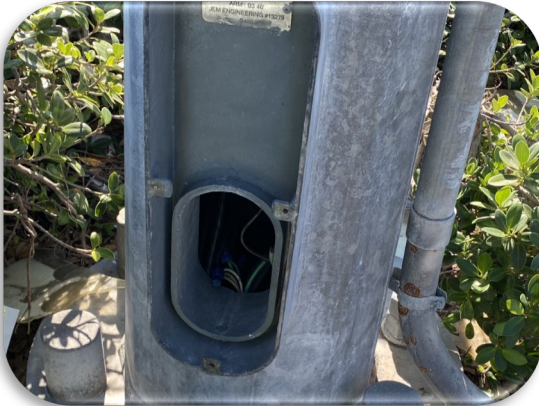
Figure 185: Sanibel - Signalization Structure 100-yards from Plaza – Missing Handhole Cover

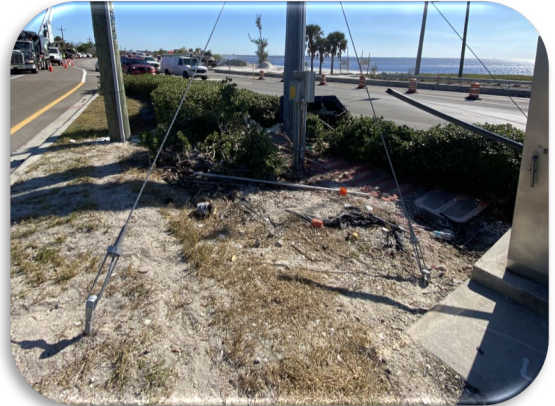
Figure 186: Sanibel - Signalization Structure 100-yards from Plaza – Guy Wire Foundation Connection

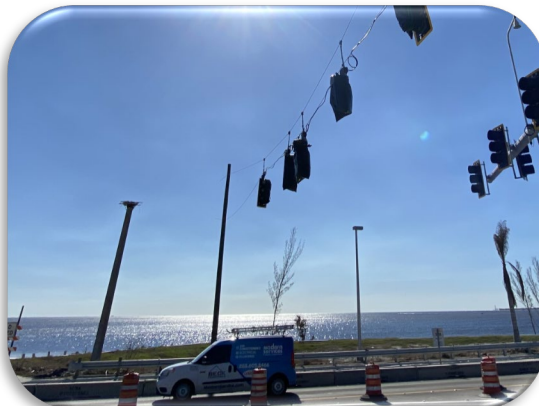
Figure 187: Sanibel - Signalization Structure 100-yards from Plaza – Temporary Signalization

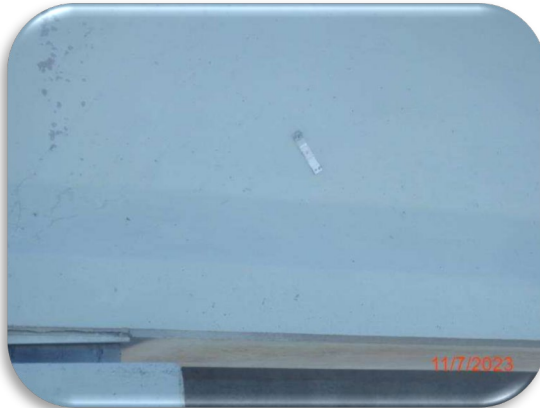
Overall, all three structures have a history of diagonal cracks in the beam webs near the ends of the prestressed concrete beams. In June 2012 Lee County retained CDM Smith to evaluate the beam end cracks, review the original design of the beams for compliance with AASHTO and FDOT specifications at the time of design, and offer an opinion as to the cause of the cracking. The evaluation concluded that the beams were code and practice compliant at the time of design, and the cracking appeared to be induced by large internal prestress forces in the beam ends. The CDM Smith report recommended Lee County initiate a crack monitoring program to fully document the cracking and provide a basis for determining whether the cracks are stabilized or continue to grow.

Figure 189: Sanibel Bridge – Typical Crack Width Monitor Gauge

In late 2012 Lee County retained T.Y. Lin International (T.Y. Lin) to implement a crack monitoring program as recommended by CDM Smith. T.Y. Lin inspected the beams and documented the length and size of the cracks in all three causeway bridges in January 2013. T.Y. Lin returned in July 2013 to reinspect the beam ends and to review and document any changes in the crack quantities and sizes. T.Y. Lin recommended Lee County continue to monitor the cracks in the beams for any increase in severity by performing follow up inspections. Repair recommendations included applying a protective coating over the smaller cracks; injecting epoxy into the larger cracks; and repairing concrete delaminations.

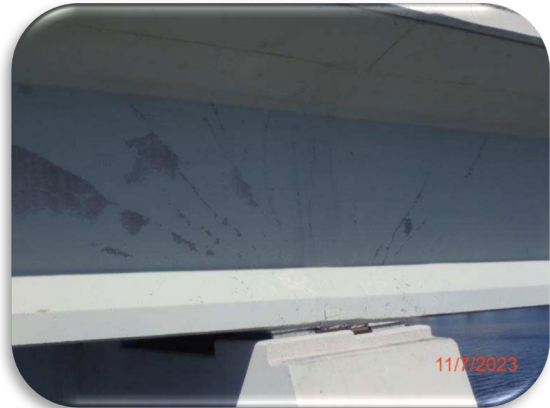
Figure 190: Sanibel Bridge – Typical Beam End Cracking

After the crack reports and recommendations were completed in July 2013, T.Y. Lin prepared a set of plans detailing the epoxy injection crack repairs. In August 2014 a contractor was on site and completed repairs to all three structures. The beam ends were reinspected in May 2015 to verify the repair conditions and document any changes to the cracks. FDOT has conducted biennial inspections of the causeway bridges since the repairs were completed.

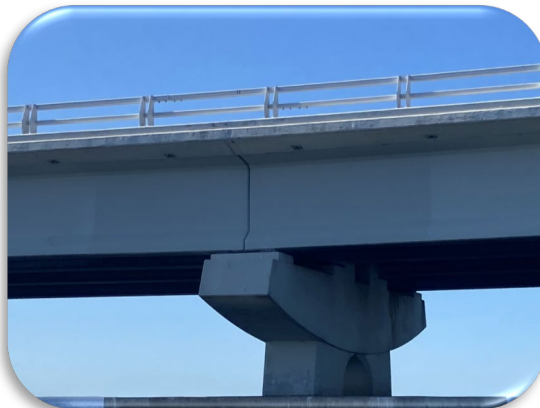
Figure 191: Sanibel Bridge – Typical Beam End Painting

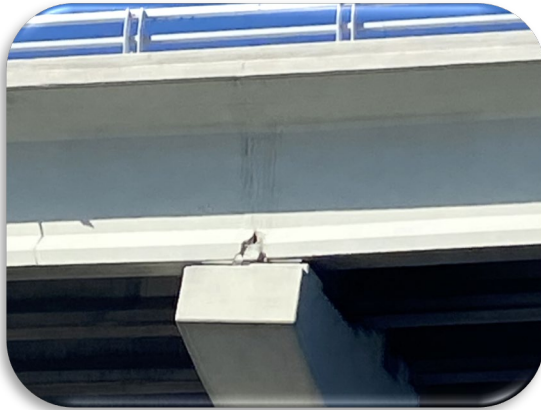
Additionally, these structures exhibit continuity end diaphragm cracking, delaminations, and spalling. Under an FDOT contract, T.Y. Lin has prepared rehabilitation plans and technical specifications to address the cracking of these diaphragms. These repairs will be performed by Lee County maintenance in accordance with the rehabilitation plans once FDOT's Causeway rehabilitation project is completed.

Figure 193: Sanibel Bridge – Typical End Diaphragm Spalling at Exterior Beam

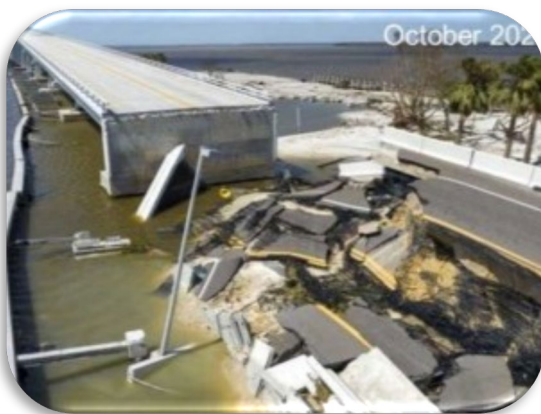
Hurricane Ian, which struck the west coast of Florida in September 2022, had a significant impact on Sanibel Island and its causeway. The hurricane exceeded the design storm event and brought a 12-foot storm surge and 8-foot wave action that caused extensive damage to the island's infrastructure and natural environment. The damage was largely at the connecting islands and bridge approaches, with the bridges themselves remaining relatively unscathed. On October 5, 2022, the FDOT contractors mobilized to complete emergency repairs to the Sanibel Causeway. After only six days, the project team was able to expedite repairs and lead a convoy of utility restoration teams and equipment across the Sanibel Causeway. On October 19, 2022, just three weeks after Hurricane Ian washed away the land and roadway connecting the mainland to Sanibel and Captiva Islands, and a week ahead of schedule, FDOT opened the bridge to first responders, utility crews, contractors and residents.

Figure 195: Sanibel Bridge – Hurricane Ian Damage

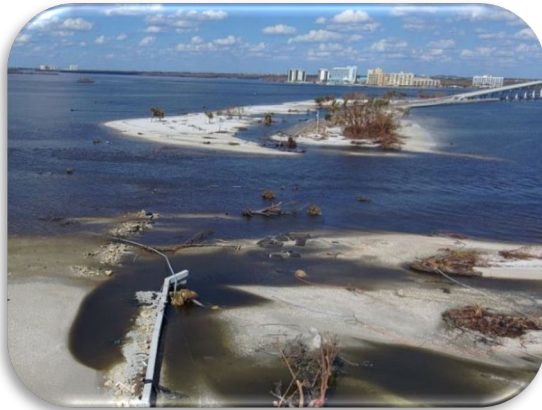
Figure 197: Sanibel Bridge – Hurricane Ian Damage

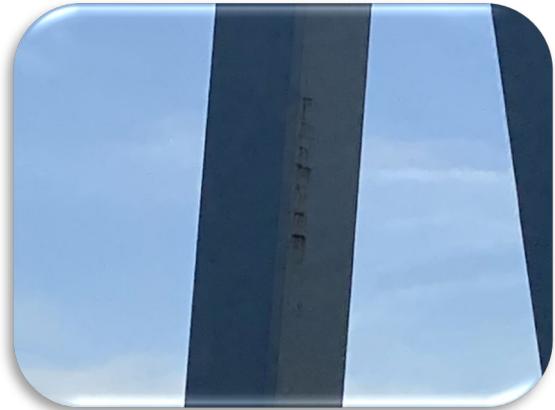
Substructure deficiencies include pier cap shrinkage cracks; pier column cracking and isolated spalling/delaminations; abutment cheek wall delaminations; pier footing form cracks and spalls; and pile spalls.

Figure 202: Sanibel Bridge, Structure A – Column Spalls with Exposed Reinforcement

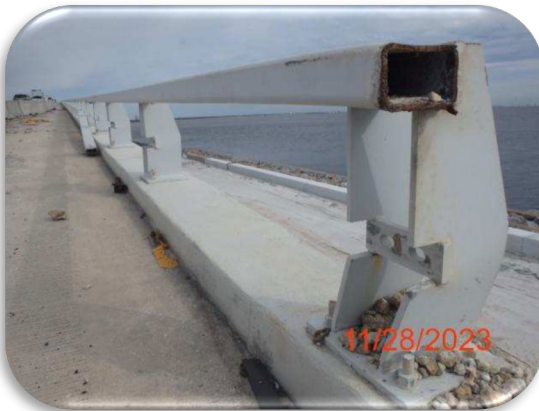
Within the biennial inspection report superstructure deficiencies include isolated cracking in the deck top, soffits, and curbs; metal bridge railing impact scrapes and light corrosion; and superstructure beam end cracking and diaphragm spalls and delaminations.

Figure 203: Sanibel Bridge, Structure A – Bridge Railing Impact Damage

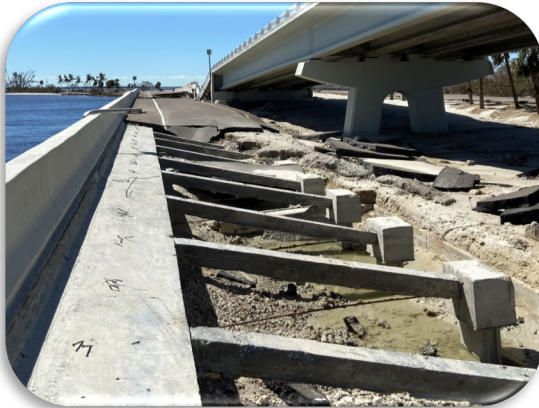
Figure 205: Sanibel Bridge, Structure A – Seawall Embankment Repairs

In July 2022 the County performed seawall embankment rehabilitation and installed articulating concrete block matting, which included soil injections for undermining which existed at the beginning of bridge U-turn.

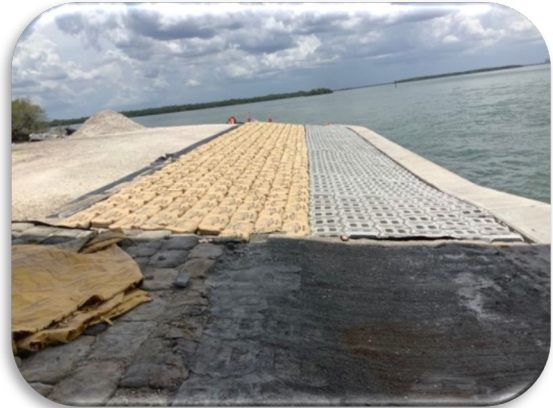
Figure 206: Sanibel Bridge, Structure A – Articulating Concrete Block Matting Installation

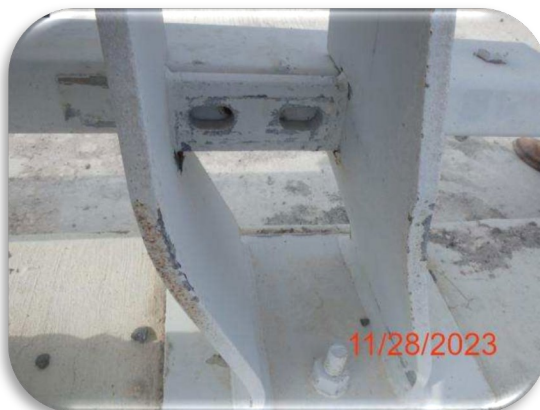
Within the biennial inspection report superstructure deficiencies include cracks in the deck surface on the top and bottom sides of the deck; metal bridge railing scrapes, light corrosion, and bent brackets; and superstructure beam end cracking.

Figure 213: Sanibel Bridge, Structure B – Bent Bridge Rail Bracket

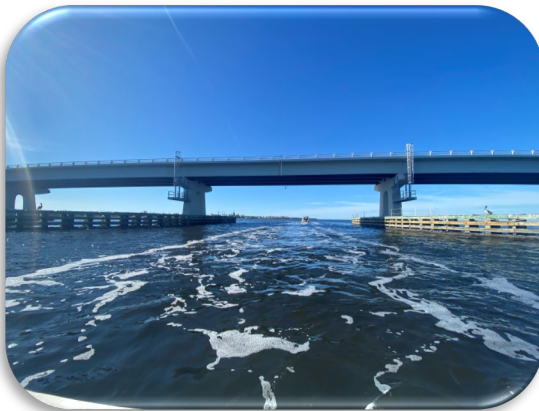
Miscellaneous deficiencies include channel degradation; south channel bank erosion resulting in the collapse and wash out of the paved pedestrian walkway; missing fender planks, sections of aluminum hand railing, and clearance gauges, as well as decayed timber members with section loss; missing or broken fender system navigational lights with broken away electrical conduit; and light corrosion on access platforms and ladders.

Figure 219: Sanibel Bridge, Structure C – General Fender System Layout

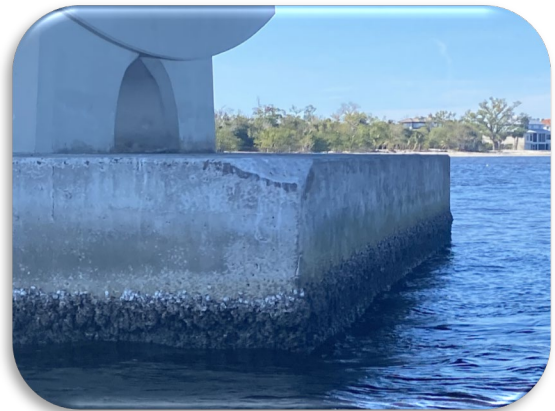
Substructure deficiencies include abutment and cheekwall cracking and delaminations; failed column repairs; and footing and pile cracks and spalls.

Figure 220: Sanibel Bridge, Structure C – Typically Footing Corner Spall

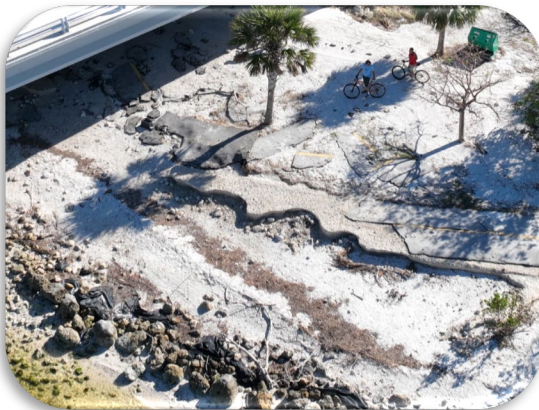
Figure 221: Sanibel Bridge, Structure C – Loss of Eastbound Approach Pedestrian Walkway

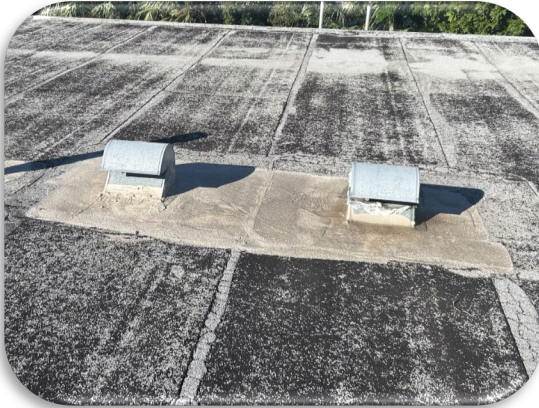
Multiple areas have been patched and coated with sealant. These areas appear to correspond with areas noted in the 2013 inspection report for bubbled and discolored roofing material. Water tends to pond along the north and southeast side of the roof possibly due to improper or inadequate sloping of the roof towards the drains. The roof patches which were failing were repaired.

Figure 234: Typical Repaired Roof Patch Condition

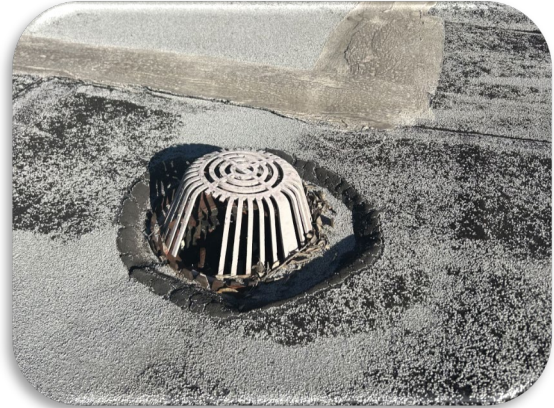
The service center roof consists of asphalt and stone impregnated, rolled material with internal drains at various locations. Some of the downspout mounting hardware is corroding with areas of full section loss. The roof surface material is generally in fair condition throughout, and the drains are clear of dirt, debris, and vegetation.

Figure 235: Typical Clear Roof Drainage Inlet

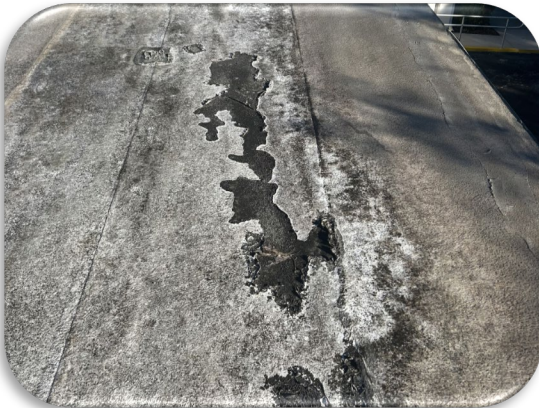
Figure 236: Deteriorating Roof Patching in Need of Repair

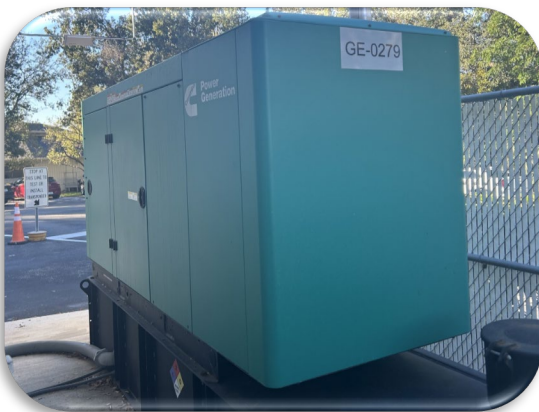
The standby generator for this facility was replaced in 2017. It appears to be in excellent condition and is tested automatically on a weekly basis to ensure it is in working condition at all times. The generator is also enclosed in a fenced and locked paddock area next to the service center building. During the inspection County staff indicated that the generator is being actively worked on to resolve technical issues.

Figure 240: Standby Generator

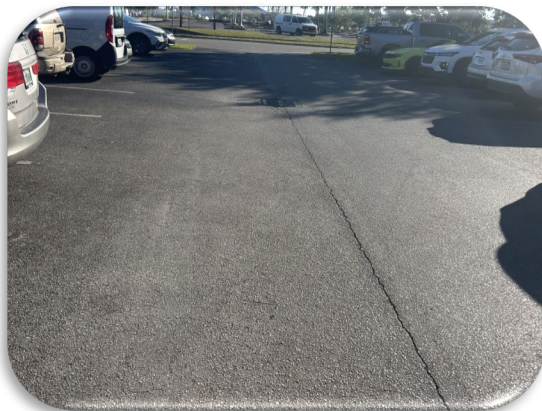
The asphalt concrete employee parking area was generally in fair condition, exhibiting cracking and degradation. The parking lot was resealed in 2017. The striping is also in fair condition. Parking lot LED security lights were added for employee safety in 2016.

Figure 244: Customer Parking Pavement

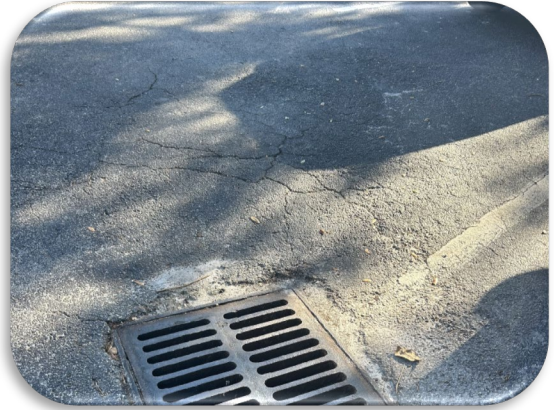
Figure 247: Typical Pavement Distress Around Drainage Inlet

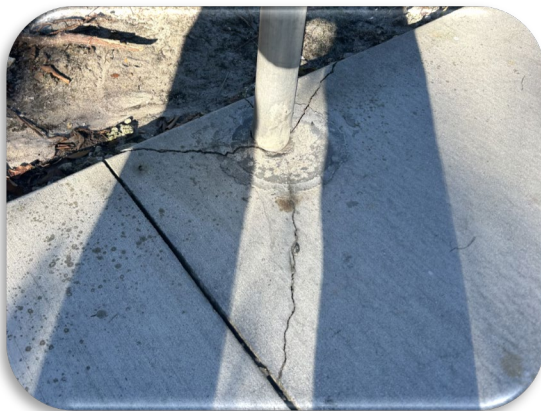
The concrete and tile sidewalks in the parking area and surrounding the building were typically in good condition, with isolated minor cracks, and discrete areas of spalling at handrail connections. No other serious deterioration was noted.

Figure 248: Concrete Sidewalk Spalling at Handrail

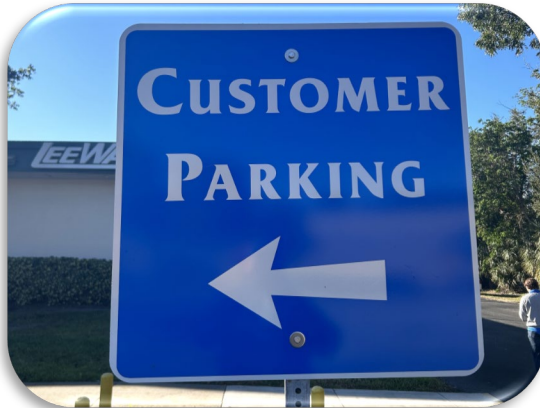
There are no overhead miscellaneous sign structures associated with the service center. Directional guide signs for the service center on surrounding streets were typically in very good condition. At the service center customer parking area, the northwest and northeast driveway entrance signs appear to be in like new condition. The employee parking only signs throughout the parking lot exhibit wear with cracking of the laminate. Parking signposts have minor corrosion at their base.

Figure 254: Typical Customer Parking Signage

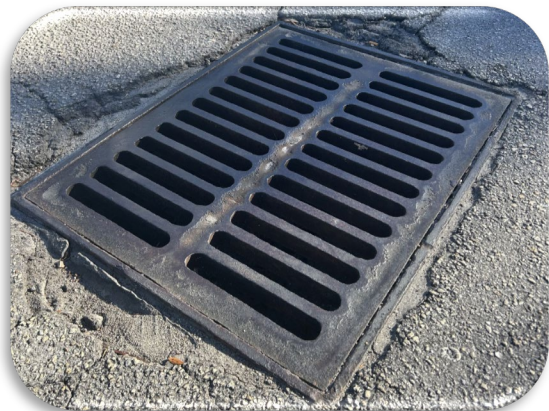
Drainage for the employee and customer parking areas is accomplished through catch basins near the center of each. The catch basins within the employee parking area are clear and appear to be functioning properly. The catch basin in the customer parking area shows signs of silt buildup, but still appears to be functioning adequately. The trash corral at the southwest corner of the entrance driveway is in good condition. Its painted brick walls are solid and appear stable, with no severe cracking or damage. The concrete slab at the interface with the asphalt parking area was recently replaced and is in good condition.

Figure 257: Typical Drainage Inlet Catch Basin
