Procedures for Post-Disaster Rebuilding/Repair of Historic Resources

Lee County Historic Preservation Board

November 17, 2022

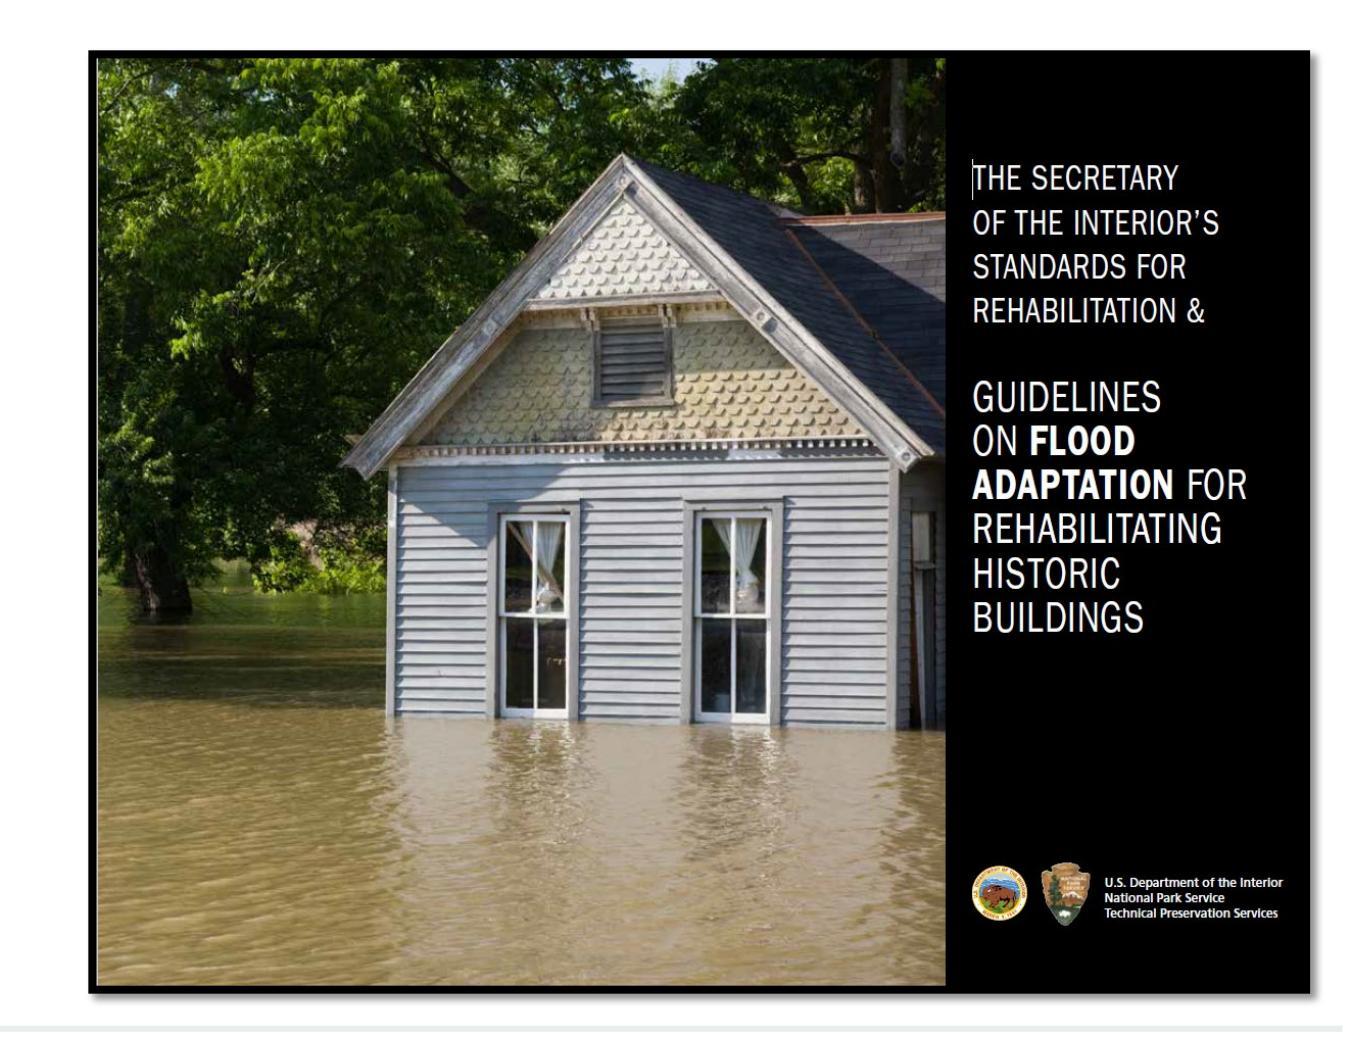
- Prepared by NPS in 2019
- Provides for adaptation strategies of varying scope and complexity
 - Temporary protective measures
 - Dry floodproofing
 - Wet floodproofing
 - Elevate buildings on a new foundation
- Includes case studies for various strategies

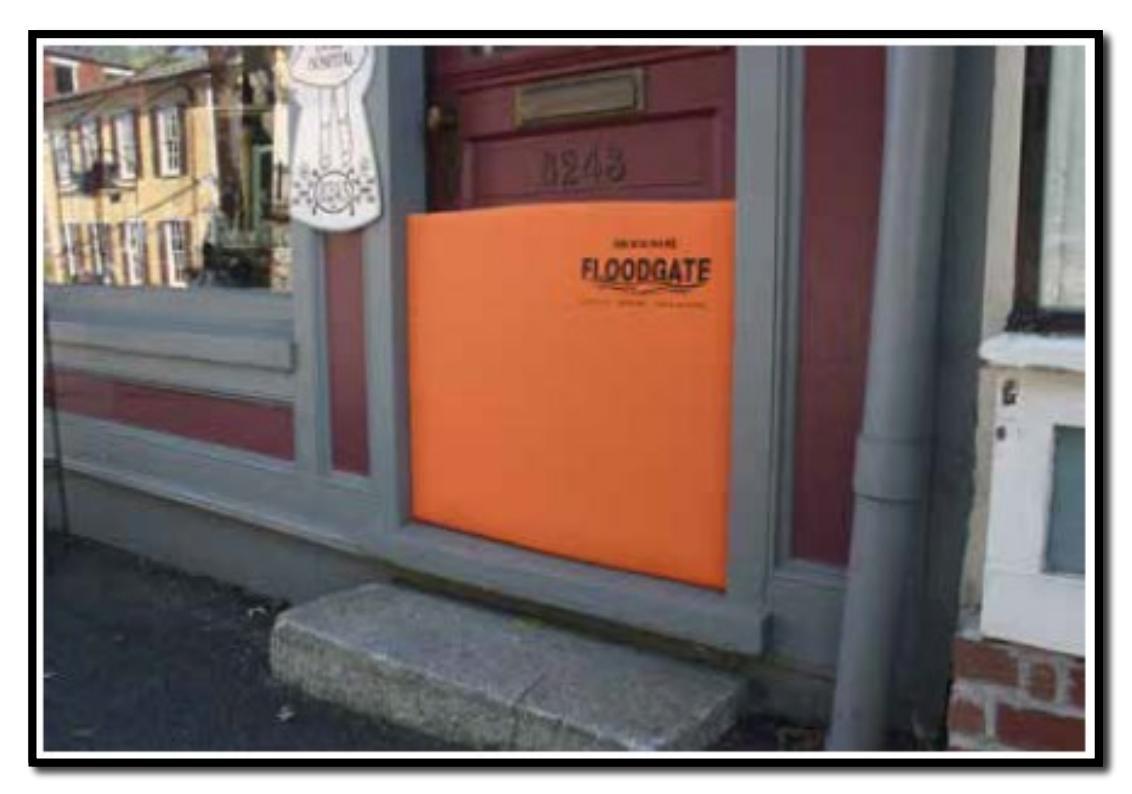
Photo: Liz Petrella/NPS

- Deployed/activated when flooding is predicted
 - Requires time and people
- Low impact on historic character
- Affordable
- Not failproof
 - Designed for relatively shallow floods of limited duration
 - Requires storage space
 - Must not rely on continual on-site monitoring

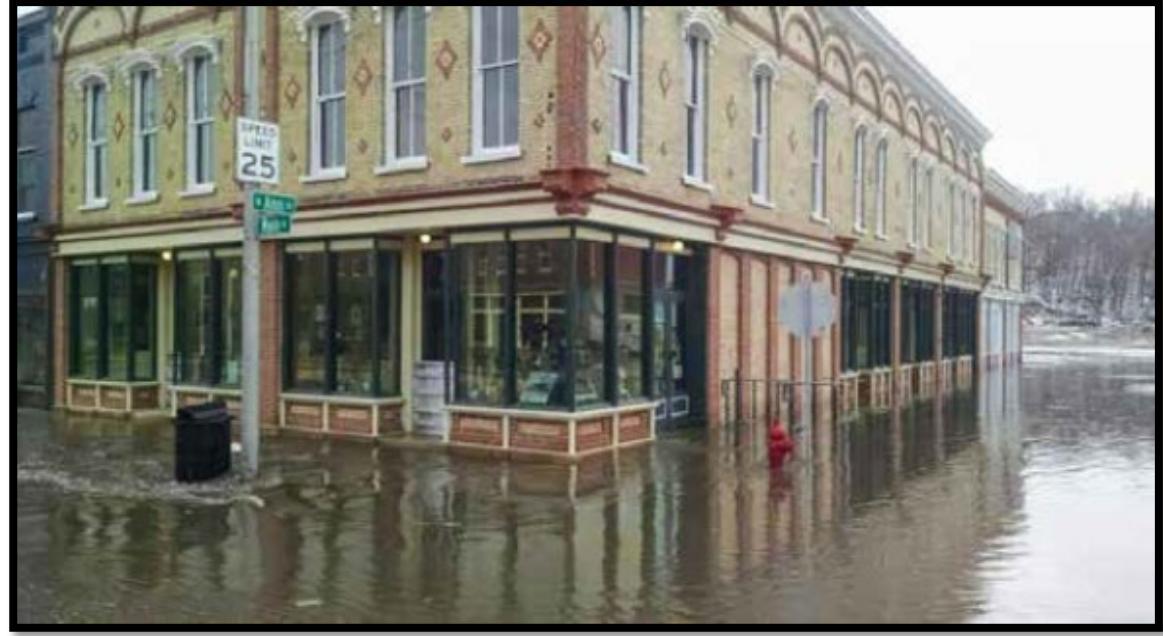
Photo: Brian Mesmer

- Designed to keep water out
- Involves significant alterations
 - Windows/doors/utility penetrations must be sealable
 - Exterior foundation surfaces must be impervious to water
- Only appropriate for:
 - Load-bearing masonry buildings
 - Frame buildings with masonry foundations
 - Established flood risk must be below top of foundation
- Requires regular maintenance, monitoring, and repair to remain effective

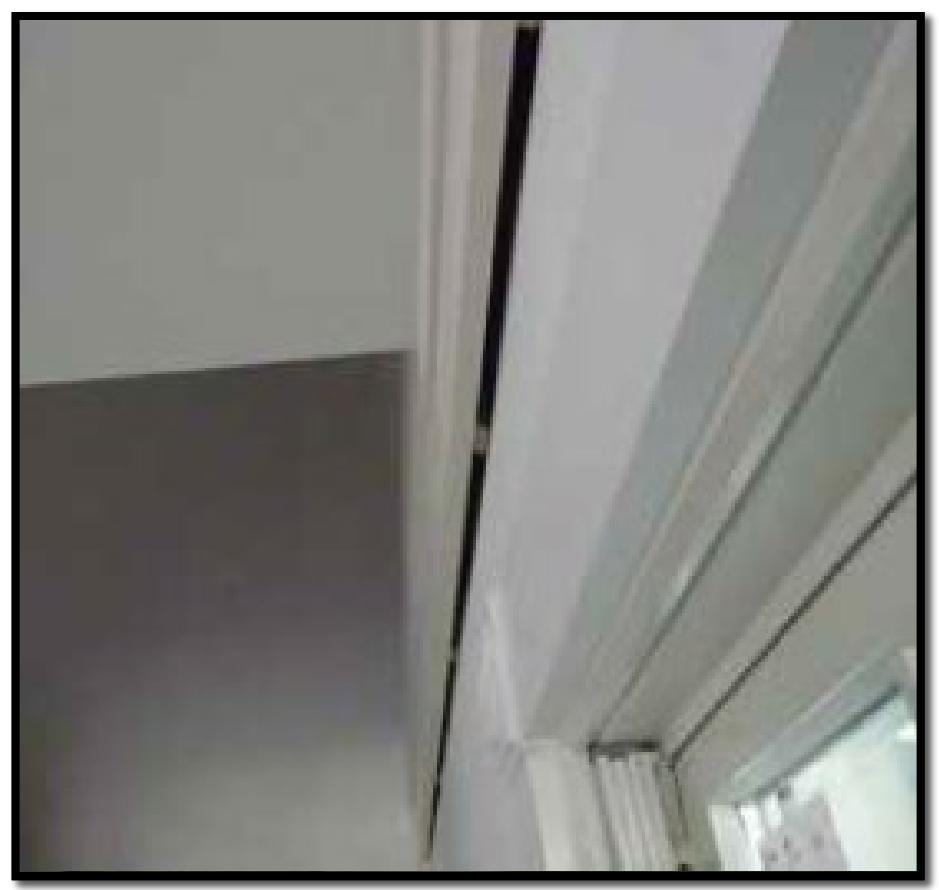
Photo: Mary Delaney Krugman, JD, MSHP

- Allows water to enter/drain out of a building
 - Controlled by vents
 - May require structural reinforcement
 - Utility systems must be located above established flood risk level
- Interior spaces must be altered
 - Use of water-resistant/impervious materials
 - Wall cavities need to opened/accessed for cleaning/drying
 - May involve harsh chemicals
 - May take extended periods of time

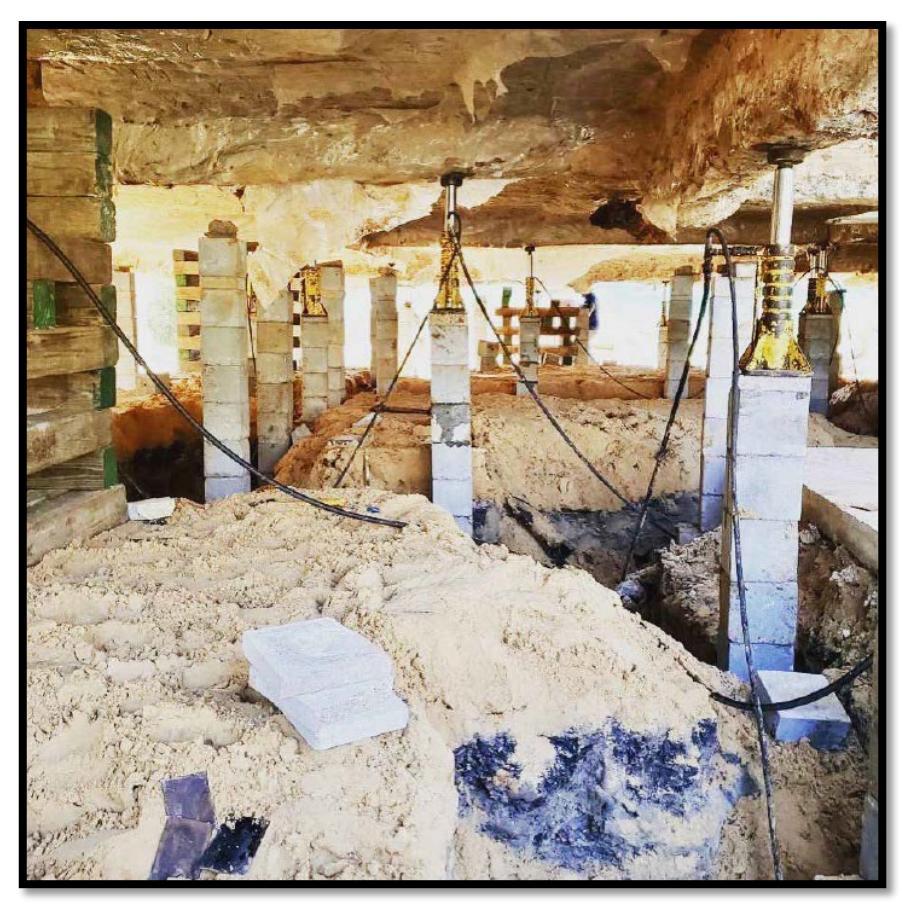
Photo: p3elevation.com

- Most common solution for addressing flood risk
- Easiest for frame buildings above crawlspaces, piers, or post foundations
- Must be carefully planned/considered
 - Size/shape of lot
 - Placement of building/setbacks
 - Horizontal/vertical orientation
 - Access
- Elevations in historic districts can be coordinated to maintain historic spatial/architectural relationships

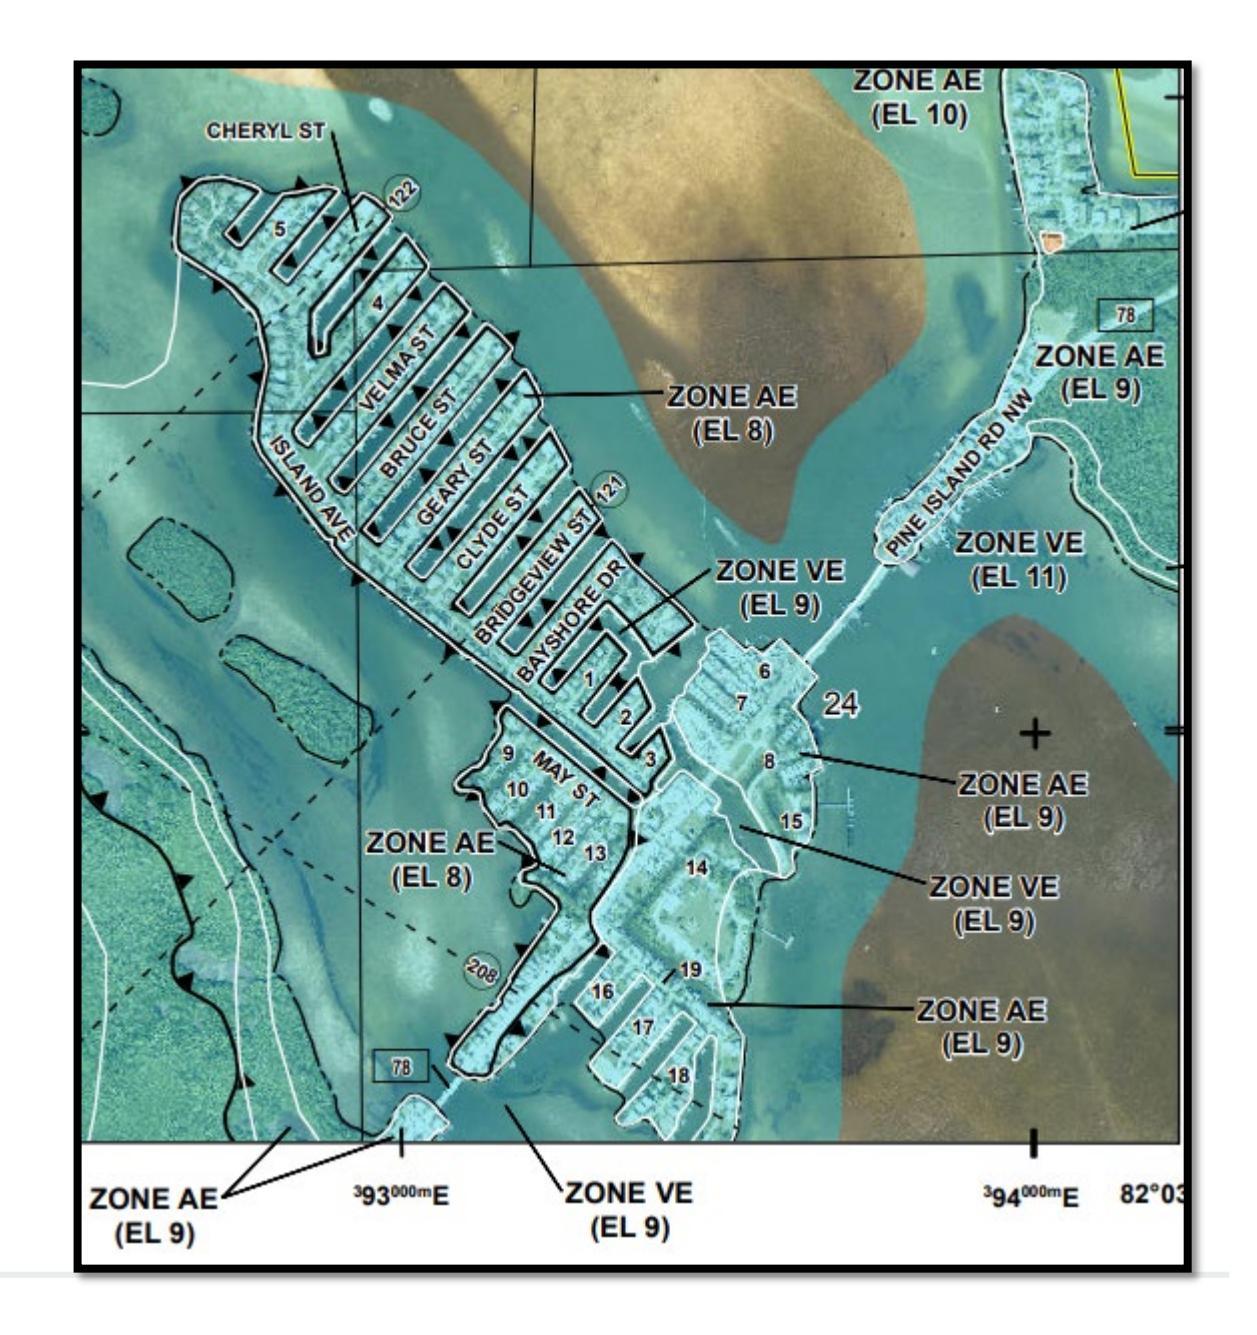
- Consider high water mark measurements for elevation standards
 - High water mark +/- 4 feet
- Also consider established
 NFIP BFEs
 - New NFIP maps effective today
