Lee County
Southwest Florida

**FINAL
POST STORM FLOOD ASSESSMENT
ANALYSIS**

**Bayshore Creek Watershed
Nalle Grade Road
Popash Creek Watershed
Strouds Creek Watershed
Whiskey Creek Watershed**

FEBRUARY 28, 2018

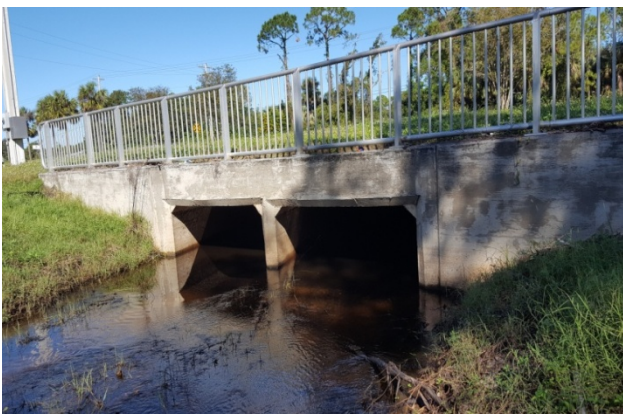
Clear box culverts under Bayshore Road looking north.
*Data Point 1494 Lat: 26.71478 Long: -81.8217

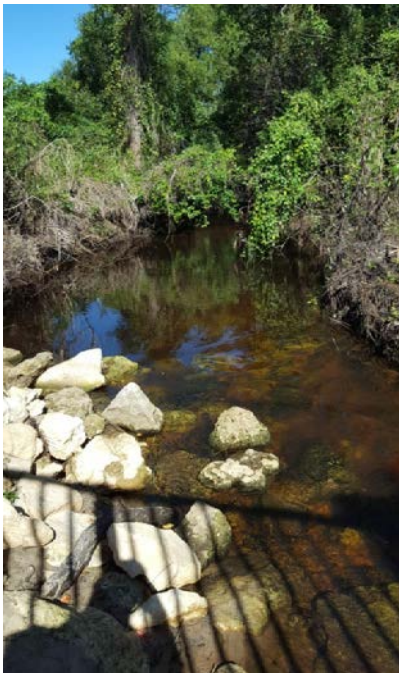
Picture is taken at the north culvert of Bayshore Road looking upstream.*Data Point 192 Lat: 26.71478 Long: -81.8217

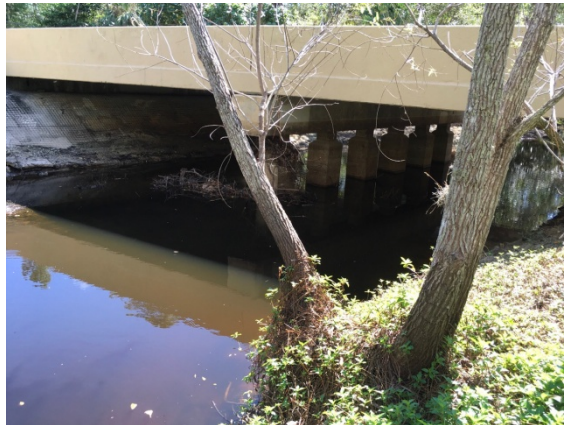
From North looking South under Daughtrey's Creek Bridge.
*Data Point 219 Lat: 26.7553 Long:-81.8514

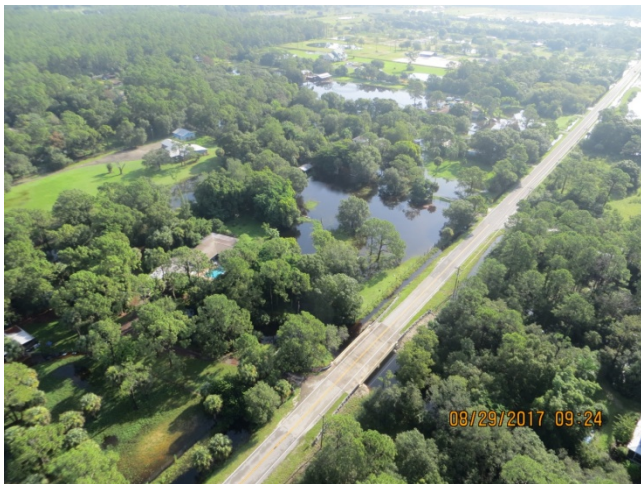
Lee Co. Aerial of Nalle Grade Road at Daughtrey’s Creek crossing
*Data Point 2084 Lat: 26.7553 Long:-81.8514

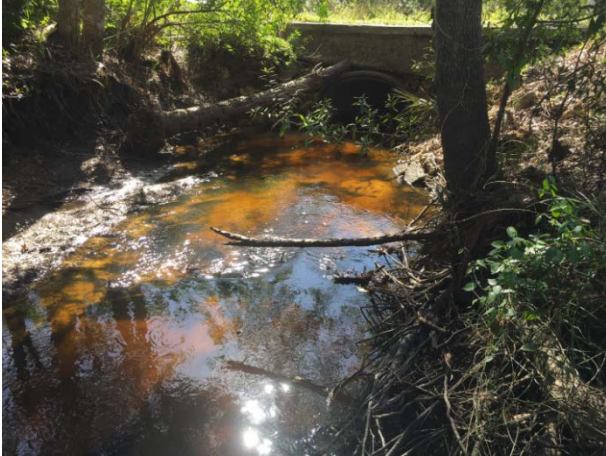
*Data Point 2084 Lat: 26.7568 Long:-81.8503

This view is looking South of resident's driveway access.

- 400 lineal feet of sediment removal from driveway culverts.
- Debris removal blocking driveway culverts.

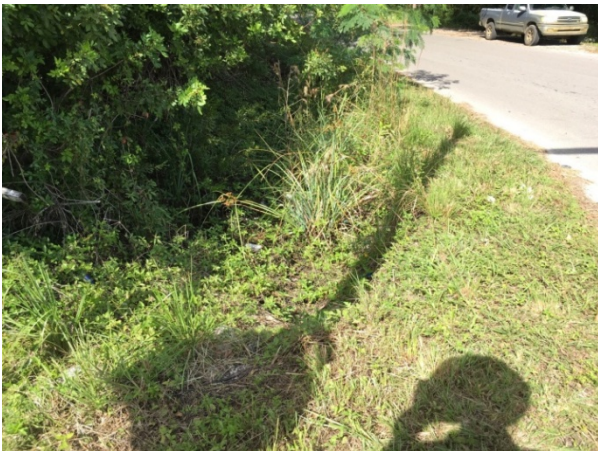
*Data Point 1553 Lat: 26.7555 Long:-81.8423

Road culvert on North side of Nalle Grade Road.

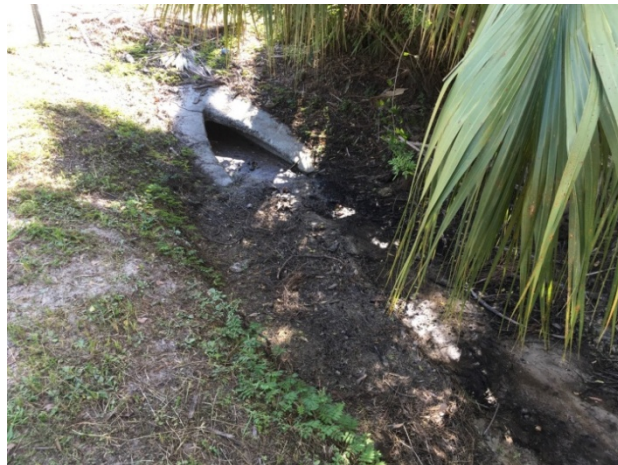
*Data Point 1552 Lat: 26.7555 Long: -81.8420

Road culvert on North side of Nalle Grade Road.

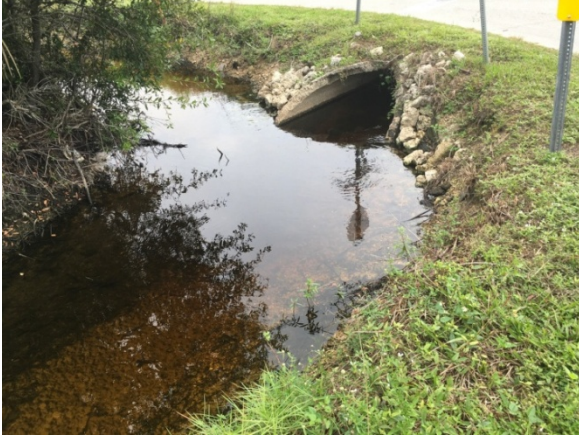
West of intersection at Nalle Grade Rd and Williams Dr.
*Data Point 1763 Lat: 26.7555 Long: -81.8260

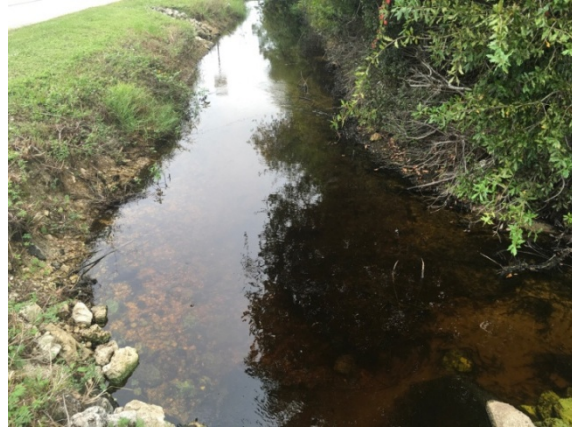
Looking West on West side of Nalle Grade Rd and Williams Dr.
*Data Point 1763 Lat: 26.7555 Long: -81.8260

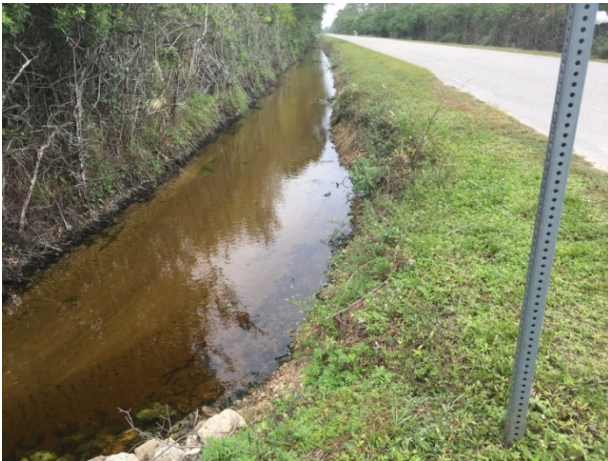
Looking North on West side of Nalle Grade Rd & Williams Dr.
*Data Point 1763 Lat: 26.7555 Long: -81.8260

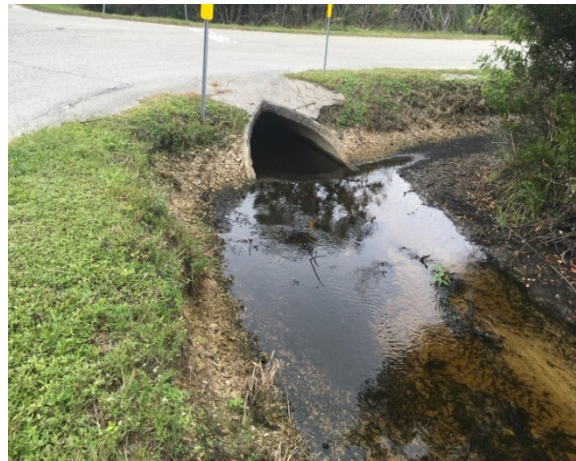
East side of Nalle Grade Rd & Williams Dr.
*Data Point 849 Lat: 26.7555 Long: -81.8260

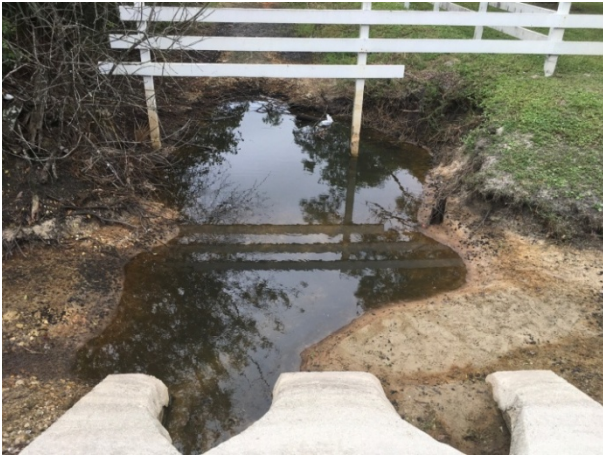
*Data Point 1773 Lat: 26.7554 Long:-81.8218

South of Nalle Grade Road culvert draining to Nalle Grade Park. Road culvert between Nalle Grade Park &

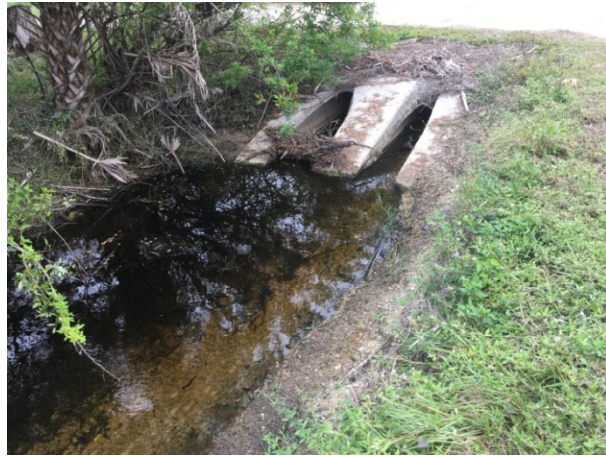
Bayshore Creek. *Data Point 1773 Lat: 26.7554 Long:-81.8218

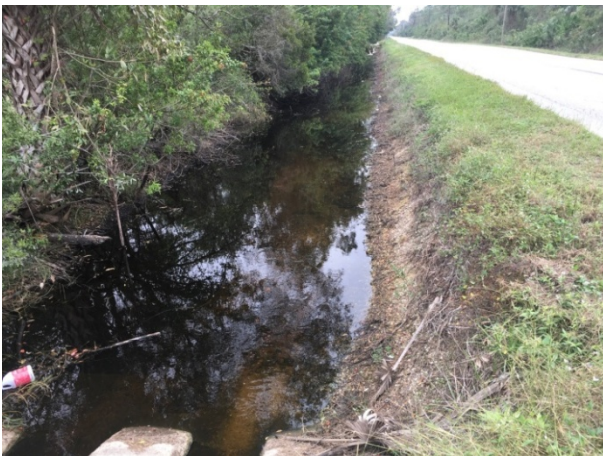
*Data Point 1773 Lat: 26.7554 Long:-81.8218

Easterly view before Nalle Grade Park.

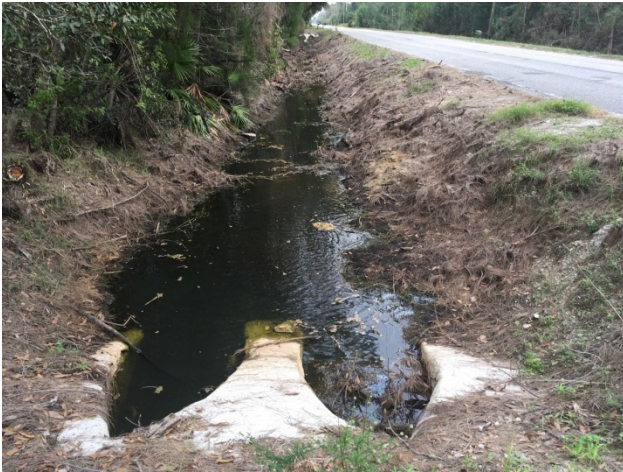
*Data Point 1777 Lat: 26.7555 Long: -81.8178

Looking East on the North side of Nalle Grade Road.

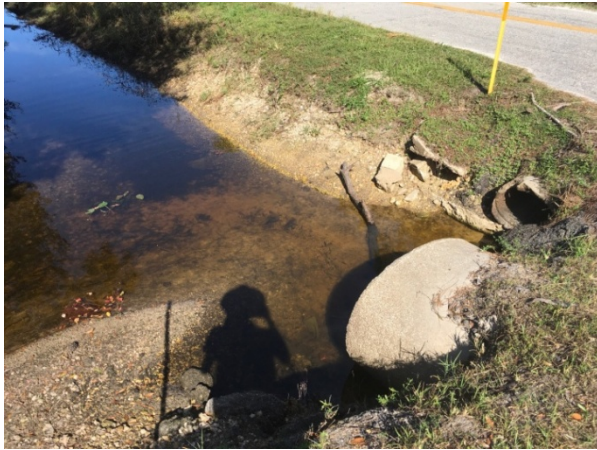
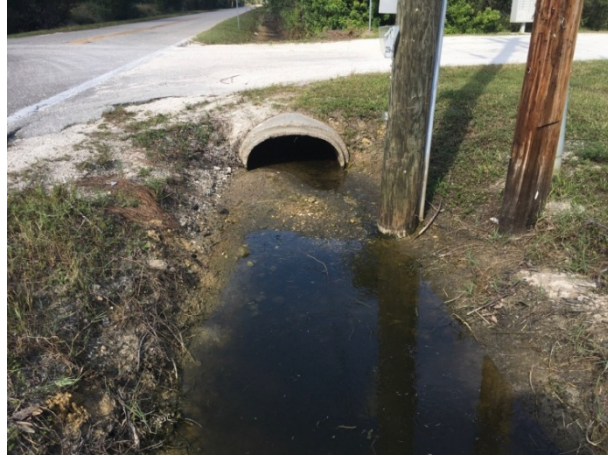
*Data Point 893 Lat: 26.7554 Long: -81.8017

Received from North & being forced West. Sediment build-up at SE corner of Nalle Rd. & Nalle Grade Rd. intersection

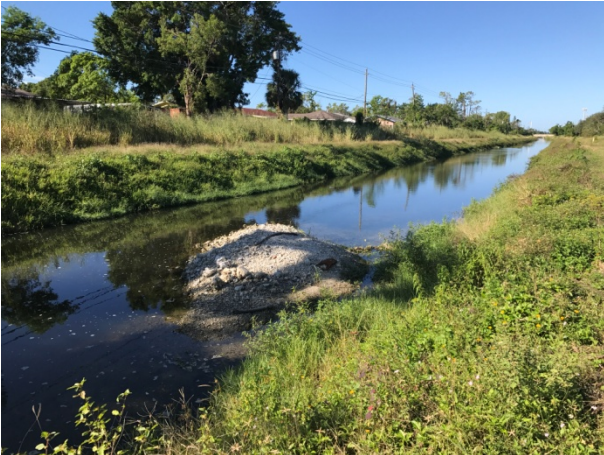
*Data Point A14 Lat:26.57537386 Long:-81.87604780

Examples of sediment:

L canal just w. of intersection w/ L3 canal, looking w.

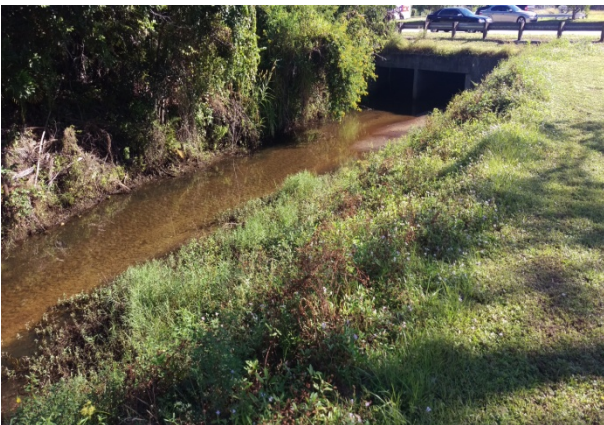
*Data Point A19 Lat:26.56065191 Long:-81.88466508

Brantley canal west of Summerlin Rd.
